# Styrax Fashions Ltd. (10244)

Plot # 194 DEPZ (Ext.), Ganakbari, Savar, Dhaka

09.MARCH.2014

**ACCORD**  
on Fire and Building Safety in Bangladesh

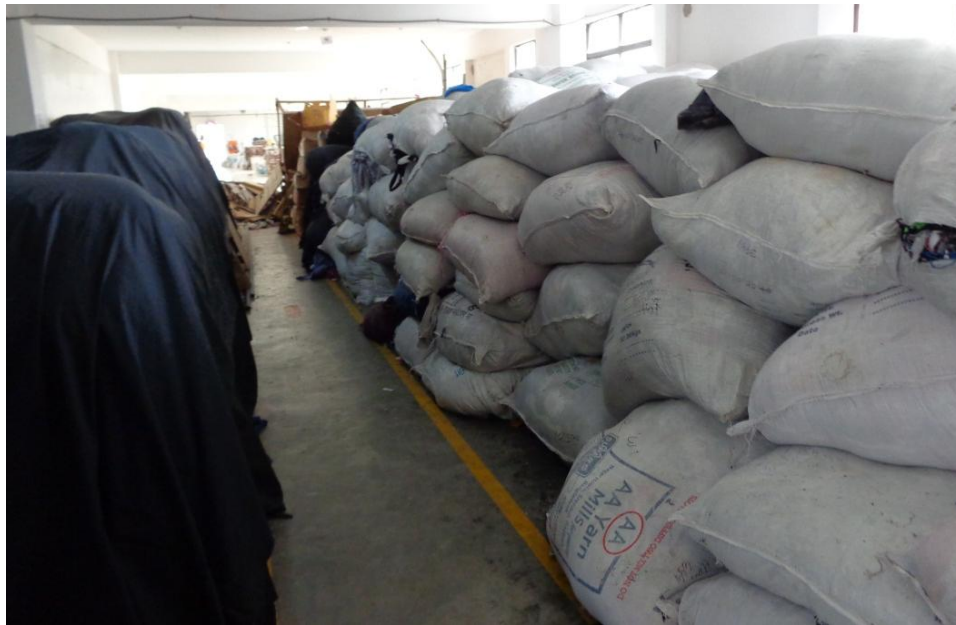
**High Storage Yields Low Column Safety Factors**

As determined using the observed steel reinforcement ratio and the strength appropriate for stone aggregate concrete, observed slab loading appears excessive. The resulting low column working stress safety factor warrants consideration.

**Low column working stress safety factor (result of excessive loading)**

Priority 1 Concern

**ITEM 3: (Priority 1) Column loading/capacity checks yield low safety factors, due to relatively high machine and storage loading at the 1<sup>st</sup> and 2<sup>nd</sup> stories.**

Column safety factors are low under observed loading, as a result of overloading at 1<sup>st</sup> and 2<sup>nd</sup> floor levels.

It should be noted that a removal of excess floor loadings down to the designed level ( $3\text{kN/m}^2$ ) would be sufficient to result in a 'green' rating for the column load run-down.

- Reduce storage and equipment loadings at the 1<sup>st</sup> and 2<sup>nd</sup> levels to no more than 3.0kN/m<sup>2</sup>

- Factory engineer to review design loads and column stresses.

- Produce and actively manage a loading plan for all floors within the factory giving consideration to slab and column capacity.

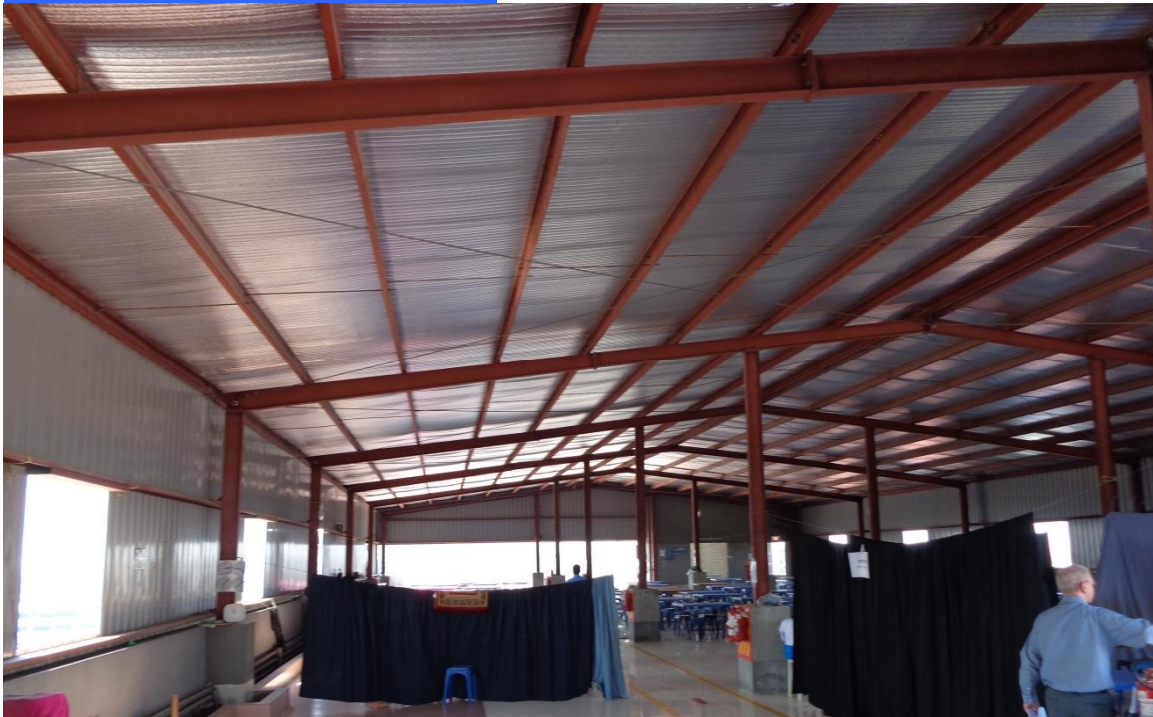
Lack of vertical bracing

There was present at the roof level a steel framed structure. Connections were observed to be poorly constructed. The structure had no lateral load restraint system.

Priority 2 Concern

- A detailed engineering assessment is to be performed upon the steel roof structure.

- Carry out any remedial measures or alteration works deemed necessary by the aforementioned structural assessment.

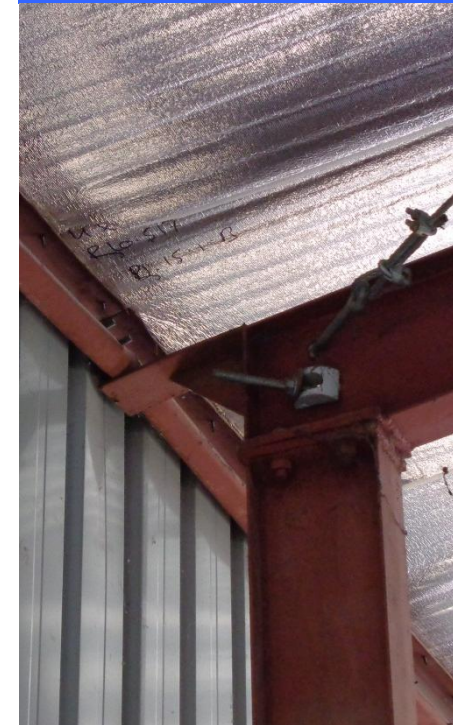
Poor connection detailing at steel roof structure

**ITEM 1: (Priority 2) At the steel roof structure connections were inconsistent and suspect in their capacity. Also, untightened anchor bolts were observed.**

The steel roof structure displays signs of overloading and connections are detailed in a poor fashion.

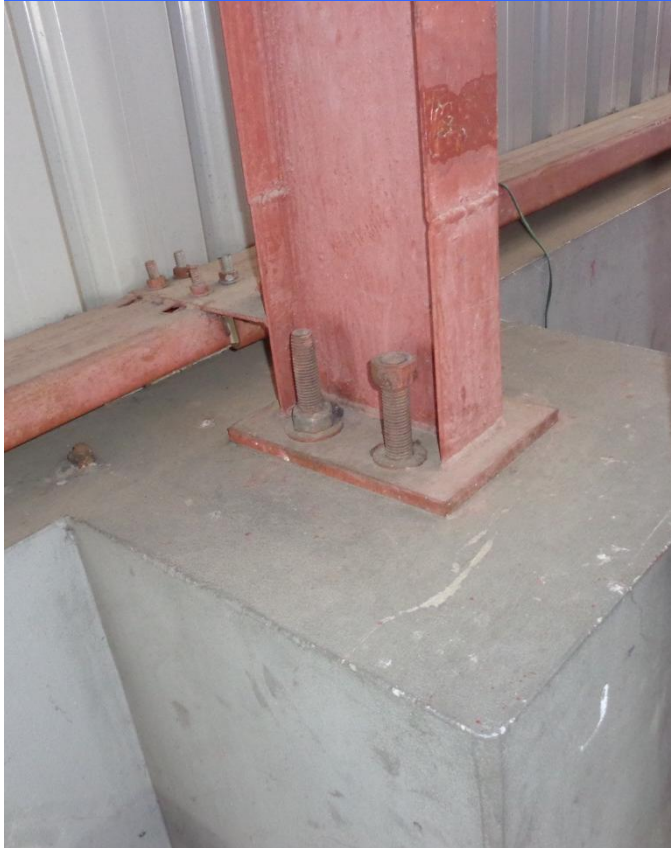
Nuts left loose on anchor bolts

Priority 2 Concern

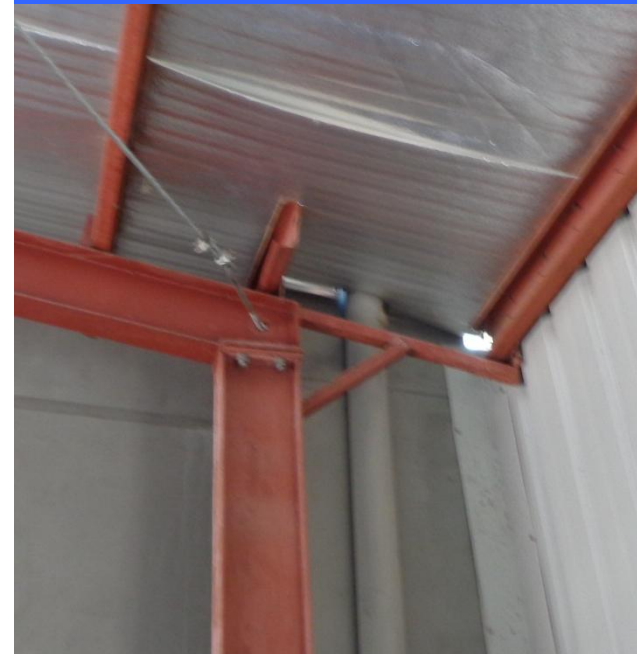
Poorly detailed steel framing

Priority 2 Concern

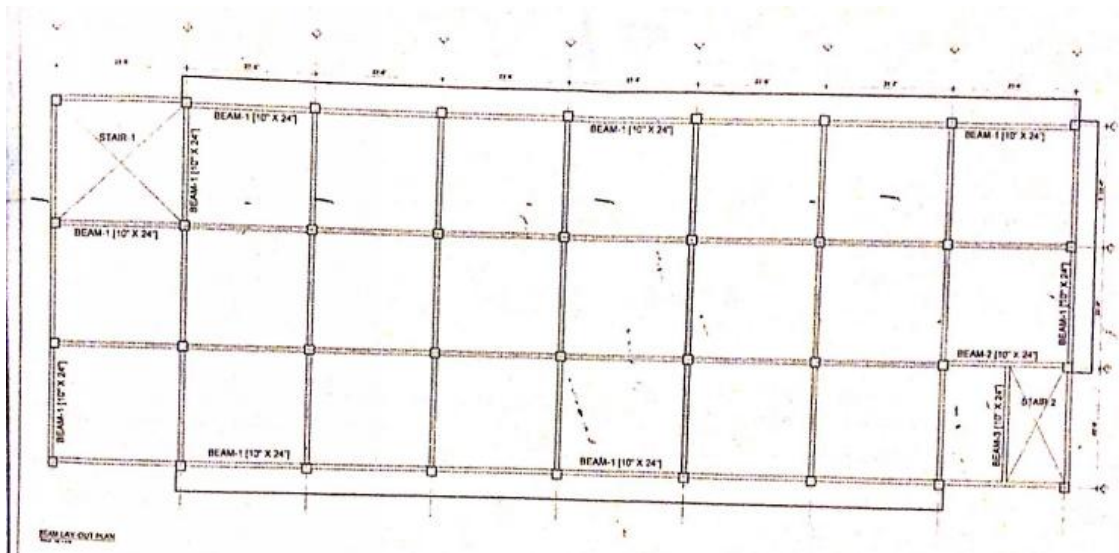
It was noted that the 1<sup>st</sup> & 2<sup>nd</sup> floor slabs were a flat slab arrangement and the 3<sup>rd</sup> to Roof slabs were a beam/slab arrangement. Structural Drawings show a beam/slab arrangement for typical floors and a flat slab arrangement at the 3<sup>rd</sup>, 4<sup>th</sup> & 5<sup>th</sup> floors.

In addition to this discrepancy, the structural drawings do not show the steel frame upon roof level.

Discrepancies between structural drawings and actual construction

**ITEM 2: (Priority 2) Examination of structural drawings and the provided loading certificate are inconsistent with the actual building construction and column capacities respectively.**

Drawings are inconsistent with actual construction.

- A detailed engineering assessment is to be conducted on the building in order to determine the capacity of the structure in its existing condition.

- Update the structural drawings to reflect the as-built conditions, and carry out any remedial measures deemed necessary by the aforementioned engineering assessment.

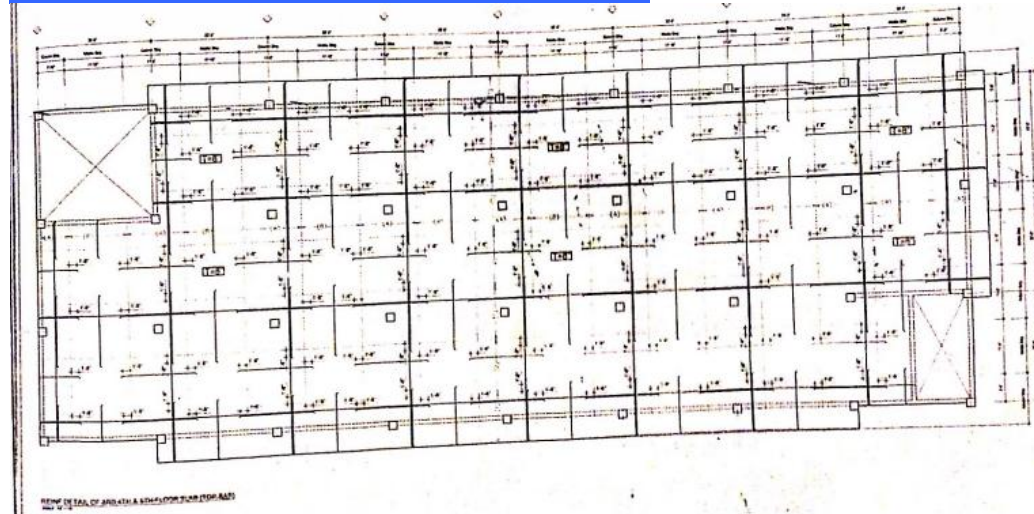
3<sup>rd</sup>, 4<sup>th</sup> & 5<sup>th</sup> Floor plan showing flat slab

**Discrepancies between structural drawings and actual construction**

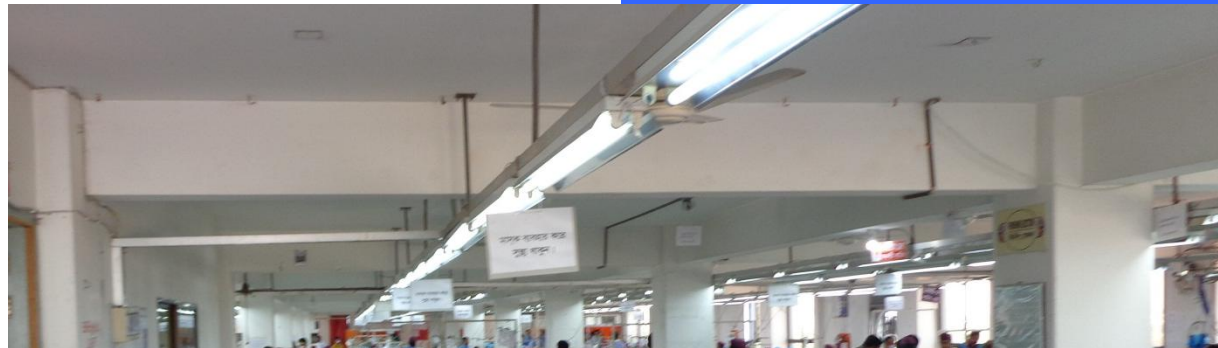
Underside of 4<sup>th</sup> floor showing beam-slab arrangement
