# Dekko Ready Wear Ltd (9185)

Plot #M/1, Road #7, Section #7, Mirpur, Dhaka, 1216, Bangladesh

12.MARCH.2014

## Identified Priority 1 Concerns

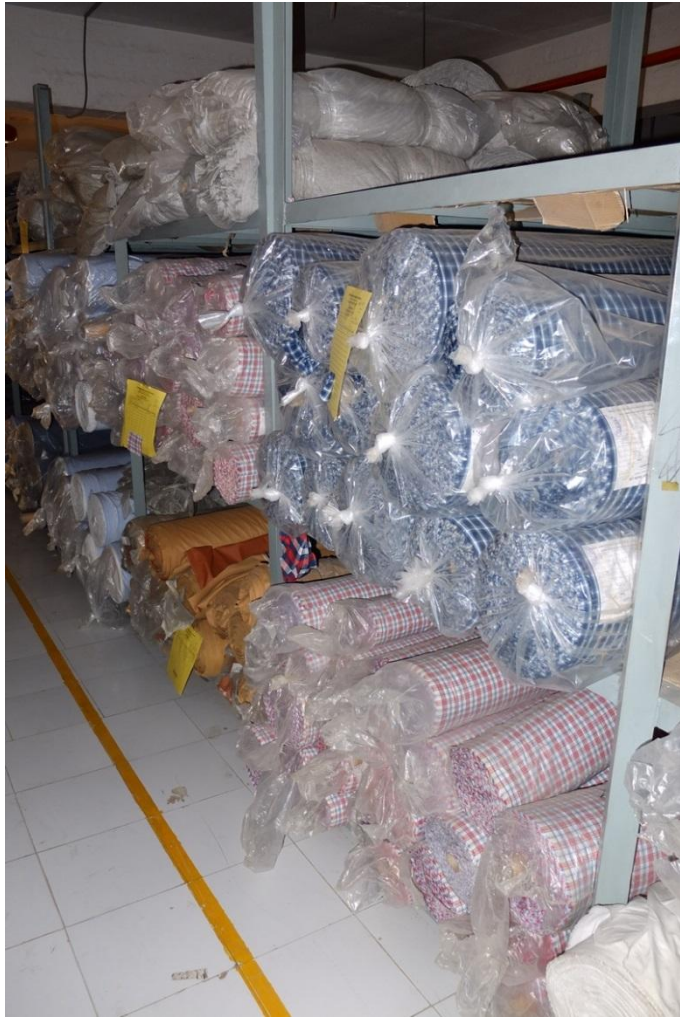
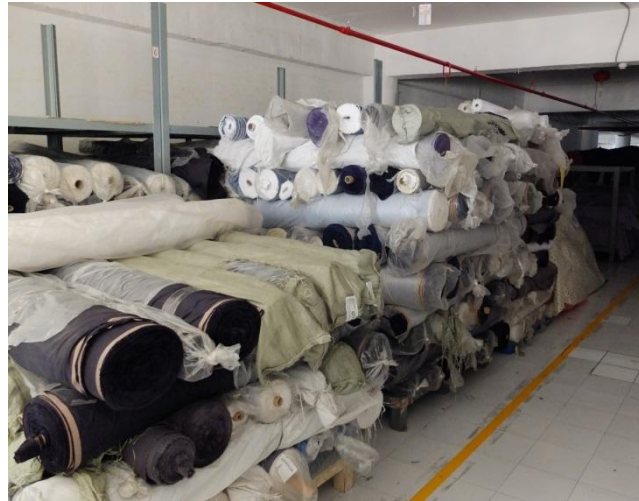
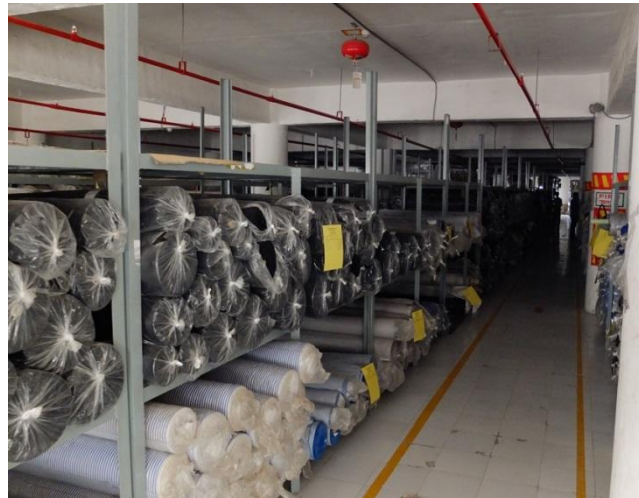
The bonded warehouse area covered a significant portion of the floor area, and was occupied by a lot of fabric rolls. It was estimated that the imposed load from the fabric in some areas far exceeded the permissible floor loading of the floor (taken to be 3.0kPa), being as much as 6.5kPa in localised areas. It was instructed to spread out the storage of the fabric rolls as much as possible and to try not to use the upper racks if at all possible

**Excessive storage of Fabric in Bonded Storage Area on 8/F**

**ITEM 1: (1<sup>st</sup> Priority 1) Storage height of fabric in bonded store had exceeded allowable live load limit.**

- Reduce the stacking height of the fabric rolls to ensure that the loading from the fabric does not exceed 300kg/m<sup>2</sup> at any area.

- Building Engineer to check structural capacity of floor elements to establish actual structural capacity, and then implement loading demarcation plan for the storage area in particular.

- Maintain loading plan and check for non-compliance.
