INITIAL STRUCTURAL INTEGRITY ASSESSMENT REPORT (SIAR)

Factory Name: **Rupa Fabrics Ltd**

Assessor: **Bureau Veritas**

Date: **29 May 2014**

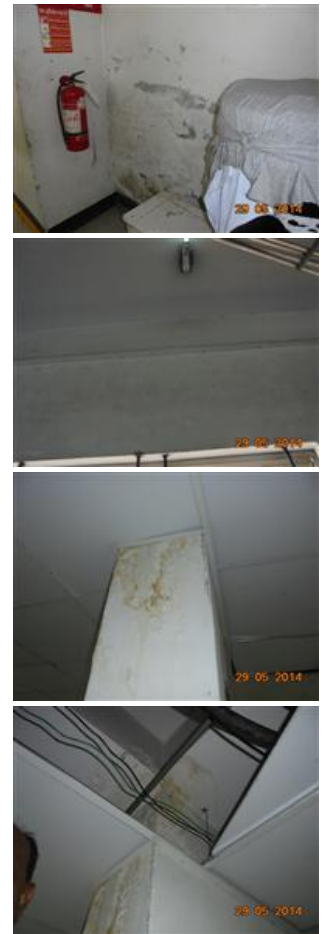
Question:	Have all areas of needed maintenance, including areas with efflorescence, dampness, standing water on rooftops, and corrosion been addressed.
Priority Level:	Medium
Non-Compliance Level:	1
Description:	Dampness was noted in the buildings in the following locations: Building 1: Ceiling of Level 1, walls of Level 9 and ground floor. Building 3: Wall of Level 1. Building 4: Column and beams at the Basement Level.
Source of Findings:	Photograph: Dampness at different building locations.
Suggested Plan of Action:	
Suggested Deadline Date:	
Standard:	Alliance Standard Part 8 Section 8.26 Durability and Maintenance

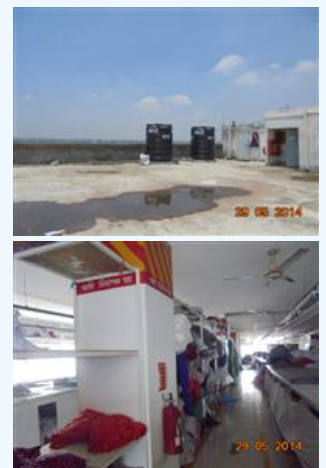
Question:	Are all non-structural elements suspended from, attached to, or resting atop the structure adequately anchored and braced to resist earthquake forces?
Priority Level:	Medium
Non-Compliance Level:	1
Description:	The following elements were noted to not contain adequate bracing or anchorage to resist seismic forces: -Building 1: 4 plastic water tanks at rooftop, storage racks at Level 7.
Source of Findings:	Photograph: Unbraced and unanchored elements.
Suggested Plan of Action:	
Suggested Deadline Date:	
Standard:	Alliance Standards Part 8 Section 8.18 Seismic Bracing of Key Non-Structural Elements and 2006 BNBC Part 6
