# INITIAL STRUCTURAL INTEGRITY ASSESSMENT REPORT (SIAR)

Factory Name: **SOUTH EAST TEXTILES (PVT.) LTD.**  
Address: **GORAI, MIRZAPUR, TANGAIL BANGLADESH**  
Assessor: **Sumerra**  
Date: **28 May 2014**

## ASSESSMENT FINDINGS

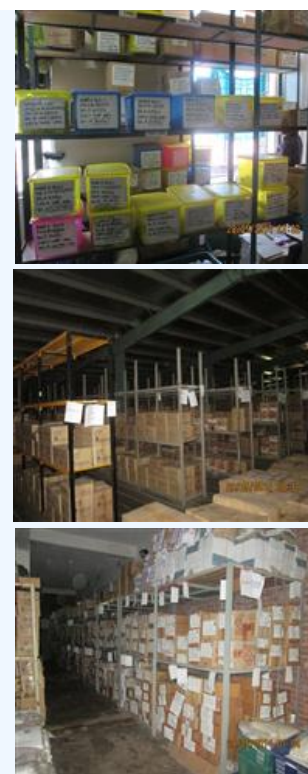
Question:	Are all non-structural elements suspended from, attached to, or resting atop the structure adequately anchored and braced to resist earthquake forces?
Priority Level:	Medium
Non-Compliance Level:	2
Description:	The following structures are not properly braced/anchored: Building 1: Accessories Racks - GF, 1st Floor, 4th floor Building 2: Accessories Racks, 2nd Floor Building 3: Accessories Racks, GF
Source of Findings:	Photograph: Accessories Racks
Suggested Plan of Action:	Adequately anchor and brace all non-structural elements such as the rack systems to resist earthquake forces to comply with the BNBC and Alliance Standard.
Suggested Deadline Date:	30 Nov 2014
Standard:	Alliance Standards Part 8 Section 8.18 Seismic Bracing of Key Non-Structural Elements and 2006 BNBC Part 6
