# FIRE SAFETY INSPECTION REPORT

**TEB FASHION INTERNATIONAL LTD**  
**HAJI AFAJUDDIN BHUIYAN PLAZA (3RD TO 5TH**  
**FLOOR)**  
**99 MOLLARTEK, DAKKHIN KHAN, DHAKA-1230,**  
**BANGLADESHA**

**ACC**   **RD**  
on Fire and Building Safety in Bangladesh

February 28, 2014

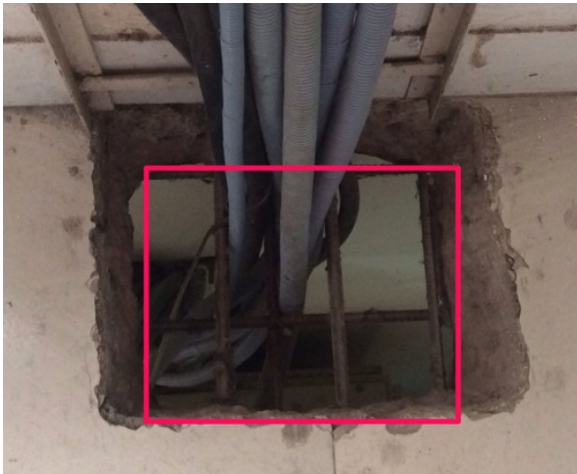
F-1	Fire Rated Construction	Unsealed penetrations and openings are located in the fire-rated floor/ceiling assemblies.	Provide a minimum 2-hr fire-rated shaft to separate the utility risers from each floor level.	Within 3 months
-----	-------------------------	--	---	-----------------

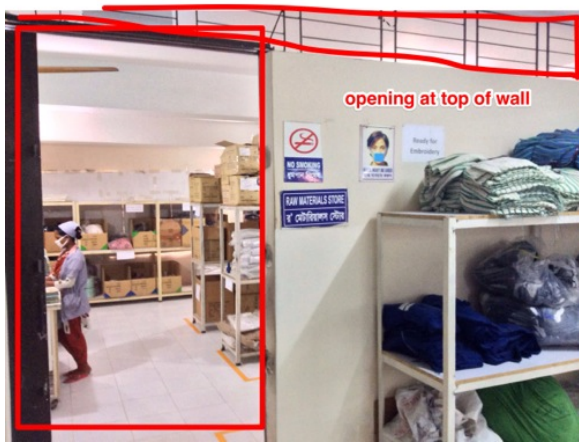
F-2	Fire Rated Construction	Areas used for combustible storage are not completely separated by fire-rated construction.	Provide dedicated storage rooms separated by minimum 1-hr fire-rated construction.	Within 3 months
-----	-------------------------	---	--	-----------------

The storage area on the 3rd floor needs to have the masonry walls go up to the ceiling slab and a fire rated door is required.

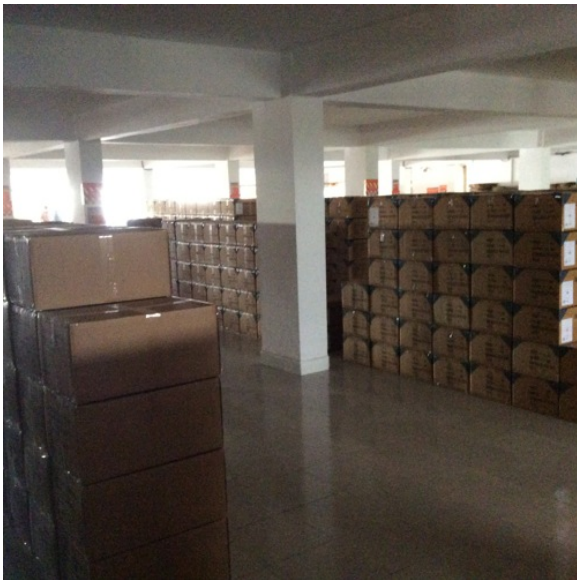
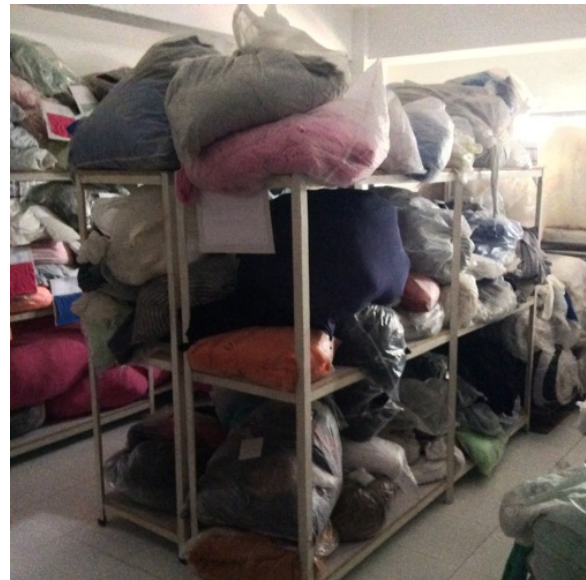
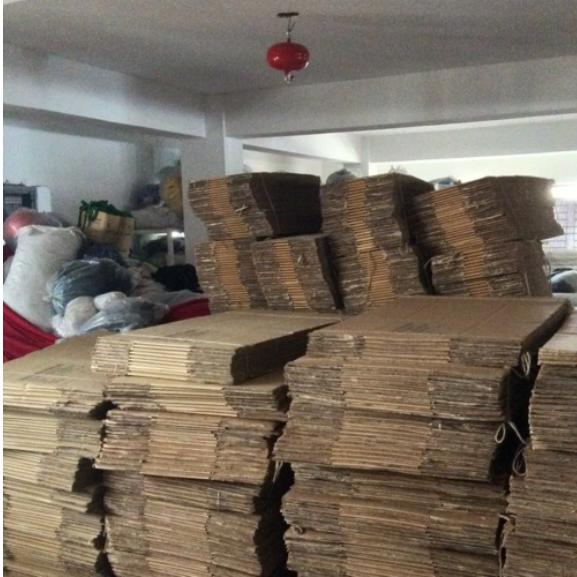
F-3	Fire Rated Construction	<p>Areas used for combustible storage are not separated by fire-rated construction from dining area and other manufacturing areas on the 5th floors. There are also dedicated storage rooms on the 5th floor that would need appropriate separation if the dining and manufacturing areas are retained.</p>	<p>Provide dedicated storage rooms separated by minimum 1-hr fire-rated construction between the storage and the dining and manufacturing areas. Alternatively, the dining area and the small manufacturing areas could be relocated off the 5th floor and the 5th floor could be dedicated for storage thus avoiding the need of occupancy separations.</p>	Within 3 months
-----	-------------------------	---	--	-----------------

Where separate storage rooms are not feasible, provide defined storage areas and limit the storage arrangement as follows:  
 - Maximum height of 2.4m and maximum area of 23m<sup>2</sup>

Separate areas of unenclosed combustible storage by a minimum clear distance of 3m.

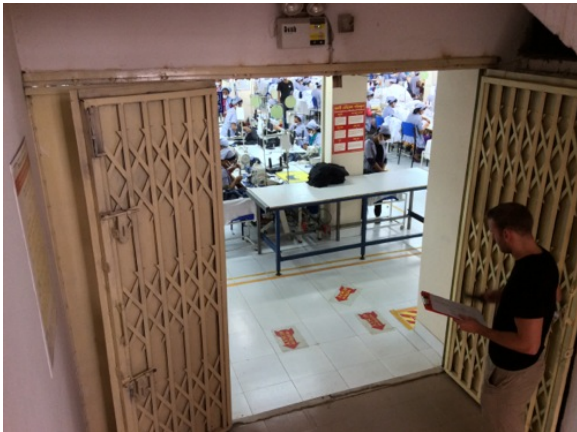
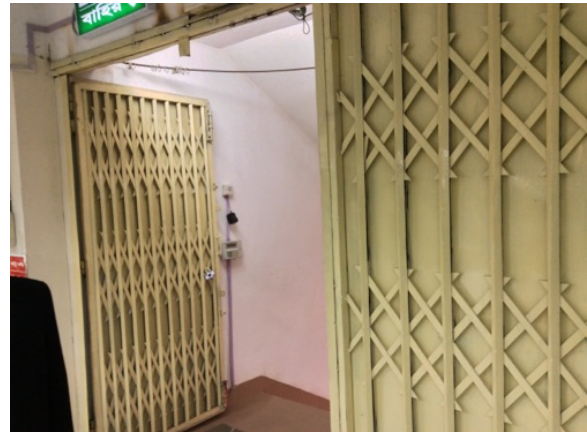
F-4	Fire Rated Construction	The exit stairs are not separated from the factory areas on the 3rd, 4th, and 5th floors on by fire-rated construction.	<p>Provide minimum 1.5-hr fire rated doors and seal all unprotected openings to separate the exit stairs from work areas and other building spaces on all floor levels. Ensure that the fire doors are self-closing and positive latching and that they are provided with fire exit (panic) hardware where serving production floors.</p> <p>If fire doors are required to be held open for functional reasons, provide automatic-closing devices tied to the fire alarm system.</p>	Within 3 months
-----	-------------------------	---	--	-----------------

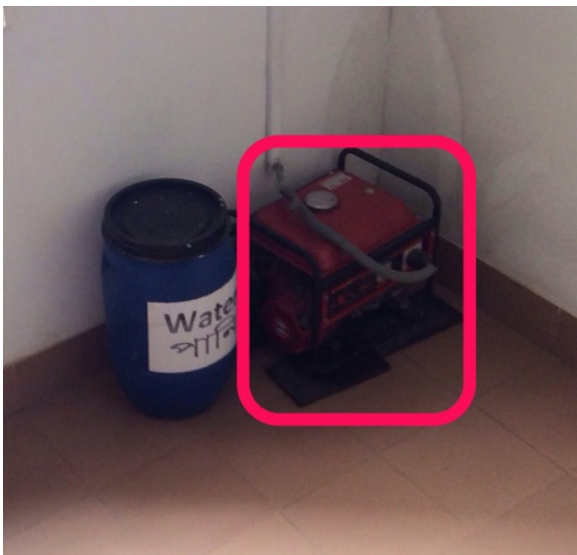
F-5	Egress	Small emergency generator was seen located in the north exit stair.	Remove all storage from exit stairs and egress paths.	Immediate
-----	--------	---	---	-----------

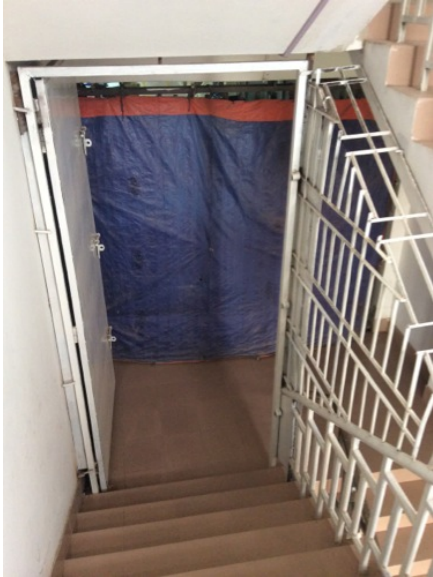
F-6	Egress	Locking gates are located in the stairways between the 2nd and 3rd floor landings in all three stairs. Gates were open and unlocked at the time of the inspection.	Completely remove intermediate gates in all three stairways.	Immediate
-----	--------	--	--	-----------

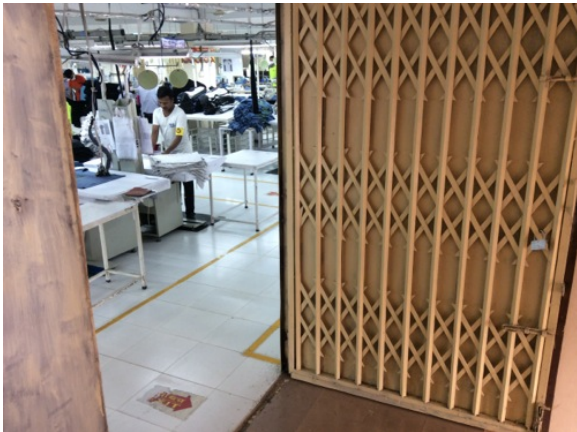
F-7	Egress	<p>Egress doors with locking features are provided at each of the three exits on all three floors. Exit doors should not be lockable unless locks comply with NFPA 101 requirements.</p>	<p>Remove locking features from all egress doors / gates.</p> <p>If locks are required for security reasons, utilize special door locking features complying with NFPA 101.</p>	Immediate
		<p>All exits were open and unlocked at the time of the inspection. Exit doors all swing in the direction of egress.</p>

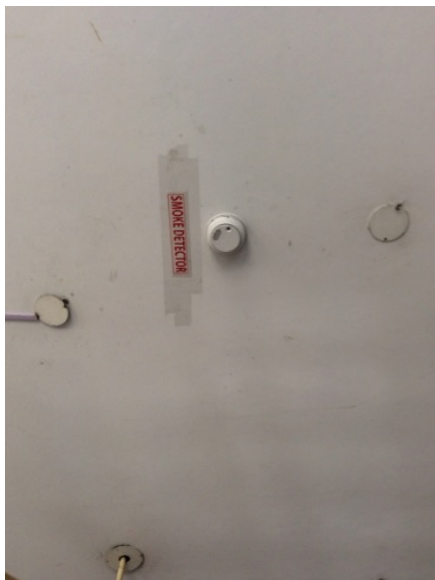
F-11	Fire Protection	The building is equipped with single-station smoke alarms. Smoke alarm activation sounds only a local alarm and does not provide automatic fire alarm notification of occupants.	Remove single-station smoke alarms. Provide automatic smoke detection throughout the building in accordance with NFPA 72.	Within 6 months
------	-----------------	--	---	-----------------

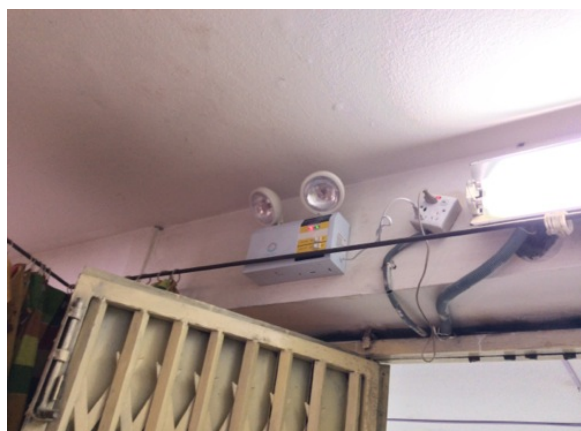
F-12	Egress Lighting	Emergency light at the 4th floor north stair had one burned out light bulb when unit was placed into test mode.	Regularly test the emergency lighting system on each floor and replace/repair lights as needed.	Immediate
------	-----------------	---	---	-----------
