# **FIRE SAFETY INSPECTION REPORT**

**ONUS GARMENTS LTD.**

**ACCORD**  
on Fire and Building Safety in Bangladesh

June 15, 2014

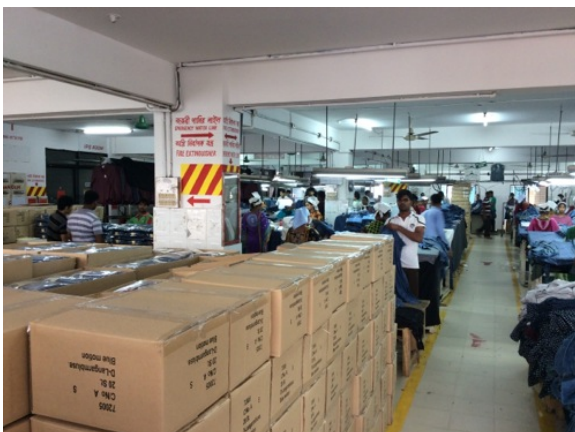
| No. | Category | Finding | Recommendation | Remediation Timeframe |
|---|---|---|---|---|
| F-1 | Fire Rated Construction | Areas used for combustible storage on floors 2 and 3 are not separated by fire-rated construction. | <p>Provide dedicated storage rooms separated by minimum 1-hr fire-rated construction.</p> <p>Where separate storage rooms are not feasible, provide defined storage areas and limit the storage arrangement as follows:</p> <ul style="list-style-type: none"> <li>- Maximum height of 2.4m and maximum area of 23m<sup>2</sup></li> <li>- If sprinkler protected: maximum height of 3.66m and maximum area of 93m<sup>2</sup></li> </ul> <p>Separate areas of unenclosed combustible storage by a minimum clear distance of 3m.</p> | Within 3 months |

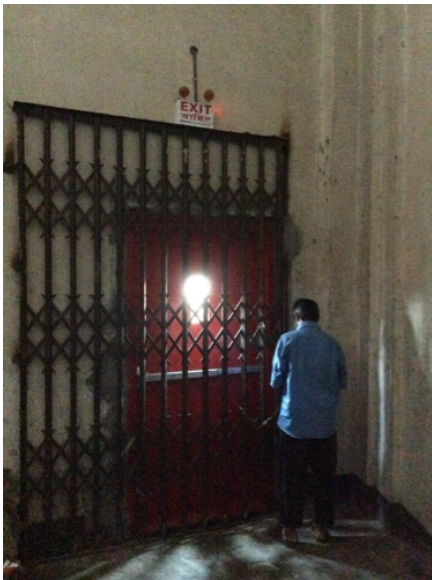
| F-2 | Egress | <p>Egress gates with locking features are provided at roof, mezzanine, and dining room exits.</p> <p>Two sliding gates were locked along the egress route from the dining room during the inspection.</p> | <p>Remove locking features from all egress doors / gates.</p> <p>If locks are required for security reasons, utilize special door locking features complying with NFPA 101.</p> | Immediate |

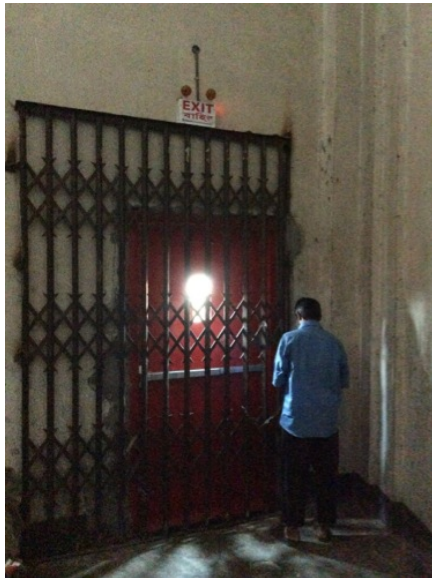
| F-3 | Egress | <p>Collapsible and sliding gates are provided at roof, mezzanine, and dining room exits.</p> | <p>Replace all collapsible gates along the means of egress with side-hinged, swinging egress doors.</p> <p>If locks are required for security reasons, utilize special door locking features complying with NFPA 101.</p> | Within 3 months |

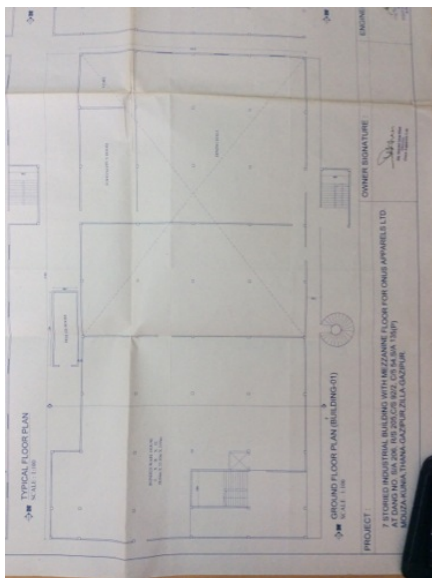
| F-4 | Egress | The two exit stairs are not remotely located from each other such that a single fire event could compromise both exits. | Provide additional exit(s).<br><br>OR<br><br>Provide sprinkler protection in accordance with NFPA 13. | Within 6 months |

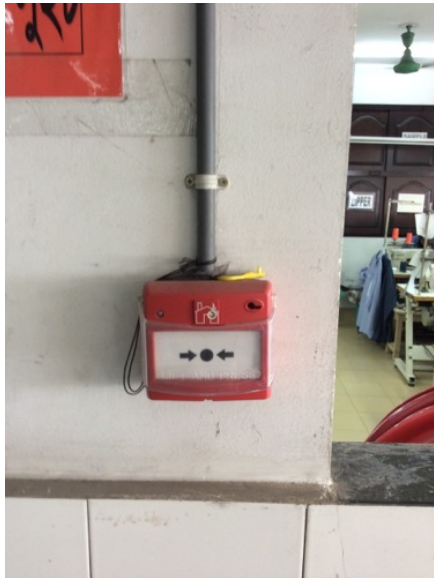
| F-5 | Fire Protection | Inspection, testing, and maintenance for the fire alarm system was not in accordance with NFPA 72. | Inspect, test and maintain the fire alarm system, and keep written records on-site, in accordance with NFPA 72. | Within 3 months |

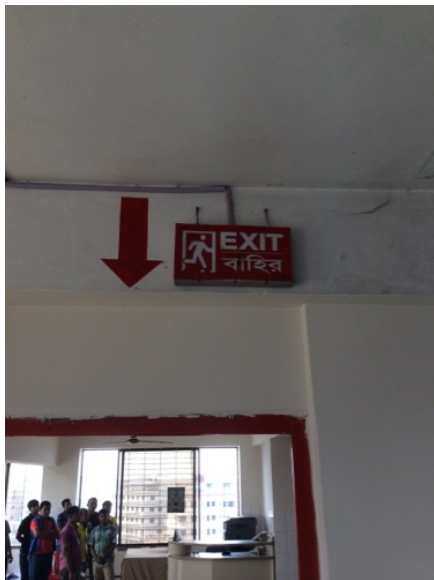
| F-6 | Egress Lighting | Exit signage not illuminated (burned out, broken, etc.) in multiple locations. | Regularly inspect all exit signage and replace/install lights as needed to illuminate signs. | Within 1 month |

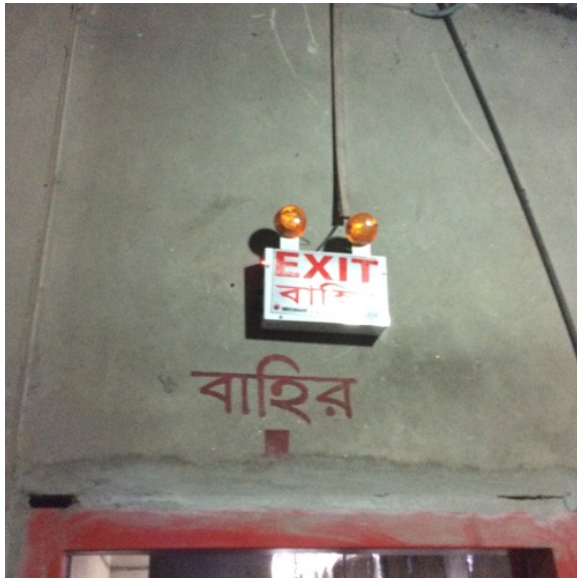
| F-7 | Egress Lighting | Inspection, testing, and maintenance records for the emergency lighting system were not in accordance of the ACCORD standards. | Inspect, test and maintain the emergency lighting system in accordance with The ACCORD standard. Keep written records on-site. | Within 3 months |
