FIRE SAFETY INSPECTION REPORT

**LIFE TEXTILE (PVT.) LTD.
69,70,71 BSCIC INDUSTRIAL ESTATE, KONABARI,
GAZIPUR**

June 18, 2014

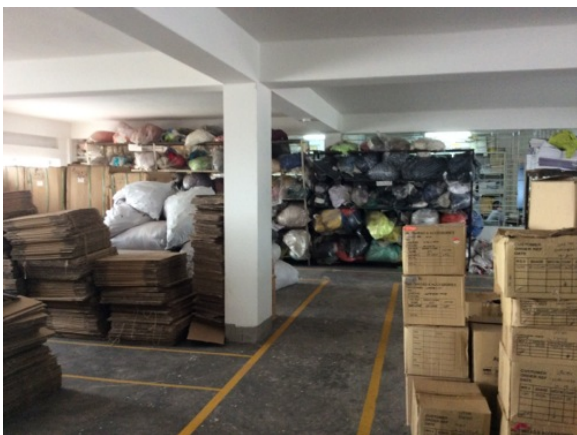
No.	Category	Finding	Recommendation	Remediation Timeframe
F-1	Fire Rated Construction	Areas used for combustible storage on all floors are not separated by fire-rated construction.	<p>Provide dedicated storage rooms separated by minimum 1-hr fire-rated construction.</p> <p>Where separate storage rooms are not feasible, provide defined storage areas and limit the storage arrangement as follows:</p> <ul style="list-style-type: none"> - Maximum height of 2.4m and maximum area of 23m² - If sprinkler protected: maximum height of 3.66m and maximum area of 93m² <p>Separate areas of unenclosed combustible storage by a minimum clear distance of 3m.</p>	Within 3 months

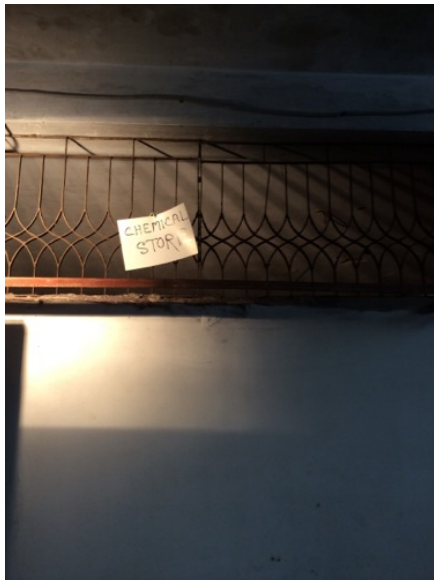
F-2	Fire Rated Construction	Hazardous materials area is not separated by fire-rated construction.	Separate the hazardous materials storage by a minimum 2-hr fire-rated construction. Seal and/or protected all openings to maintain the required fire separations.	Within 3 months
-----	-------------------------	---	---	-----------------

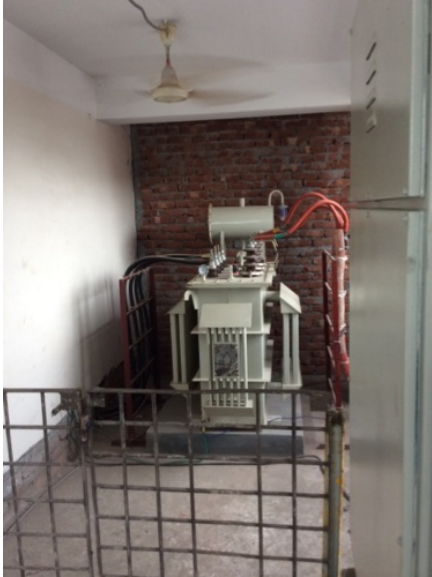
F-3	Fire Rated Construction	The boiler, generator, and transformer rooms are not separated by fire-rated construction from an exit stairwell.	Separate the boiler, generator, and transformer rooms by a minimum 2-hr fire-rated construction. Seal and/or protected all openings to maintain the required fire separations	Within 3 months
-----	-------------------------	---	---	-----------------

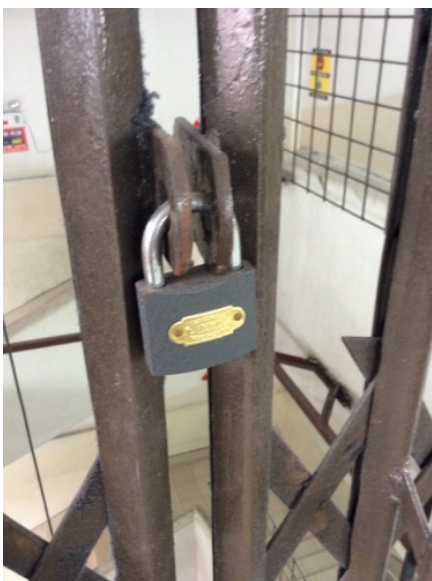
F-4 Egress

Egress gates with locking features are provided at roof, mezzanine, and dining room exits.

Two sliding gates were locked along the egress route from the dining room during the inspection.

Remove locking features from all egress doors / gates.

If locks are required for security reasons, utilize special door locking features complying with NFPA 101.

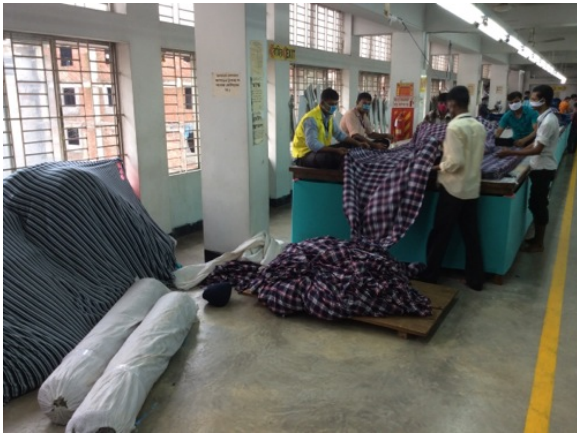
F-5	Egress	Storage was located in the egress path on floor 4.	Keep egress paths and stairs clear of storage.	Immediate
-----	--------	--	--	-----------

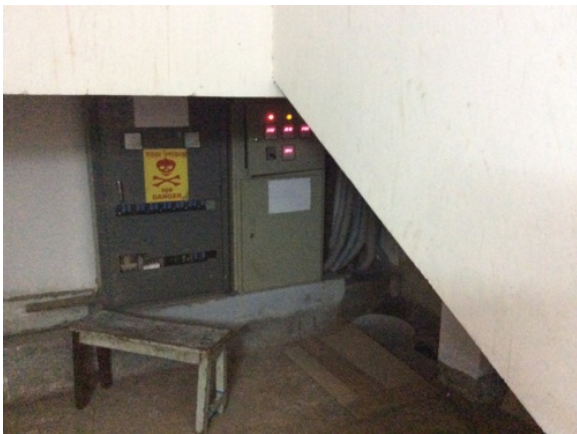
F-6	Egress	Storage and an electrical panel was located in the East exit stair on floor 1.	Remove all storage from exit stairs and egress paths. Relocate or provide separation for electrical panel.	Immediate
-----	--------	--	--	-----------

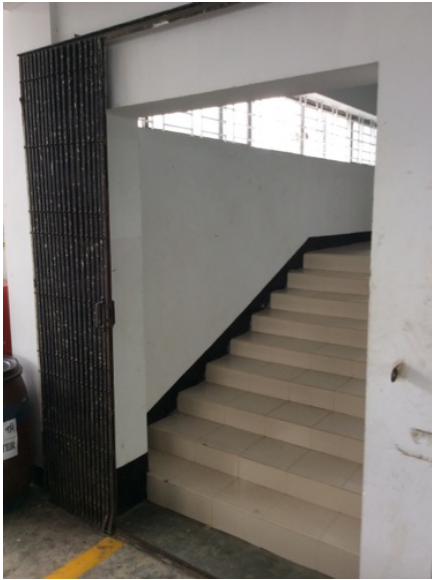
F-7	Egress	Collapsible and sliding gates are provided at roof, mezzanine, and dining room exits.	Replace all collapsible gates along the means of egress with side-hinged, swinging egress doors.	Within 3 months
-----	--------	---	--	-----------------

If locks are required for security reasons, utilize special door locking features complying with NFPA 101.

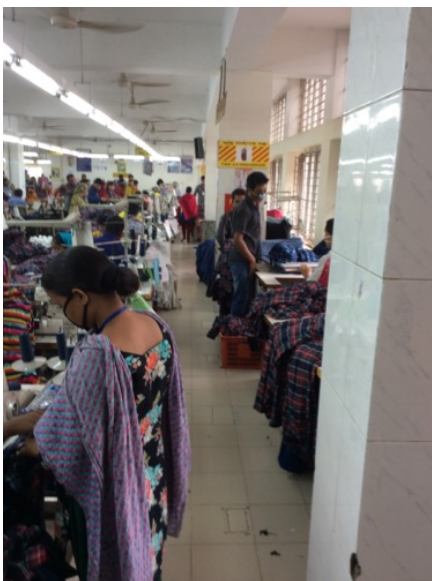
F-8	Egress	The width of egress aisles is less than 36-in. on floors 4 and 2.	Provide minimum aisle widths of 36-in.	Within 3 months
-----	--------	---	--	-----------------

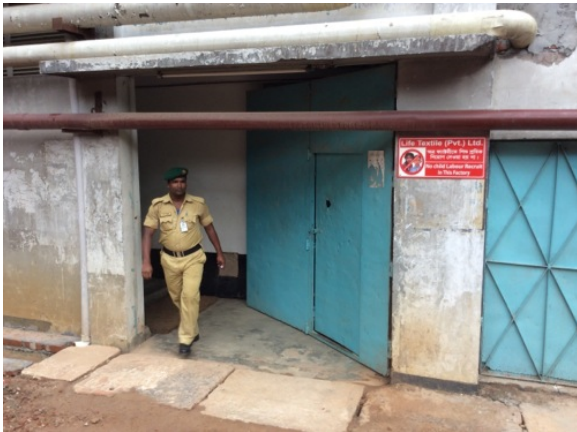
F-9	Egress	Exit discharge door of the East stair does not swing in the direction of egress travel.	Modify the egress door to swing in the direction of egress travel.	Within 3 months
-----	--------	---	--	-----------------

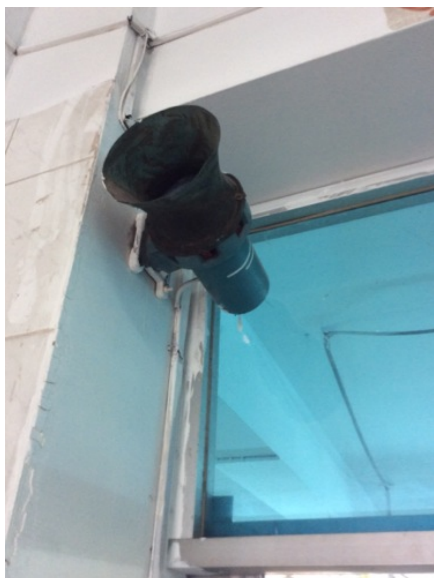
F-10	Fire Protection	The fire alarm system is antiquated, not a listed system, and does not provide alarm and notification features consistent with acceptable standards.	Replace the fire alarm system with a new, listed addressable fire alarm system in accordance with NFPA 72.	Design within 4 months, install within 9 months
------	-----------------	--	--	---

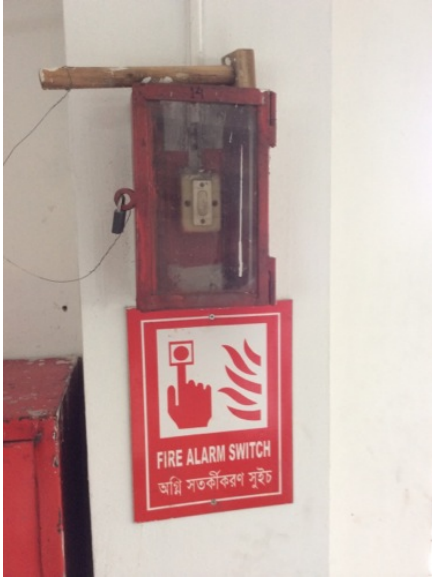
F-11	Fire Protection	Inspection, testing, and maintenance for the fire alarm system was not in accordance with NFPA 72.	Inspect, test and maintain the fire alarm system, and keep written records on-site, in accordance with NFPA 72.	Within 3 months
------	-----------------	--	---	-----------------

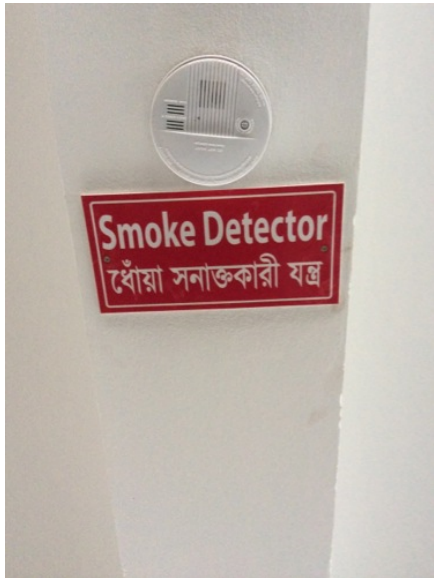
F-12	Fire Protection	The building is equipped with single-station smoke alarms. Smoke alarm activation sounds only a local alarm and does not provide automatic fire alarm notification of occupants.	Remove single-station smoke alarms. Provide automatic smoke detection throughout the building, tied into the fire alarm system, in accordance with NFPA 72.	Within 6 months
------	-----------------	--	---	-----------------

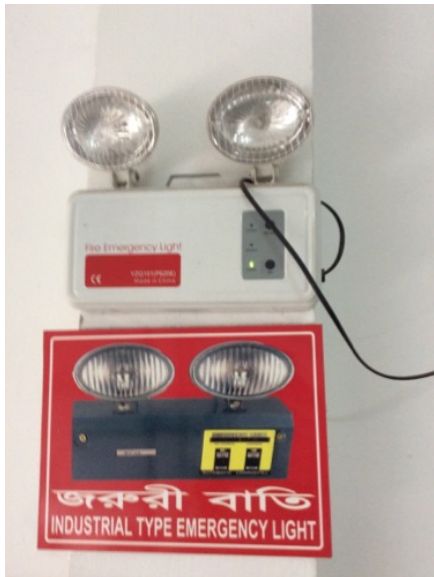
F-13	Egress Lighting	Some emergency lighting was missing and some were discovered to have burned out bulbs in test mode.	Regularly test the emergency lighting system on each floor and replace/repair lights as needed.	Within 1 month
------	-----------------	---	---	----------------

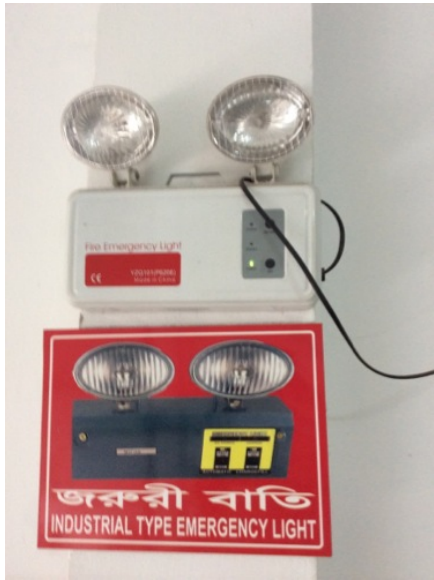
F-14	Egress Lighting	Inspection, testing, and maintenance records for the emergency lighting system were not in accordance of the ACCORD standards.	Inspect, test and maintain the emergency lighting system in accordance with The ACCORD standard. Keep written records on-site.	Within 3 months
------	-----------------	--	--	-----------------
