# ELECTRICAL SAFETY INSPECTION REPORT

**KNIT BAZAR (PVT.) LTD.**

**40/41, Vadam, Tongi, Gazipur, Bangladesh.**

**Inspected on April 5, 2014**

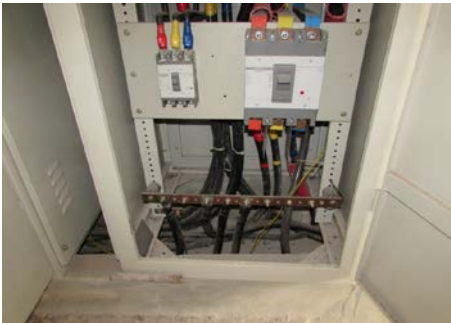
| <b>Finding:</b><br>Earth bonding and base plate of panel are missing. | |

| <b>Recommendation:</b><br>Provide earth connection for body and doors of metallic distribution boards using green cables preferably braid so that the metallic door remains at zero potential all the time. Panel base plate must be installed to prevent ingress of lint/dust into the panel. Provide cable gland in the base plate according to the respective cable size for cable entry and exit so that the cables are not stressed on the sharp edges of the hole of panels. Provide covers (of noncombustible material) if any additional gap remains after installing cable glands. | |
| <b>Remediation Timeframe:</b> Within 3 months | |

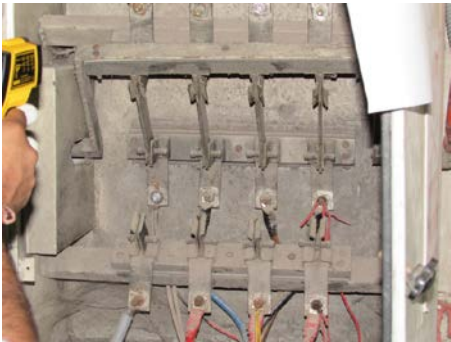
| <b>Finding:</b><br>Excessive dust and lint inside COS panel. | |

| <b>Recommendation:</b><br>Disconnect the COS panel from power source and clean the interior of the panel regularly and seal the opening to protect ingress of lint and dusts. Provide covers if any additional gap remains after installing cable glands. | |
| <b>Remediation Timeframe:</b> Within 1 month | |

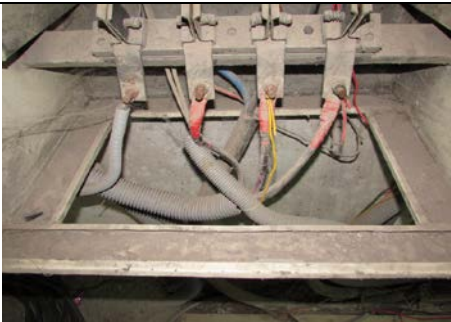
| <b>Category:</b> SWITCH BOARD & PANELS | <p>Cables connected to bus bar</p> |
| <b>Finding:</b><br>Cables directly connected to terminal inside COS panel. | |

| <b>Recommendation:</b><br>Cables shall be connected to terminals only by soldered/welded lugs according to the size of the respective cables. Proper crimping tools must be used to punch the socket. The connection should be taken from a distribution panel. | |
| <b>Remediation Timeframe:</b> Within 1 month | |

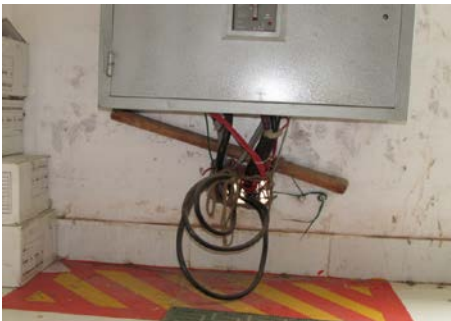
| <b>Finding #:</b> E- 4 | <p>Cables outgoing from panel.</p> |

| <b>Finding:</b><br>Cables outgoing from panel is not protected and supported by combustible material. | |

| <b>Recommendation:</b><br>Combustible material near panel should be removed from below panel. Use covered cable duct/ladder to support the cable at bottom of the panel. | |
| <b>Remediation Timeframe:</b> Within 3 months | |

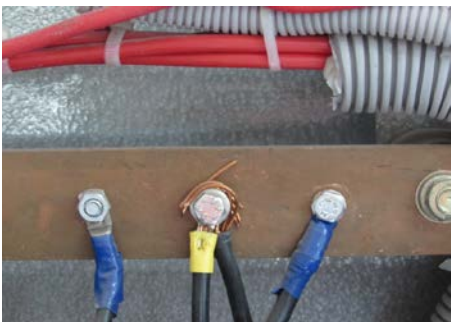
| <b>Finding #:</b> E- 5 | <p>Cables connected to bus bar</p> |

| <b>Finding:</b><br>Incoming cable in the panel directly connected to bus bar. | |

| <b>Recommendation:</b><br>Cables shall be connected to terminals only by soldered/welded lugs according to the size of the respective cables. Proper crimping tools must be used to punch the socket. | |
| <b>Remediation Timeframe:</b> Within 1 month | |

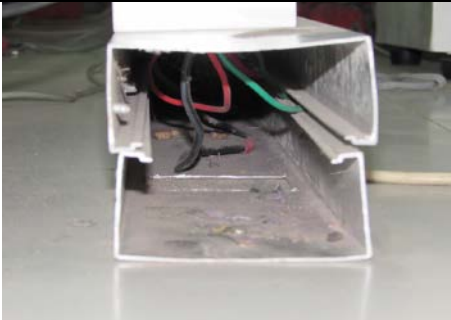
| <b>Finding #:</b> E- 6 | |

| <b>Finding:</b><br>Terminal of cable duct is not protected with cover. | |

Terminal of cable duct

| <b>Recommendation:</b><br>Cable duct must be tightly closed(providing end cap) to prevent ingress of lint and dust. | |
| <b>Remediation Timeframe:</b> Within 1 month | |

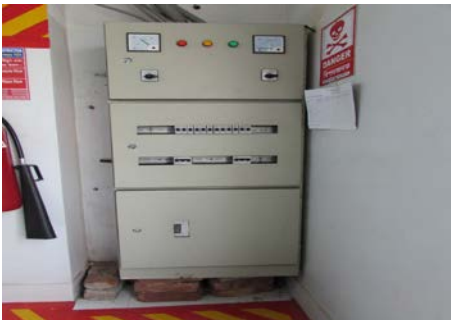
| <b>Finding #:</b> E- 7 | |

| <b>Finding:</b><br>Panel supported by improper material. | |

Panel laid on blocks.

| <b>Recommendation:</b><br>The existing panels should be fixed with the foundation plinth (on concrete floor) with nuts and bolts. If installed on wall, top end of panel shall be at 2 meter at max. | |
| <b>Remediation Timeframe:</b> Within 3 months | |

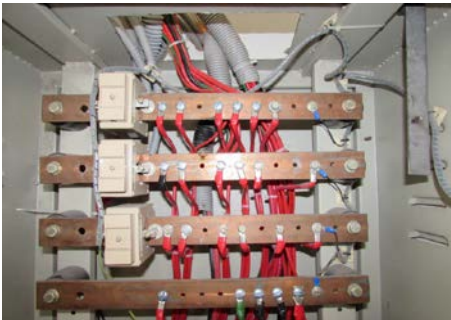
| <b>Finding #:</b> E- 8 | |

| <b>Finding:</b><br>Mismatched color code of the wires inside the panel. | |

Cables inside panel

| <b>Recommendation:</b><br>Color code should be maintained as per standard i.e. Red, Yellow and Blue colors for phases; Black for neutral and Green for earthing. Panels including its door should be earthed with better earth continuity. | |
| <b>Remediation Timeframe:</b> Within 1 month | |

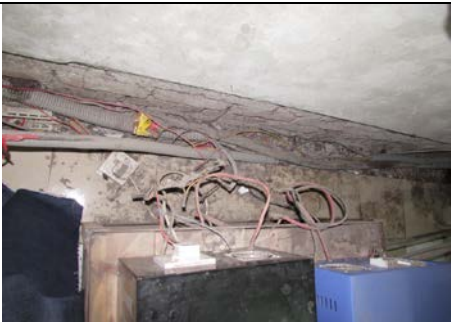
| <b>Finding #:</b> E- 9 | |

| <p><b>Finding:</b><br/>Wiring &amp; flexible PVC conduit is laid directly on the floor.</p> | |

Wiring in sub-station.

| <p><b>Recommendation:</b><br/><br/>Use steel pipe/cable tray to ensure the mechanical protection of the cable laid on floor otherwise cable insulation may damage due to falling object or stepping of occupants onto it.</p> | |
| <p><b>Remediation Timeframe:</b> Within 3 months</p> | |

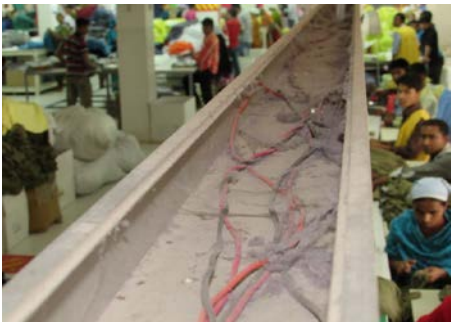
| <p><b>Finding:</b><br/><br/>Excessive dust and lint inside cable duct.</p> | |

Inside cable duct

| <p><b>Recommendation:</b><br/>Disconnect the power source of the cable laid into channel and clean dust and debris of all interior components. Establish a periodic cleaning program and maintain records of the activities. Provide cover made of noncombustible material on the channel for preventing ingress of dust and debris in future.</p> | |
| <p><b>Remediation Timeframe:</b> Within 3 month</p> | |
