# **FIRE SAFETY INSPECTION REPORT**

## **SECTION SEVEN LIMITED**

**PLOT : 21-24 (PART), SECTOR-3, ROAD - 4, SOUTH  
HALISHAHAR, CEPZ, CHITTAGONG**

June 11, 2014

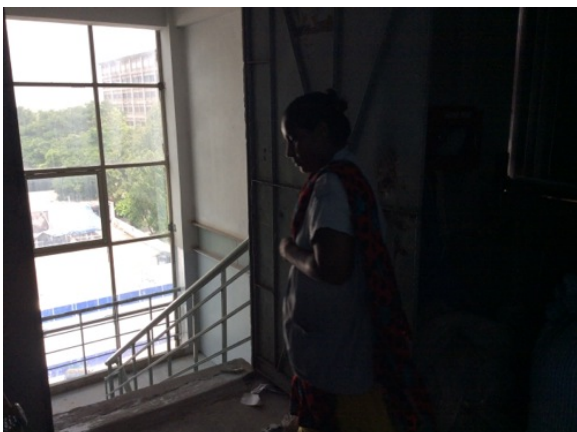
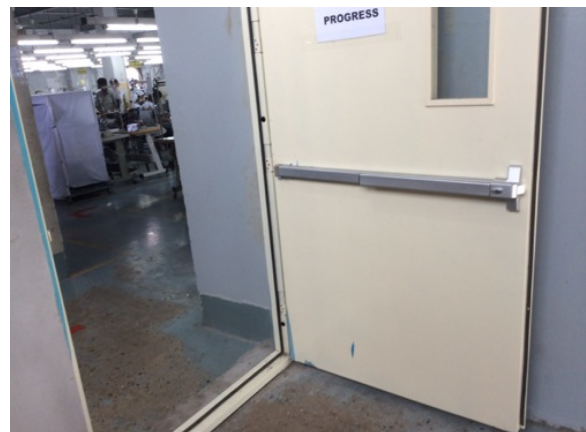
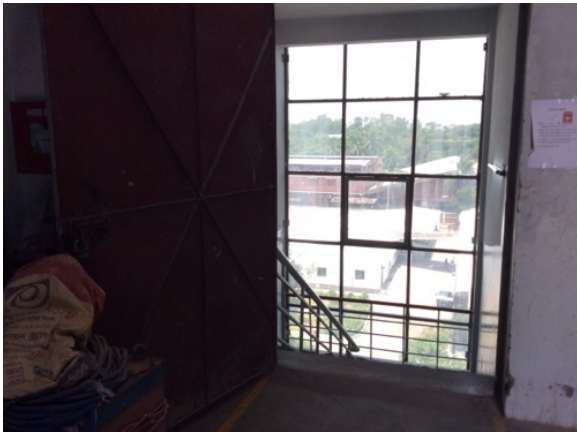
| No. | Category | Finding | Recommendation | Remediation Timeframe |
|---|---|---|---|---|
| F-1 | Fire Rated Construction | The exit stairs are not separated from work areas and other spaces on each floor by fire-rated construction and unclosed fire-rated doors. | <p>Provide minimum 1.5-hr fire rated doors and seal all unprotected openings to separate the exit stairs from work areas and other building spaces on all floor levels. Ensure that the fire doors are self-closing and positive latching and that they are provided with fire exit (panic) hardware where serving production floors.</p> <p>If fire doors are required to be held open for functional reasons, provide automatic-closing devices tied to the fire alarm system.</p> | Within 3 months |

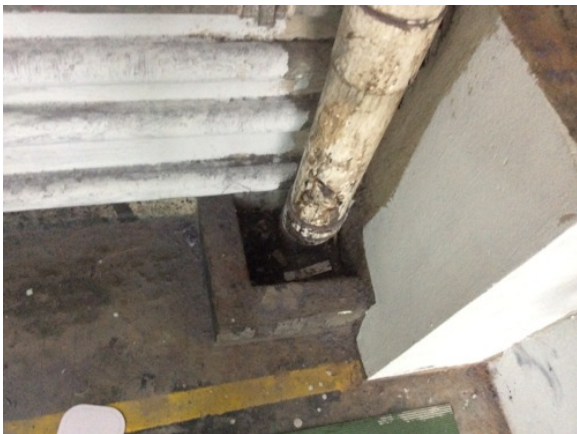
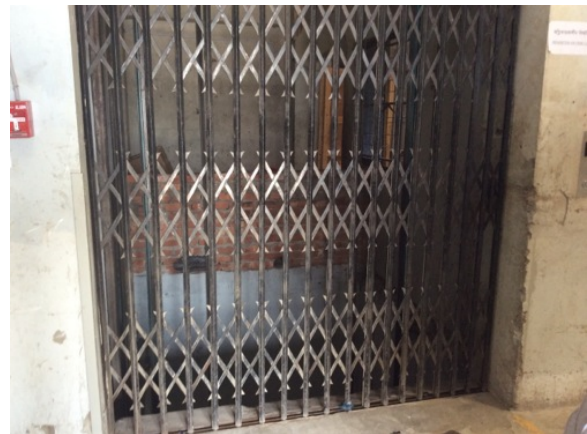
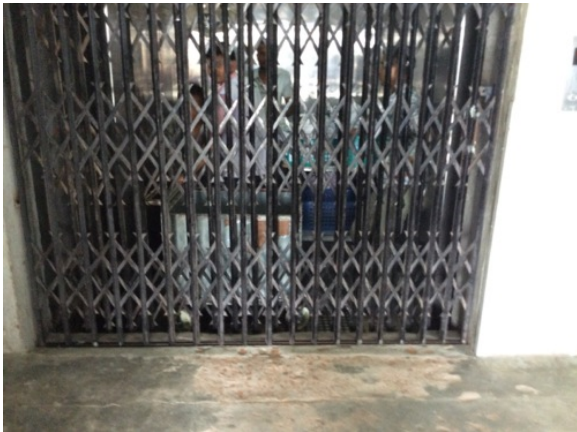
| F-2 | Fire Rated Construction | Unsealed penetrations and openings are located in the fire-rated floor, ceiling and wall assemblies. | Provide a minimum 2-hr fire-rated shaft to separate the utility risers and elevators from each floor level. | Within 3 months |

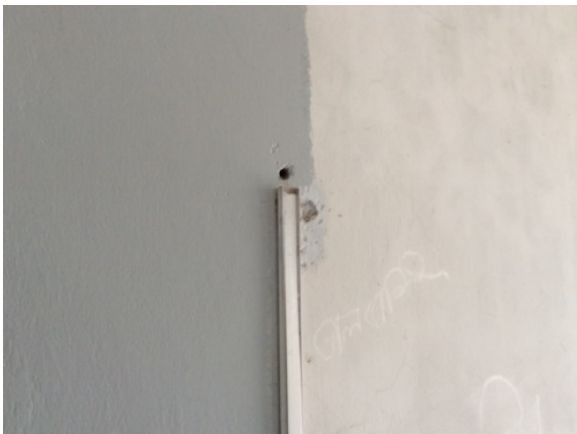
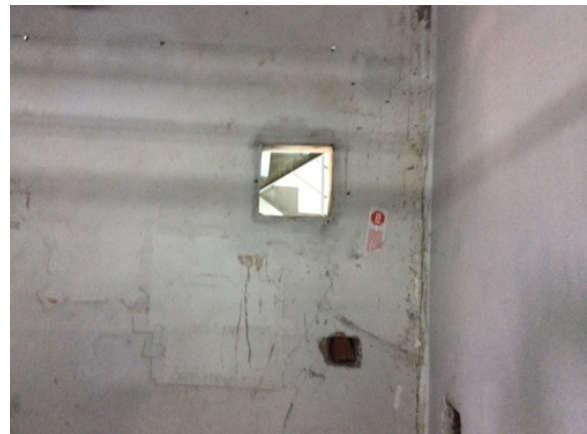
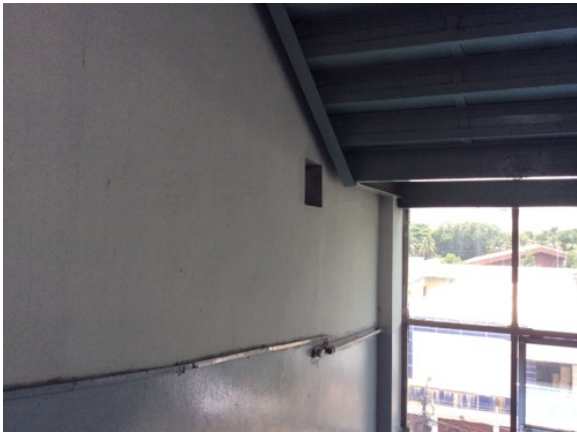
| F-3 | Fire Rated Construction | Unsealed penetrations and openings are located in exit stair enclosures. | Seal all penetrations and openings in exit stair enclosure walls to maintain the fire separation. | Within 3 months |

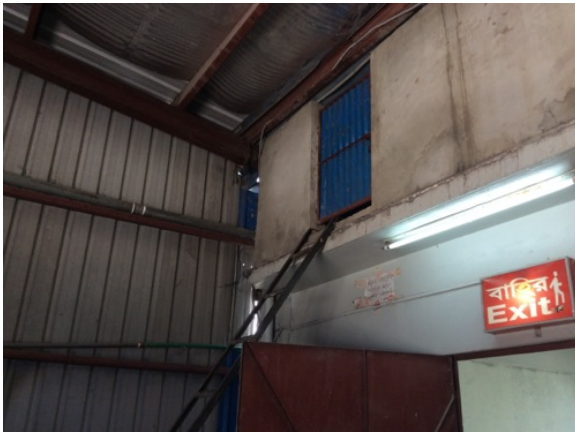
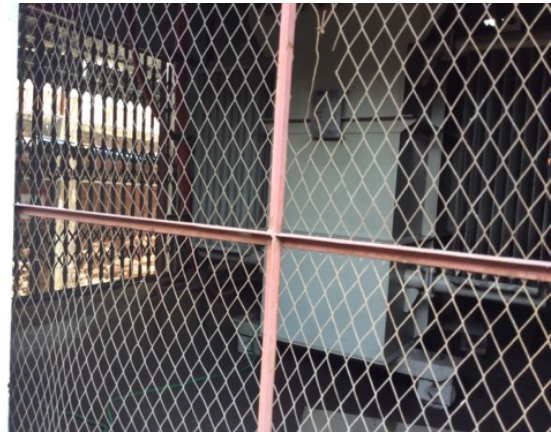
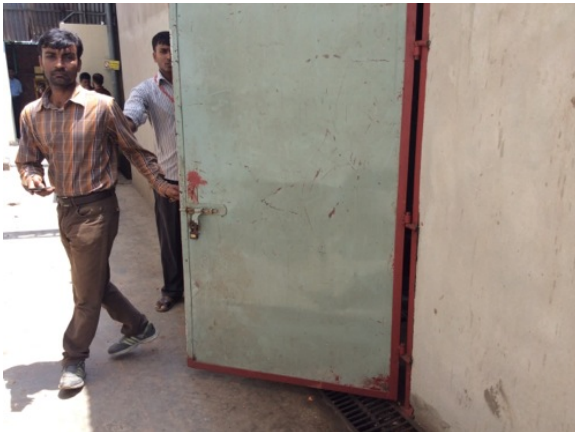
| F-4 | Fire Rated Construction | The boiler and transformer room is not separated by fire-rated construction due to openings and non-rated doors on the ground floor. The generator room is not separated by fire-rated construction due to openings and non-rated doors in the West side of the building. The EMR rooms are not separated by fire-rated construction due to non-rated doors on the fourth floor. | Separate the boiler, generator, transformer and EMR room by a minimum 2-hr fire-rated construction. Seal and protect all openings to maintain the required fire separations. | Within 3 months |

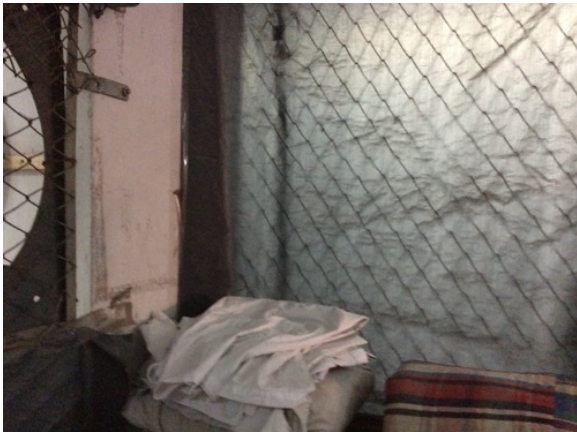
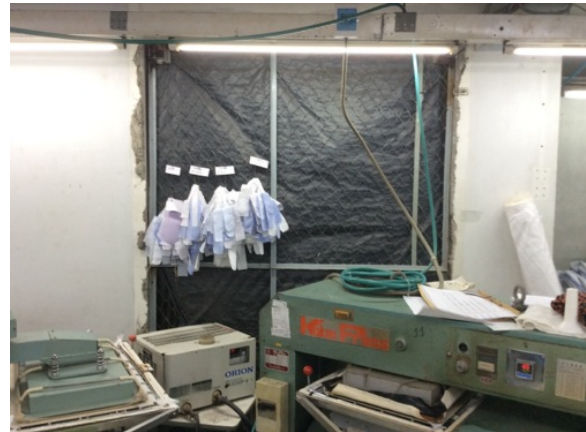
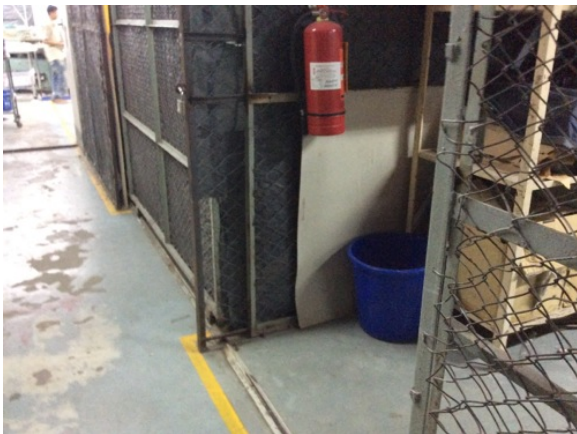
| F-5 | Fire Rated Construction | Storerooms used for combustible storages are not separated by fire-rated construction on the ground floor. | Provide dedicated storage rooms separated by minimum 1-hr fire-rated construction. | Within 3 months |

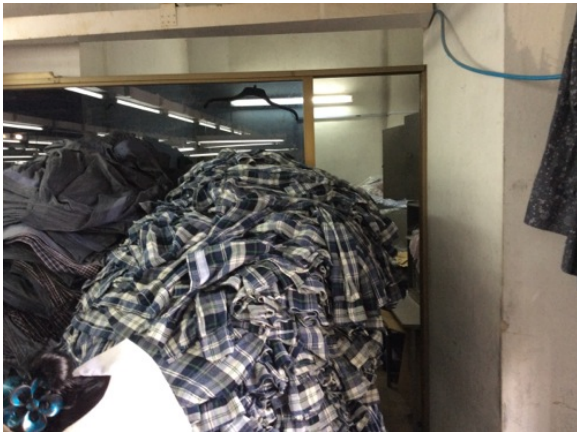
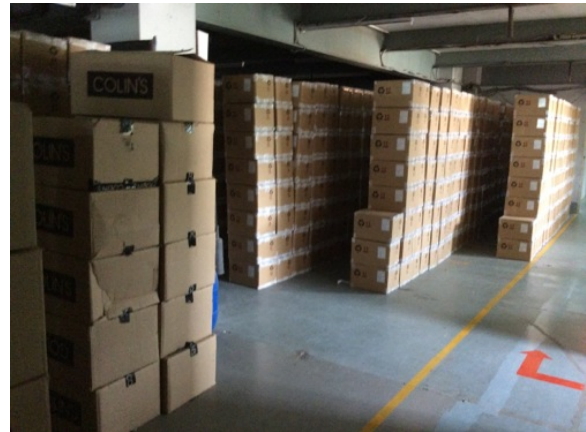
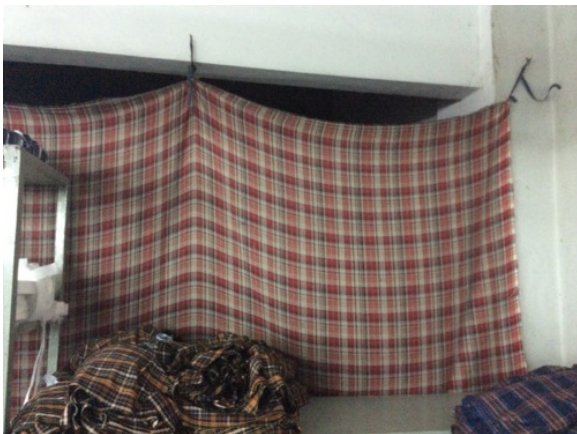
| F-6 | Fire Rated Construction | Areas used for combustible storages are open to the factory floor on the first and second floor. | Provide defined storage areas and limit the storage arrangement as follows:<br>- Maximum height of 2.4m and maximum area of 23m <sup>2</sup> .<br><br>- Separate areas of unenclosed combustible storage by a minimum clear distance of 3m. | Within 3 months |

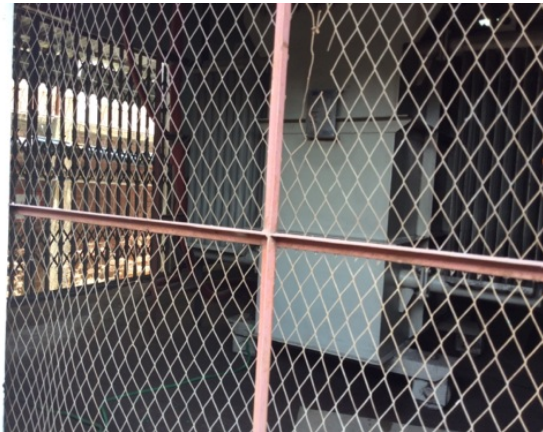
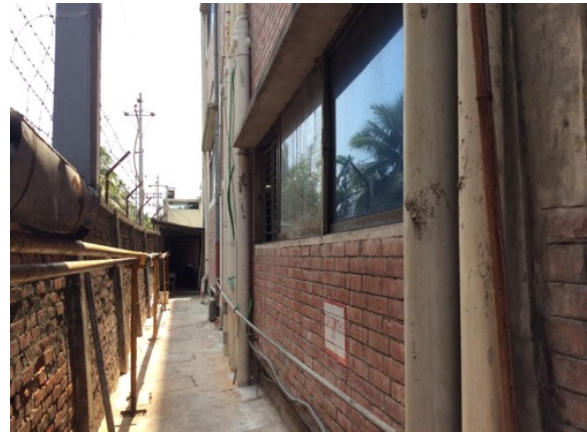
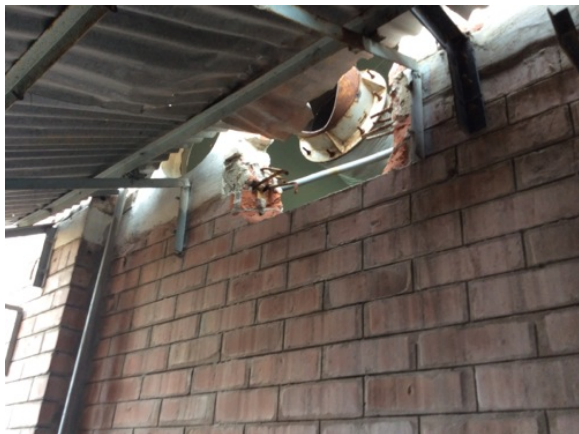
| F-7 | Fire Rated Construction | The exit discharge path serving North, East, South exit is less than 10 ft wide and is not separated from the building interior. | Seal all penetrations and openings to the interior of the building along the discharge path, up to a height of 10 ft., to provide a minimum 1-hr fire separation. | Within 6 months |

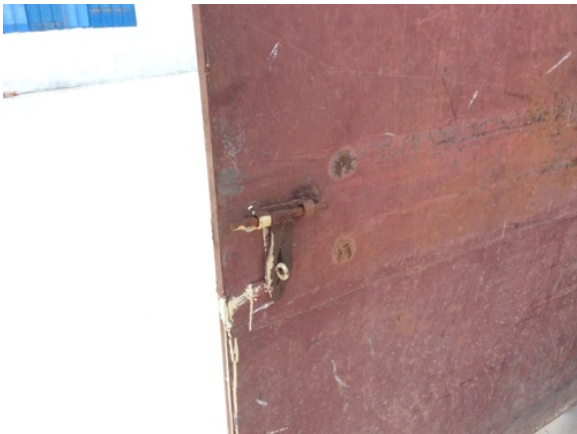
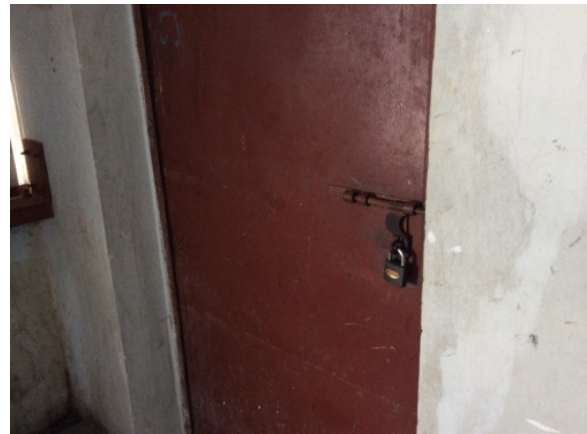
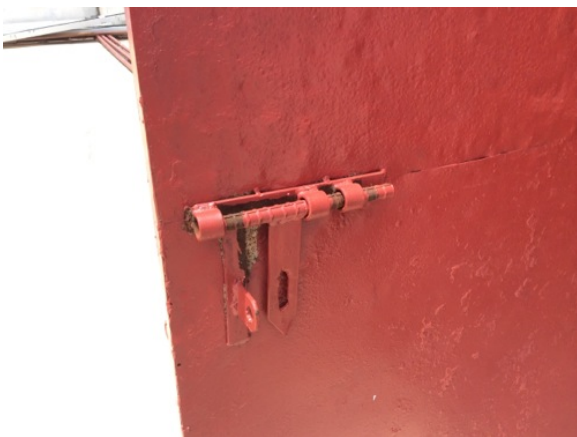
| F-9 | Egress | Egress doors and gates with locking features (padlocks, rim latch locks) are provided at building exits, exit stairs, along egress routes and exit discharges. All gates and doors are not open and unlocked during the inspection. | Remove locking features from all egress doors and gates.<br><br>If locks are required for security reasons, utilize special door locking features complying with NFPA 101. | Immediate |

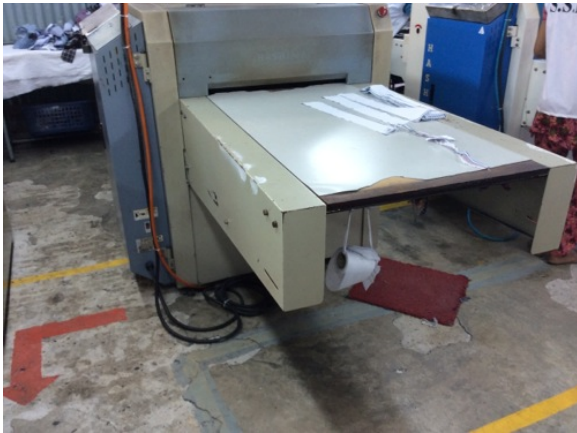
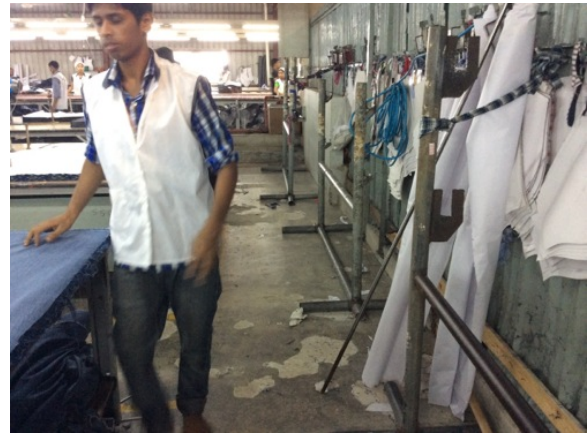
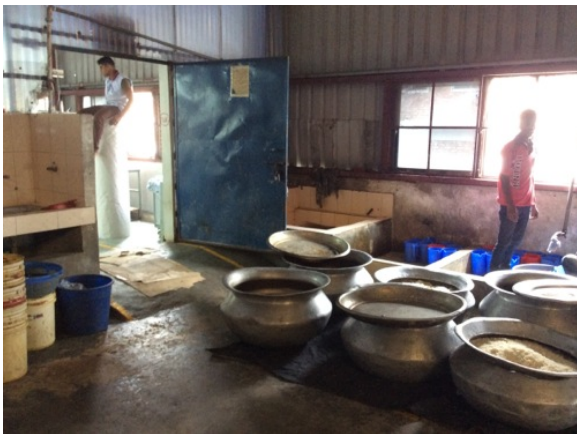
| F-10 | Egress | Storage was located in the interior and exterior egress paths on all the floors and outside the building. | Keep egress paths and stairs clear of storage. | Immediate |

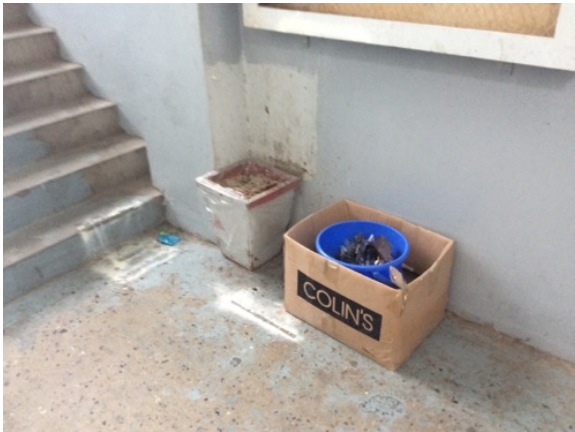
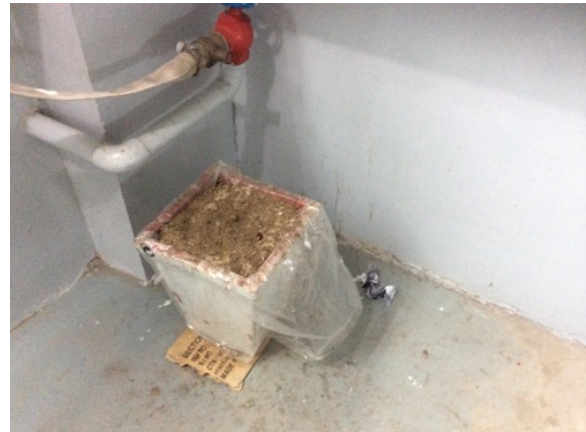
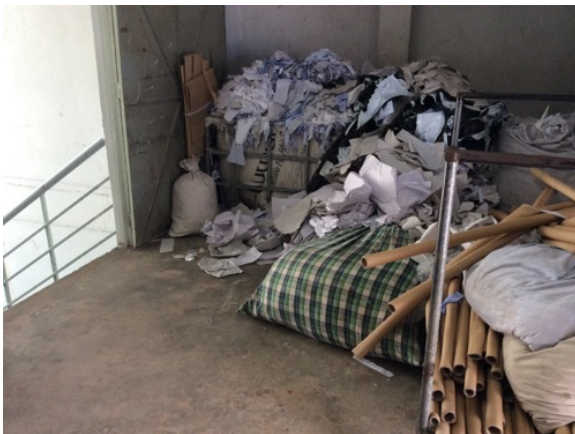
| F-11 | Egress | Storage is located in the exit stairs on all the floors. | Remove all storage from exit stairs and egress paths. | Immediate |

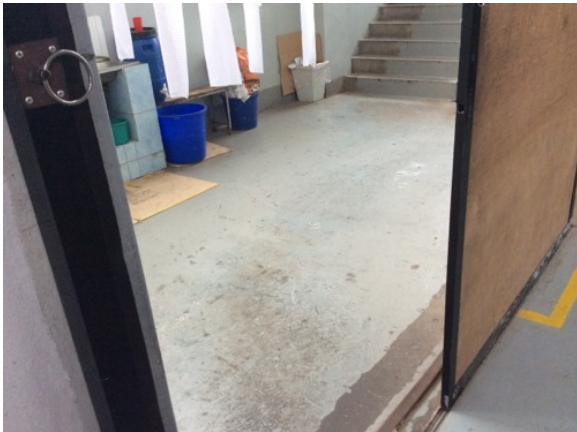
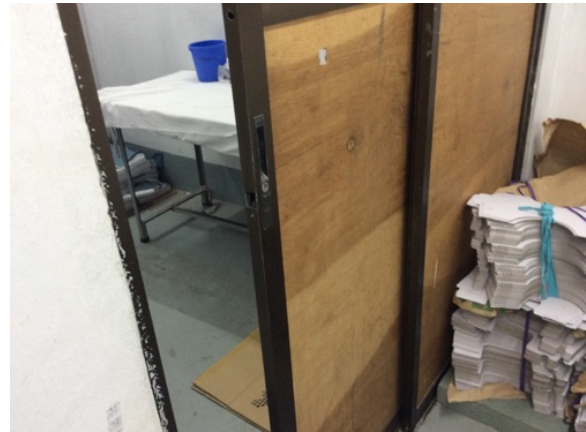
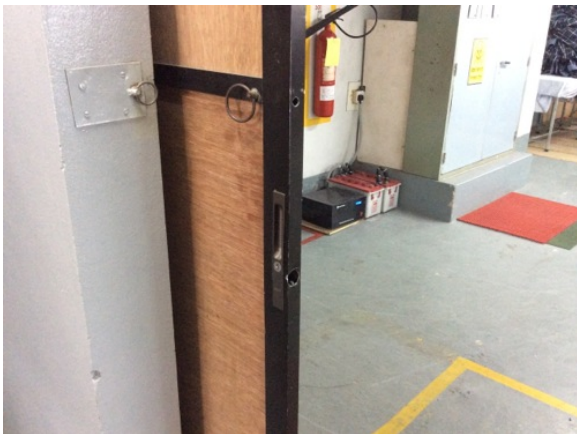
| F-12 | Egress | Collapsible gates and sliding doors are provided at building exits, exit stairs, along egress routes and exit discharges. | Replace all gates and sliding doors along the means of egress with side-hinged, swinging egress doors.<br><br>If locks are required for security reasons, utilize special door locking features complying with NFPA 101. | Within 1 month |

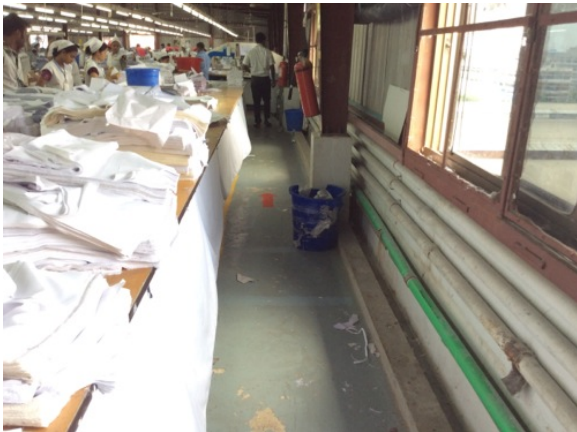
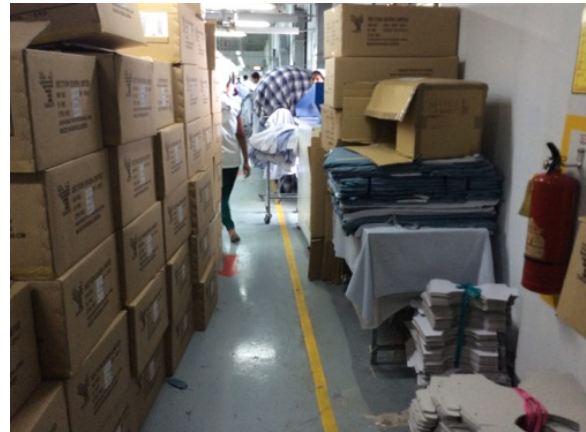
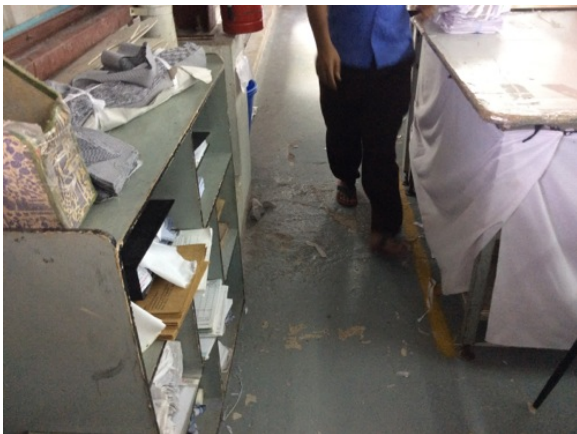
| F-13 | Egress | The width of egress aisles is less than 36-in. on all the floors. The width of East exit discharge is less than 32-in. | Provide minimum aisle widths of 36-in. and minimum door width of 32-in. | Within 3 months |

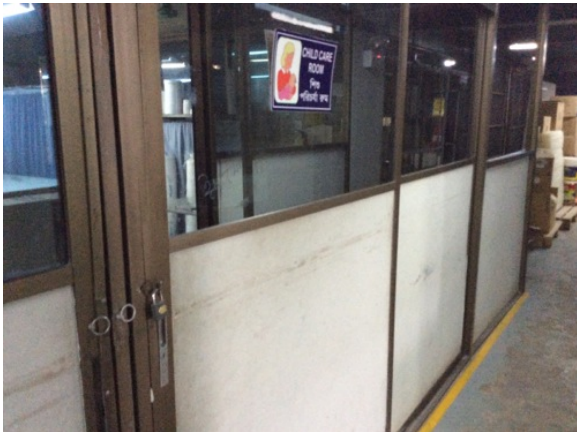
| F-14 | Egress | The travel distance is more than 9 m. (30 ft.) from day-care room to the nearest exit on the ground floor. | Relocate day-care room to ground floor with maximum travel distance of 9m (30 ft). | Within 3 months |

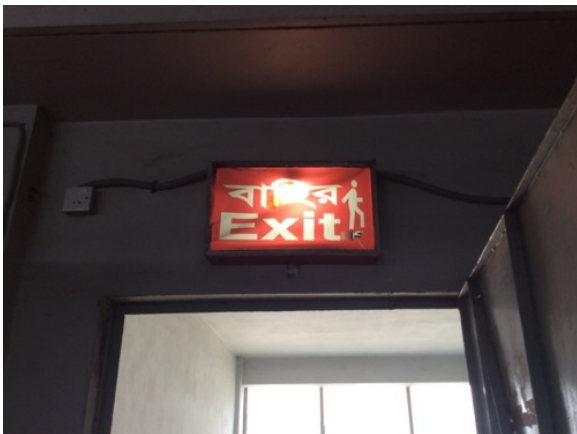
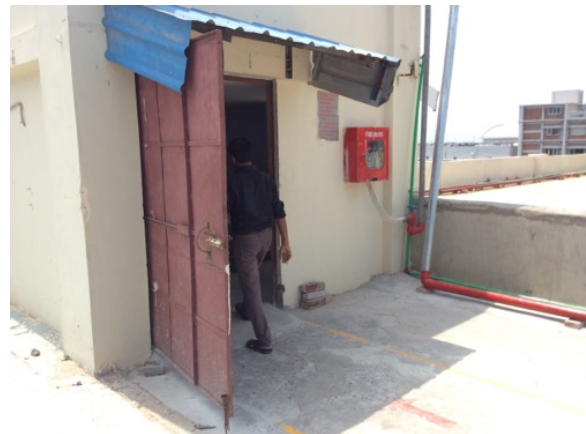
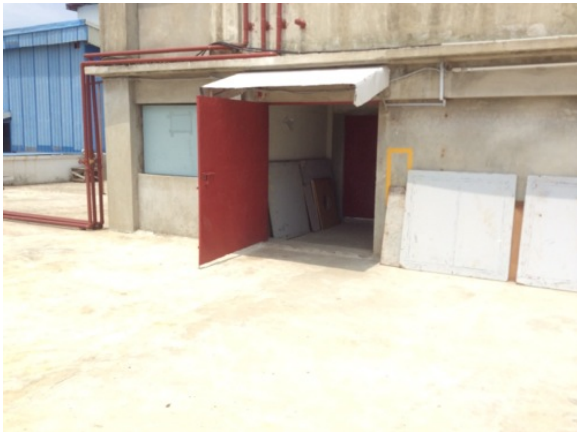
| F-15 | Egress | Exit stair doors serving 50 or more occupants do not swing in the direction of egress travel on the fourth floor. | Modify the egress door to swing in the direction of egress travel. | Within 3 months |

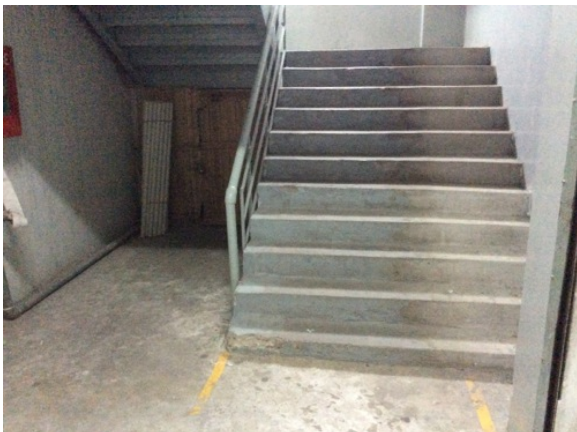
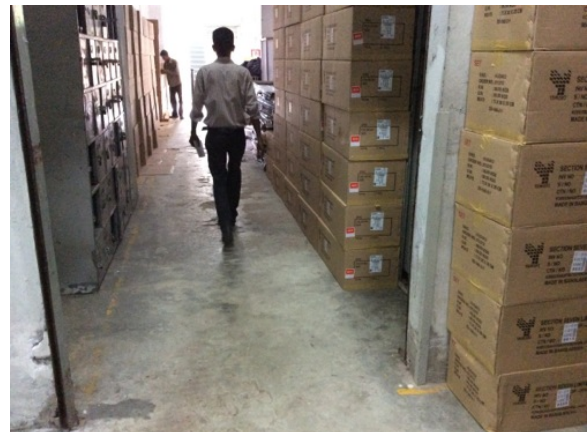
| F-16 | Egress | North East Exit stair discharge inside the building on the ground floor. It discharges through Store and is open to storage on the ground floor. | Provide 2-hr fire-rated exit passageway leading directly outside (vestibules to separate any storage areas). | Within 6 months |

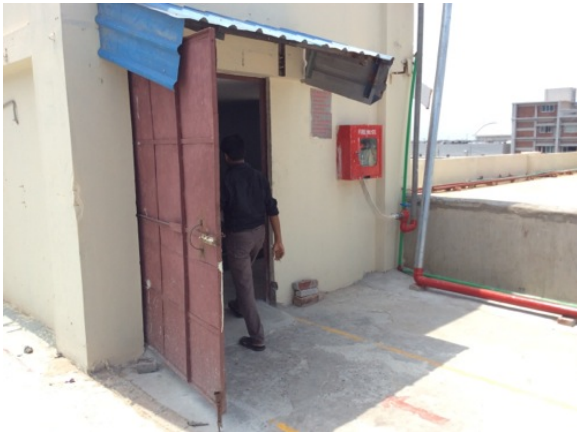
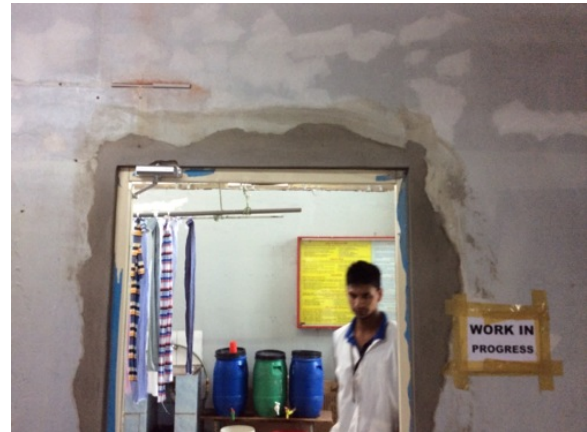
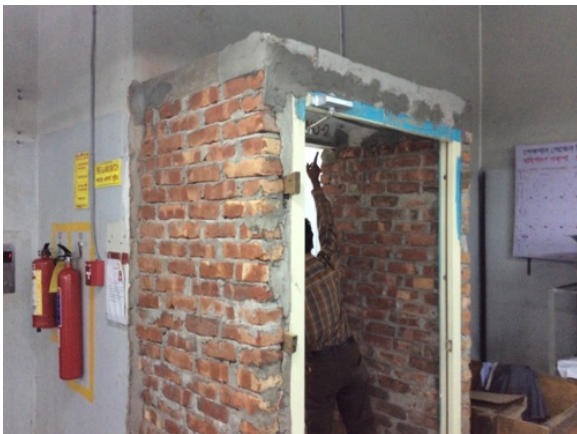
| F-20 | Egress Lighting | Exit sign not provided at North West exit on the ground floor, North Exit stair entrance on the first floor, North and South exit stair entrance on the third floor and North, North West, North East exit on the fourth floor. | Provide exit signs above all exits to the exterior and all doors to the exit stairs. | Within 1 month |

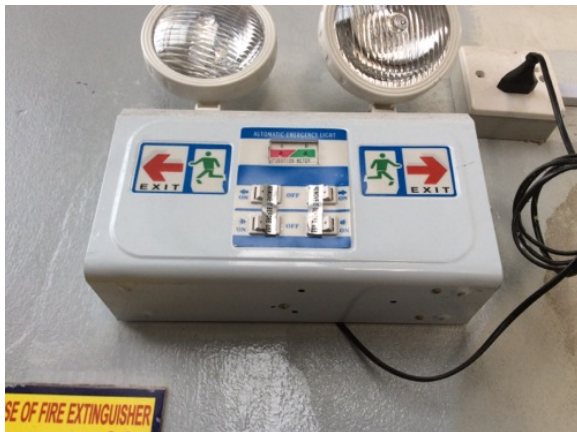
| F-22 | Egress Lighting | Manual on-off switch is provided for emergency lighting units on the body of the units. All the units are found in switched off position. | Remove manual on/off switches from emergency lighting units to prevent them from being switched off. | Within 1 month |
