# **FIRE SAFETY INSPECTION REPORT**

**LUMBINI LIMITED**  
**MEGHLA, BANDARBAN**

**ACCORD**  
on Fire and Building Safety in Bangladesh

May 28, 2014

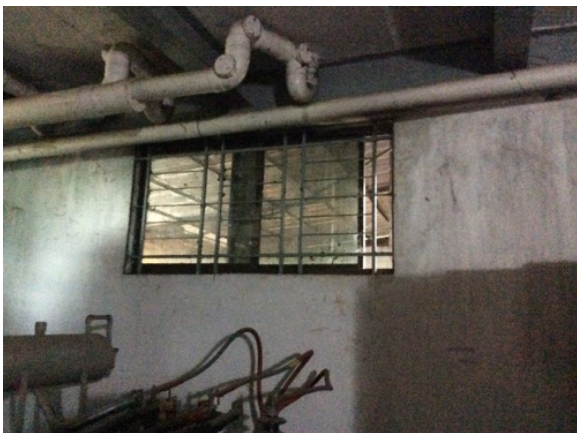
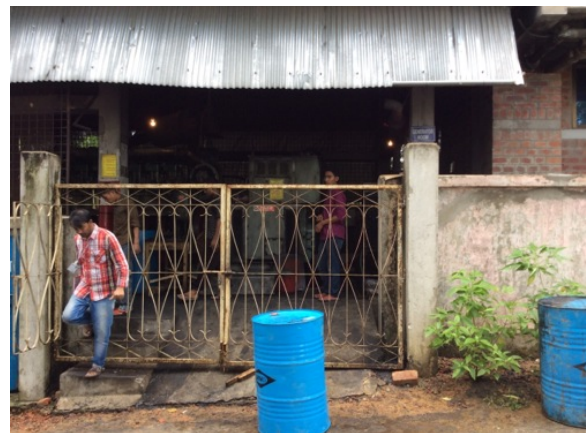
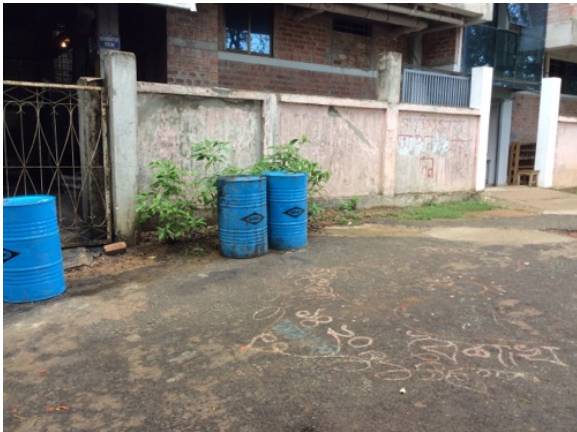
| No. | Category | Finding | Recommendation | Remediation Timeframe |
|---|---|---|---|---|
| F-1 | Fire Rated Construction | The generator and transformer room is not separated by fire-rated construction due to openings and non-rated doors on the ground floor. The generator is open to the exterior discharge path and the transformer is open to the North exit stair. | Separate the generator and transformer room by a minimum 2-hr fire-rated construction. Seal and protect all openings to maintain the required fire separations. | Within 3 months |

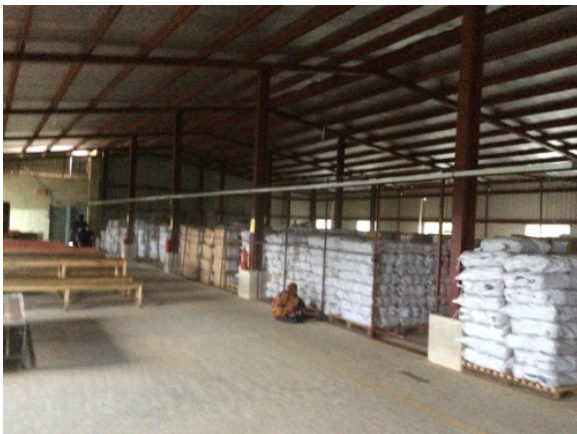
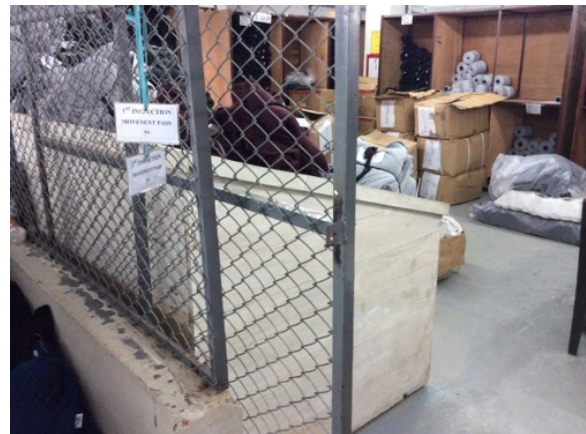
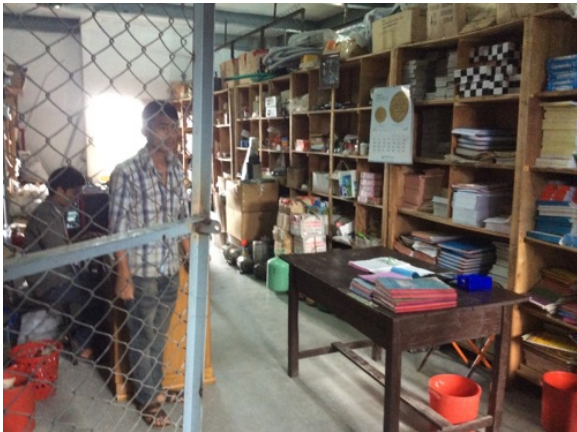
| F-2 | Fire Rated Construction | Storage rooms used for combustible storage are not separated by fire-rated construction on all floors except the second floor. | Provide dedicated storage rooms separated by minimum 1-hr fire-rated construction. | Within 3 months |

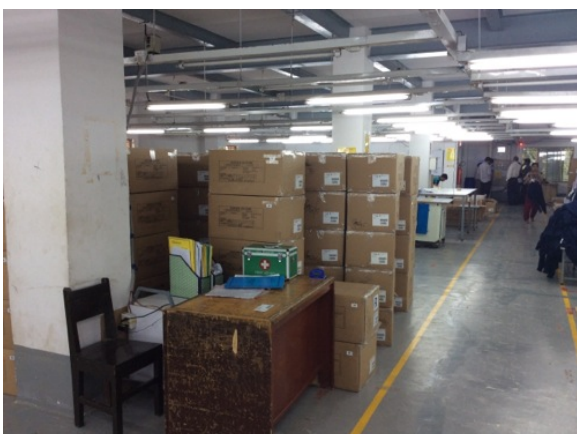
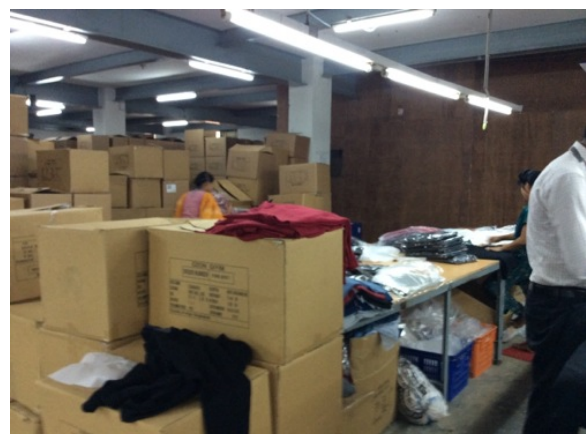
| F-3 | Fire Rated Construction | Areas used for combustible storage are open to the factory floor on all floors. | Provide defined storage areas and limit the storage arrangement as follows:<br>- Maximum height of 2.4m and maximum area of 23m <sup>2</sup> .<br><br>Separate areas of unenclosed combustible storage by a minimum clear distance of 3m. | Within 3 months |

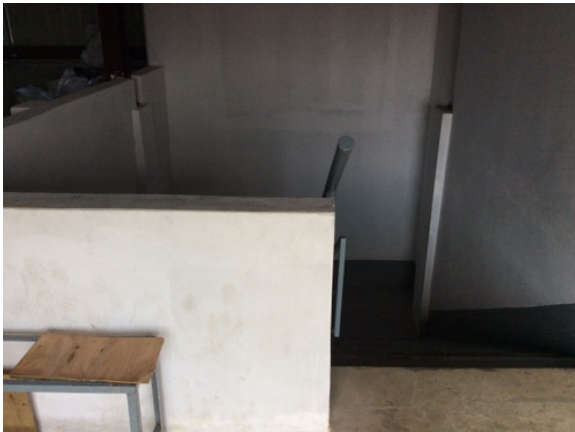
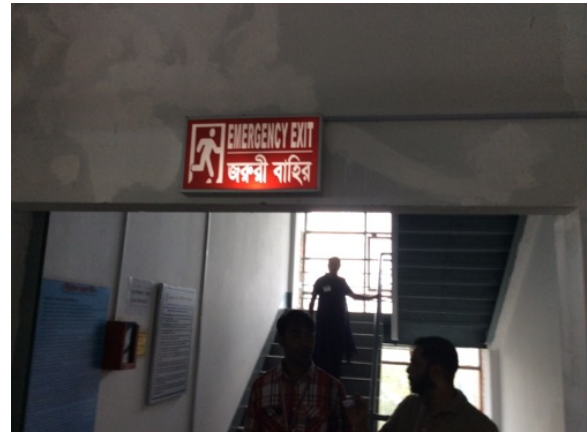
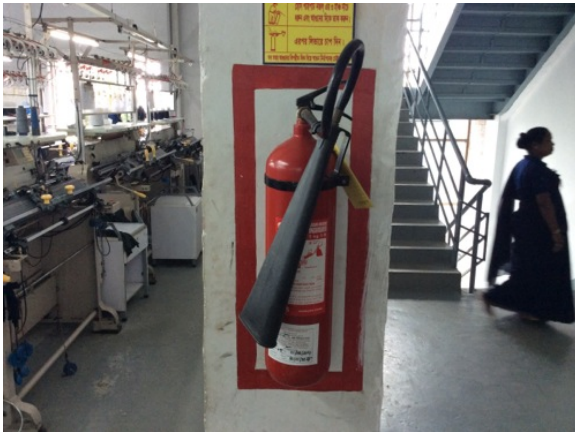
| F-4 | Fire Rated Construction | The exit stairs are not separated from work areas and other spaces on each floor by fire-rated construction. | <p>Provide minimum 1.5-hr fire rated doors and seal all unprotected openings to separate the exit stairs from work areas and other building spaces on all floor levels. Ensure that the fire doors are self-closing and positive latching and that they are provided with fire exit (panic) hardware where serving production floors.</p> <p>If fire doors are required to be held open for functional reasons, provide automatic-closing devices tied to the fire alarm system.</p> | Within 3 months |

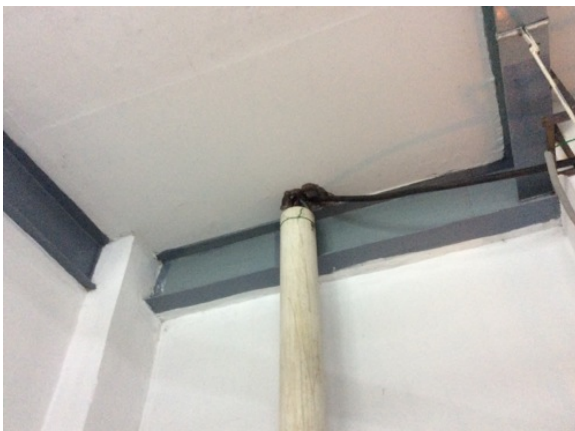
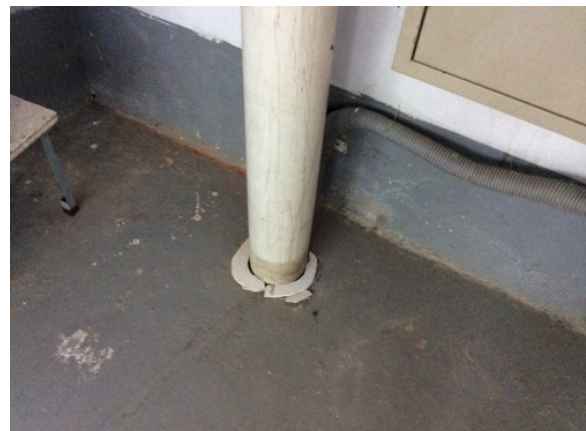
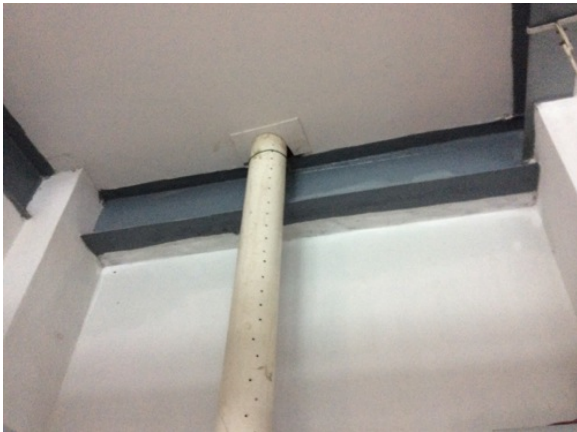
| F-5 | Fire Rated Construction | Unsealed penetrations and openings are located in the fire-rated floor and ceiling assemblies. | Provide a minimum 2-hr fire-rated shaft to separate the utility risers from each floor level.<br><br>Seal all penetrations and openings in floor and ceiling assemblies to maintain the fire separation. | Within 3 months |

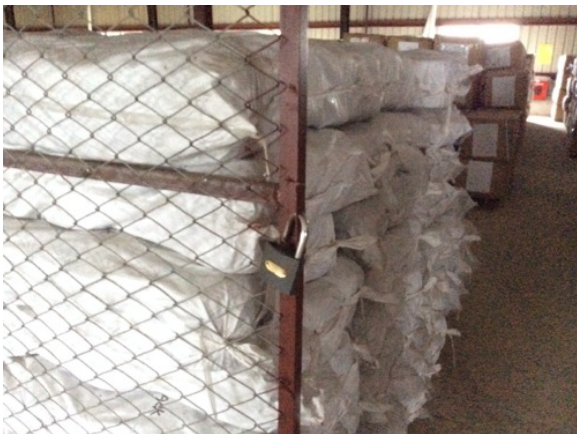
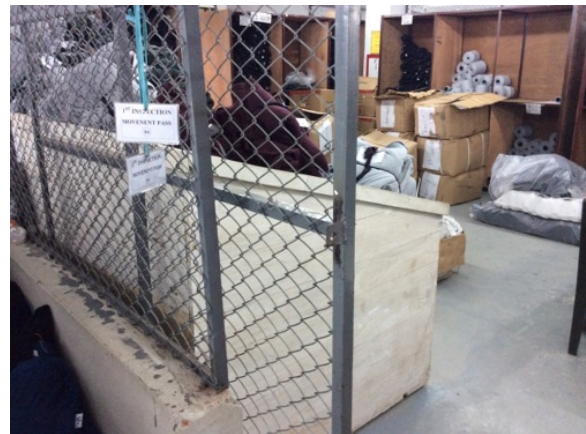
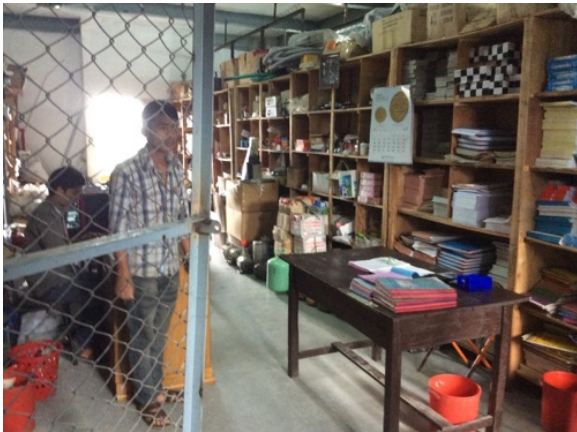
| F-6 | Egress | Egress doors and gates with locking features (padlocks) are provided at building exits, exit stairs, along egress routes and exit discharges. | Remove locking features from all egress doors and gates.<br><br>If locks are required for security reasons, utilize special door locking features complying with NFPA 101. | Immediate |

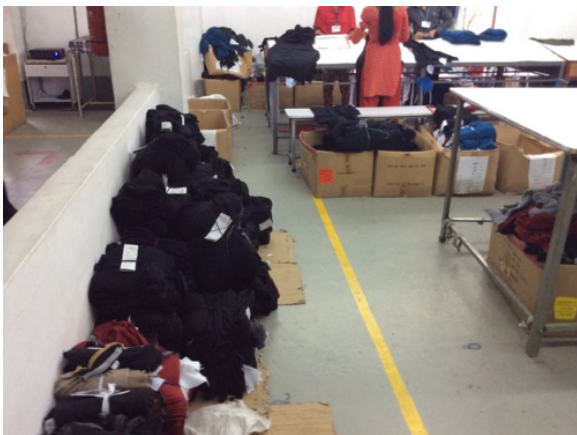
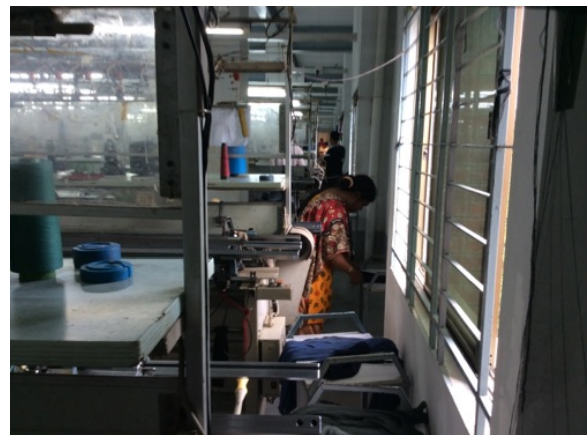
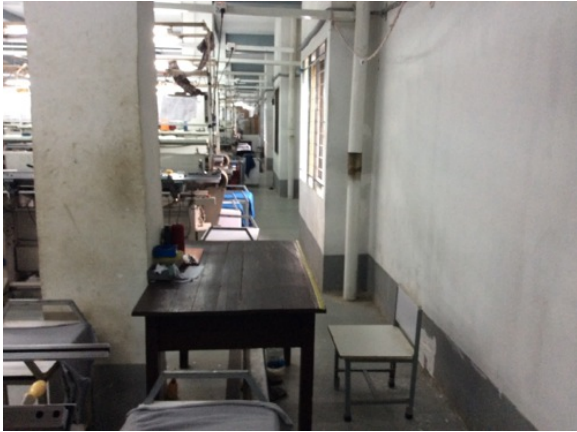
| F-7 | Egress | Storage is located in the egress path on the second and third floor. | Keep egress paths and stairs clear of storage. | Immediate |

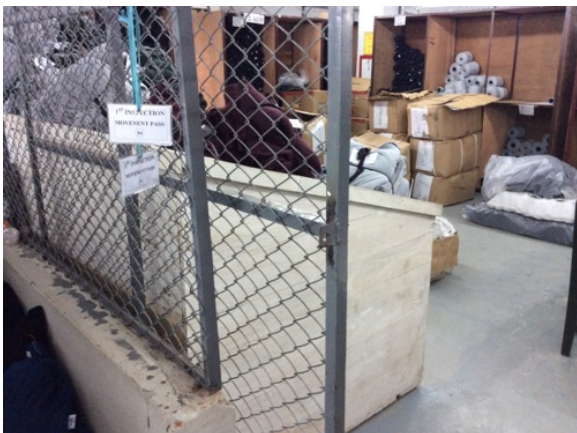
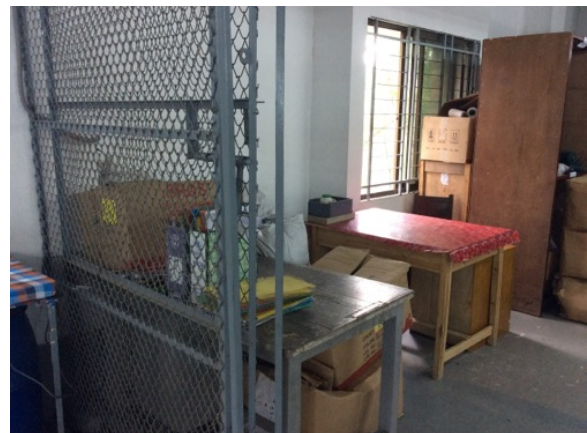
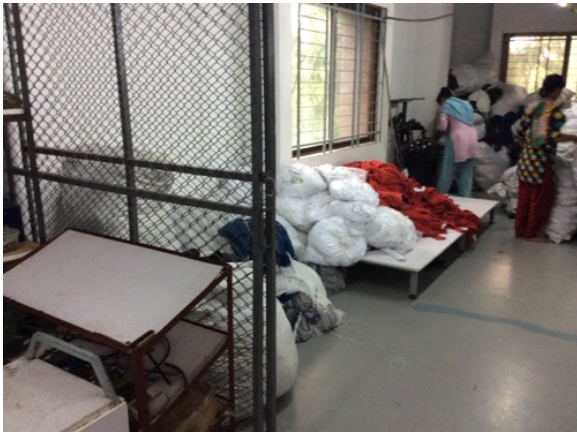
F-8 Egress

Collapsible gates and sliding doors are provided at building exits, exit stairs, along egress routes and exit discharges.

Replace all gates and sliding doors along the means of egress with side-hinged, swinging egress doors.

If locks are required for security reasons, utilize special door locking features complying with NFPA 101.

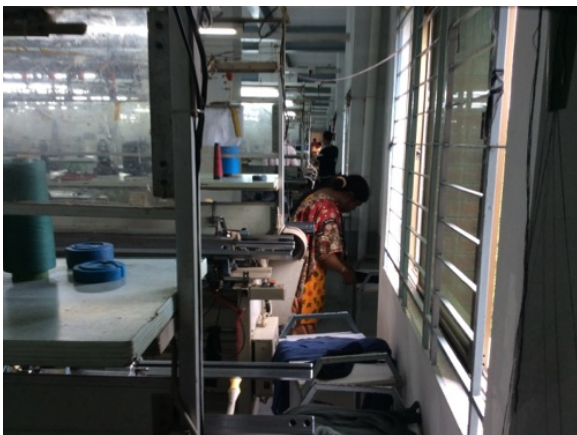
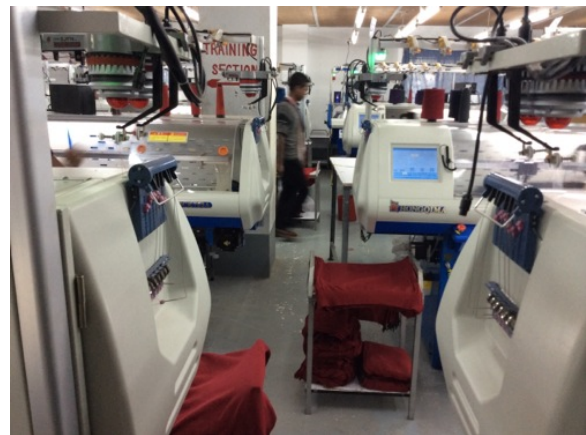
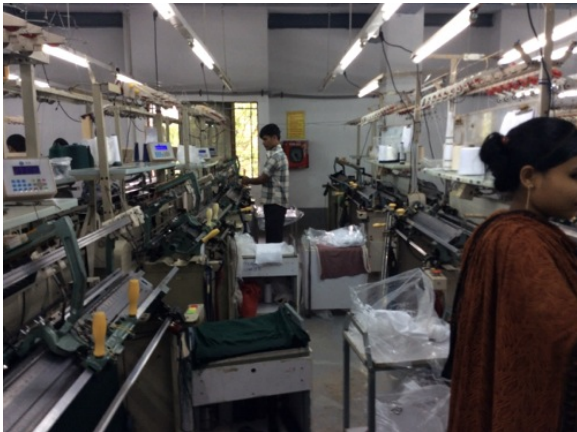
| F-9 | Egress | The width of egress aisles is less than 36-in. on all the floors. | Provide minimum aisle widths of 36-in. | Within 3 months |

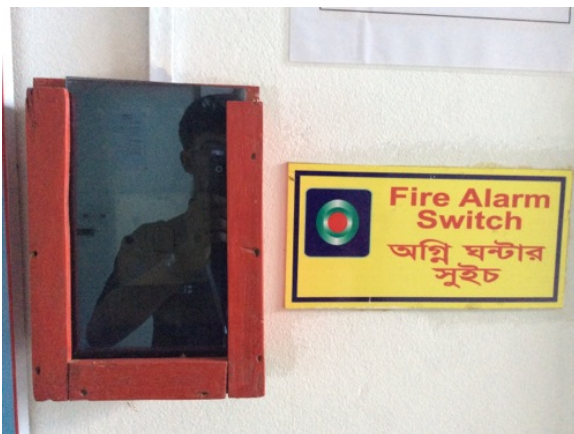
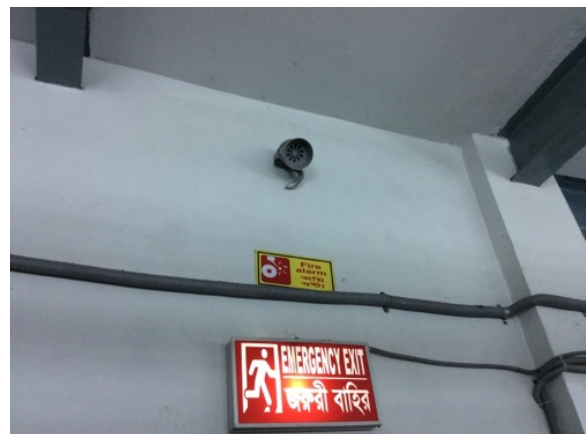
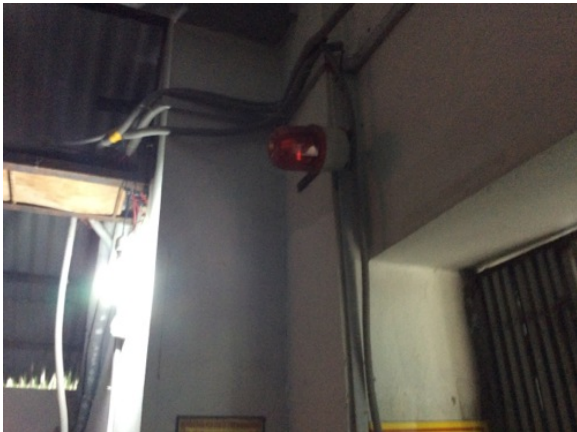
| F-10 | Fire Protection | The fire alarm system is antiquated, not a listed system, and does not provide alarm and notification features consistent with acceptable standards. | Replace the fire alarm system with a new, listed addressable fire alarm system in accordance with NFPA 72. | Design within 4 months, install within 9 months |

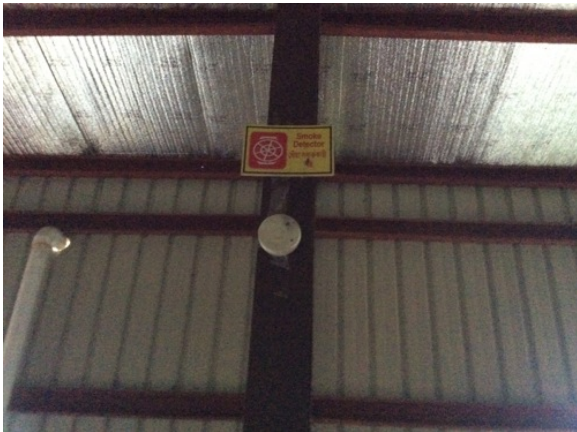
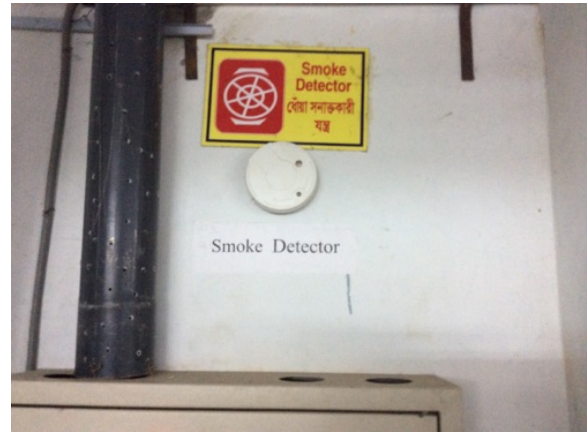
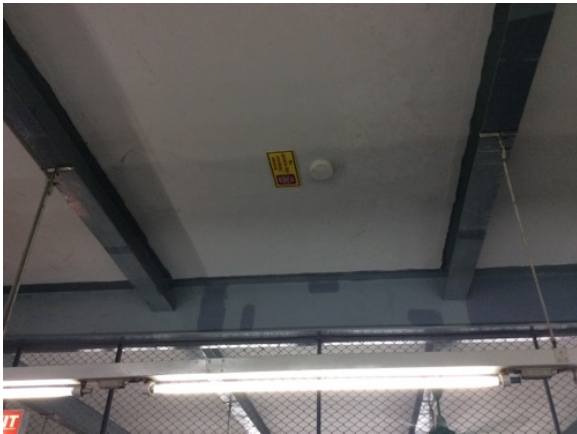
| F-12 | Fire Protection | The building is equipped with single-station smoke alarms. Smoke alarm activation sounds only a local alarm and does not provide automatic fire alarm notification of occupants. | Remove single station smoke alarms. Provide automatic smoke detection throughout the building in accordance with NFPA 72. | Within 6 months |

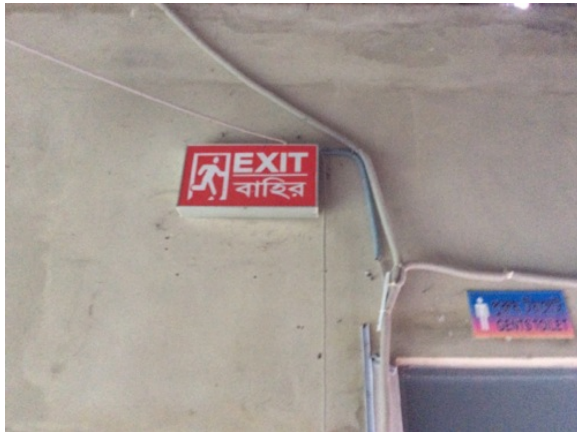
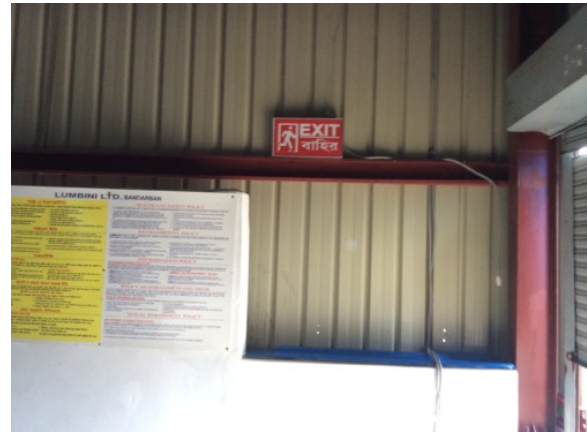
| F-13 | Egress Lighting | Exit signage not illuminated on the fifth floor. | Regularly inspect all exit signage and replace and install lights as needed to illuminate signs. | Within 1 month |

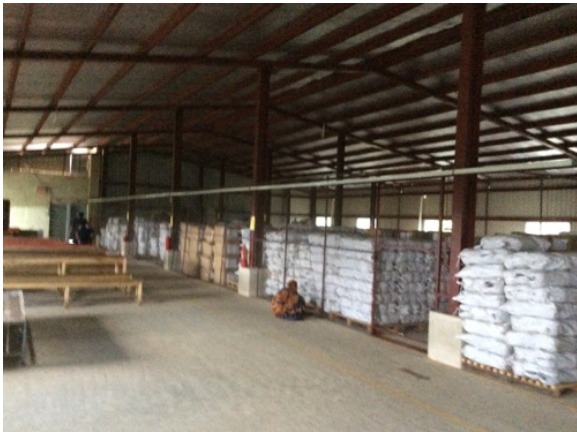
| F-15 | Egress Lighting | Based on the number and location of emergency lights observed, adequate illumination levels are not anticipated along egress routes on all the floors and exit stairs. | Provide additional emergency fixtures to provide adequate illumination along the means of egress. Provide a minimum illumination of 10 lux at the floor level within exit stairs and exit discharge paths and minimum 2.5 lux along exit access aisles. | Within 3 months |
