Hannan Fashions Ltd Ext.-1

868, Kalmishor, Shahid Siddique Road, Board Bazar, Gazipur-1704
(Coordinates: 23.942686N, 90.385297E)
Survey Date: 25th March 2015

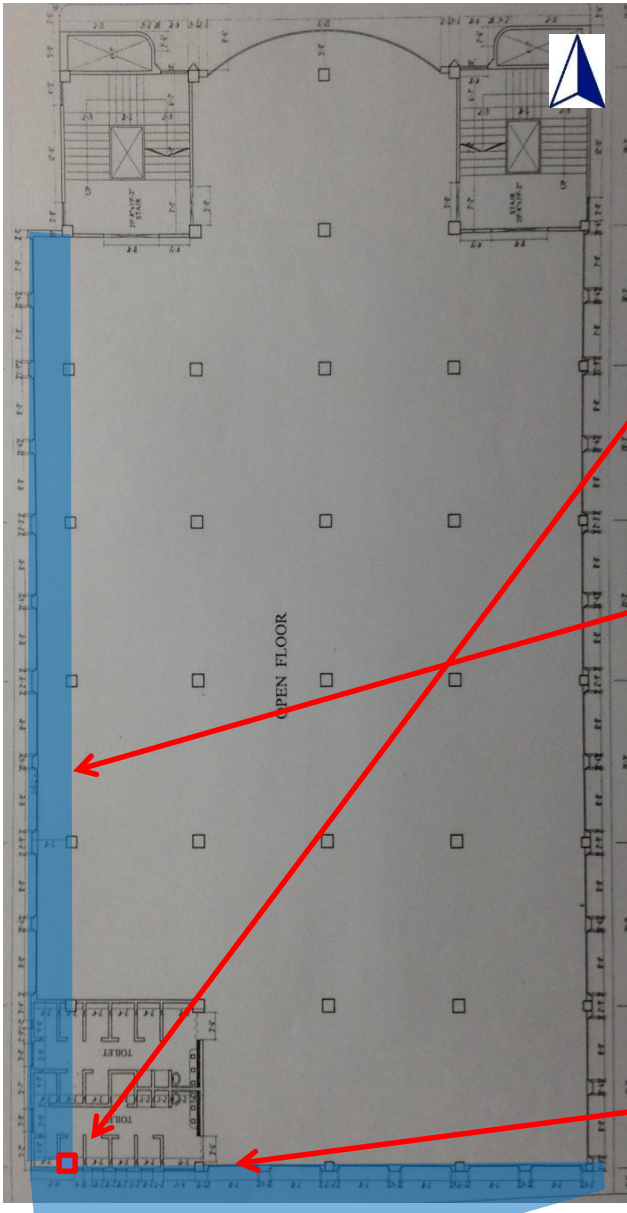
**Moderate to highly stressed
column in toilet area**

ITEM 1: Moderate to highly stressed columns in the toilet area at the corner of the building

Item No.	Observation	Recommended Action Plan	Recommended Timeline
1	Moderate to highly stressed columns in the toilet area at the corner of the building, moderate stress to other factory columns	Factory Engineer to review design, loads and columns stresses in all columns.	Immediate - Now
2	Moderate to highly stressed columns in the toilet area at the corner of the building, moderate stress to other factory columns	Verify insitu concrete stresses either by taking 100mm dia. cores from a min. 4 columns at ground floor or by using existing cylinder strength data for ground floor columns.	Immediate - Now
3	Moderate to highly stressed columns in the toilet area at the corner of the building, moderate stress to other factory columns	Verify the reinforcing steel grade used and no of column bars.	Immediate - Now
4	Moderate to highly stressed columns in the toilet area at the corner of the building, moderate stress to other factory columns	A Detail Engineering Assessment of Factory to be commenced, see attached Scope	Immediate - Now

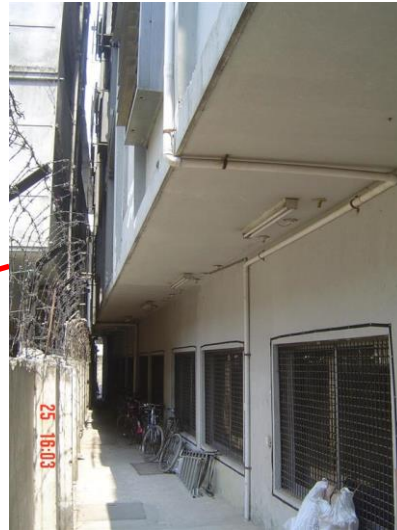
**Moderately Stressed Column.
Supported area: Toilets, Cantilever**

1. Verification of the strength of steel reinforcing to be obtained for the building constructed before 2005
2. Review of the reports (by the report authors) to be undertaken to confirm the allowable floor live load following confirmation of material assumptions
3. All columns but particularly corner column under loads from toilets to be given careful consideration.

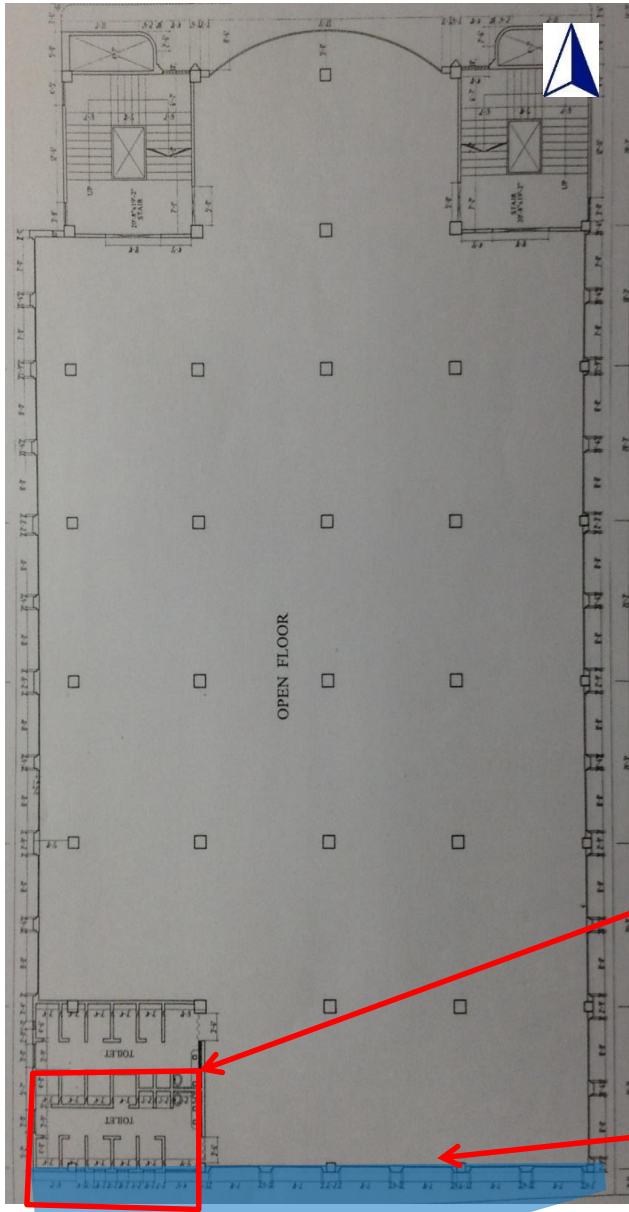
Toilets layout doesn't match (typical size shown but varies)

Cantilever is not shown in the drawings

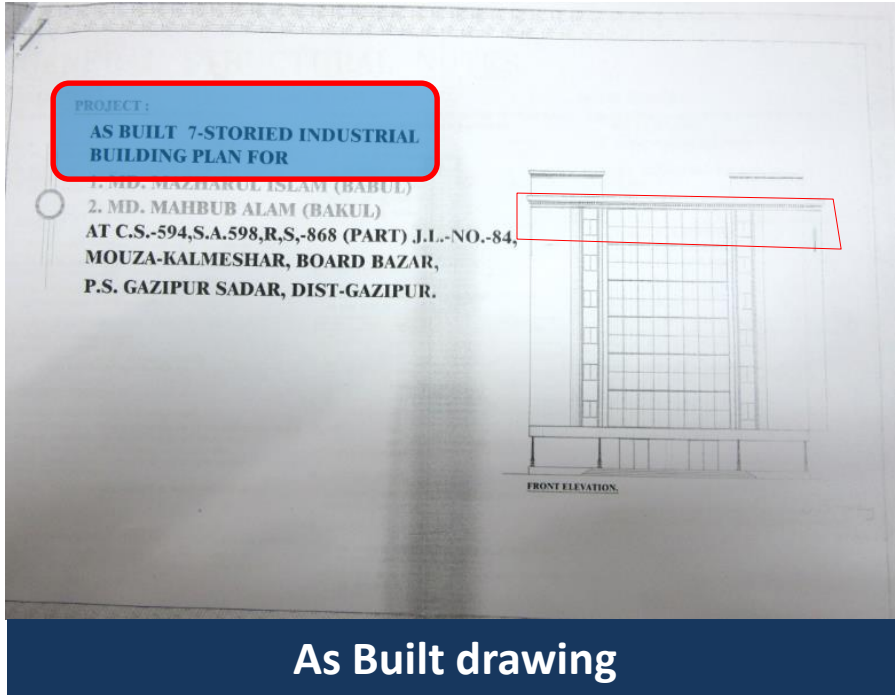
As Built drawing

As Built Drawing and permit drawings doesn't match

- As built drawing indicates 7 storey.
- Permit drawing shows 6 storey.
- Actual construction 6 storey plus dining halls at roof.
