# Denitex Limited.

## Client Summary Report

### Observations & Actions

On Tuesday 22 March, 2016 Md. Abdul Momin, Abu Daud Kabir Ahmed & Md. Kamruzzaman Shohug of Bangladesh ACCORD foundation carried out a visual structural survey of the Denitex Limited at the address and coordinates given on the cover page of this report.

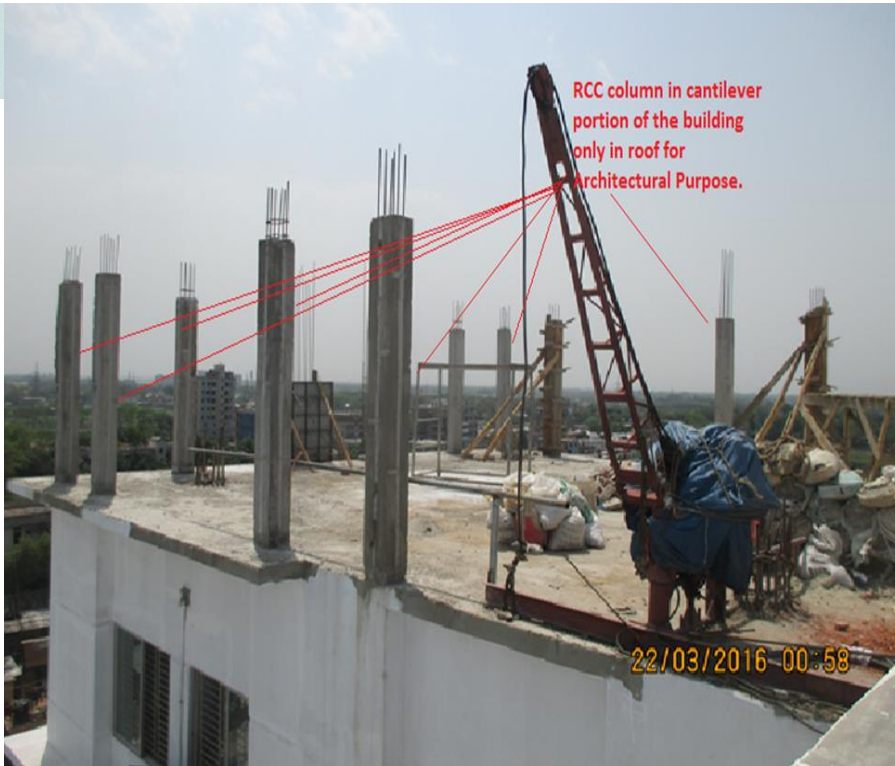
RCC column in cantilever  
portion of the building  
only in roof for  
Architectural Purpose.

RCC columns in roof provided for architectural purposes not continued to the bellow floor hence acting as point load in cantilever portion of the building.

- No additional loads to be applied on area indicated in red on all floors
- Factory Engineer to review design, loads and columns stresses in area identified above.
- Verify insitu concrete stresses by 100mm diameter cores.
- A Detail Engineering Assessment of Factory to be commenced, see attached Scope
- No vertical or horizontal extension before completion of Detail Engineering Assessment.

- Produce and actively manage a loading plan for all floor plates within the factory giving consideration to floor capacity and column capacity.
- Building engineer to investigate the crack of the column.
- Detail Engineering Assessment to be completed

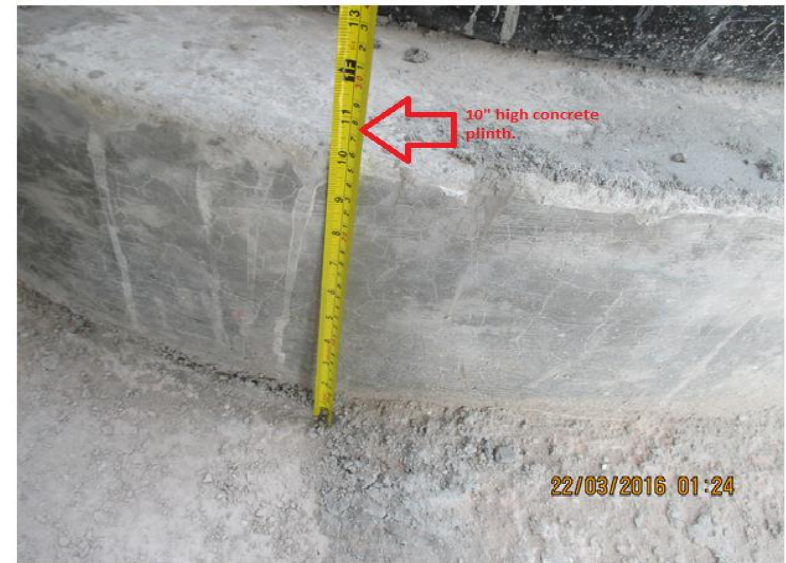
10" high concrete  
plinth.

9 (5000 L) water tank upon 10" built up

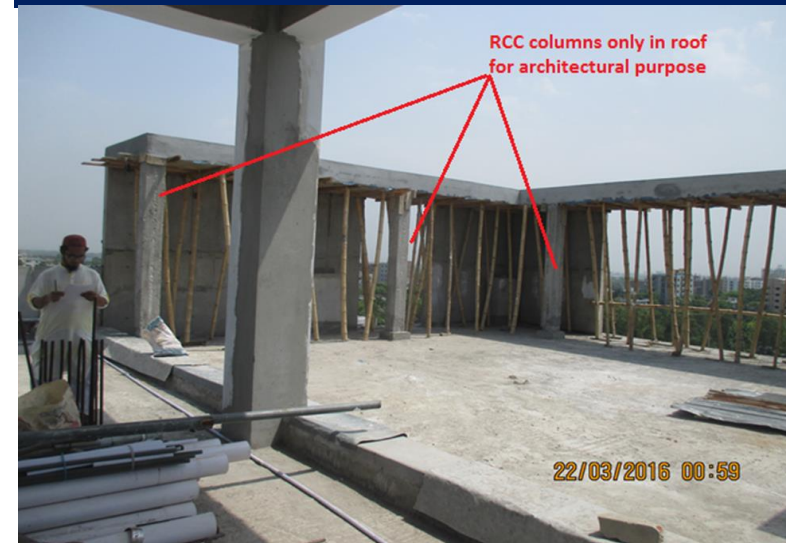
RCC columns only in roof  
for architectural purpose

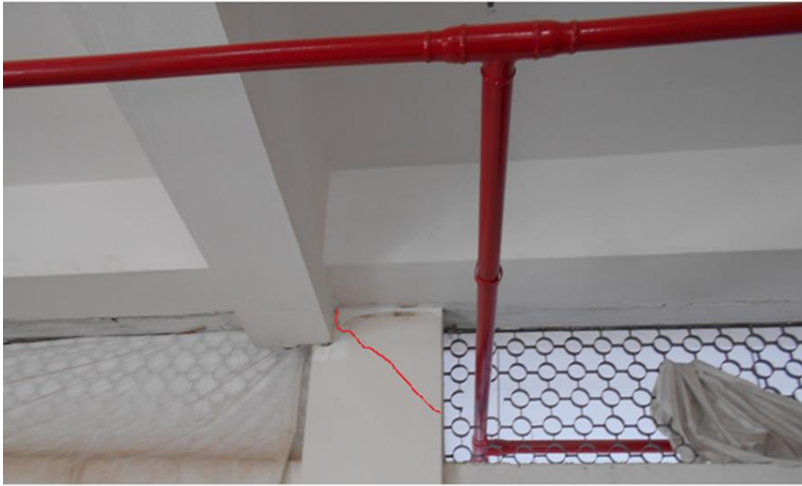
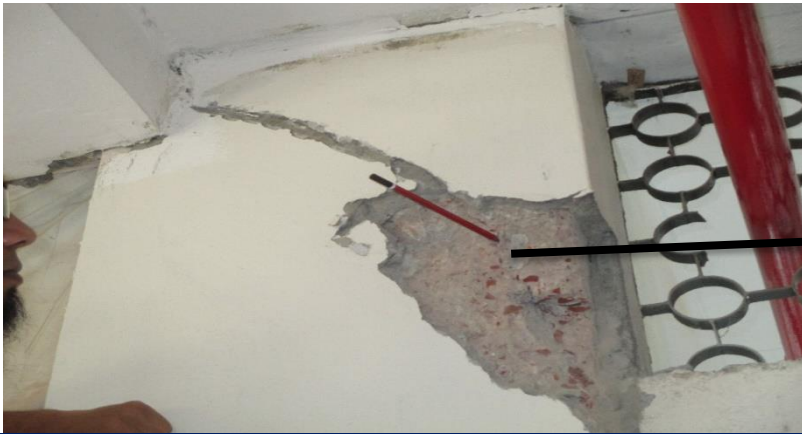
Column with eccentric beam found cracked  
Unclear Beam-Column arrangement.

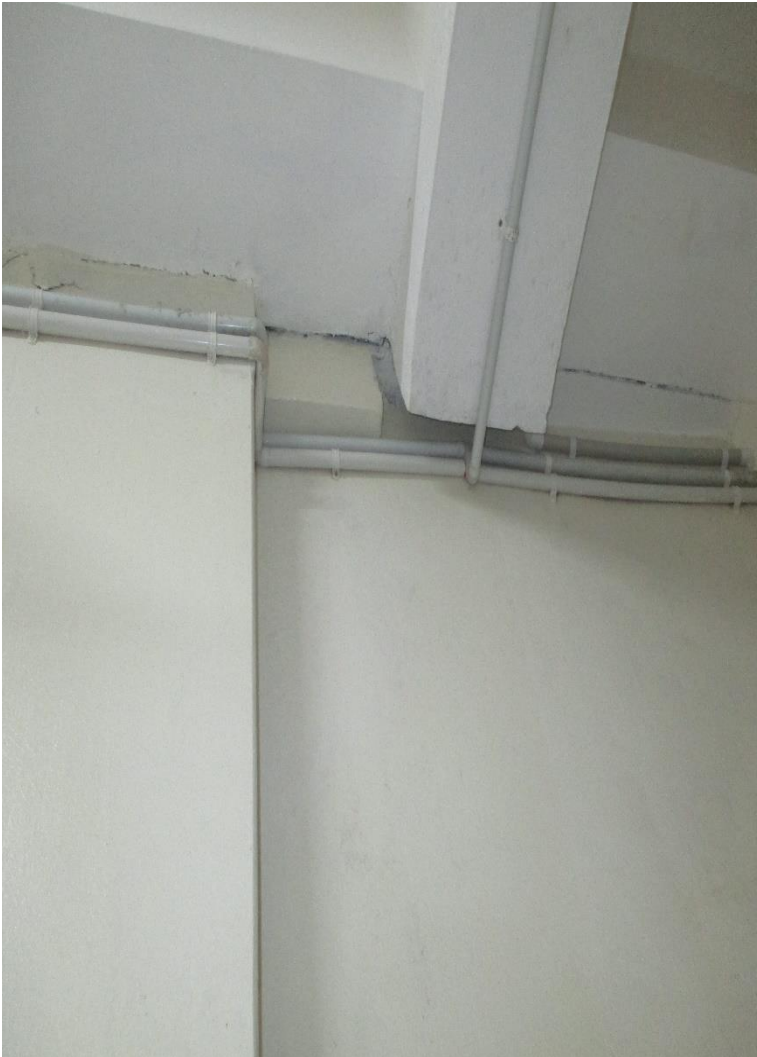
Beam offset to the column at 4<sup>th</sup> Floor

- Building engineer to review the design of beams of the building.
- Building engineer to investigate the cracks of the beam & suggest remedial action.

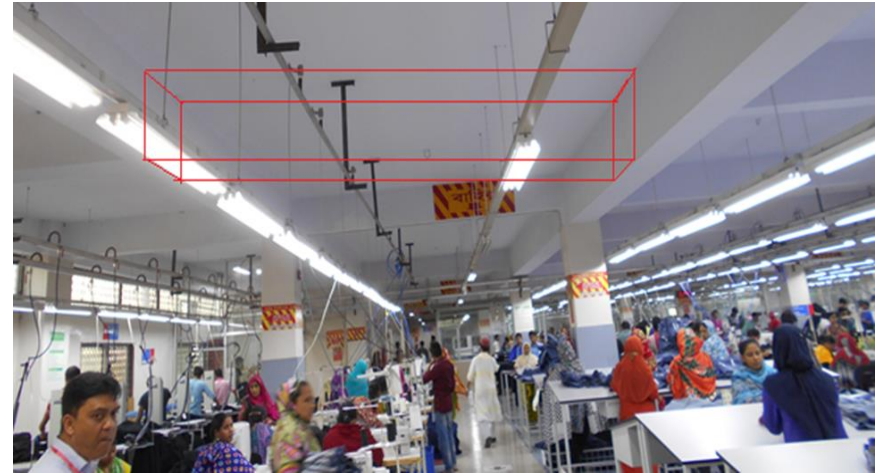
Discontinued beam in every floor on several grid

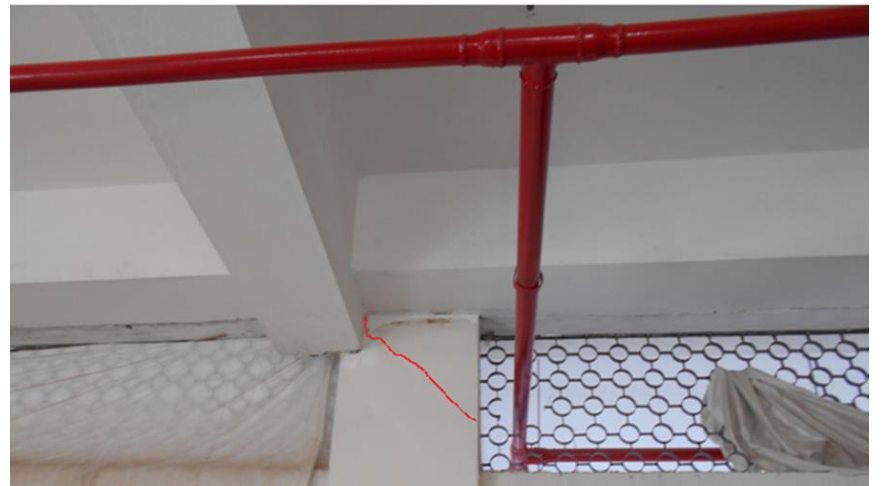
Eccentric beam in 5<sup>th</sup> floor

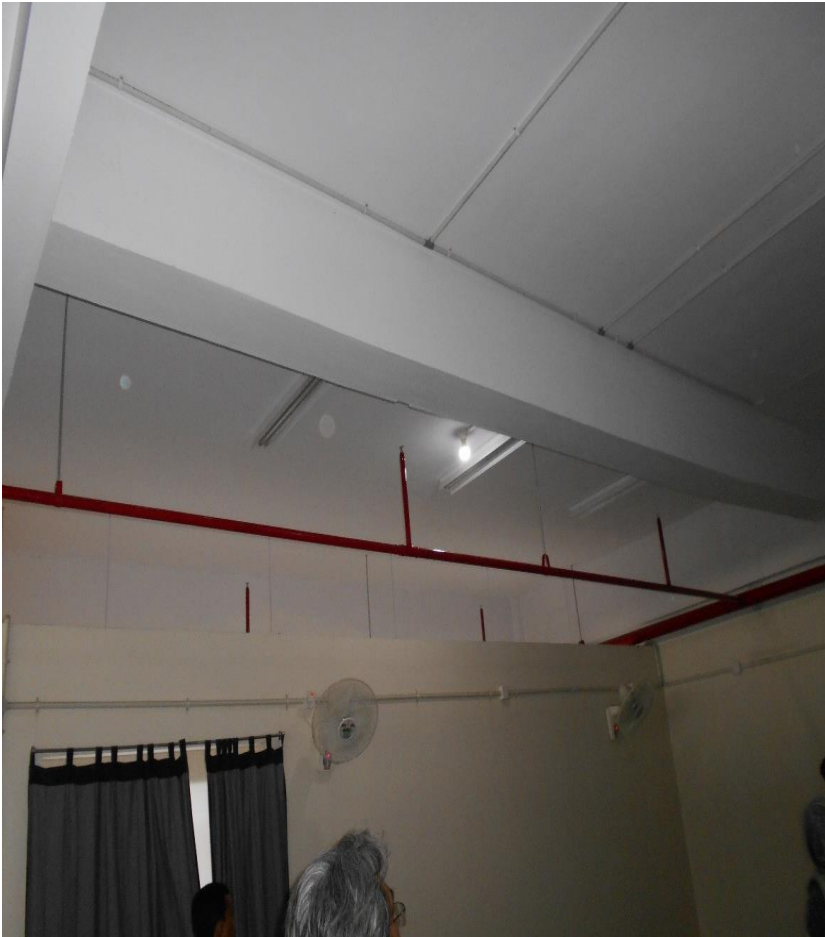
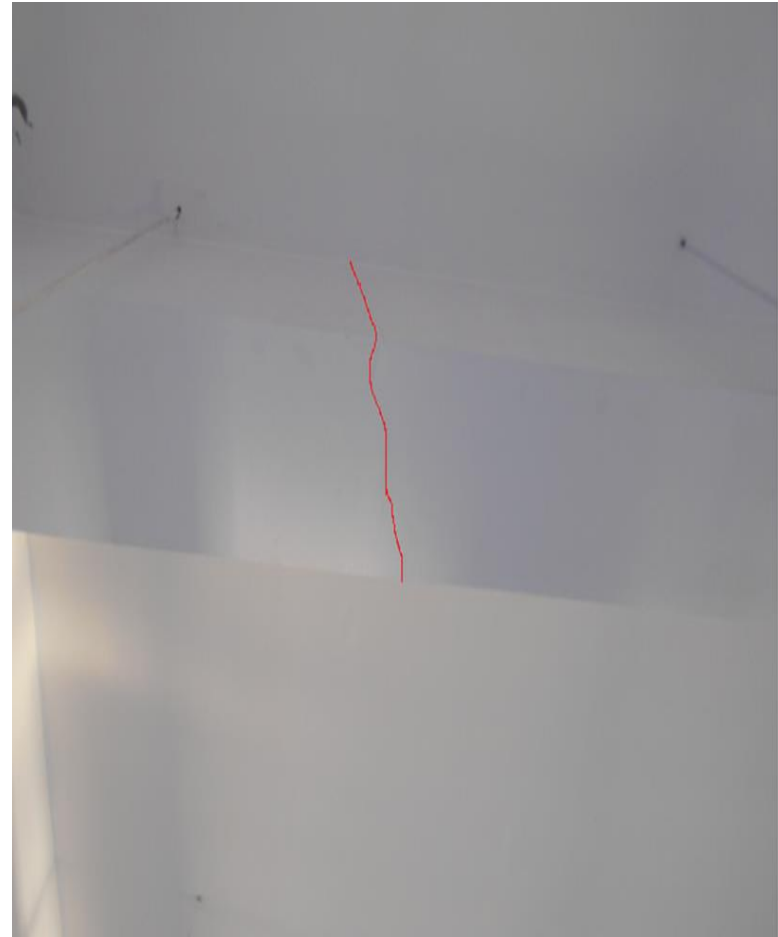
Deflected beam with crack observed in 5<sup>th</sup> Floor of the building.

- Perform strengthening work to the deflected beams if deemed necessary by the DEA.

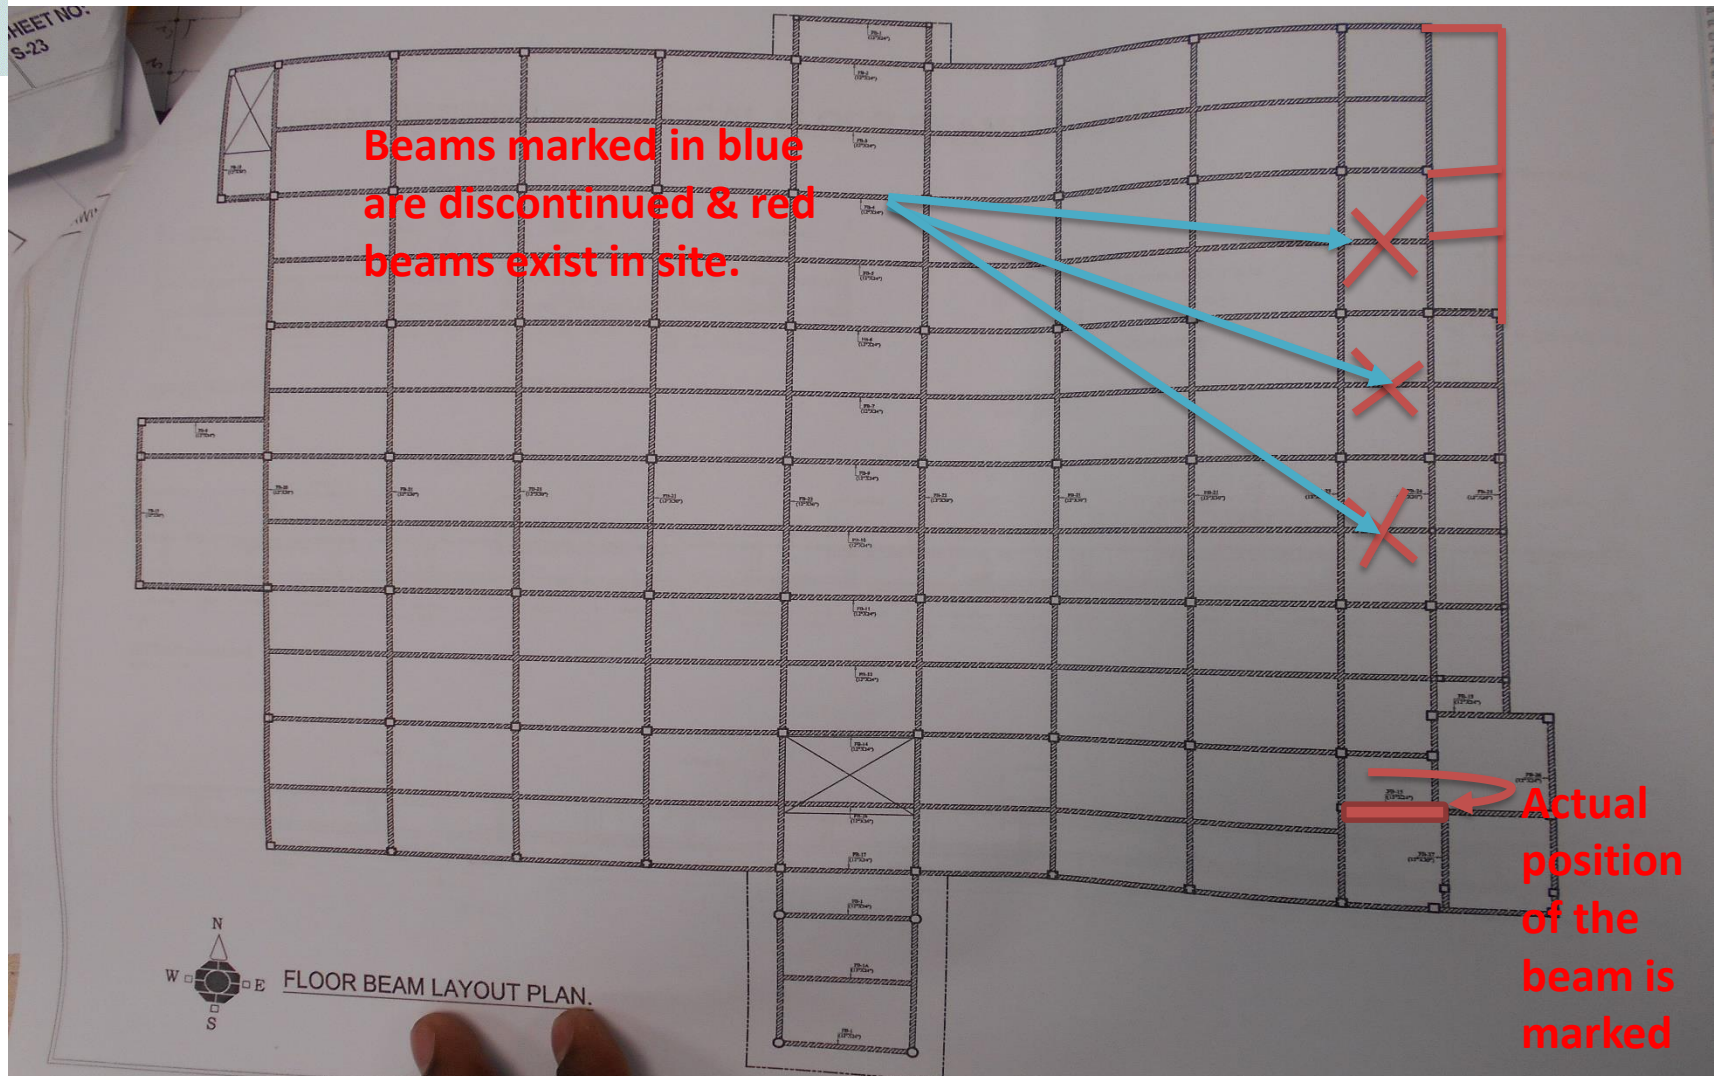
Beam layout Plan

**Inconsistencies of drawings and As built construction.**

- Review actual existing site conditions and update structural and permit drawings as required

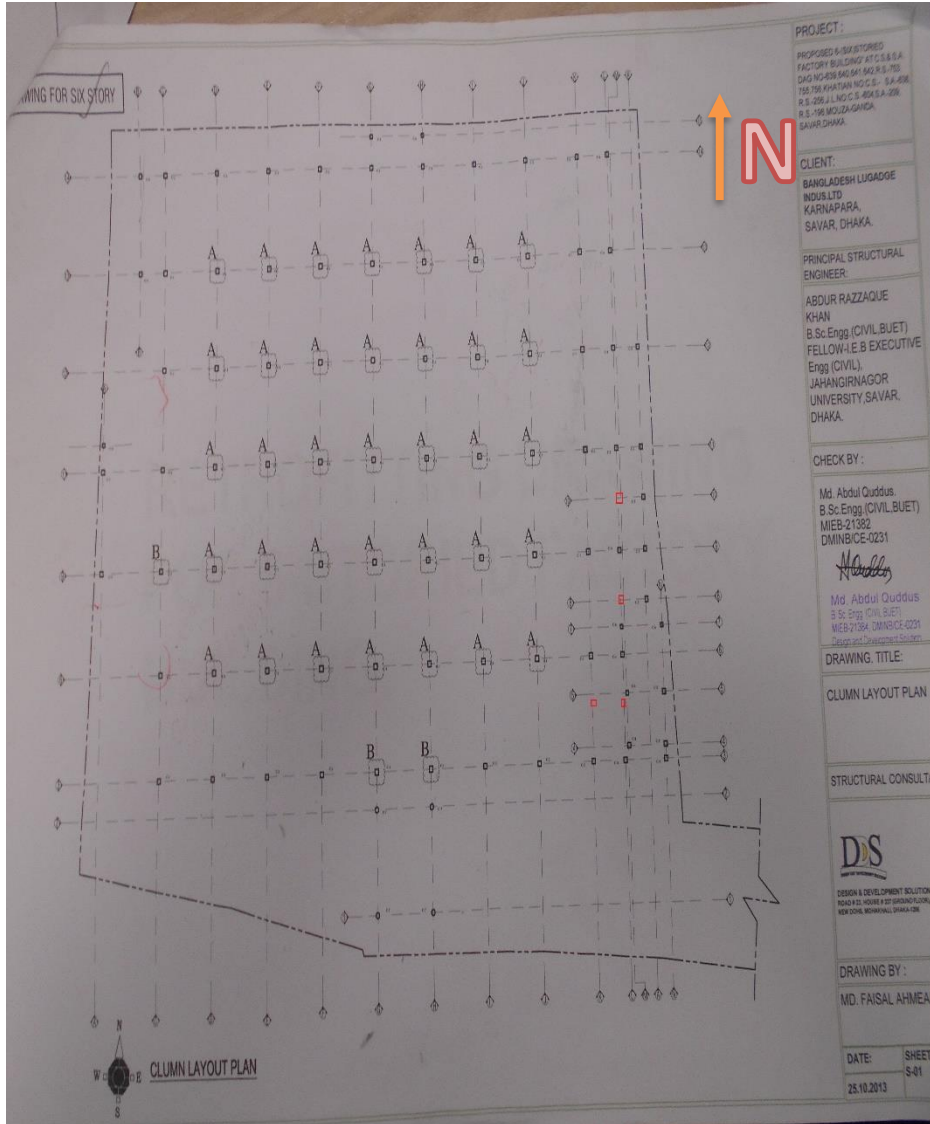
C5, C6 & C7 column is not shown in column schedule but found in column layout of structural drawing.

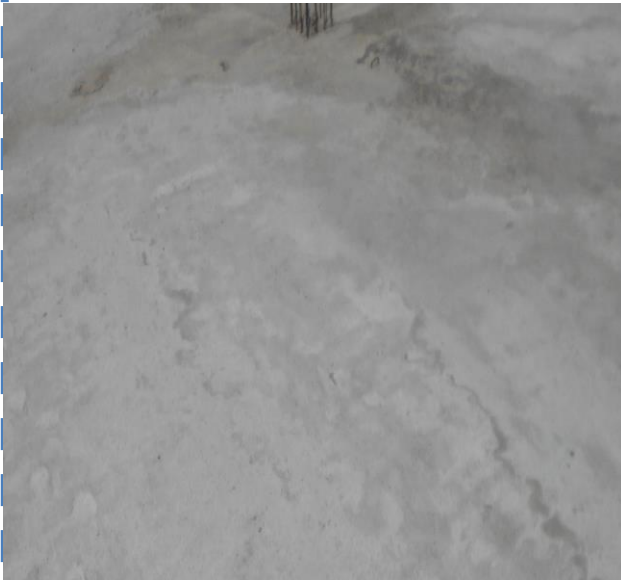
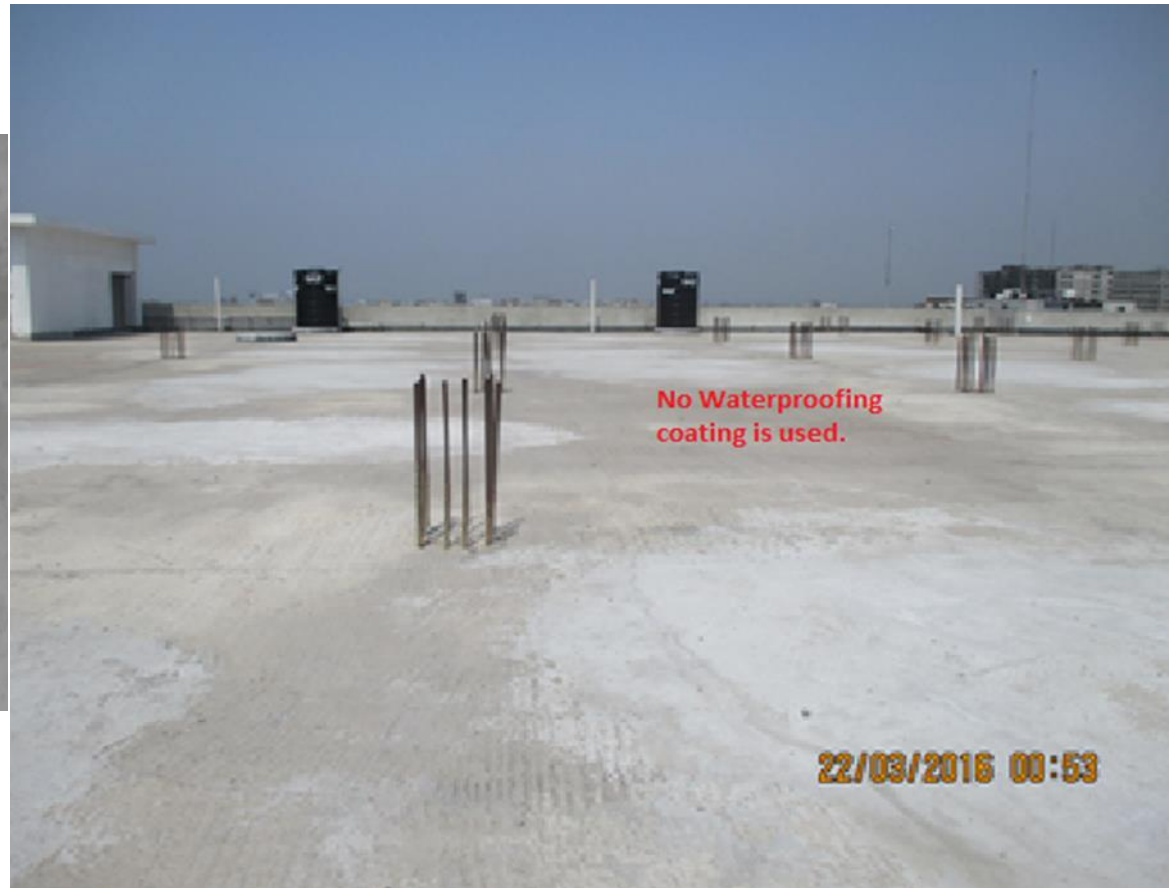
There did not appear to be any waterproofing to the concrete roof. The concrete of the roof will be subject to large temperature changes as it heats up in the sun and cools. This will induce stresses in the structure and could lead to cracking of the concrete slab. In the long term the cracking and lack of waterproofing could cause leaks and durability issues for the structure.

- Investigate options to ensure that the structure is not subject to deterioration arising from possible thermal cracking in concrete roof and consequent water penetration.
- Consideration should be given to waterproofing the roof.

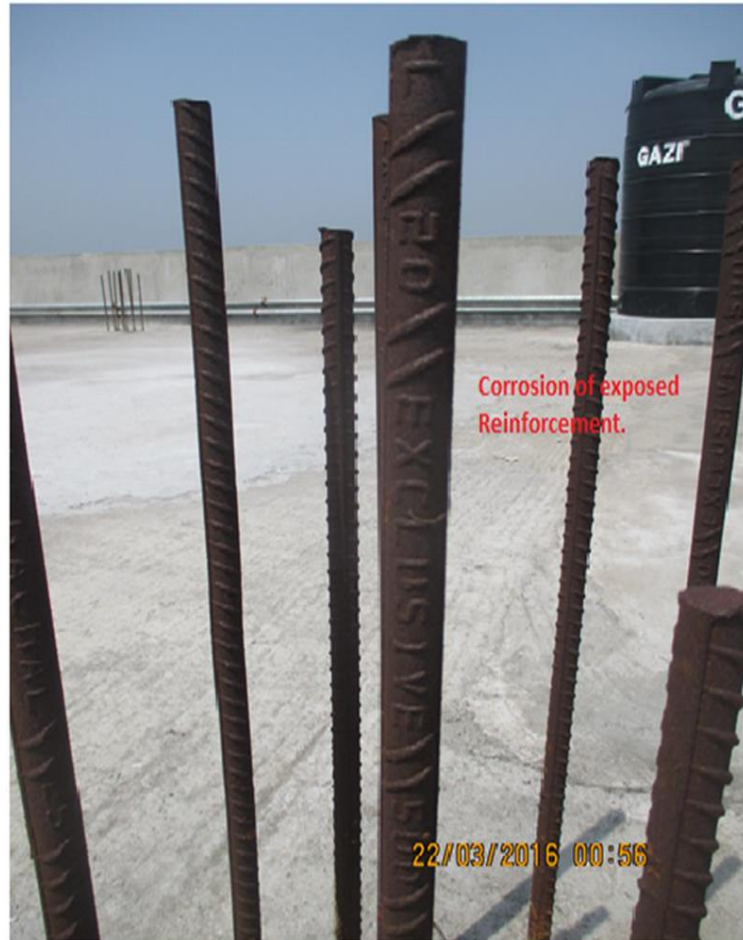
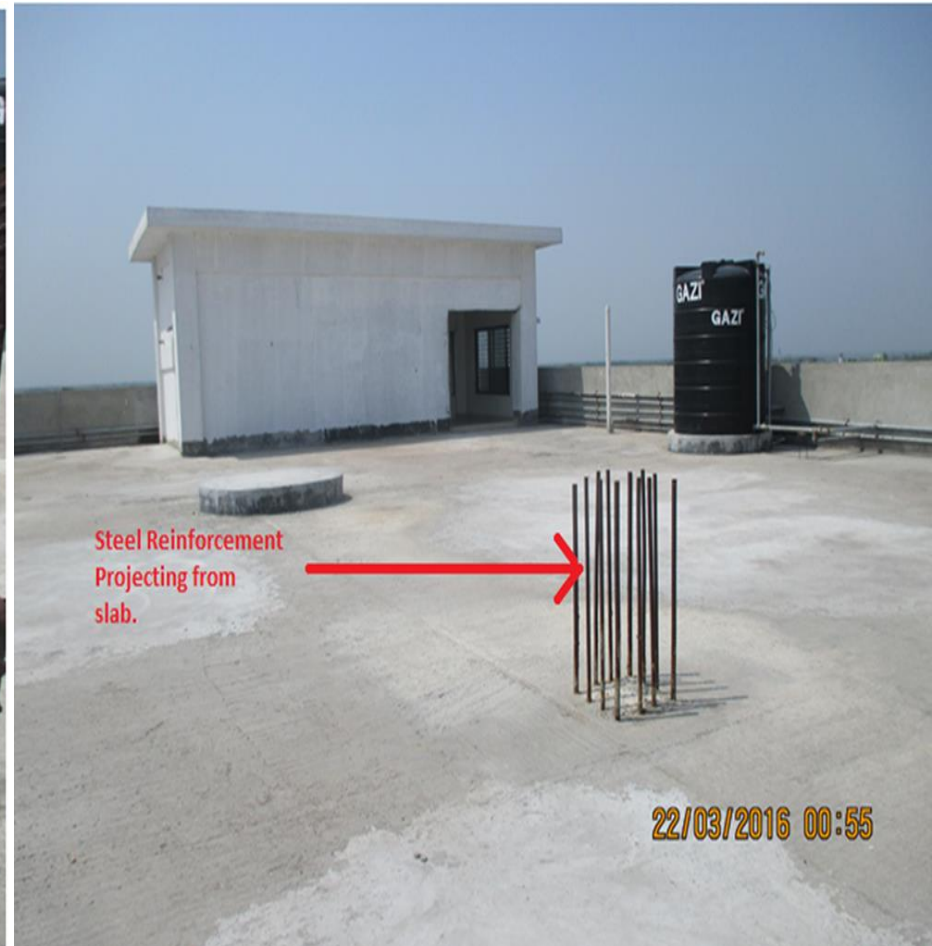
Corrosion in exposed reinforcement. Steel reinforcement projects from roof slab.

- Protect projecting bars by casting a concrete 'cap' over area of column.
- Fix water tank overflow so that it doesn't discharge on to column below.

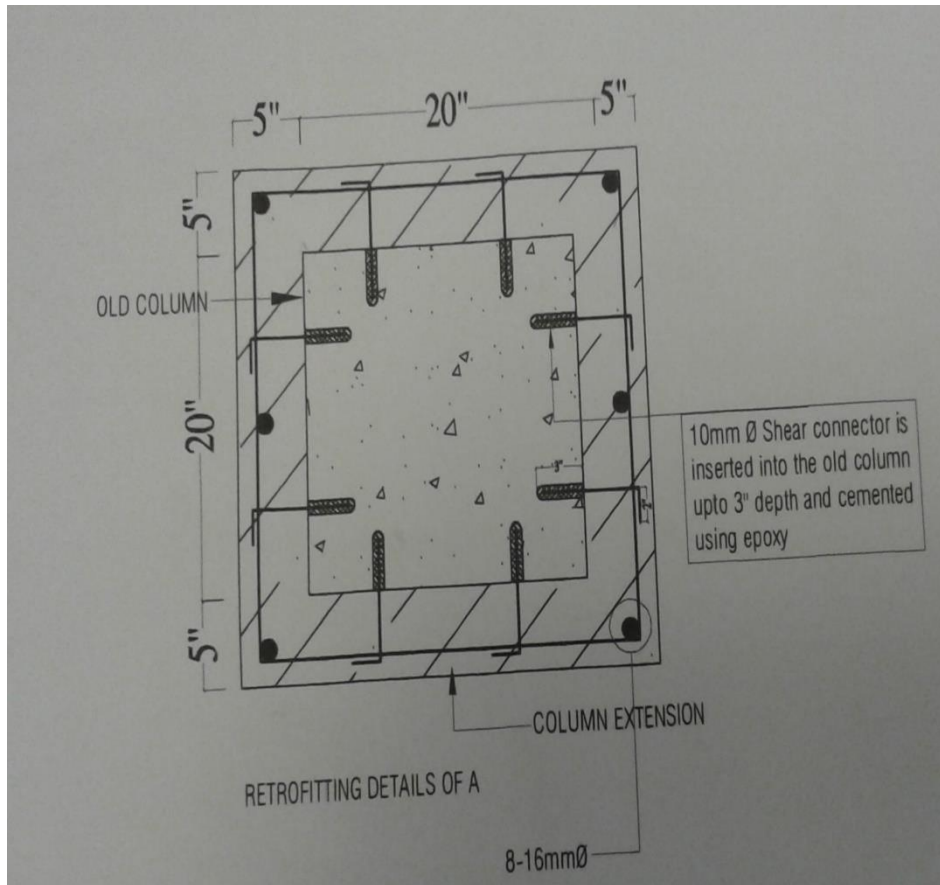
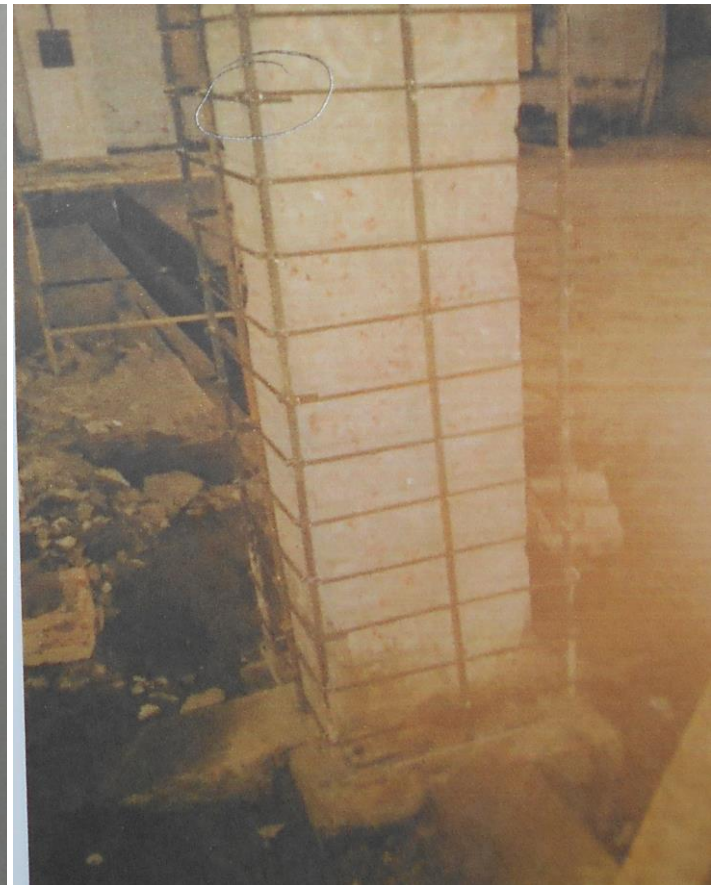
Distance between longitudinal reinforcement is greater than 6" but no lateral ties are provided for confinement of the longitudinal reinforcement.

- Building engineer to re-check the design of retrofitting scheme taken previously

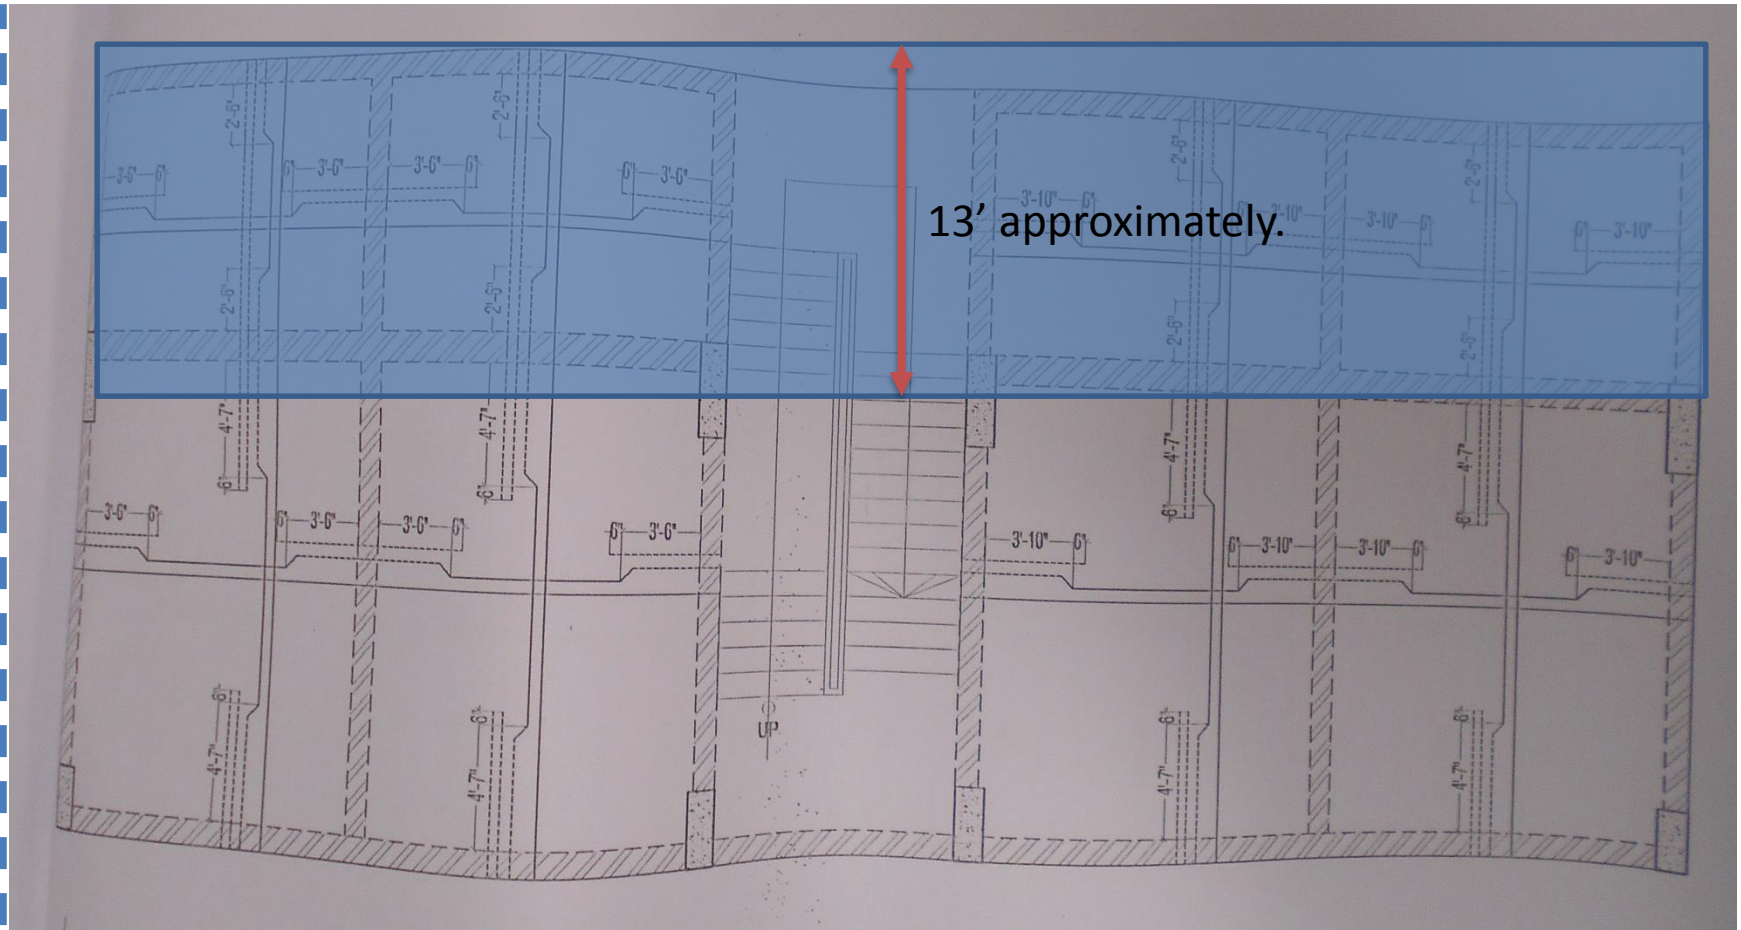
Large cantilever portion of the building

Large beam-cantilever portion with of approximately 13' .

- Building engineer to find the actual slab thickness & carry out a design adequacy check for the cantilever portion of the slab.

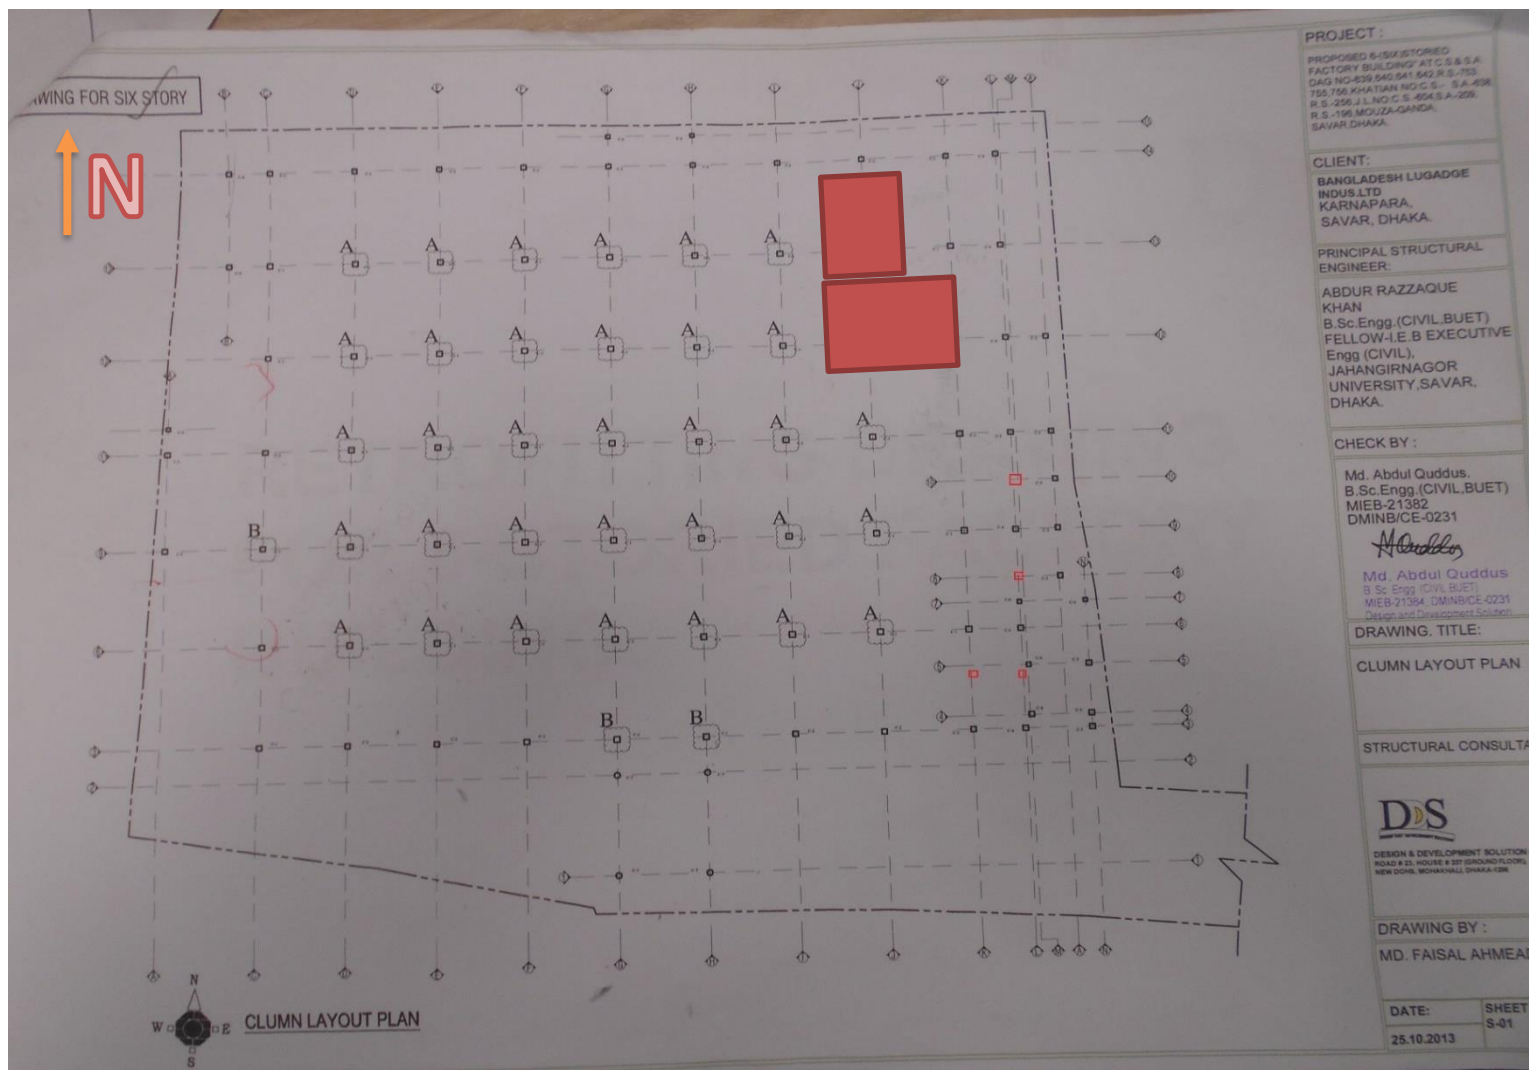
Column layout showing areas to be evacuated.
