# **FIRE SAFETY INSPECTION REPORT**

**MT SWEATER LTD**

**GACHA, PLOT#1703-1704, POST# GACHA, GAZIPUR**

March 13, 2014

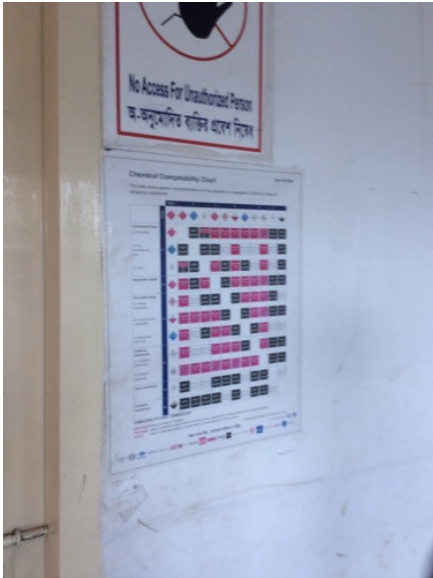
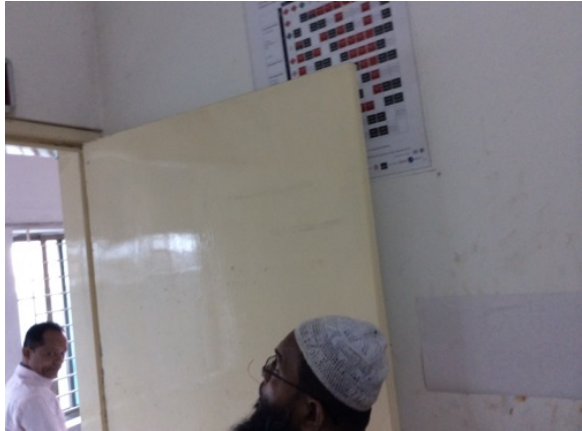
| No. | Category | Finding | Recommendation | Remediation Timeframe |
|---|---|---|---|---|
| F-1 | Fire Rated Construction | Hazardous materials / flammable liquid storage area is not separated by fire-rated construction due to openings to the corridor and non-rated doors. | Separate the hazardous materials / flammable liquid storage room by a minimum 2-hr fire-rated construction. Seal and/or protected all openings to maintain the required fire separations. | Within 3 months |

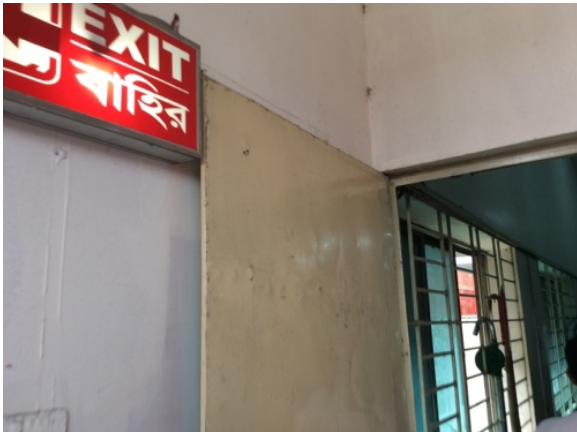
| No. | Category | Finding | Recommendation | Remediation Timeframe |
|---|---|---|---|---|
| F-2 | Fire Rated Construction | The boiler room is not separated by fire-rated construction, due to non-rated door connecting to yarn winding room. | Separate the boiler room by a minimum 2-hr fire-rated construction. Seal and/or protected all openings to maintain the required fire separations | Within 3 months |

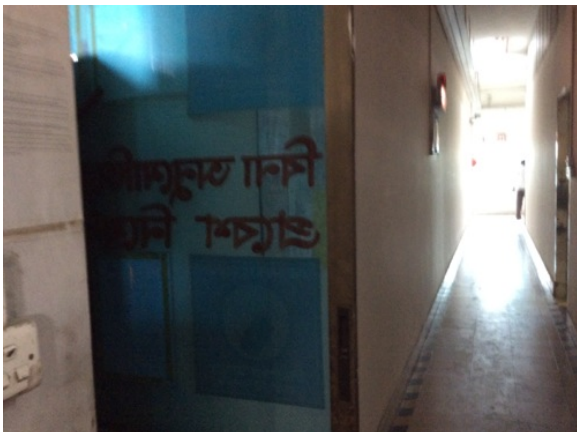
| F-3 | Fire Rated Construction | The generator room is not separated by fire-rated construction, due to non-rated door connecting to interior corridor. | Separate the generator room by a minimum 2-hr fire-rated construction. Seal and/or protected all openings to maintain the required fire separations | Within 3 months |

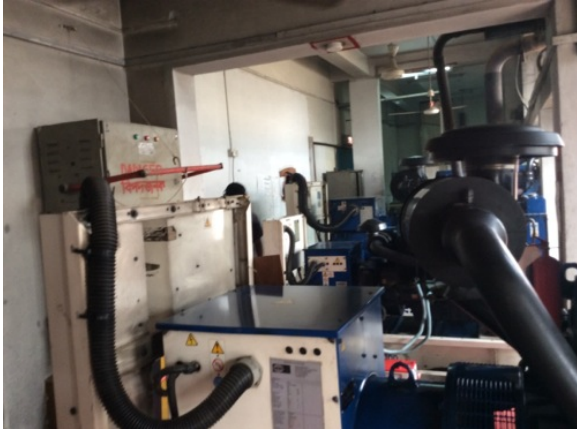
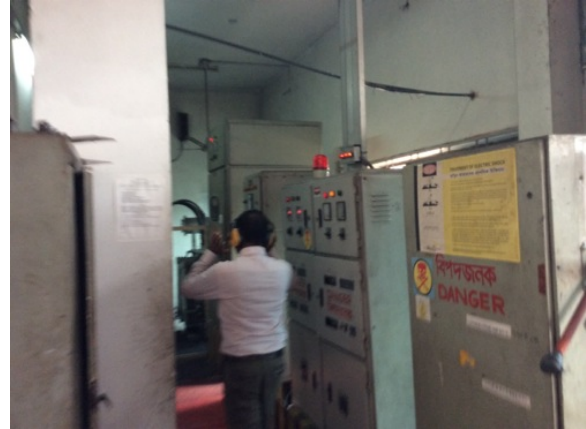
| F-4 | Fire Rated Construction | The generator room is not separated by fire-rated construction from the transformer room. The two share the same room. | Separate the generator and transformer in separate rooms by a minimum 2-hr fire-rated construction. Seal and/or protected all openings to maintain the required fire separations | Within 3 months |

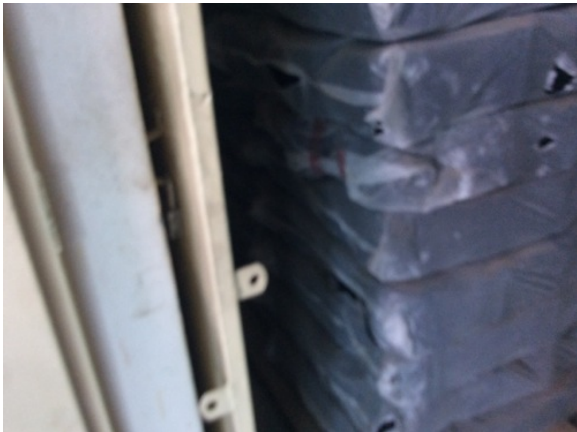
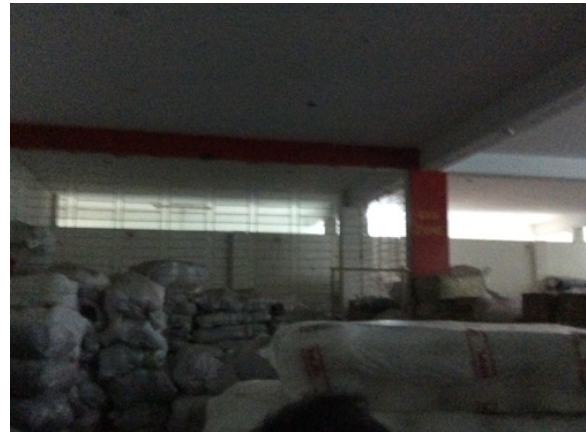
| F-5 | Fire Rated Construction | Yarn storage warehouse is not separated by fire-rated construction. Openings at the top of the wall connect to the corridor serving as part of the egress route. Also, doors to the warehouse room are not fire-rated doors. | Provide dedicated storage rooms separated by minimum 1-hr fire-rated construction. | Within 3 months |

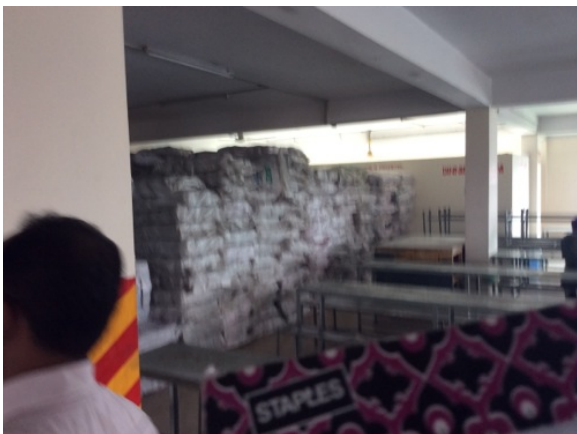
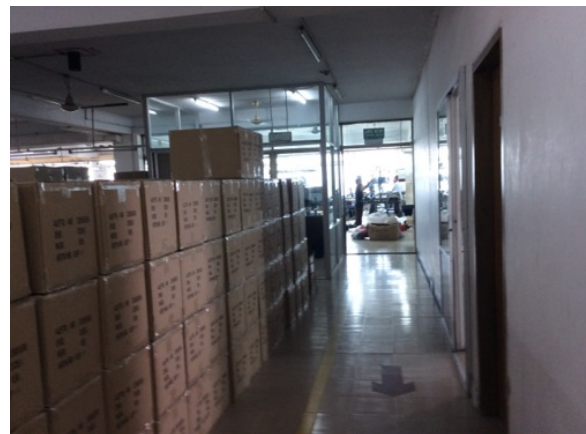
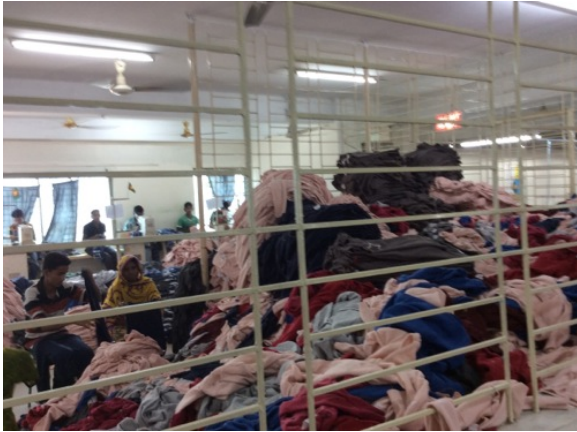
| F-6 | Fire Rated Construction | Significant quantities of storage are located within the factory floor, the dining area, and in some cases in rooms open to the factory floor. (Linking Distribution, Dumping rooms) | Provide defined storage areas and limit the storage arrangement as follows: <ul style="list-style-type: none"><li>- Maximum height of 2.4m and maximum area of 23m<sup>2</sup></li><li>- If sprinkler protected: maximum height of 3.66m and maximum area of 93m<sup>2</sup></li></ul><br>Separate areas of unenclosed combustible storage by a minimum clear distance of 3m. | Within 3 months |

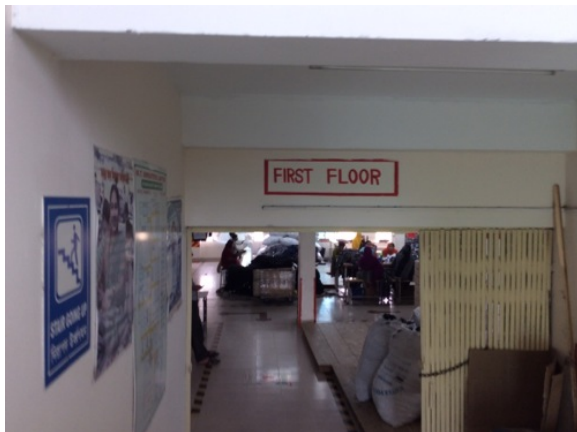
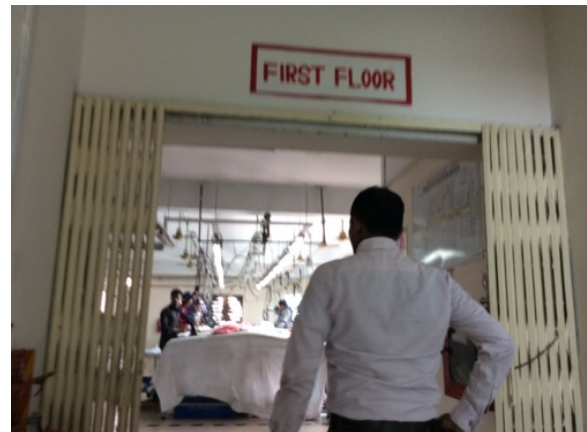
| F-7 | Fire Rated Construction | The exit stairs are not separated from occupied spaces on each floor by fire-rated construction. | <p>Provide minimum 1.5-hr fire rated doors and seal all unprotected openings to separate the exit stairs from work areas and other building spaces on all floor levels. Ensure that the fire doors are self-closing and positive latching and that they are provided with fire exit (panic) hardware where serving production floors.</p> <p>If fire doors are required to be held open for functional reasons, provide automatic-closing devices tied to the fire alarm system.</p> | Within 3 months |

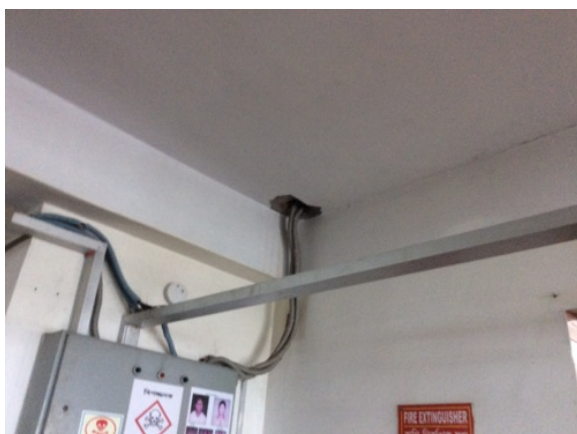
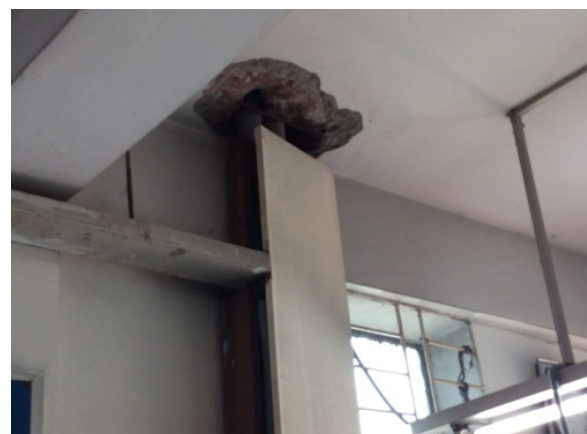
| F-8 | Fire Rated Construction | Unsealed penetrations and openings are located in the fire-rated floor/ceiling assemblies. | Provide a minimum 2-hr fire-rated shaft to separate the utility risers from each floor level.<br><br>Seal all penetrations and openings in floor/ceiling assemblies to maintain the fire separation. | Within 3 months |

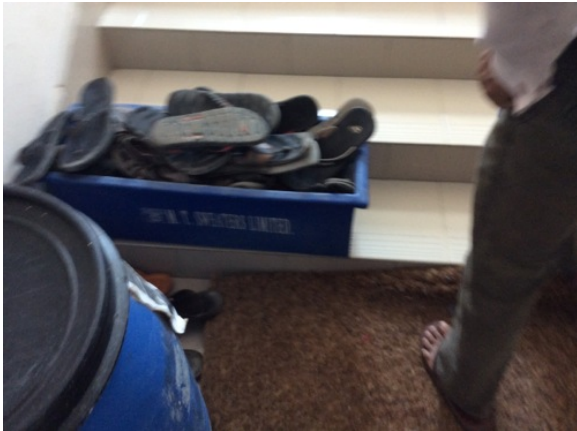
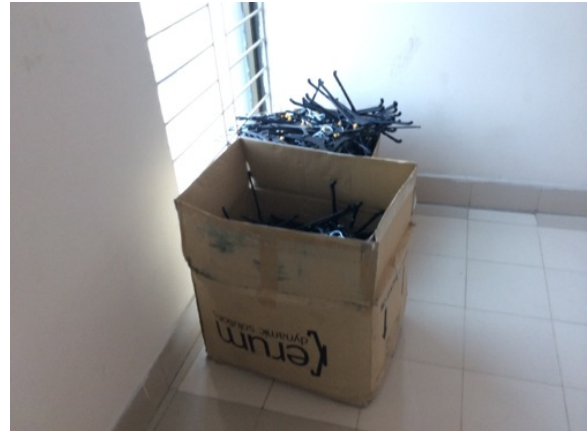
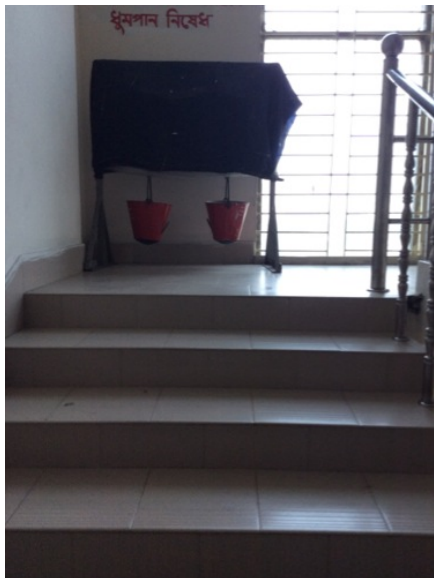
| F-9 | Egress | Storage was located in the exit stair. Dustbins and sand buckets were located on the landings between floors, restricting the width available to be used for egress. | Remove all storage from exit stairs and egress paths. | Immediate |

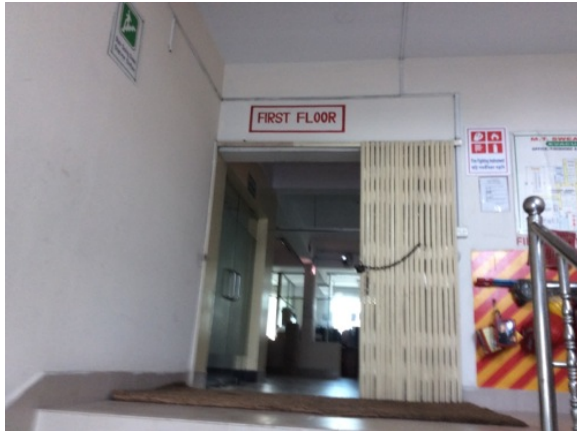
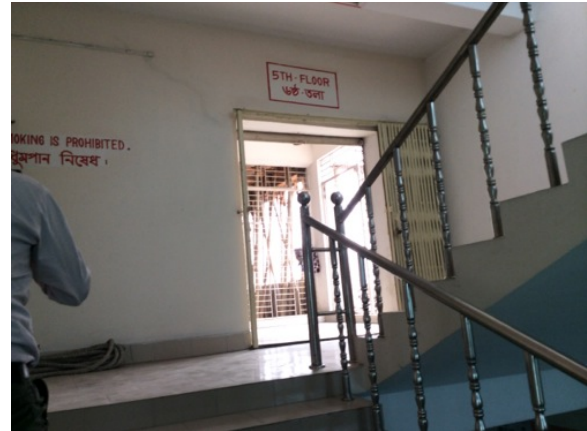
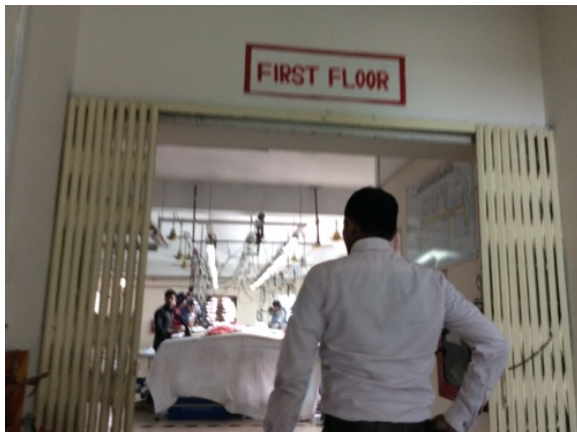
| F-10 | Egress | Egress doors / gates with locking features are provided at all stair doors. | Remove locking features from all egress doors / gates.<br><br>If locks are required for security reasons, utilize special door locking features complying with NFPA 101. | Immediate |

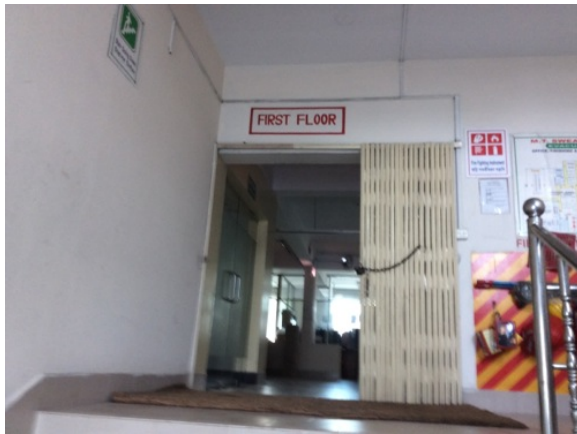
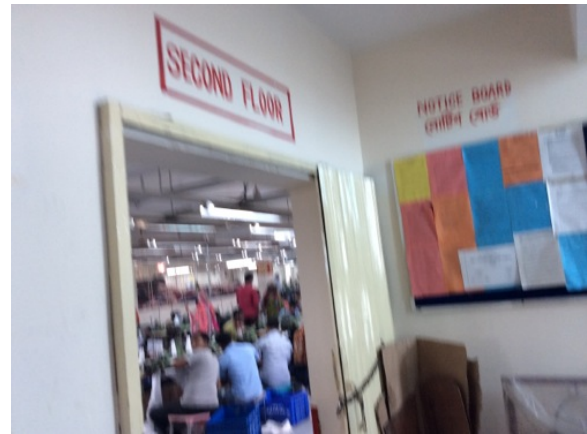
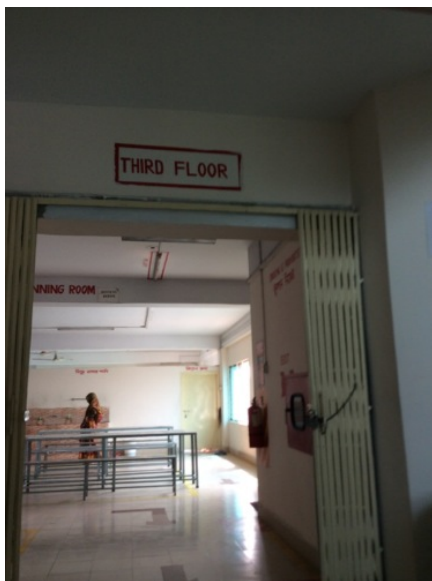
| F-11 | Egress | Collapsible gates / sliding doors are provided at all stair doors. | Replace all gates / sliding doors along the means of egress with side-hinged, swinging egress doors. | Within 1 month |

| | | | If locks are required for security reasons, utilize special door locking features complying with NFPA 101. | |

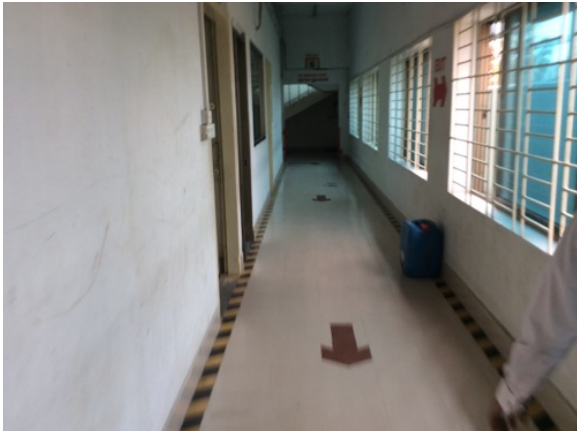
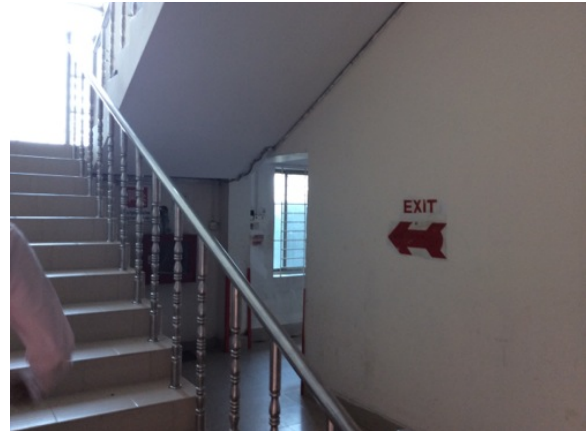
| F-12 | Egress | South exit stairs discharge inside the building. | Correct by providing either:<br>- Modify stair to discharge directly outside.<br>- Provide 2-hr fire-rated exit passageway leading directly outside (with vestibules to separate any storage rooms). | Within 3 months |

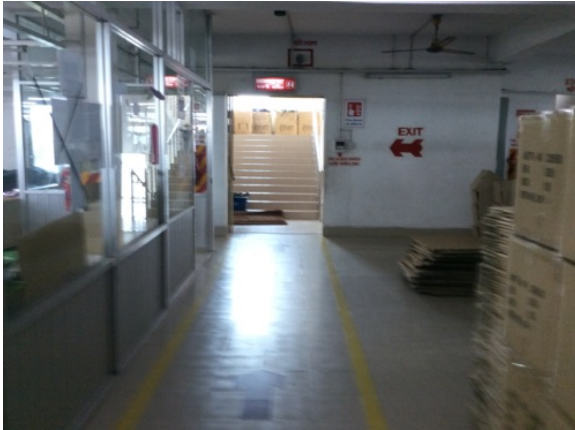
| F-13 | Fire Protection | The fire alarm system is antiquated, not a listed system, and does not provide alarm and notification features consistent with acceptable standards. | Replace the fire alarm system with a new, listed addressable fire alarm system in accordance with NFPA 72. | Design within 4 months, install within 9 months |

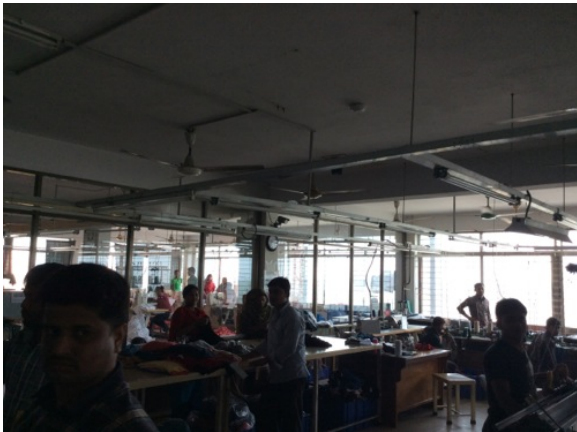
| F-15 | Fire Protection | The building is equipped with single-station smoke alarms. Smoke alarm activation sounds only a local alarm and does not provide automatic fire alarm notification of occupants. | Remove single-station smoke alarms. Provide automatic smoke detection throughout the building, tied into the fire alarm system, in accordance with NFPA 72. | Within 6 months |

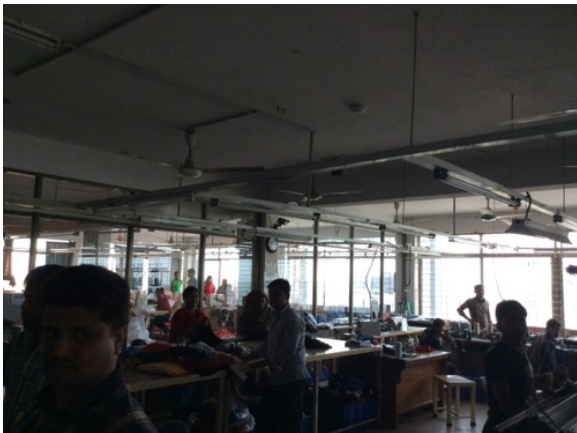
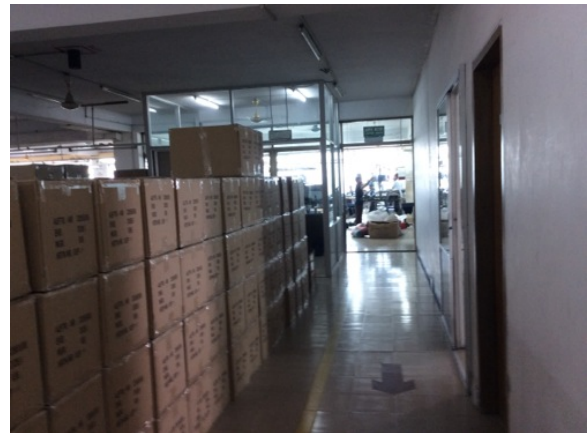
| F-16 | Egress Lighting | IPS lights did not come on when power went out. Assertions were made that the installation is in-process and was not yet connected on the floor in question. | Regularly test the emergency lighting system on each floor and replace/repair lights as needed. | Within 3 months |
