# **FIRE SAFETY INSPECTION REPORT**

## **DENITEX LIMITED**

**ADDRESS: 9/1, Karnapara, Savar, Dhaka-1340, Bangladesh.**

**Date: March 22, 2016**

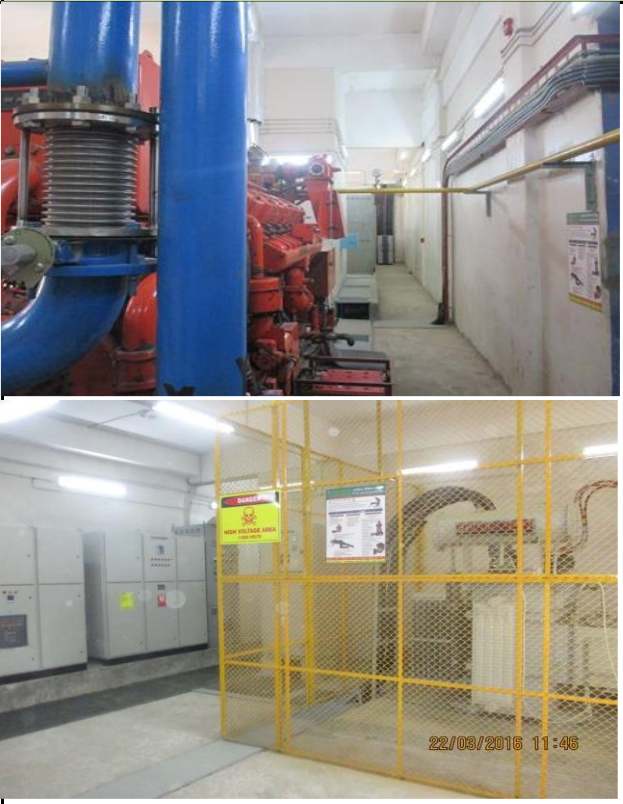
| SI No. | Category | Findings | Required Action | Remediation Time Frame | Pictorial Evidence |
|---|---|---|---|---|---|
| 1 | Fire Rated Construction | Generators, Transformer & Switchgears room are not properly separated by fire rated construction from each others.<br>Location: Ground Floor, South Side. | Generator, Transformer & Switchgear room shall be separated from each other by a minimum 2-hr fire rated construction (wall, floor, slab etc.). Seal all penetrations and to maintain required fire separation provide 1.5-hr fire rated materials in the openings (door, window etc.) if required. All exhaust systems shall discharge to the exterior of the building in a safe location. | Within 3 months | |

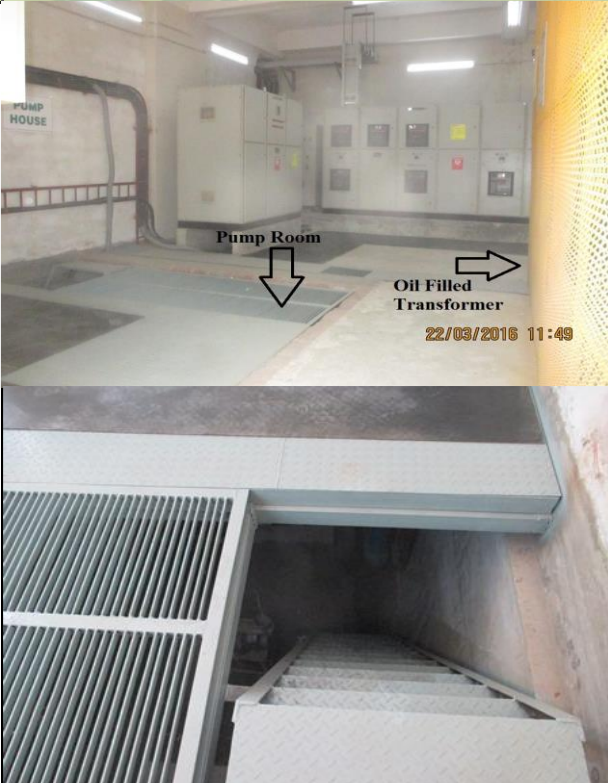
| Sl No. | Category | Findings | Required Action | Remediation Time Frame | Pictorial Evidence |
|---|---|---|---|---|---|
| 2 | Fire Rated Construction | Fire pump room is not separated by fire rated construction. | <p>The Pump room shall be separated from Transformer/Sub-station room by a minimum 2-hr fire rated construction (wall, floor, slab etc.). Seal all penetrations and openings (door, window etc.) should be protected by 1.5-hr fire rated materials to maintain the fire separation if required. All exhaust systems shall discharge to the exterior of the building in a safe location.</p> <p>&amp;</p> <p>Provide a safe exit to directly out site of the building.</p> | Within 3 months | <p>The top photograph shows an interior room with several large electrical cabinets. A black arrow points to a specific area labeled 'Pump Room', and a white arrow points to another area labeled 'Oil Filled Transformer'. A timestamp '22/03/2016 11:49' is visible in the bottom right corner of the photo. The bottom photograph shows a concrete staircase with metal grates leading downwards, providing an exit from the room.</p> |

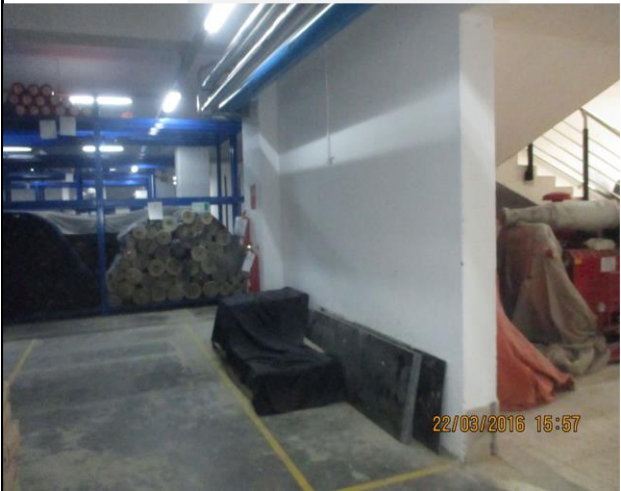
| Sl No. | Category | Findings | Required Action | Remediation Time Frame | Pictorial Evidence |
|---|---|---|---|---|---|
| 3 | Fire Rated Construction | The exit stairs are not separated from work areas on each floor by fire-rated construction. | <p>For non-sprinklered Building: Stair shall be enclosed with a minimum 2-hr fire-rated construction. Seal all unprotected openings and provide minimum 1.5-hr fire rated doors to separate the exit stairs from work areas and other building spaces on all floor levels. Ensure that the fire doors are self-closing, positive latching and that they are provided with fire exit (panic) hardware where serving production floors.</p> <p>If fire doors are required to be held open for functional reasons, provide automatic-closing devices tied to the fire alarm system.</p> | Within 3 months | |

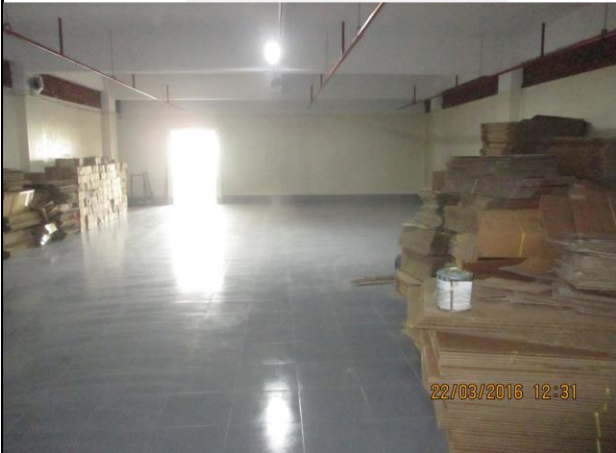
| Sl No. | Category | Findings | Required Action | Remediation Time Frame | Pictorial Evidence |
|---|---|---|---|---|---|
| 4 | Fire Rated Construction | Rooms used for storage of combustible materials are not separated from the surrounding occupancy/areas. | Rooms used for storage of combustible materials shall be separated from the surrounding occupancy with a minimum 1 hour construction. | Within 3 months | |

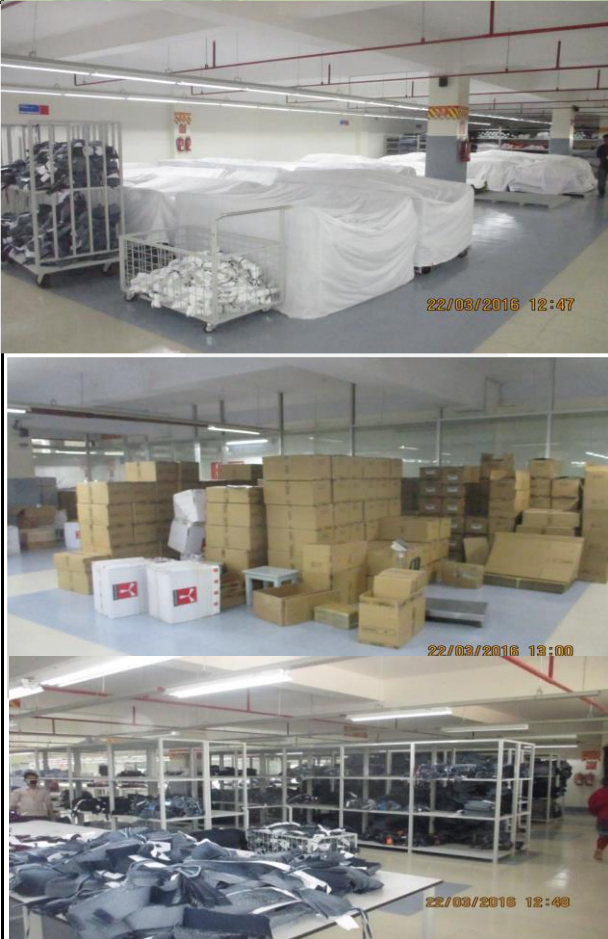
| Sl No. | Category | Findings | Required Action | Remediation Time Frame | Pictorial Evidence |
|---|---|---|---|---|---|
| 5 | Fire Rated Construction | Areas used for in-process storage of combustible materials are open to the surrounding production areas | <p>Provide defined storage areas and limit the storage arrangement as follows:-</p> <p>1. General Condition: Maximum height of 2.4m and maximum area of 23m<sup>2</sup>. Separate areas of unenclosed combustible storage by a minimum clear distance of 3m.</p> <p>2. If sprinkler protected: maximum height of 3.66m and maximum area of 93m<sup>2</sup>. Separate areas of unenclosed combustible storage by a minimum clear distance of 3m. or</p> <p>3. Enclose the storage area from the surrounding occupancy with a minimum 1 hour construction.</p> | Within 1 month | |

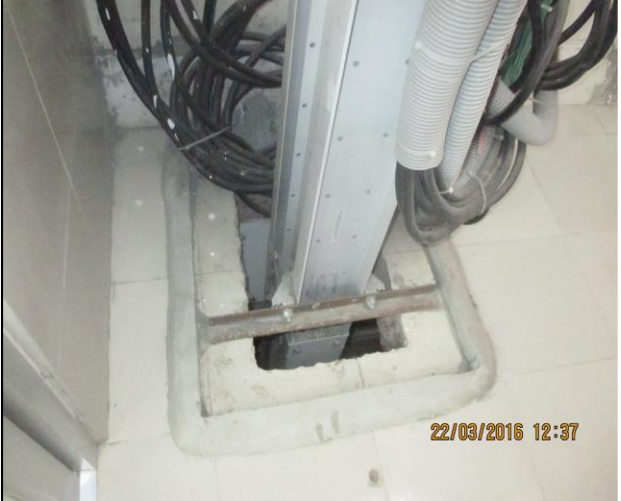
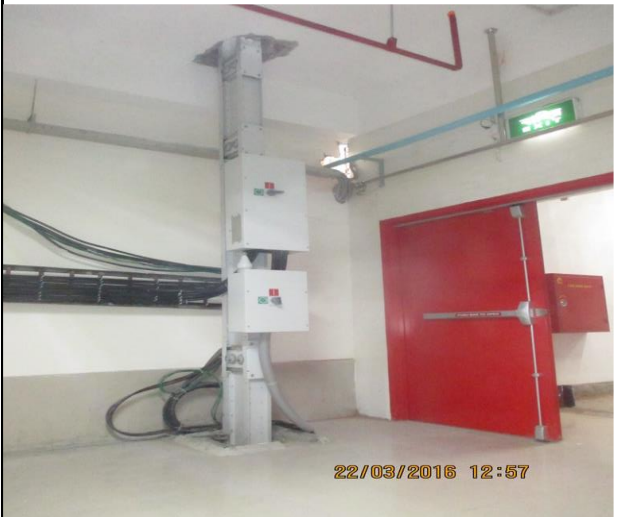
| Sl No. | Category | Findings | Required Action | Remediation Time Frame | Pictorial Evidence |
|---|---|---|---|---|---|
| 6 | Fire Rated Construction | Unsealed Penetrations through floor/ceiling assemblies are observed.<br>Location(s): Inside the production floor near South middle exit stair | Provide a minimum 2-hr fire rated shaft to separate the utility risers from each floor if required.<br>Or<br>Seal all penetrations and openings in floor/ceiling (full thickness of the floor/ceiling) assemblies by fire rated materials to maintain the fire resistance rating. | Within 3 months | |

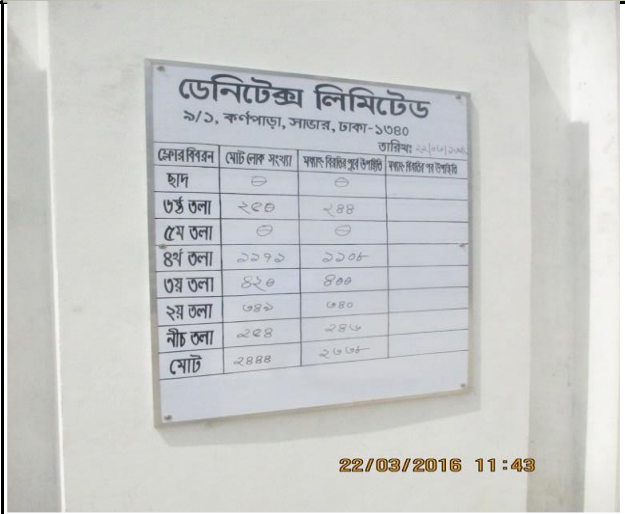
| Sl No. | Category | Findings | Required Action | Remediation Time Frame | Pictorial Evidence |
|---|---|---|---|---|---|
| 7 | Egress | Exit capacity is not adequate for the occupant load.<br>Floor: 3rd Floor<br>Present Occupant Loads: 1171 | 1. Reduce occupant load to not more than available exit capacity.<br>Or<br>2. Provide additional exits to increase exit capacity.<br>Or<br>3. Provide an automatic sprinkler protection throughout the building in accordance with NFPA 13. | Within 3 months | |

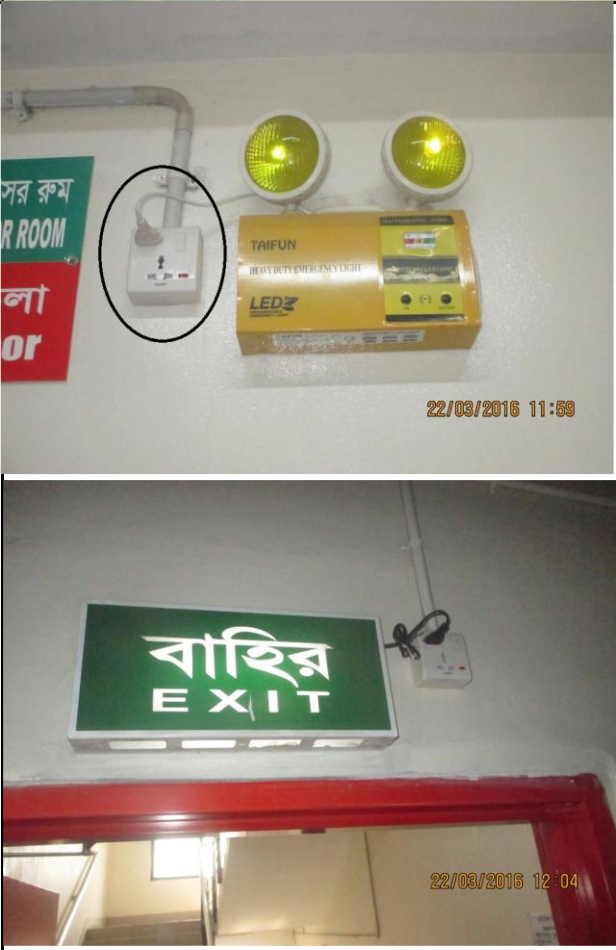
| Sl No. | Category | Findings | Required Action | Remediation Time Frame | Pictorial Evidence |
|---|---|---|---|---|---|
| 10 | Egress Lighting | Manual on-off switch is provided for [emergency lighting / exit signage] units. | Remove manual on/off switches from emergency lighting / exit signage units to prevent them from being switched off. | Within 1 month | |

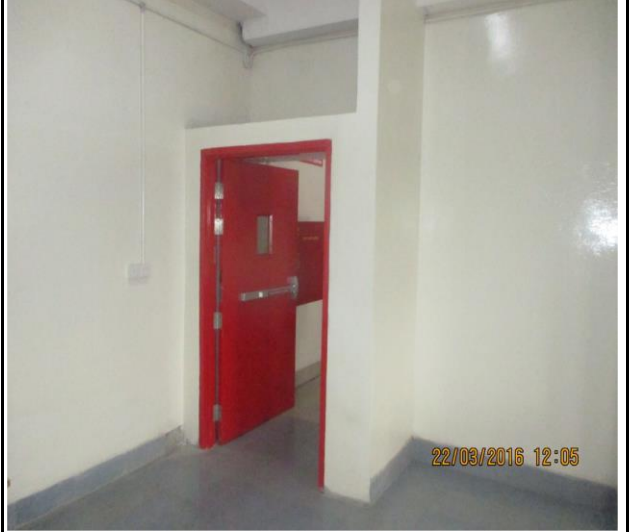
| Sl No. | Category | Findings | Required Action | Remediation Time Frame | Pictorial Evidence |
|---|---|---|---|---|---|
| 11 | Egress Lighting | Exit sign not provided on many exits. | <p>Lighted exit signs shall be placed at entrance to an exit. Additional exit signs shall be placed throughout the facility anywhere the continuation of the egress is not obvious.</p> <p>Lighted exit signs shall be provided with either battery backup or uninterruptable power supply systems and shall be continuously illuminated.</p> <p>And</p> <p>Illuminated directional signs shall be provided where there is a change in the direction for the path of travel and the direction to an exit is not obvious.</p> | Immediately | |

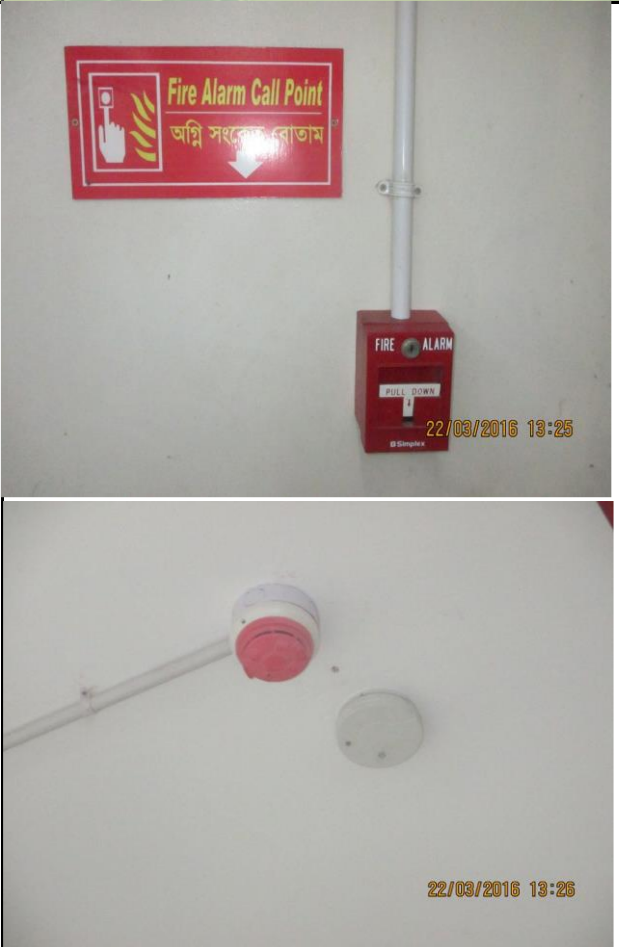
| Sl No. | Category | Findings | Required Action | Remediation Time Frame | Pictorial Evidence |
|---|---|---|---|---|---|
| 12 | Fire Detection System | The existing fire detection system is not a listed system and does not provide automatic alarm and notification features consistent with acceptable standards. | Replace the fire detection system with a new, listed addressable fire alarm system in accordance with NFPA 72. | Design within 04 Months & Installation Within 09 Months | |

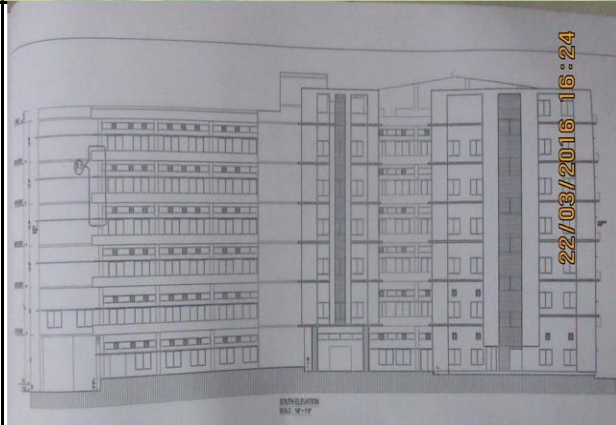
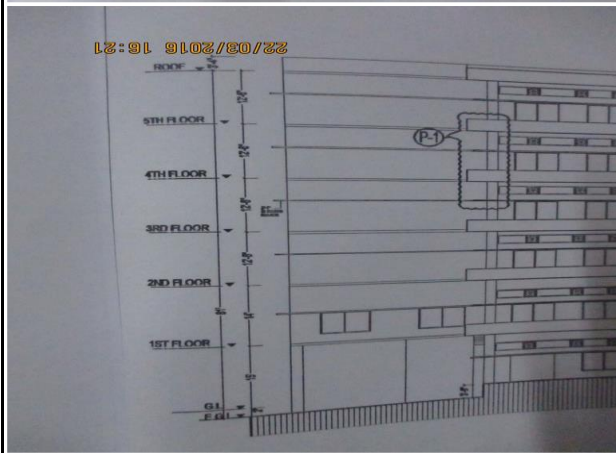
| Sl No. | Category | Findings | Required Action | Remediation Time Frame | Pictorial Evidence |
|---|---|---|---|---|---|
| 14 | Fire Protection System | The existing high-rise building with an occupiable floor greater than 23 m (75 ft) (Based on Architectural Drawing) above the finished grade is not protected with an approved automatic sprinkler system. The large occupant loads, heavy fuel loading, and anticipated extended egress times warrant sprinkler protection. | <p>Provide an automatic sprinkler protection throughout the building in accordance with NFPA 13.</p> <p>Note: If the 06 story existing building is not extend vertically, this issue will not be applicable. In that case The factory have to Provide a standpipe system (Class-III) throughout the building in accordance with NFPA 14.</p> | Design within 06 Months & Installation Within 09 Months | |
