Fortis Garments Ltd

Holding No-100/1, Block B, Saheed Mosarrah Hossain Road, Purbo Chandora, Sofipur, Kaliakoir,
Gazipur
(24.035968 N, 90.270959 E)

15th April 2014

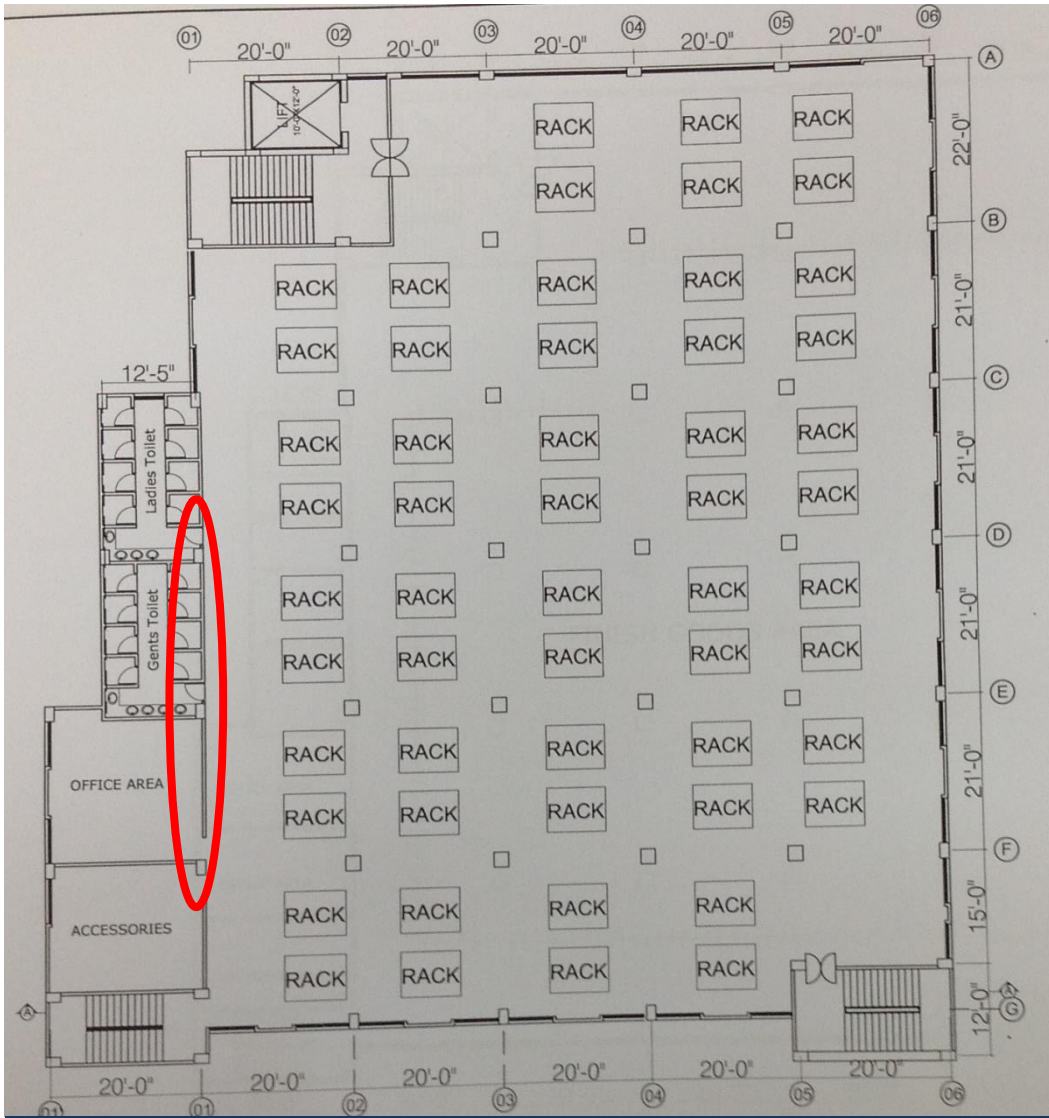
Ground floor plan

Outline calculations indicate the circled columns below are highly stressed under their current loading condition.

Item No.	Observation	Recommended Action Plan	Recommended Timeline
1	Stress levels in Columns	Building Engineer to review design, loads and stresses in columns in the area noted.	6-weeks
2	Stress levels in Columns	Building Engineer to verify insitu concrete strength by taking 100mm diameter cores from 4 columns .	6-weeks
3	Stress levels in Columns	Building Engineer to verify grade of steel reinforcement and diameter of main column bars.	6-weeks
4	Stress levels in Columns	Make structural alterations as advised by Engineer.	6-months
5	Hairline cracking on beams and some slab soffit areas	Monitor cracks on beams. Building Engineer to investigate if cracks are only in the plastering.	6-months
6	Hairline cracking on beams and some slab soffit areas	Building Engineer to advise on load reduction and repair and strengthening if required.	6-months
7	Differences between actual construction and information on design drawings.	Building Engineer to survey the structure and prepare a full set of "as-constructed" drawings.	6-months

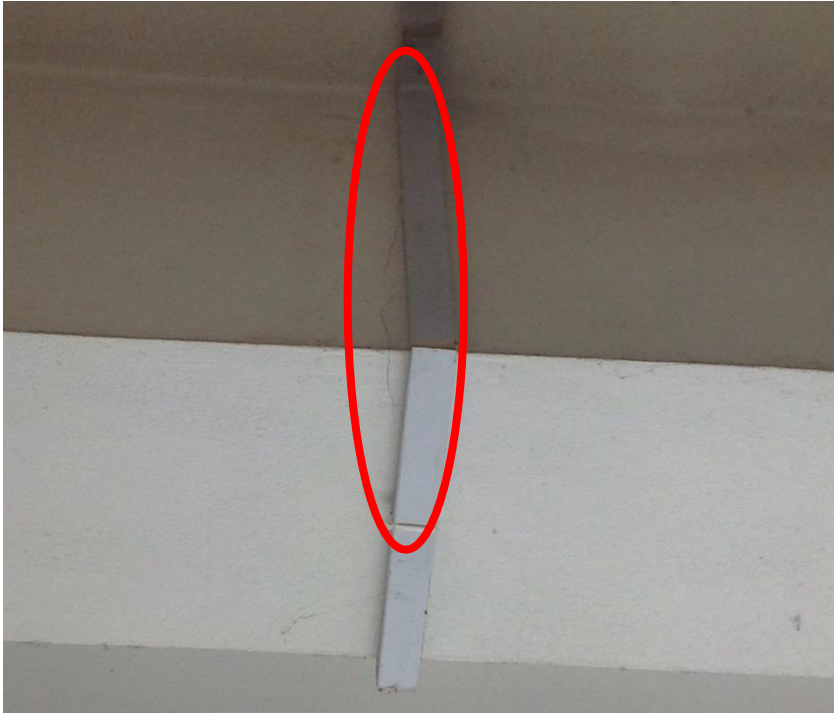
Cracking was observed in beams and/or floor slabs at some levels.

Cracking in beam

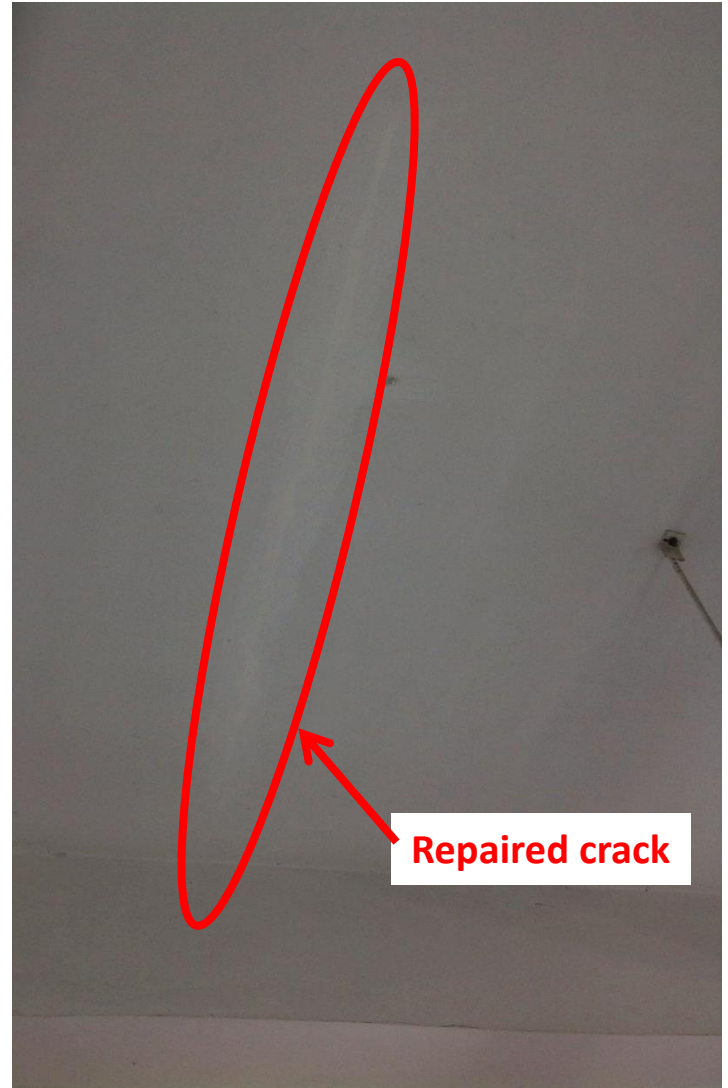
Cracking in slab

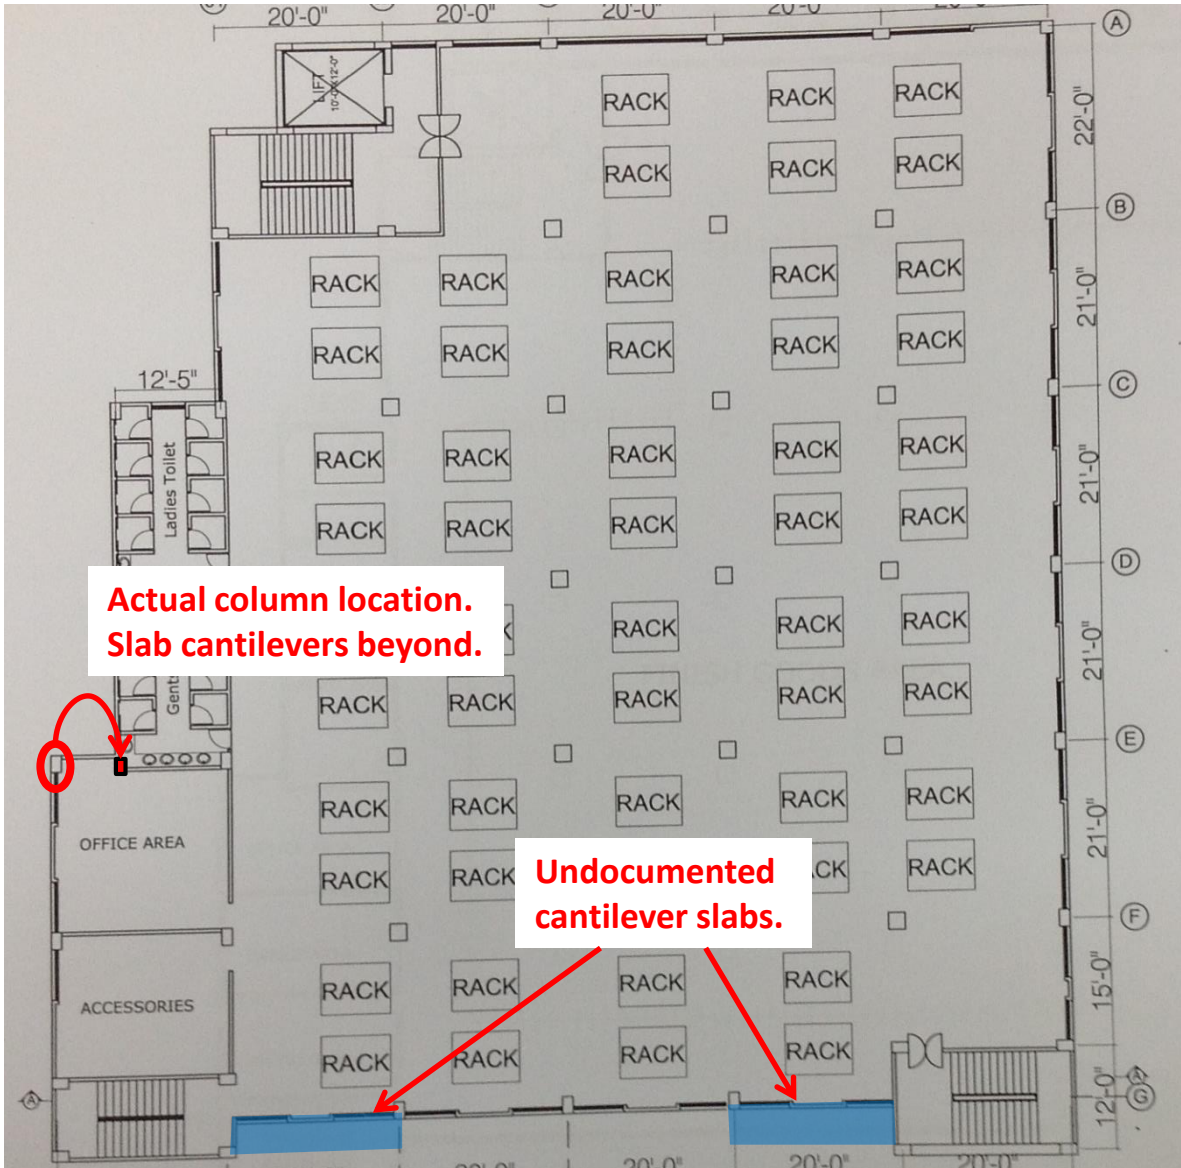
Typical floor plan

Several observations in the main factory building did not coordinate with the information presented in the structural drawings.

- Cantilever slabs
- Column locations

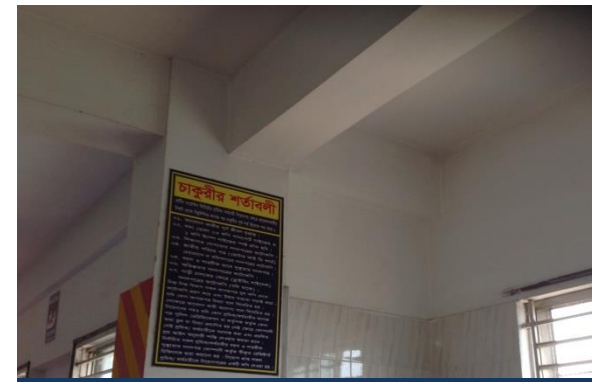
Undocumented cantilever

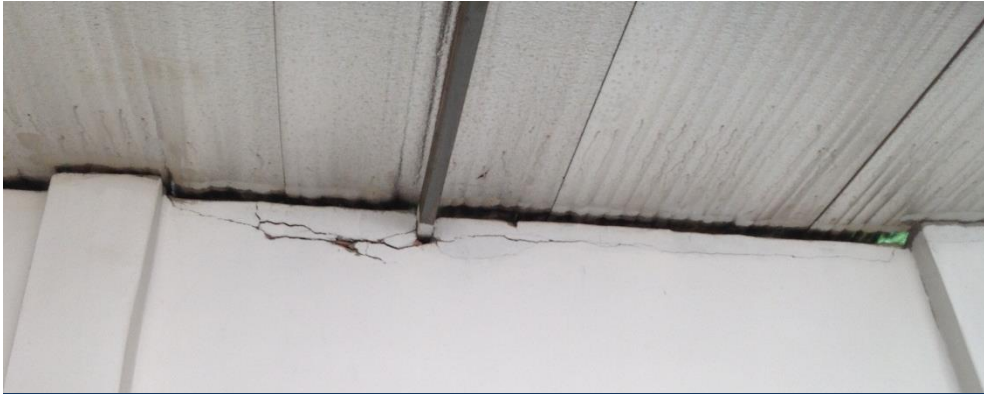
Cracking in masonry wall supporting roof beam

8	Apparently non engineered shed roof structures	Building Engineer to check the capacity of the lightweight roofs and make any necessary alterations.	6-months

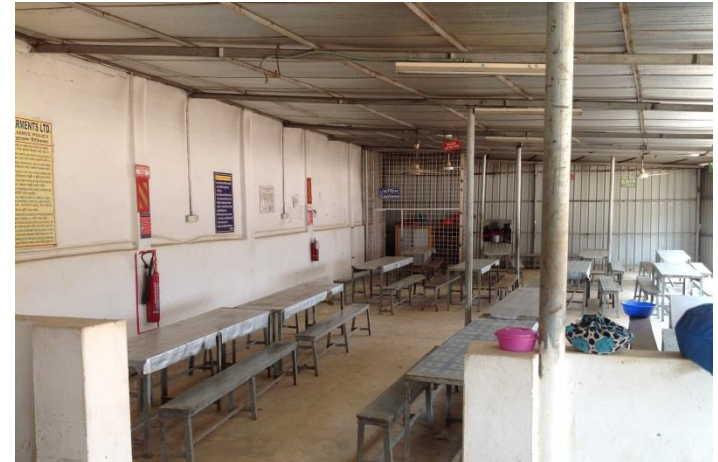
Lack of roof bracing

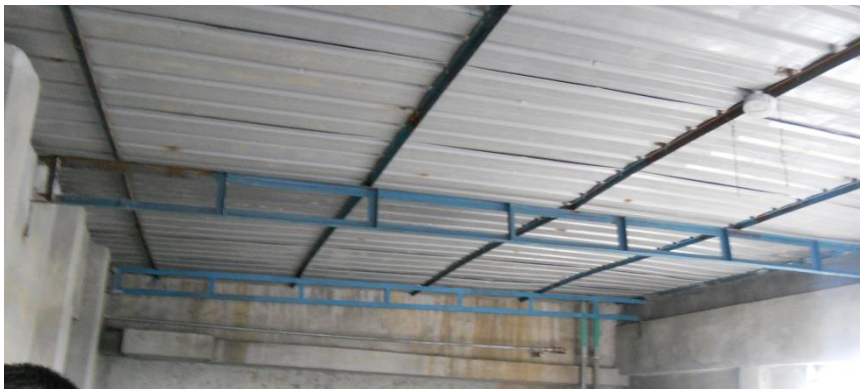
Lack of truss diagonals

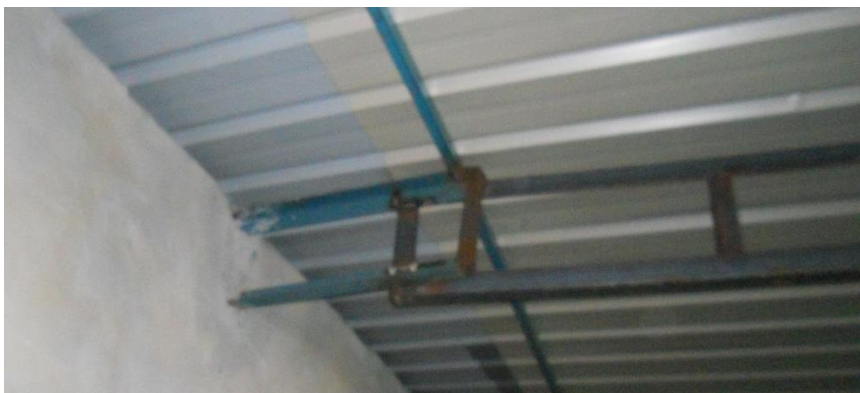
Non-engineered connection

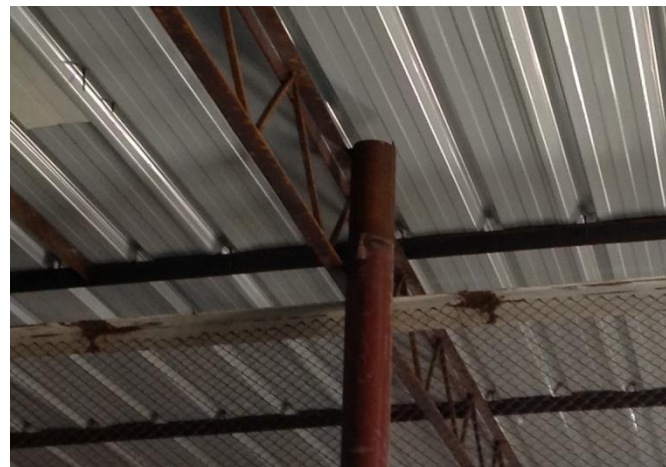
Non-engineered connection
