# L'usine Fashion (Mawna Unit)

17 April, 2016

## Client Summary Report

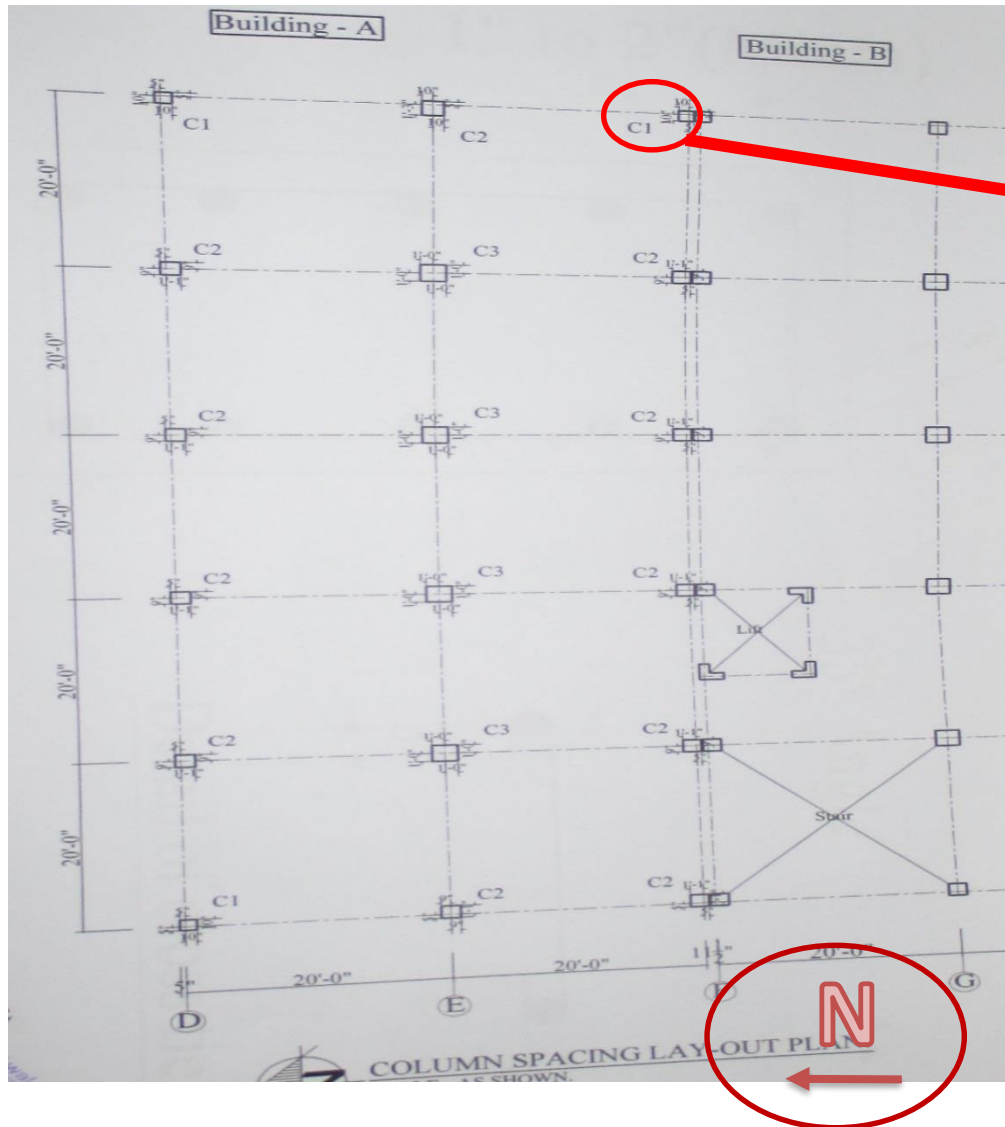
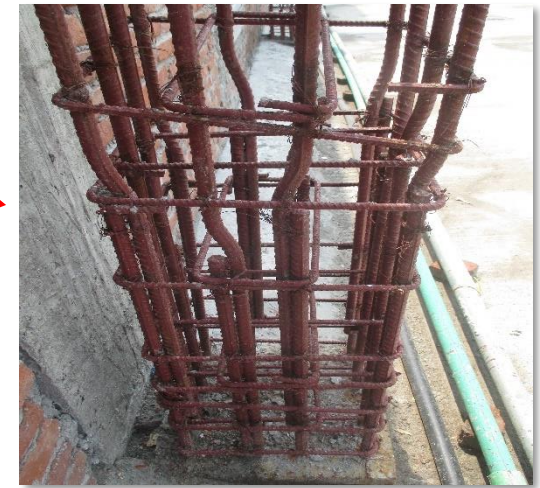
As build drawing shows C1-(381 x381mm) with 8-20mm $\varnothing$  bar. But actually column size found (457.2 x457.2mm) with 12-20mm $\varnothing$  bar. As build drawing needs to be revised as per actual site condition.

- Building engineer to check, collect information and produce accurate and fully complete as-built documentation.

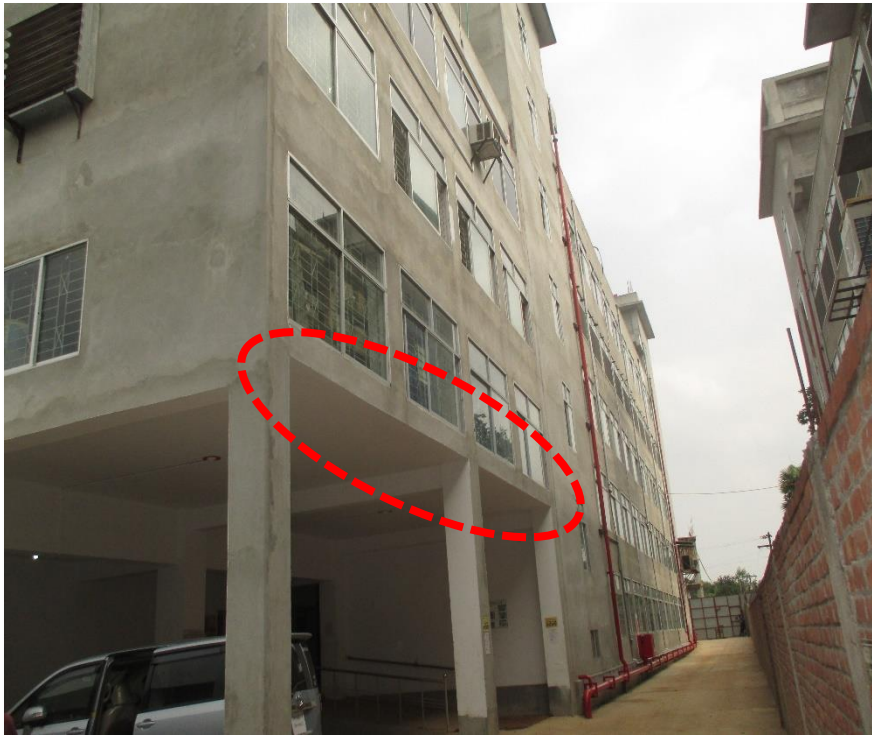
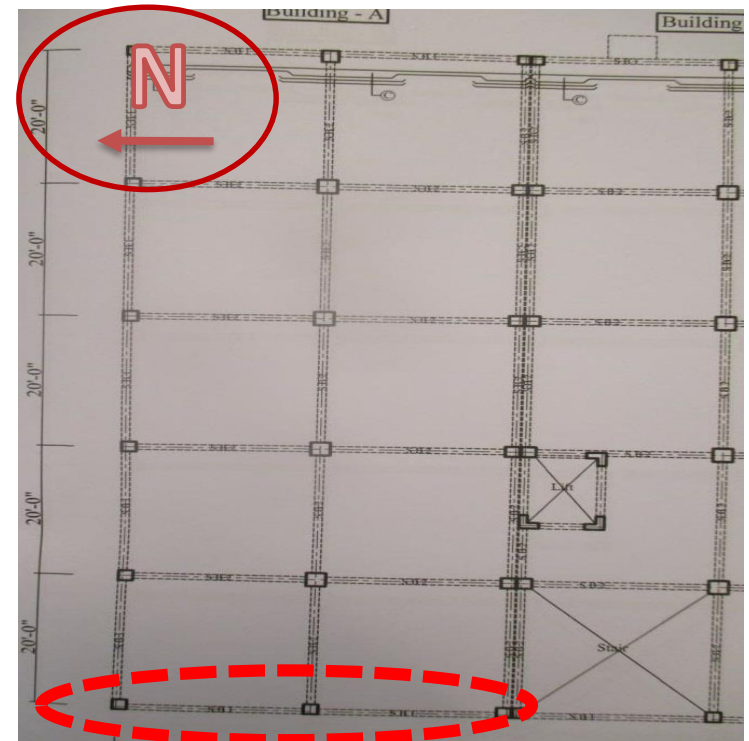
As-build drawing beam layout plan shows presence of beam in ground floor in marked area but practically no beam found. As-build drawing needs to be corrected as per present factory condition.

- The Building Engineer shall provide calculations showing the structural adequacy of members for missing beam

- Factory Engineer to survey the building and prepare as-build drawing
- Prepare load plan and continue to implement

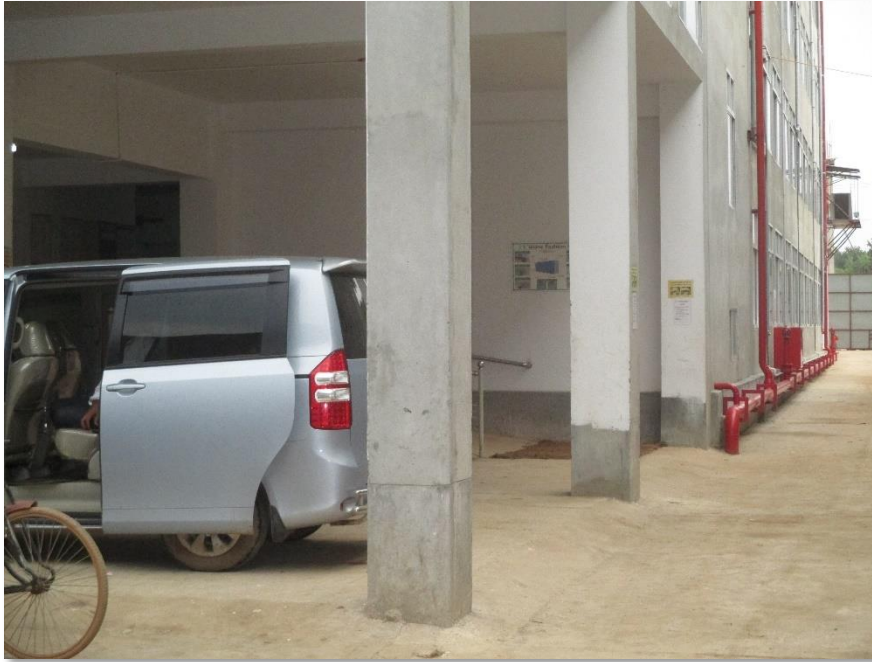
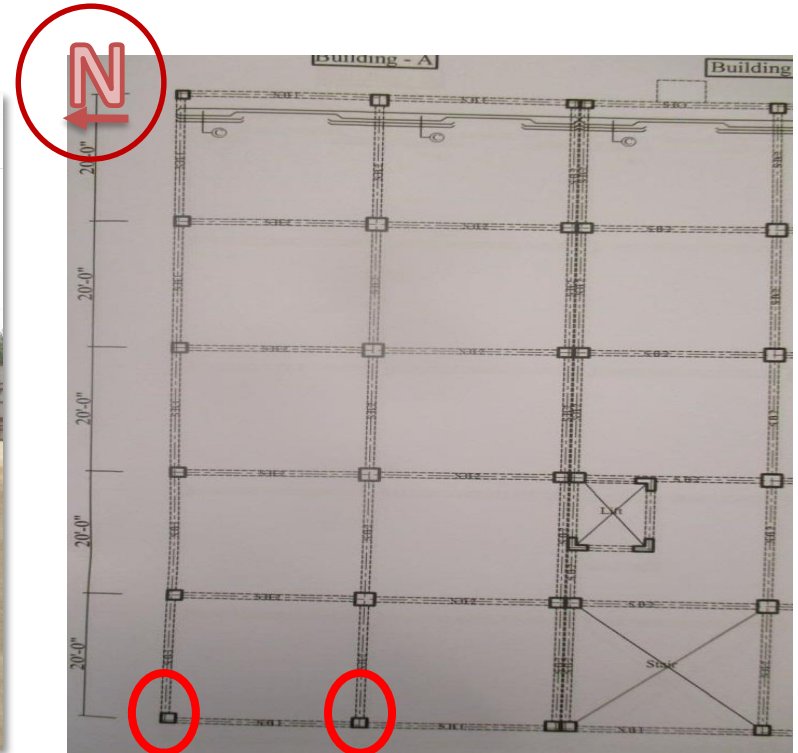
Column at ground floor level are susceptible to impact loading from vehicles. Marked columns (which carry the building above) have no protection against vehicle impact.

- Column to be protected from vehicle impact.

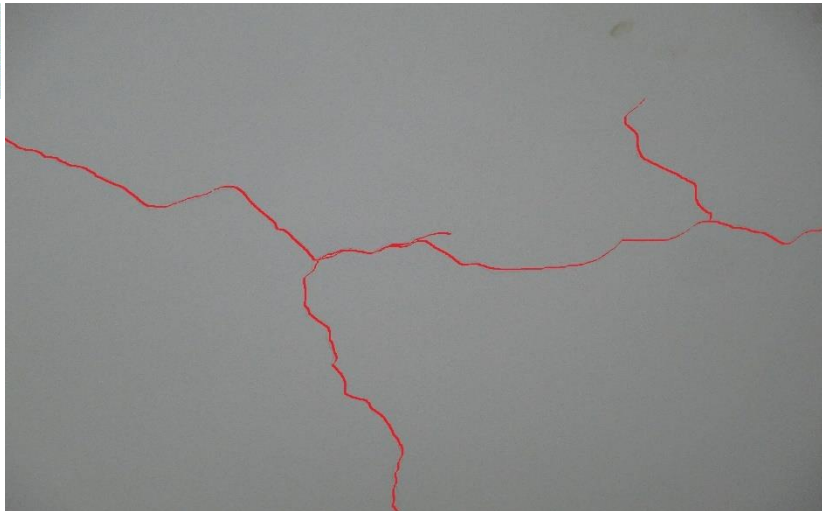
**Cracks in ground floor slab soffit**

Hairline cracks found in ground floor beam and slab soffit. Upper floor used as jacquard section and almost 150 machines are there. The cause of cracking must be checked and suggested if the slab is adequate to bear loading from upper floor.

- Factory Engineer to survey and identify the cause of cracking

- Building Engineer to provide calculations showing the structural adequacy of Slab and Beams

- The distress found is recommended to be repaired with suitable proper methods
- Prepare load plan and continue to implement

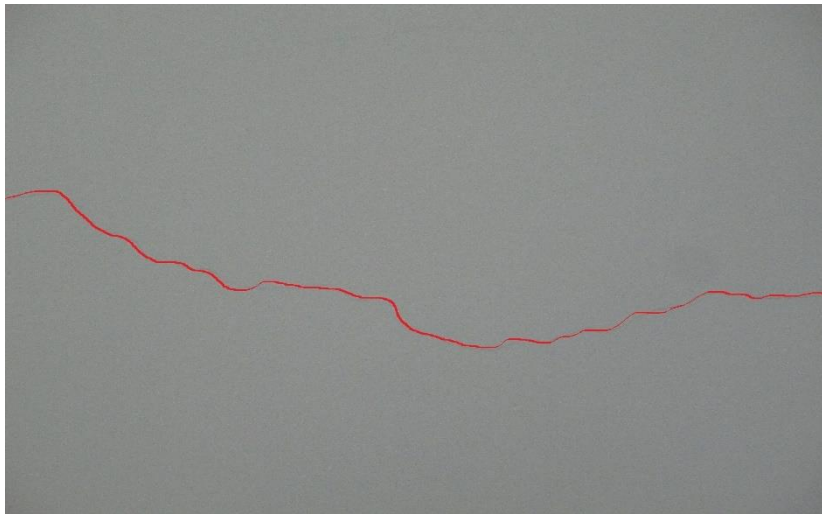
**Cracks in ground floor slab soffit**

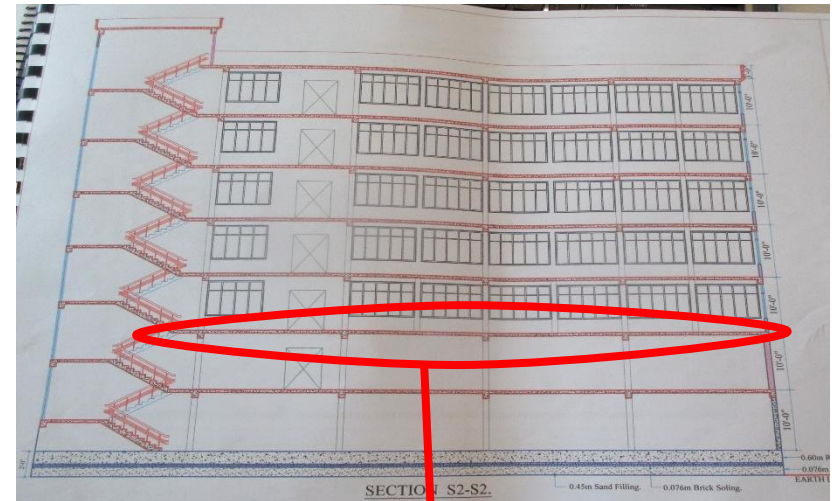
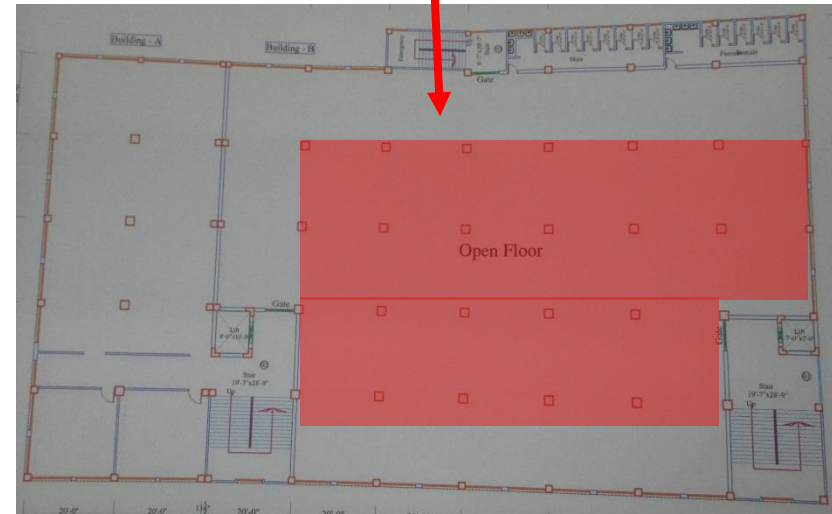
**Cracks found in marked areas**

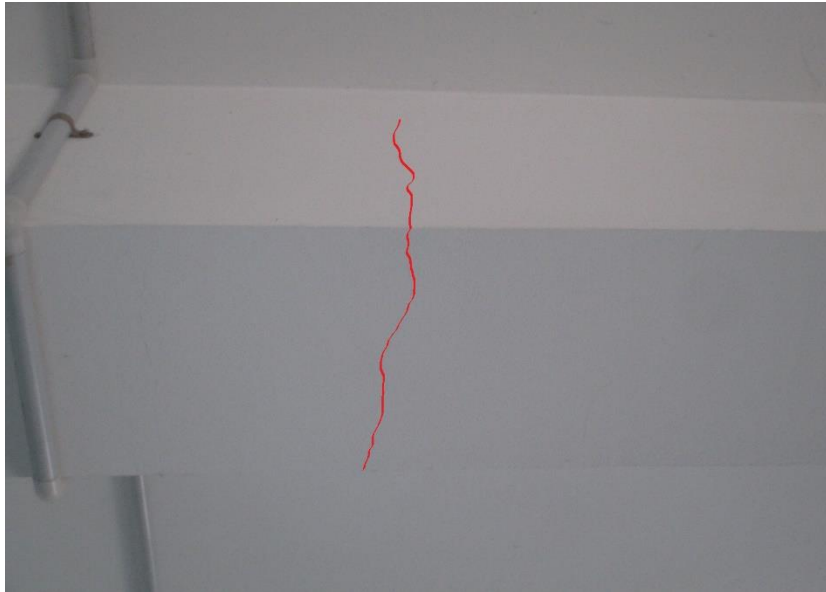
**Cracks in ground floor beam**

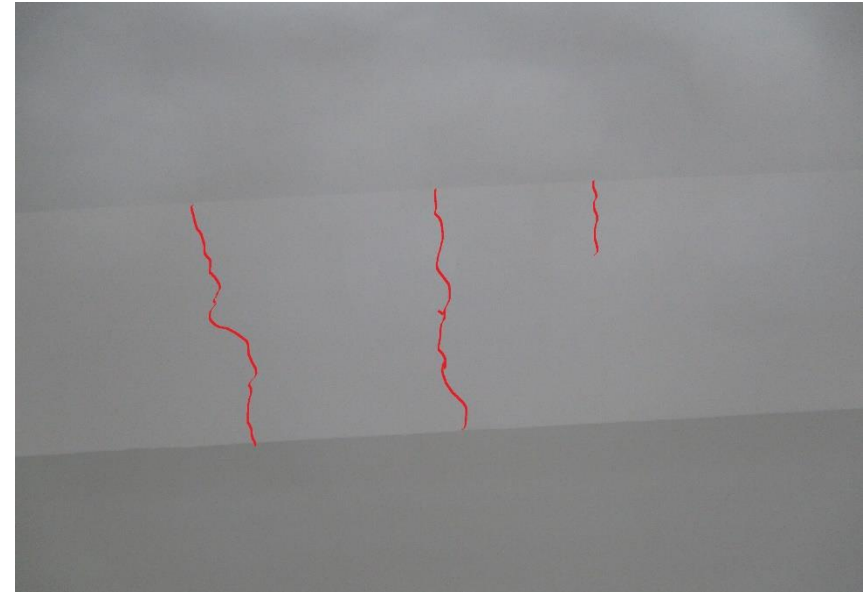
**Cracks in ground floor beam**

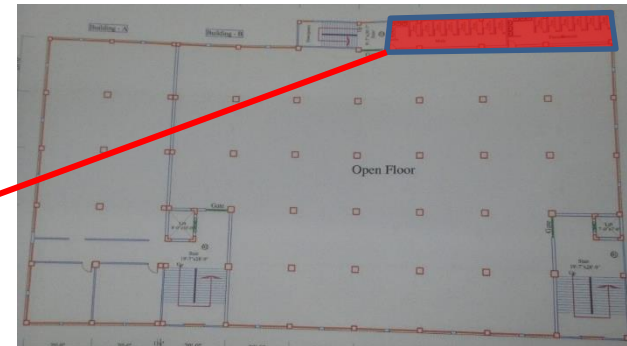
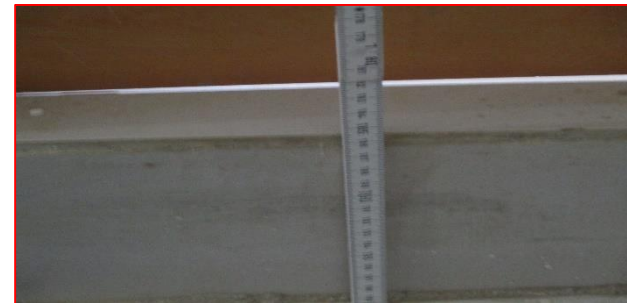
**15cm high floor build-up in toilet area supported by concrete slab.**

**Building Engineer to check that the slab has been adequately designed to carry floor build-up loads**

- Extent of build-up loading within toilet areas to be surveyed and capacity of floor slab to be assessed to confirm that the floor slab is designed to carry these loads.

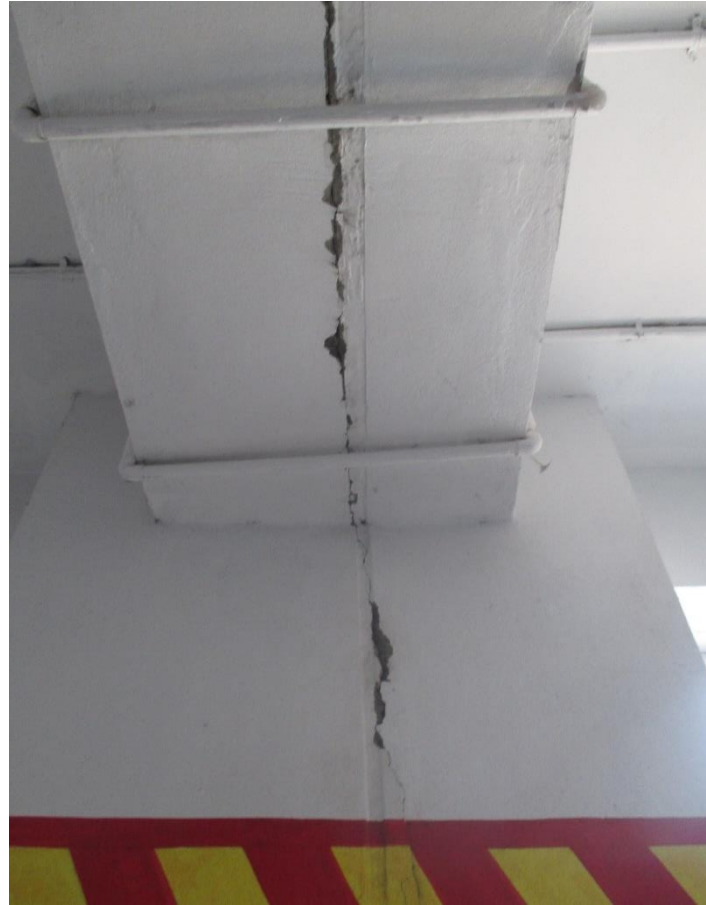
Expansion joint between two columns

- Mortar to be removed from the expansion joint and to be filled with flexible material (factory may consult with Accord fire safety team)

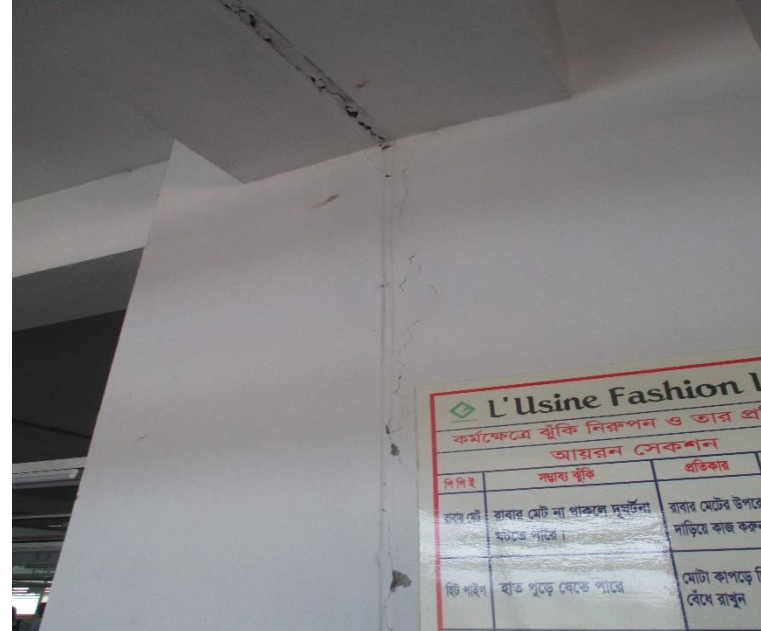
Expansion joint not maintained properly. Gap between two portions was filled with cement mortar. Factory needs to maintain the gap properly.

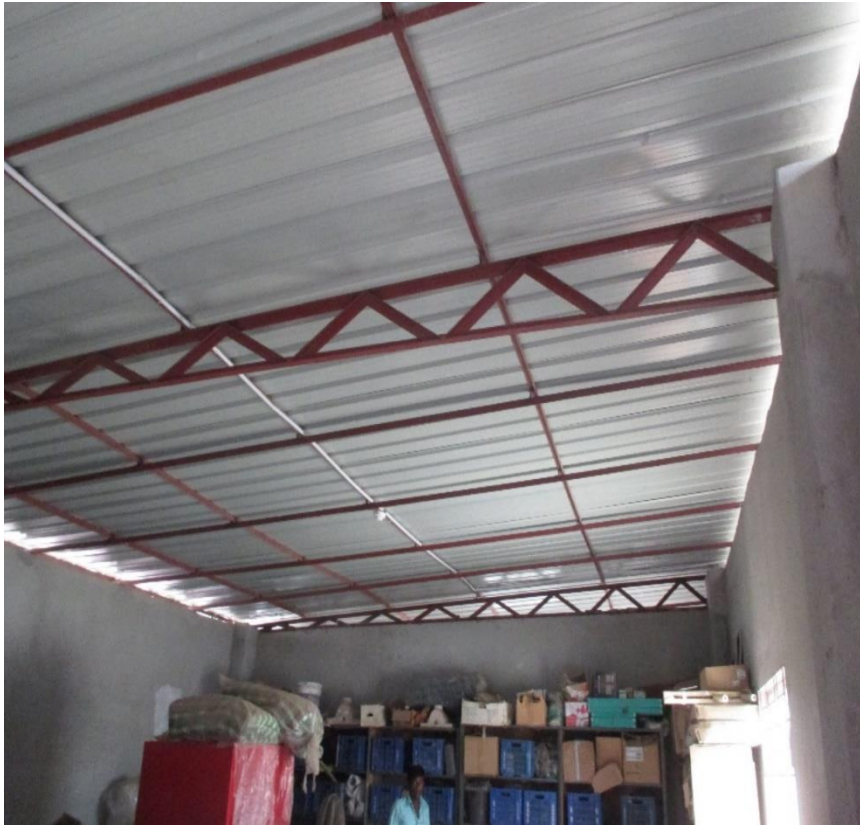
Factory showed the as-build drawing for utility building but in drawing no detailing provided for non-engineered steel shed.

- Factory Engineer to survey and prepare as build drawing providing detailing for the shed

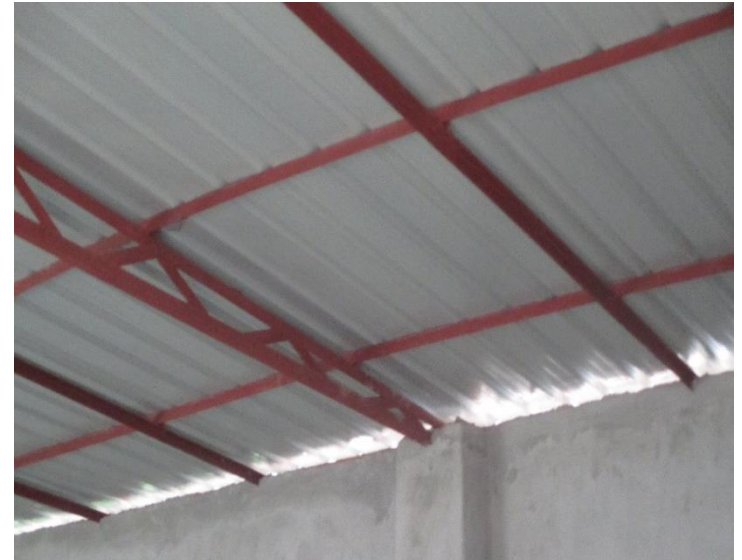
Frame section and size appear to be inadequate.  
The connection to the walls are inadequate to resist likely uplift forces and should be checked by building Engineer.  
Steel supported on brick masonry wall

- Factory Engineer to check the non engineered shed against lateral loading
