KSS Knit Composite Ltd.

Baherarchala, Mawna, Sreepur, Gazipur
(24.200909, 90.402270)
19th April, 2016

Client Summary Report

Observations & Actions

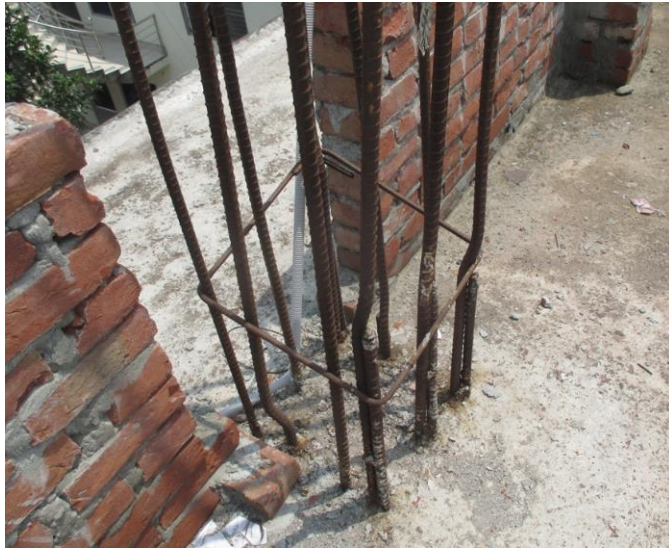
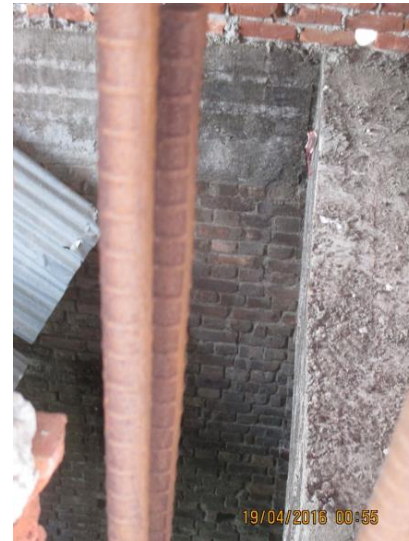
Water ingress in slab due to standing water

Damage due to standing water on present roof & column reinforcement above 1st floor left exposed affected by corrosion.

- Factory engineer to investigate the extent of damage and take steps to repair the damage.
- Remove corrosion & provide protective cover to exposed reinforcement.

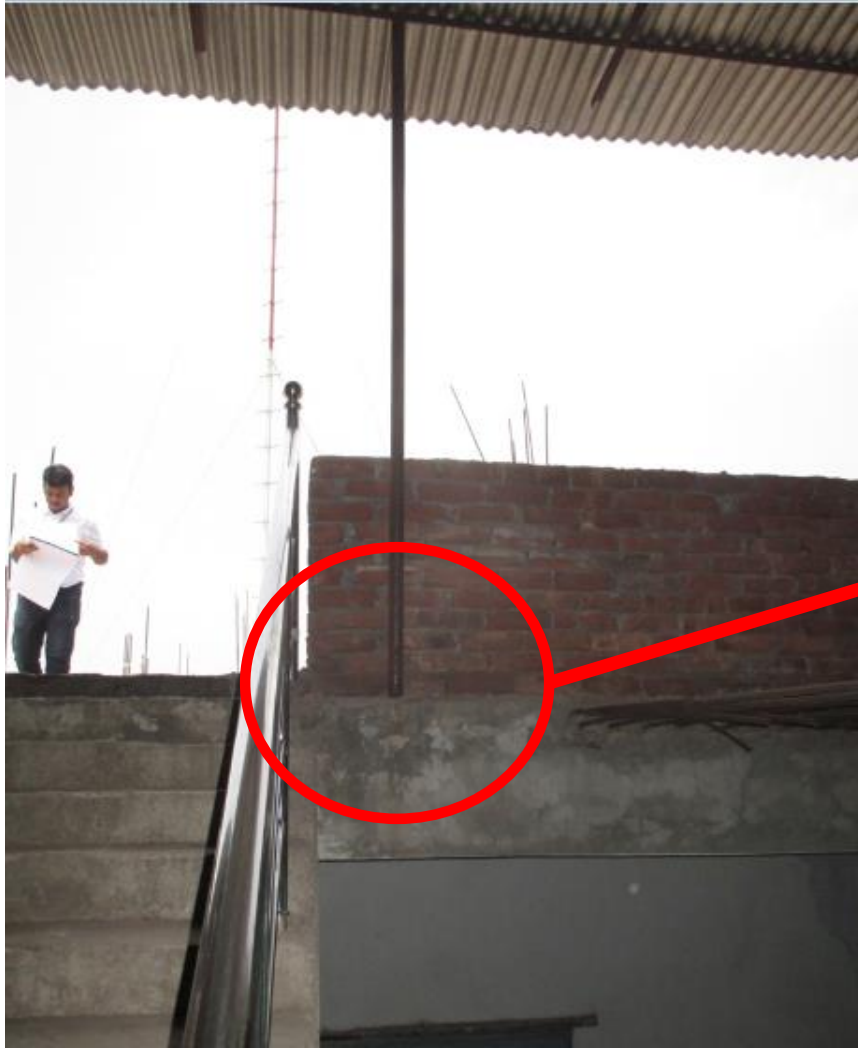
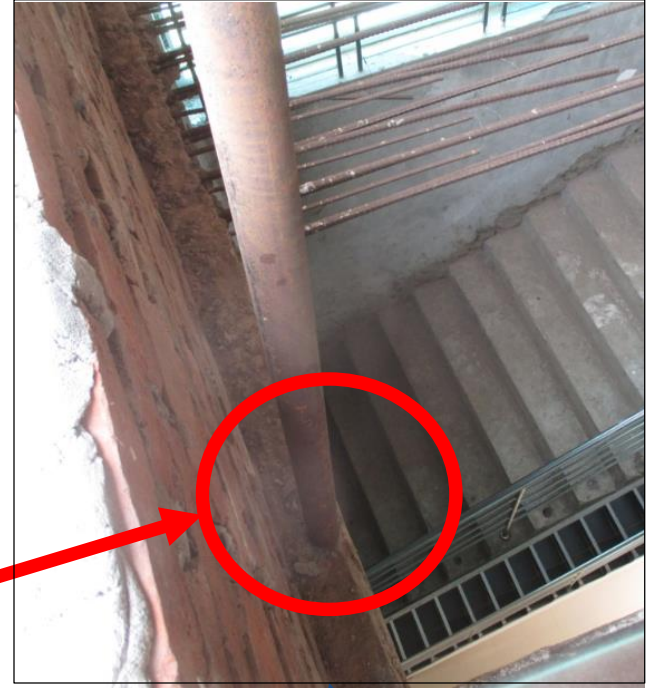
Corrosion in exposed rebar

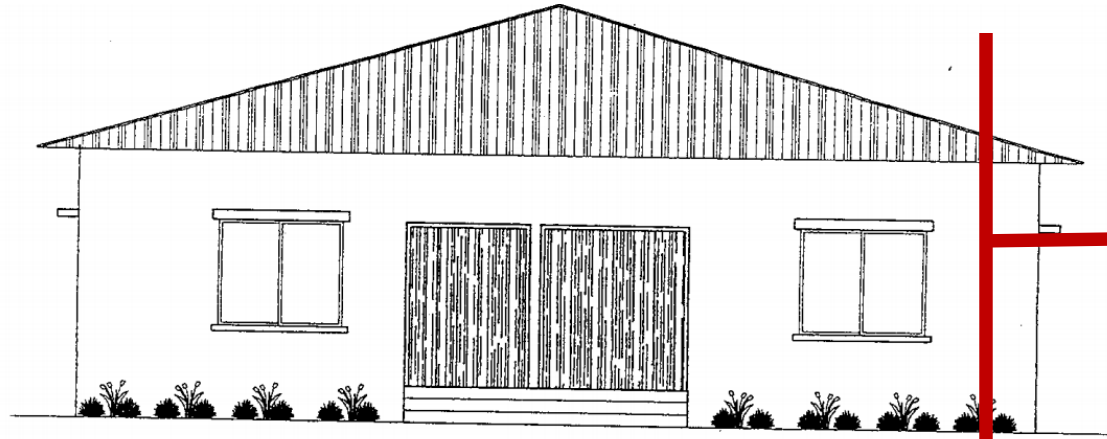
FRONT ELEVATION

Single storied steel roof shed shown in drawing

Discrepancies between drawings provided and the as constructed building

- Engage a Building Engineer to survey the structure and prepare a full set of “as-constructed” drawings.
- Produce and actively manage a loading plan for all floor plates within the factory giving consideration to floor capacity and column capacity.

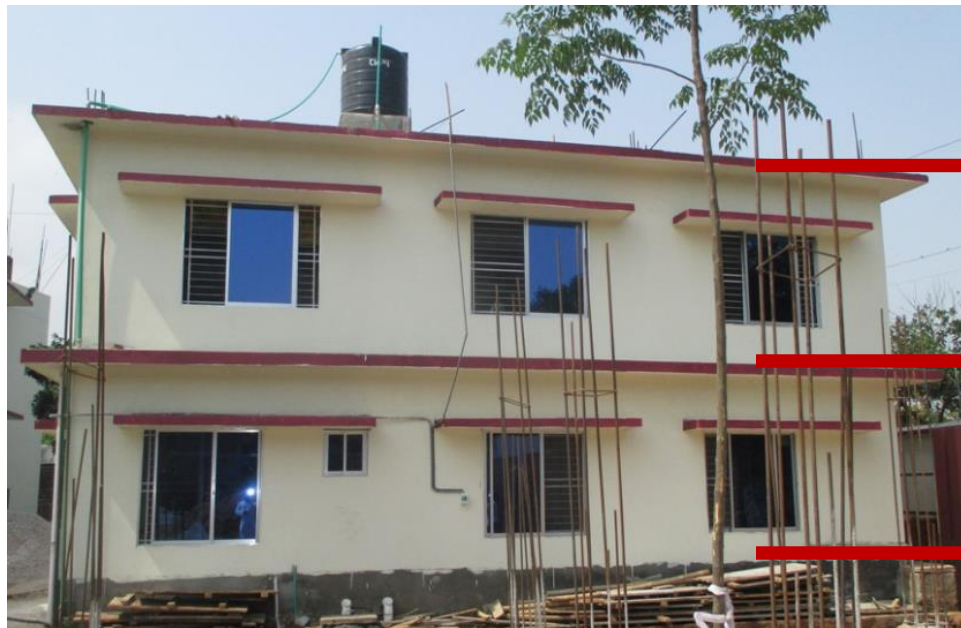
Constructed as 2-storied RCC Building

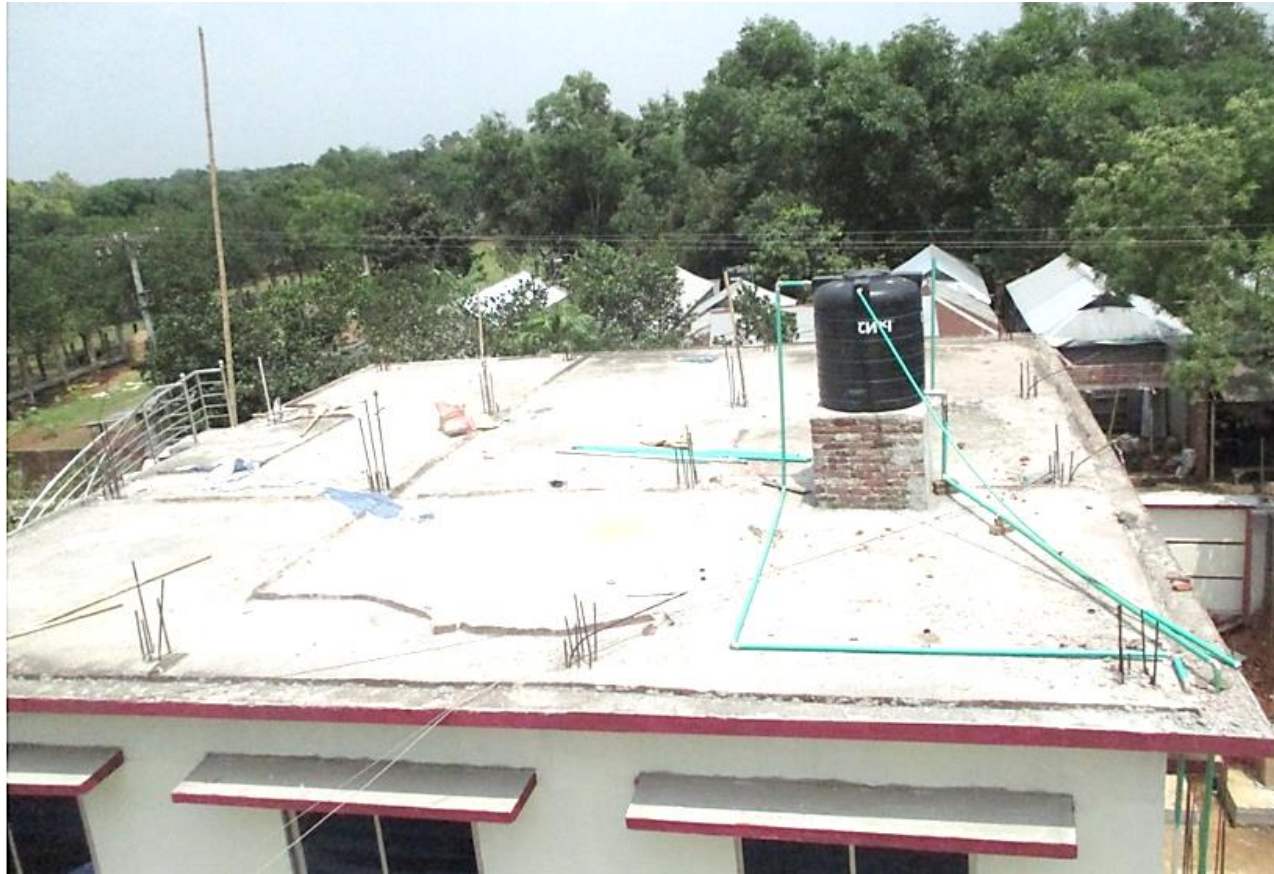
Missing edge protection on roof

- Provide necessary edge protection.

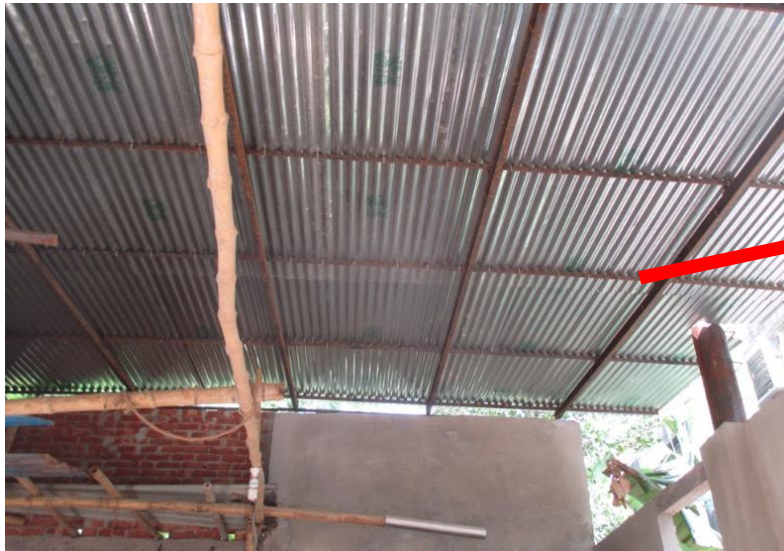
Non-engineered steel roof over boiler room. Section sizes appear inadequate

Improper support to non-engineered roof shed and apparently inadequate steel members on roof shed.

- Engage a Building Engineer to check the capacity of the lightweight steel roof structure/connection details and wall/connection details.

- Make any necessary alterations as required.

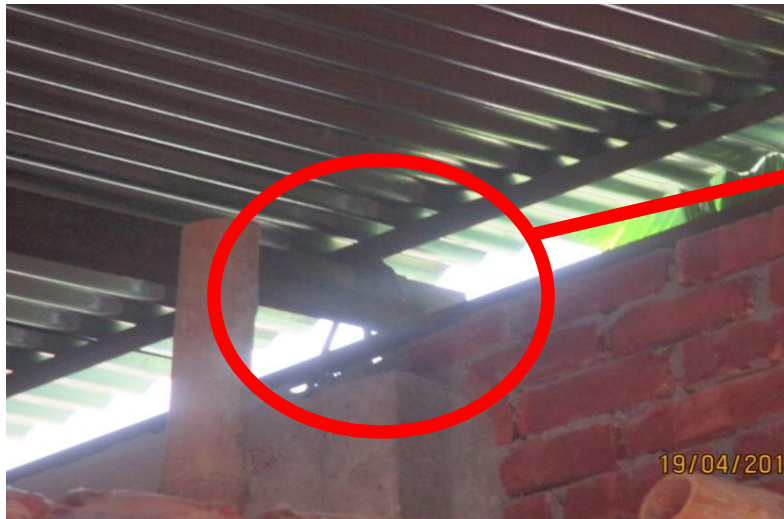
The connections to the walls are inadequate to resist likely uplift forces, and should be checked by a Building Engineer.
Steel supported on brick masonry wall.
