FIRE SAFETY INSPECTION REPORT

Workfield Knitwears

ACCORD ID: 12425

Date: May 15, 2016

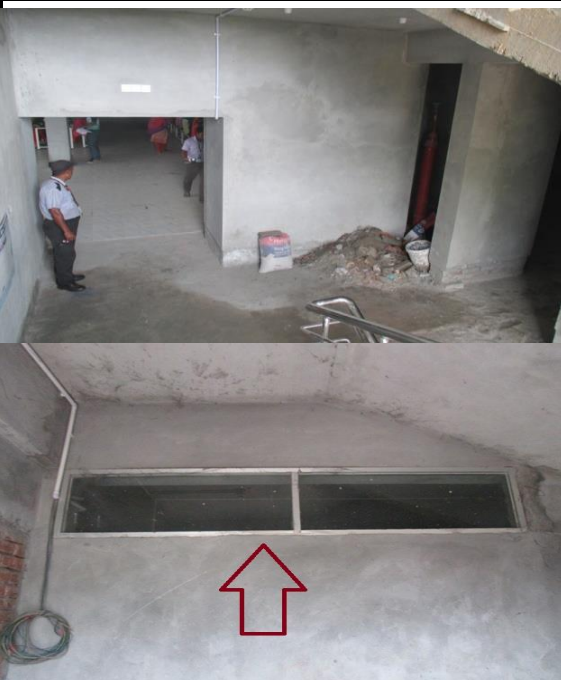
SI No.	Category	Findings	Required Action	Remediation Time Frame	Pictorial Evidence
1	Fire Rated Construction	The exit stairs are not separated from factory floor on each floor by fire-rated construction.	Provide minimum 1.5-hr fire rated doors and seal all unprotected openings to separate the exit stairs from work areas and other building spaces on all floor levels. Ensure that the fire doors are self-closing and positive latching and that they are provided with fire exit (panic) hardware where serving production floors. If fire doors are required to be held open for functional reasons, provide automatic closing devices tied to the fire alarm system.	Within 3 months

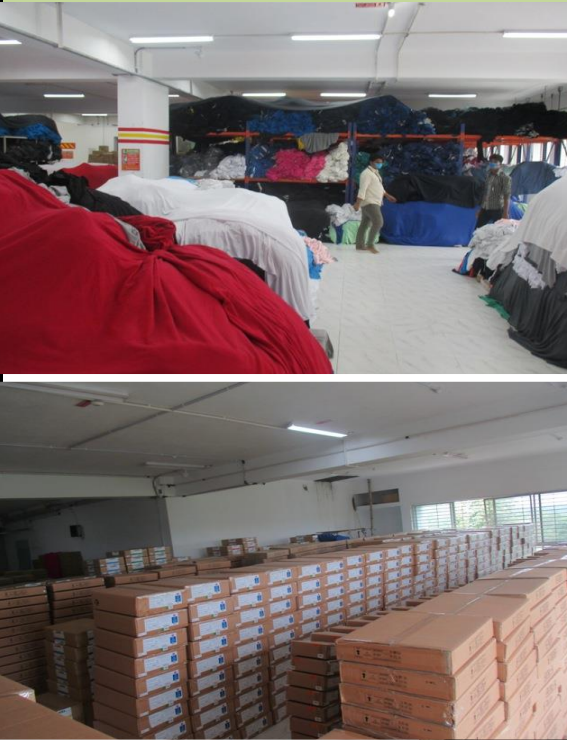
Sl No.	Category	Findings	Required Action	Remediation Time Frame	Pictorial Evidence
2	Fire Rated Construction	Areas used for combustible storage are not separated by fire rated construction. Store room on seventh floor.	Provide dedicated storage rooms separated by minimum 1-hr fire-rated construction. Where separate storage rooms are not feasible, provide defined storage areas and limit the storage arrangement as follows: - Maximum height of 2.4m and maximum area of 23m ² - If sprinkler protected: maximum height of 3.66m and maximum area of 93m ² . Separate areas of unenclosed combustible storage by a minimum clear distance of 3m.	Within 3 months

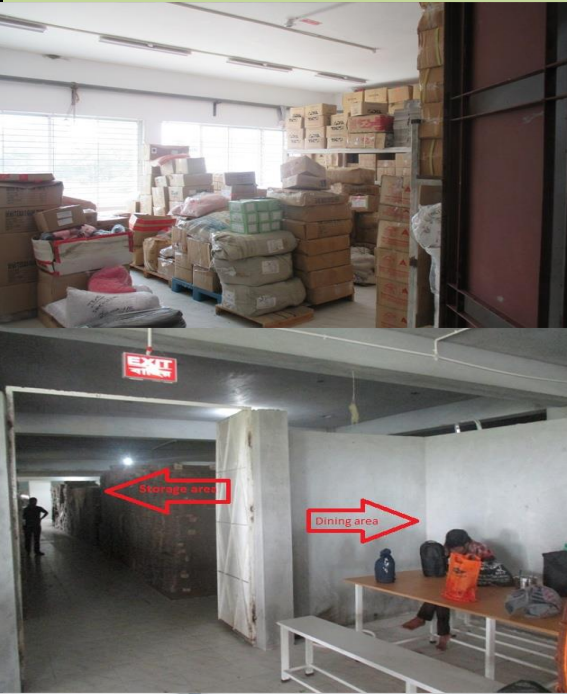
Sl No.	Category	Findings	Required Action	Remediation Time Frame	Pictorial Evidence
3	Fire Rated Construction	Rooms used for combustible storage on the ground floor are not separated by fire-rated construction. Location: 1st and 4th floor.	Provide dedicated storage rooms separated by minimum 1-hr fire-rated construction.	Within 3 months

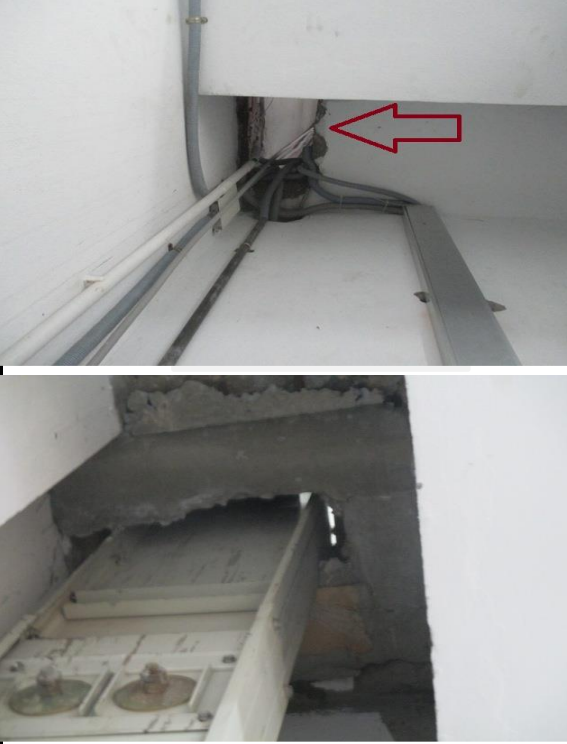
SI No.	Category	Findings	Required Action	Remediation Time Frame	Pictorial Evidence
4	Fire Rated Construction	Penetrations through floor/ceiling assemblies are found unsealed.	Seal all penetrations and openings in floor/ceiling (full thickness of the floor/ceiling) assemblies by fire rated materials to maintain the fire resistance rating. Provide a minimum 2-hr fire rated shaft to separate the utility risers from each floor if required.	Within 3 months

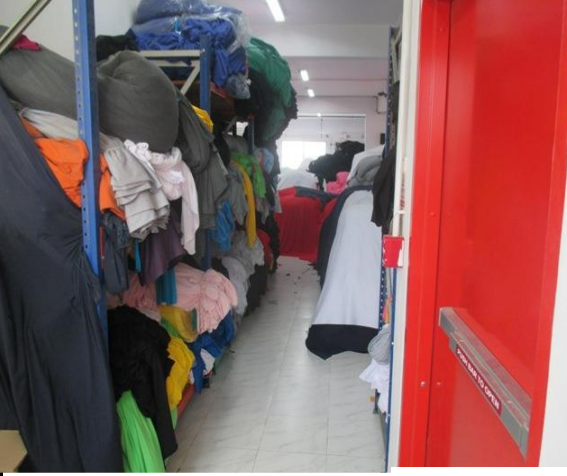
5	Egress	The egress path along means of egress has interrupted by obstruction/storage. Location: 1st floor.	Means of egress shall be maintained continuously free and clear of all obstructions/storage. Or Keep egress paths and stairs clear of storage.	Immediate

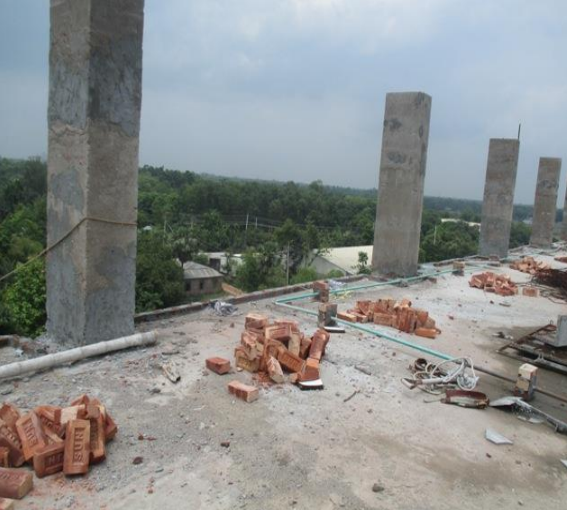
SI No.	Category	Findings	Required Action	Remediation Time Frame	Pictorial Evidence
6	Egress	Parapets or guards are not provide in occupiable roof.	Provide parapets or guards with a minimum height of 1067mm (42 inch.).	within 3 months

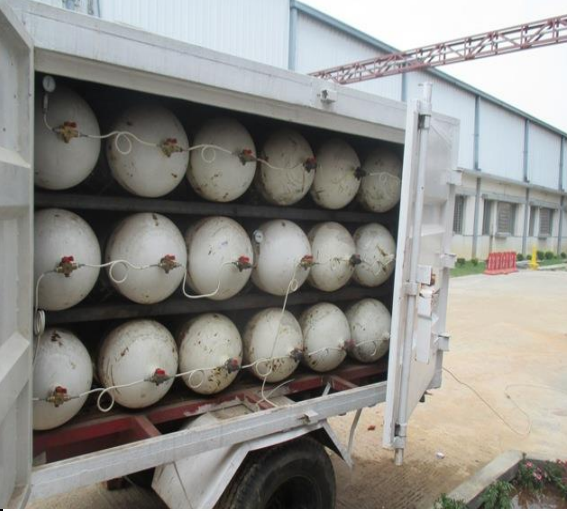
7	Fire Rated Construction	Flammable gas storage area is not separated by fire-rated construction (openings, non-rated doors, penetrations) from the west exit stair discharge path.	Separate the flammable gas cylinder storage area by a minimum 2-hr fire-rated construction. Seal and/or protected all openings to maintain the required fire separations.	within 3 months

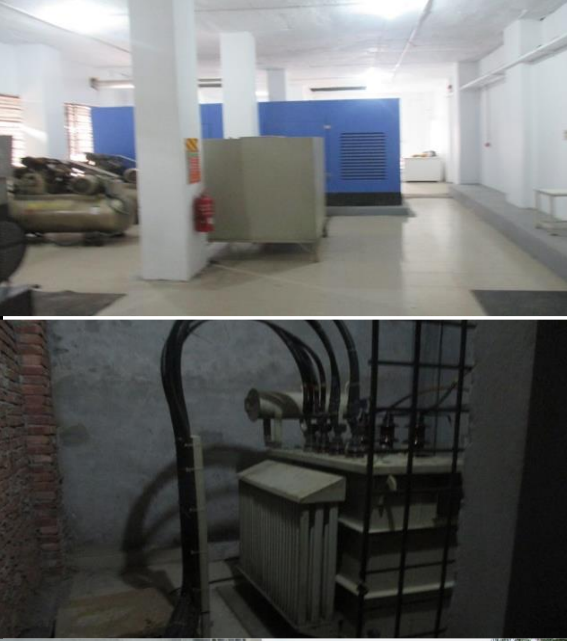
SI No.	Category	Findings	Required Action	Remediation Time Frame	Pictorial Evidence
8	Fire Rated Construction	Generator and transformer room are not separated from each other by proper fire rated construction (non rated doors, unsealed penetrations and openings etc.).	Separate between the generator and transformer room from each other by a minimum 2-hr fire rated construction. Seal and/or protect all penetrations and openings to maintain the required fire separations.	within 3 months

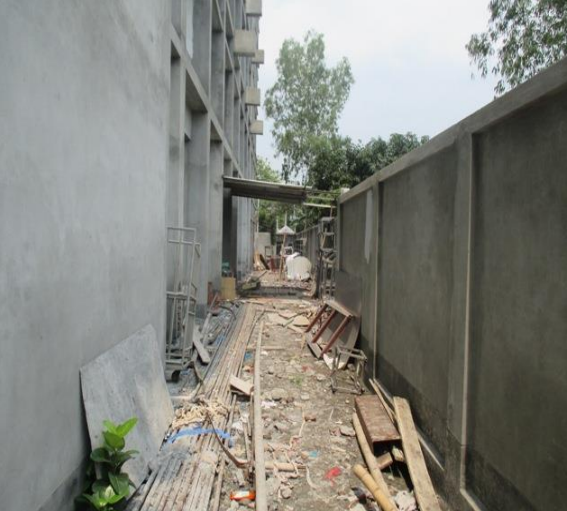
9	Egress	Storage was located in the south exit stair discharge path.	Remove all storage from exit stairs discharge path.	Immediately

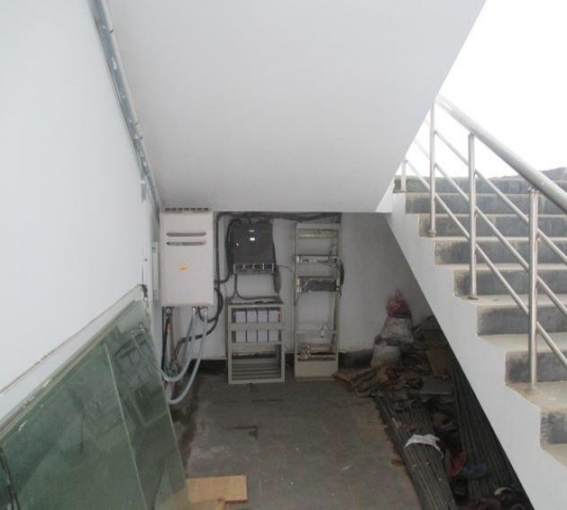
Sl No.	Category	Findings	Required Action	Remediation Time Frame	Pictorial Evidence
10	Egress	Electrical panel box was located in the east exit stair. Location: Ground floor.	Remove all electrical panel box from exit stairs.	Within 2 months

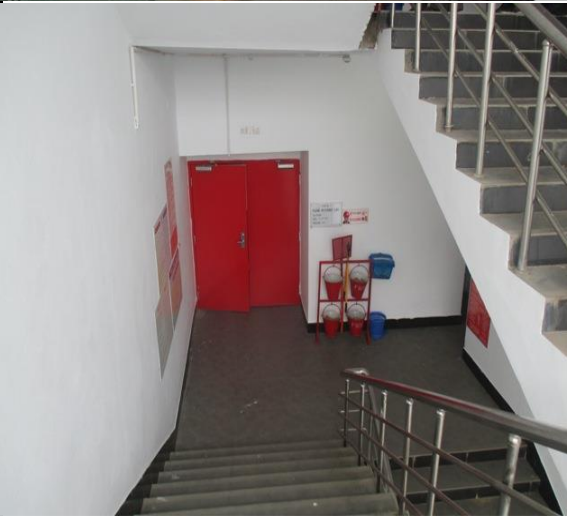
11	Egress	Building did not have stair designation signs.	Provide stair designation signs at required locations.	Within 1 month

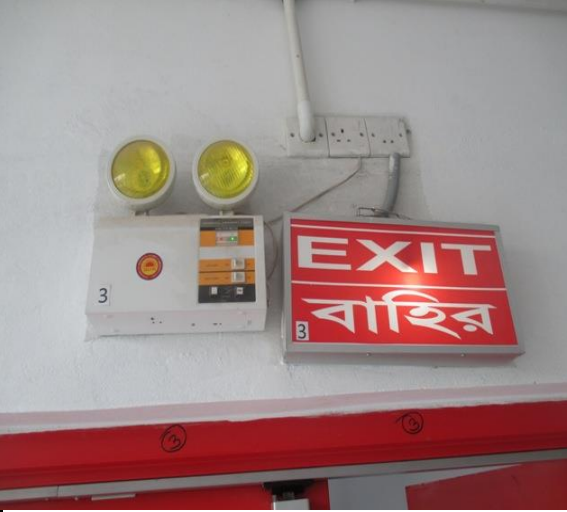
SI No.	Category	Findings	Required Action	Remediation Time Frame	Pictorial Evidence
12	Egress Lighting	Inspection, testing, and maintenance for the exit sign and emergency lighting system was not in accordance with The ACCORD standard.	Inspect, test and maintain the exit sign and emergency lighting system in the accordance with The ACCORD standard. Keep written records on-site.	Within 2 Months

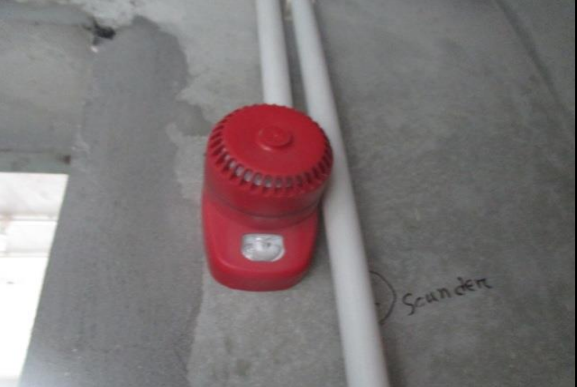
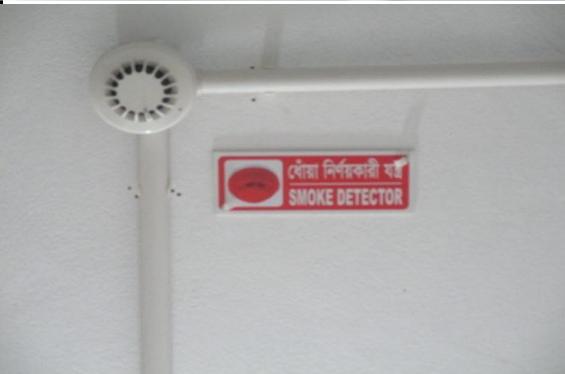
SI No.	Category	Findings	Required Action	Remediation Time Frame	Pictorial Evidence
13	Fire Detection System	The existing fire alarm & detection system is not installed properly. Still few areas are out of detection system.	Submit the as-built design/drawing of fire alarm & detection system to Accord for review.	Within 06 Months (Design review & Modification of the system)

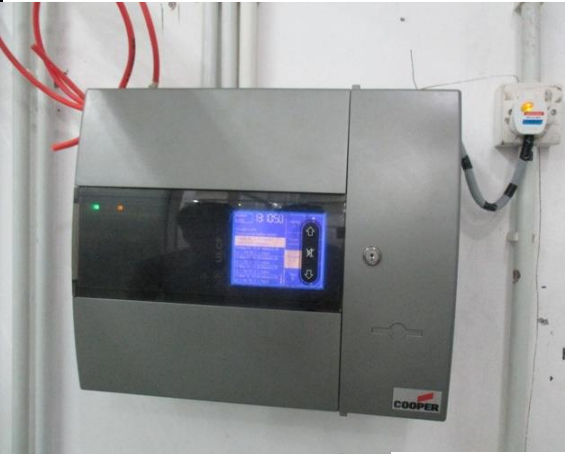
14	Fire Detection System	Inspection, testing, and maintenance for the fire alarm system was not in accordance with NFPA 72 or as per Accord standard.	Inspect, test and maintain the fire alarm system, and keep written records on-site, in accordance with NFPA 72 or as per Accord standard.	Within 2 Months

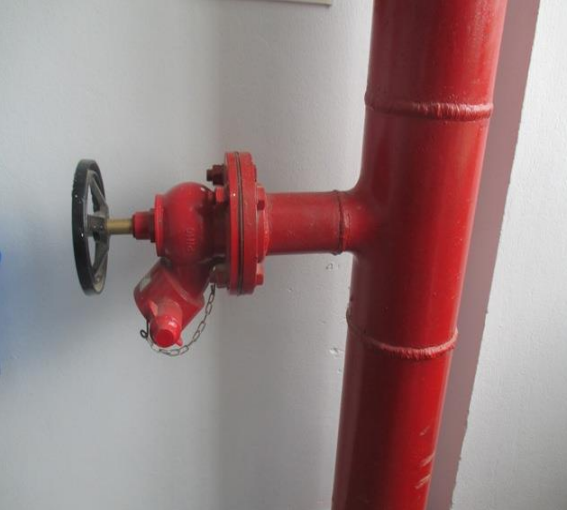
Sl No.	Category	Findings	Required Action	Remediation Time Frame	Pictorial Evidence
15	Fire Protection System	The existing factory building with an occupiable floor greater than 10 m (33 ft) above the finished grade is not protected with an approved standpipe system.	Provide a standpipe system throughout the building in accordance with NFPA 14.	(design 2 months & installation 4 months)

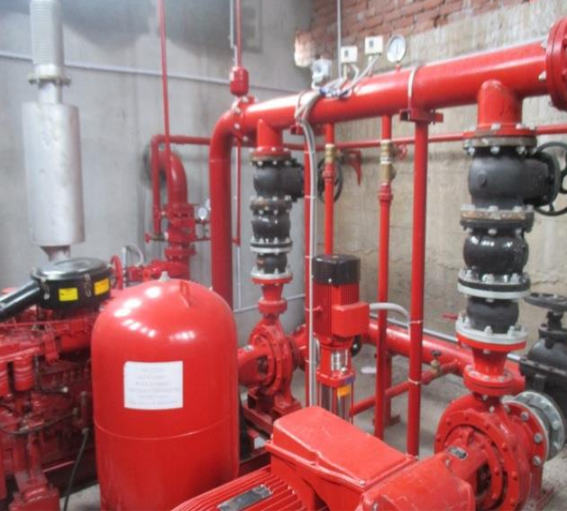
16	Fire Protection System	Inspection, testing and maintenance of the fire pump system is not in accordance with NFPA-20.	Inspect, test and maintain the fire pump system and keep written records on-site, in accordance with NFPA 20.	Within 2 months

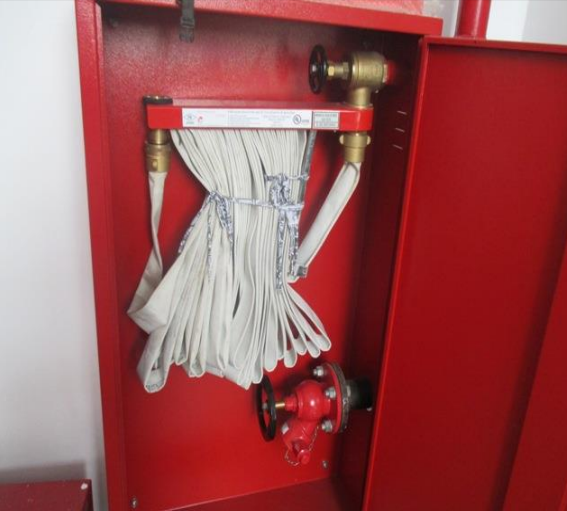
Sl No.	Category	Findings	Required Action	Remediation Time Frame	Pictorial Evidence
17	Fire Protection System	Fire Protection : Inspection, testing and maintenance of the standpipe system is not in accordance with NFPA 14.	Inspect, test and maintain the standpipe system and keep written records on-site, in accordance with NFPA 14.	Within 2 months

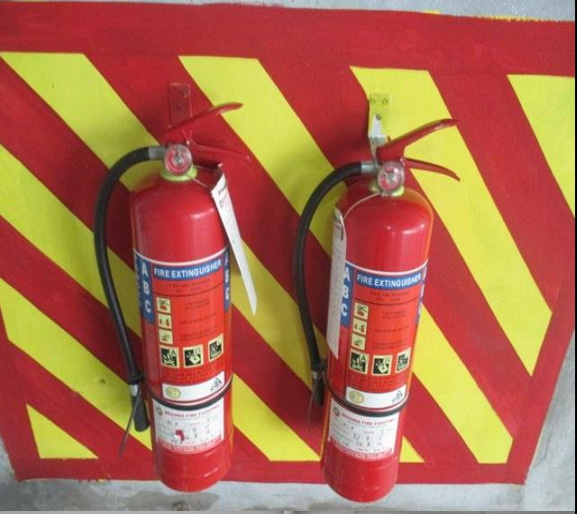
18	Fire Protection System	Inspection, testing and maintenance of portable fire extinguishers is not in accordance with NFPA 10.	Inspect, test and maintain the portable fire extinguishers and keep written records on-site, in accordance with NFPA 10.	Within 2 months

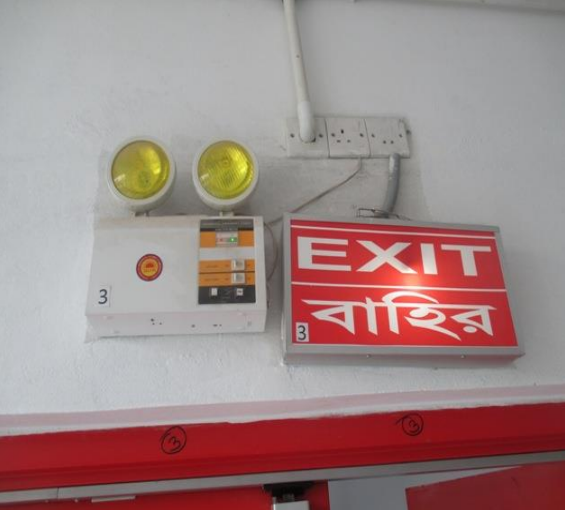
Sl No.	Category	Findings	Required Action	Remediation Time Frame	Pictorial Evidence
19	Egress Lighting	Emergency lights not illuminated during testing (burned out, broken, etc.); Location: 1st floor.	Regularly inspect all exit signage as per Accord standard and replace/install lights as needed to illuminate signs.	Within 2 months
