Textown Limited

Dewan Idris Road, Ashulia, Savar, Dhaka, Bangladesh.

11.MARCH.2014

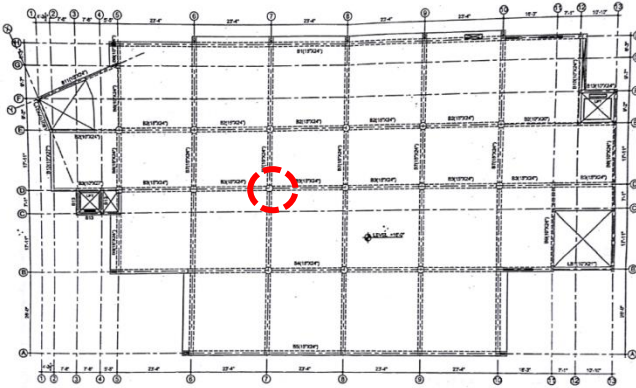
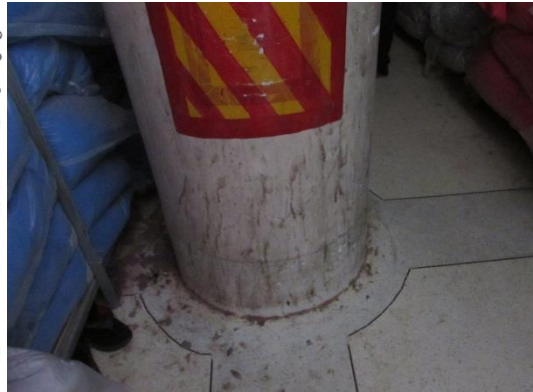
**Column Load Exceeds Allowable Limit by Code
Building 01**

Based on the load rundown analysis following the live load intensity (4.78kPa) prescribed by design (the entire Building 01 is claimed to be designed for all floors achieving live load capacity of 100psf (4.78kPa)), the column portion below 1/F level seems to have a much lower F.O.S than the column portion below ground level (AMBER warning). If based on building code loading of 3.0kPa, the column in question reverts to YELLOW status.

COL. NO.	BELOW GROUND LEVEL	UP TO GROUND LEVEL
C2

<p>SIZE: 28"Ø BAR: 16-25Ø TIE: 100@7"C/C</p>

<p>SIZE: 25"Ø BAR: 16-25Ø TIE: 100@7"C/C</p>

Preliminary load takedown calculation in Building 01 using the prescribed design live loads indicate a low factor of safety of design

- Factory Engineer to review design, loads and columns stresses in entire building
- Verify insitu concrete stresses either by 100mm dia. cores or existing cylinder strength data for the structure.
- A Detail Engineering Assessment of Factory to be commenced, see attached Scope

- Produce and actively manage a loading plan for all floor plates within the factory
- Detail Engineering Assessment to be completed

- Continue to implement load plan

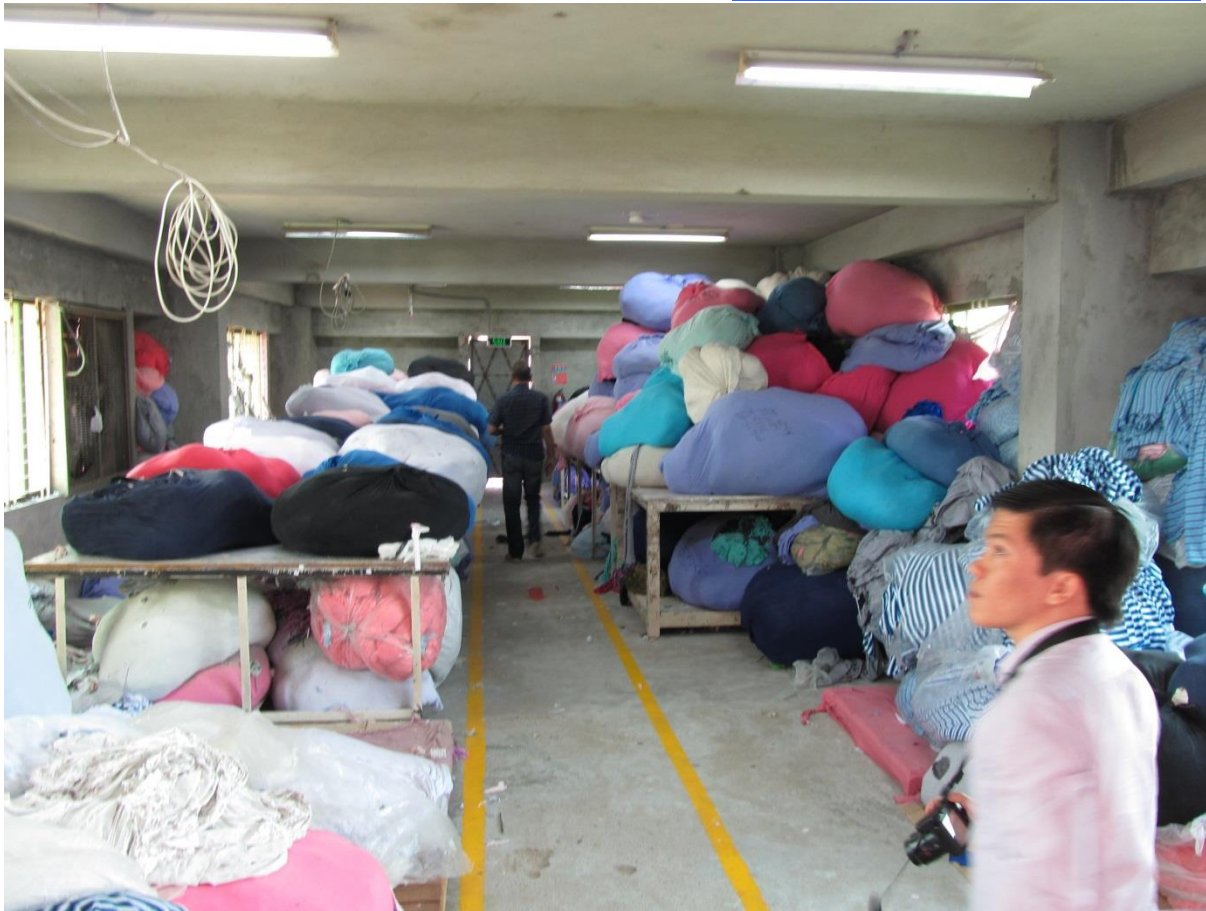
Excessive Storage Height a on Level 4 at Building 03

On Level 4 of Building 03, the room is used to store fabric. It was observed that many of the bags of fabric were quite heavy, and that the bags had been stacked to almost ceiling height.

The permissible live load for this building is 3.0 kPa only. It was calculated that the loading from the stacks of fabric had exceeded this permissible loading limit.

Storage height of fabric in storage rooms on 4/F of Building 03 appears to be excessive

- Immediately reduce stacking height of fabric to ensure total load does not exceed 3.0kPa

- Mark the maximum allowable height of fabric stacking to ensure full compliance

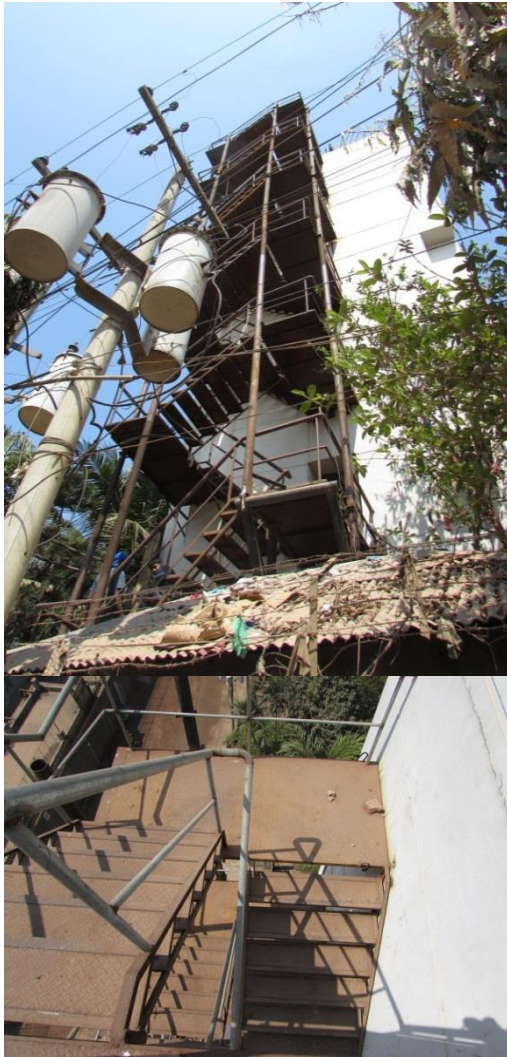
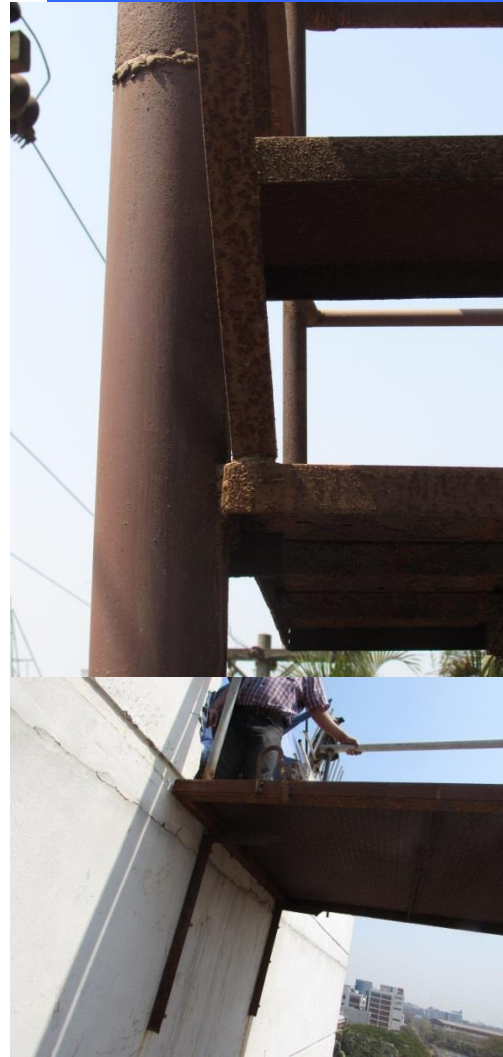
Escape Staircase is in Poor Condition

The staircase at the side of Building 03 is meant to be a fire escape staircase. This means that there is a potential for crowds of people to use this stair in the event of emergency. However, the stair was built from very small steel members, and had not been properly galvanised, and therefore had rusted very badly. The structural stability of this staircase is questionable, and appears unsafe for its intended purpose

- Consider the renewal of this staircase, using suitable corrosion-resistant materials, and of a design suitable for emergency and panic loading.

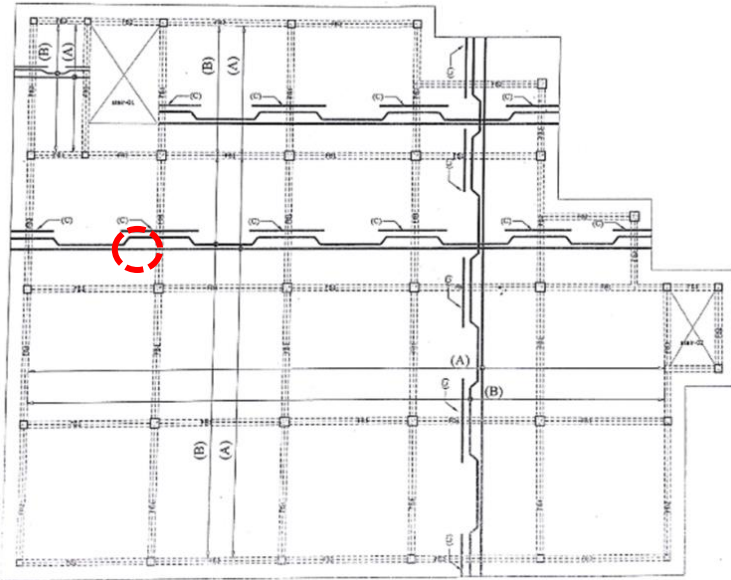
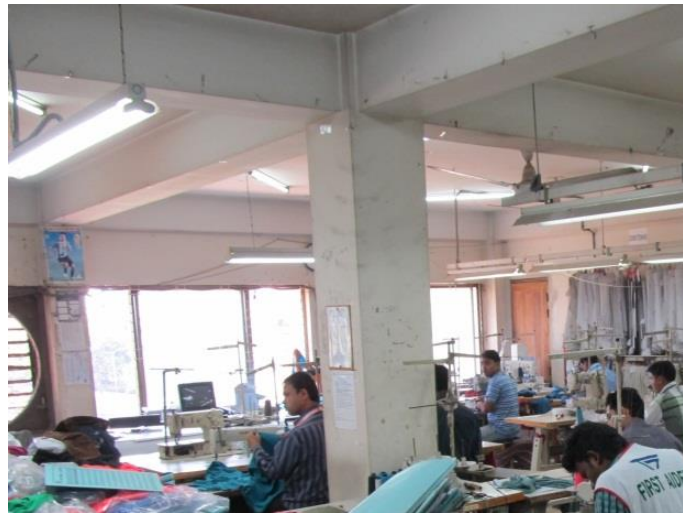
Column Load Exceeds Allowable Limit by Code
Building 02

Similar to Building 01, the capacity of the column above ground level appears to possess a smaller FOS in design than the portion of column below G/F level. Although it is only a YELLOW warning, a full review of loads and concrete design strength should be carried out. The portion of the column below G/F possesses sufficient capacity to maintain material stresses to very low limits.

Preliminary load take-down calculation in Building 02 using the prescribed design loads indicate a slightly low factor of safety of design

- Factory Engineer to review design, loads and columns stresses in area identified above.
- Verify insitu concrete stresses either by 100mm dia. cores or existing cylinder strength data
- Produce and actively manage a loading plan for all floor plates within the factory giving consideration to floor and column capacity
