Reza Fashion Ltd

Gorat, Baghbari, Ashulia, Savar, Dhaka.
(23.949330N, 90.305780E)

01 April 2014

Building Observations

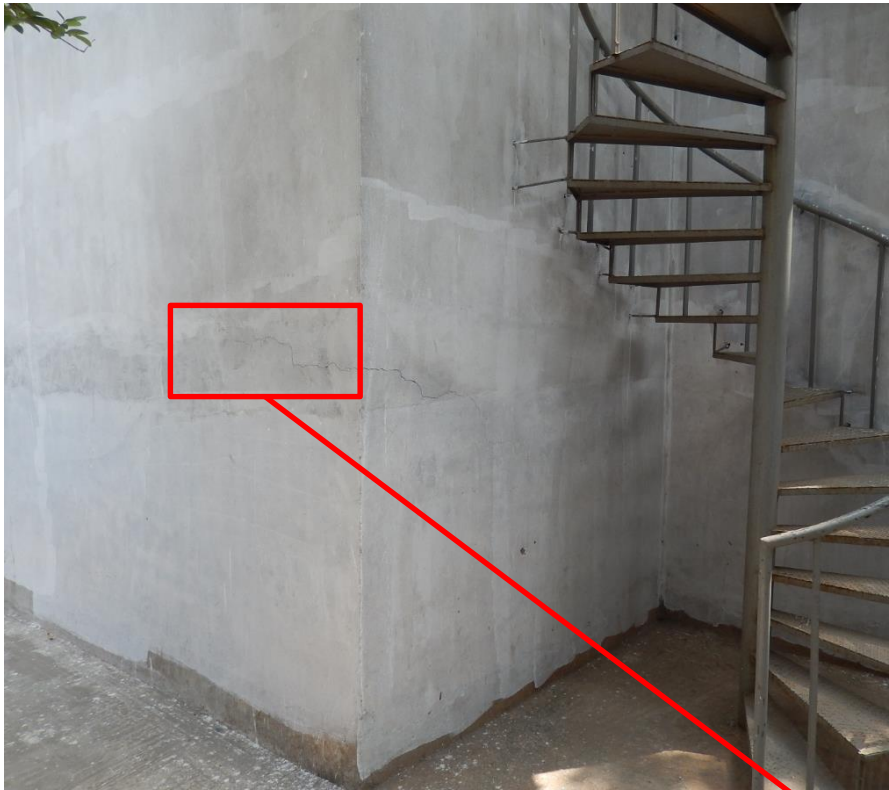
At annexe building (Utility building at ground floor)

Cracking of non-structural brick wall infill

Item No.	Observation	Recommended Action Plan	Recommended Timeline
1	Cracking of non-structural brick wall infill	Engineer to regularly monitor cracks and, in case the cracks increase, review structural behaviour	6-months
2	Cracking of non-structural brick wall infill	Repair cracks in the external wall to ensure water tightness	6-months
3	Discrepancy in Building Documentation	Before adding additional floors, verify with engineer and soils engineer the capacity of the foundations and the ground conditions to receive the loads of additional floors	6-months

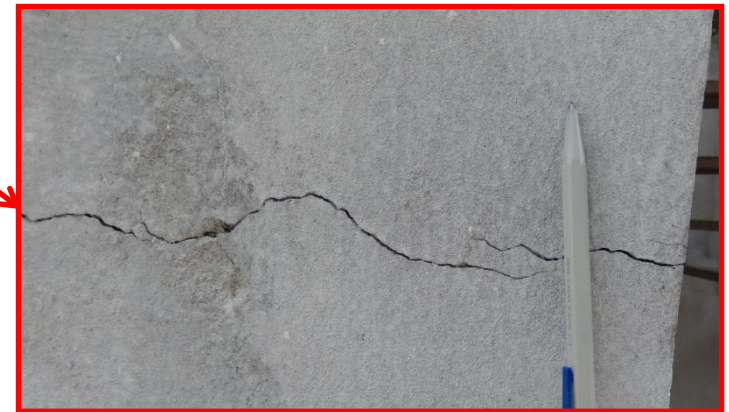
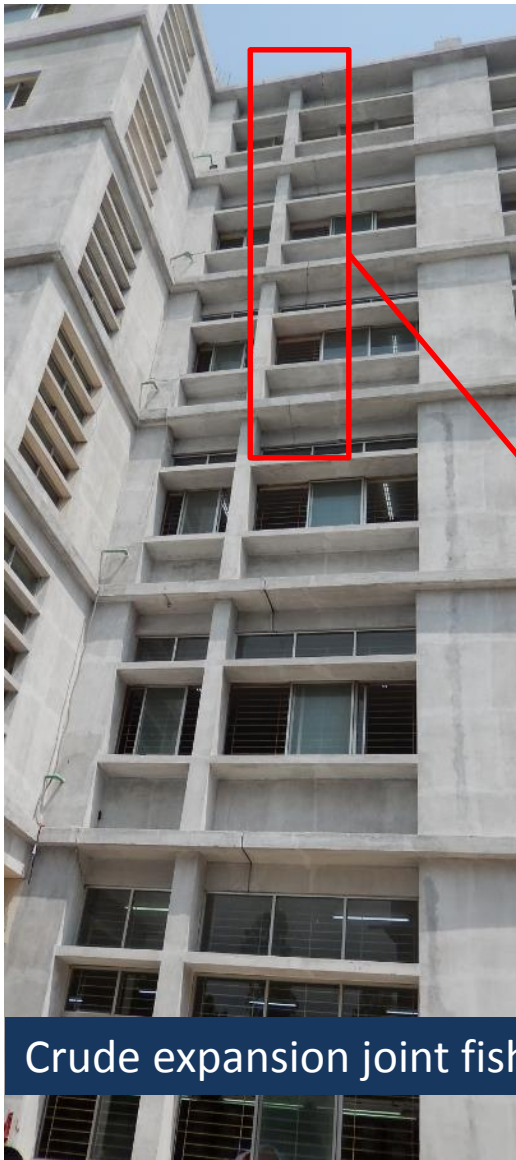
Crude expansion joint fishing

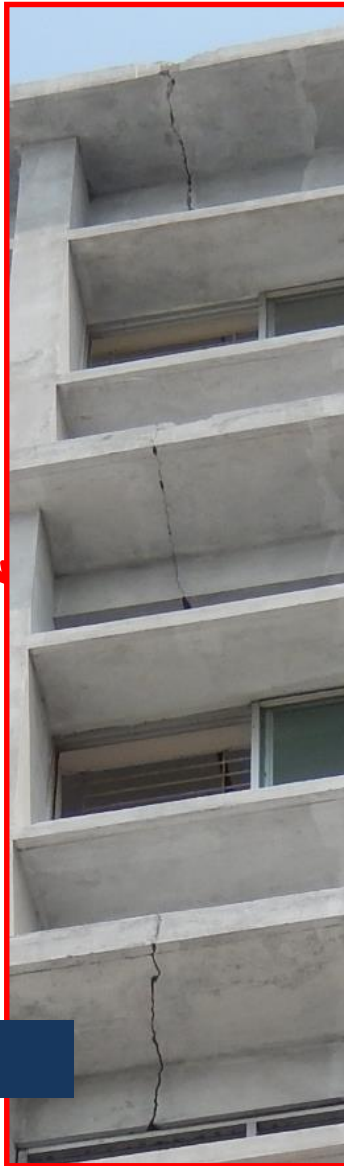
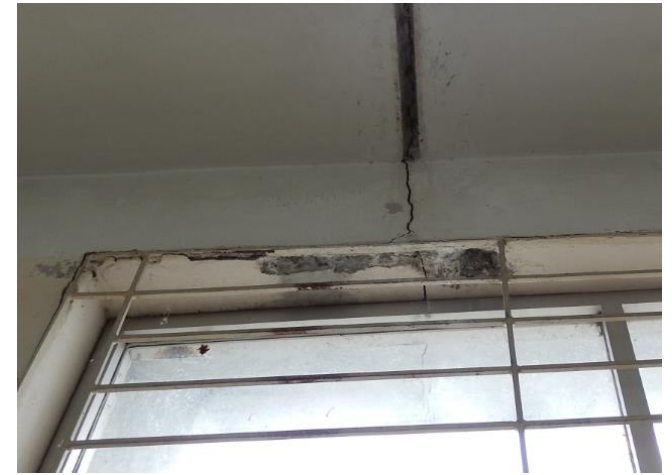
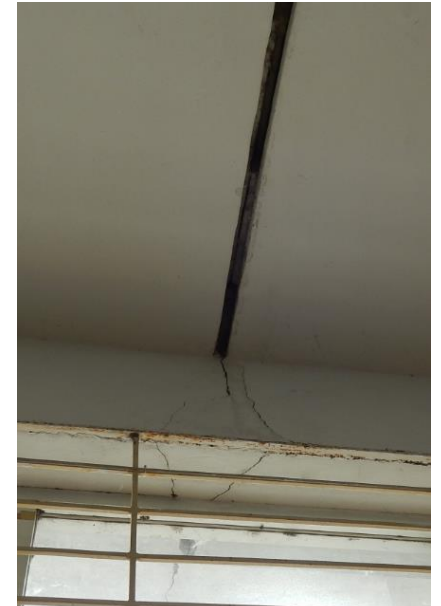
Cracking at expansion joint

5 Cracking at movement joint

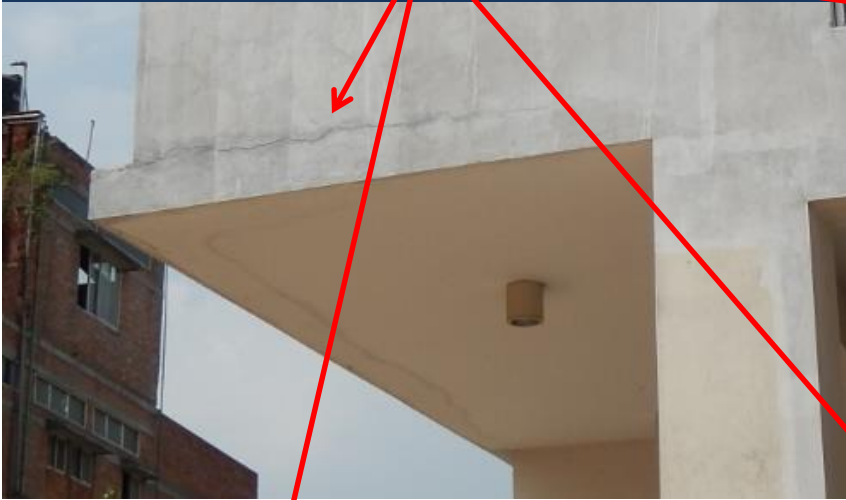
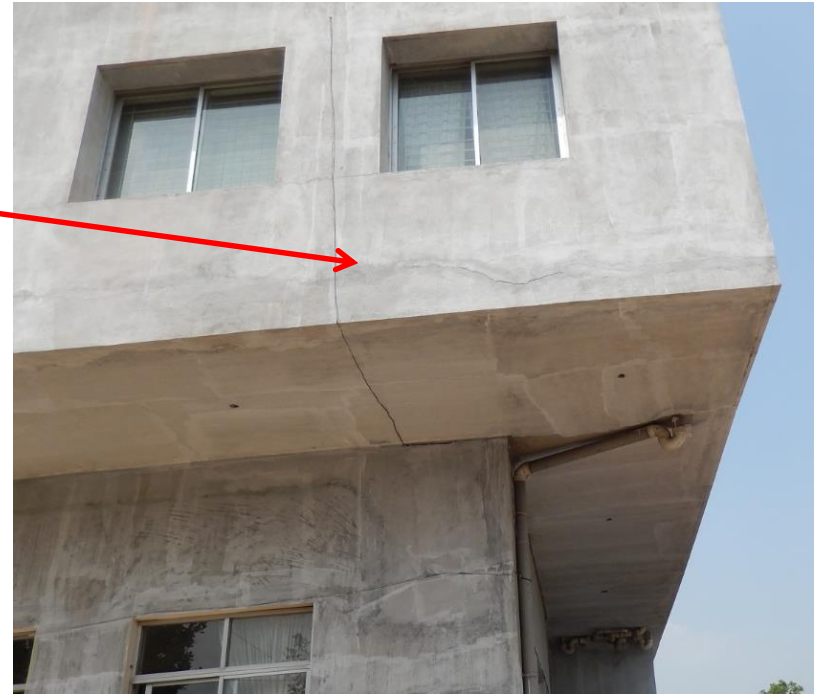
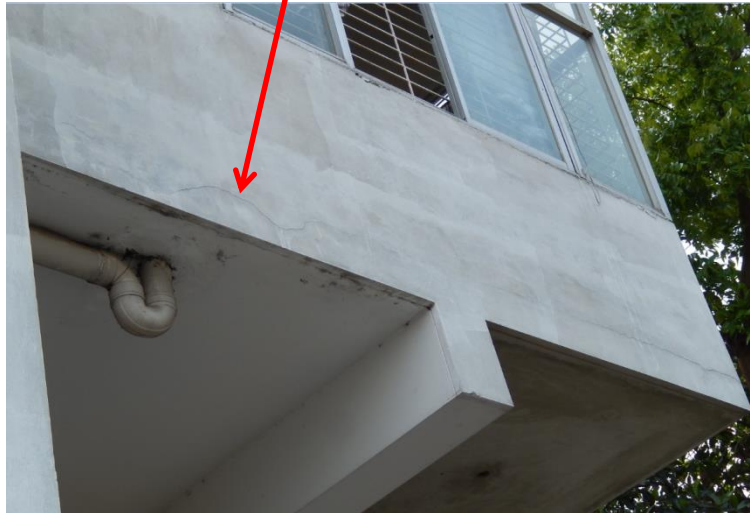
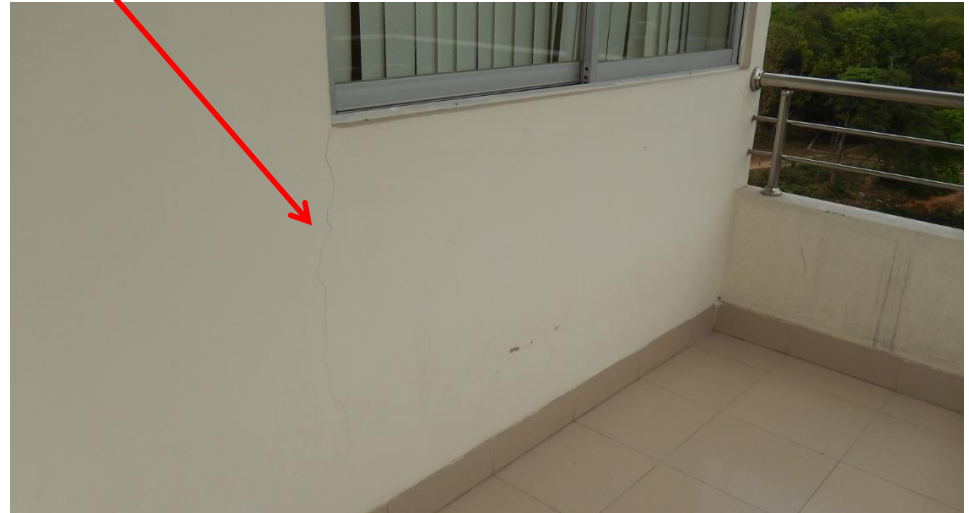
Minor cracking at cantilever slabs,
caused by rigid brick infill over flexible
slab

Cracking at cantilevers

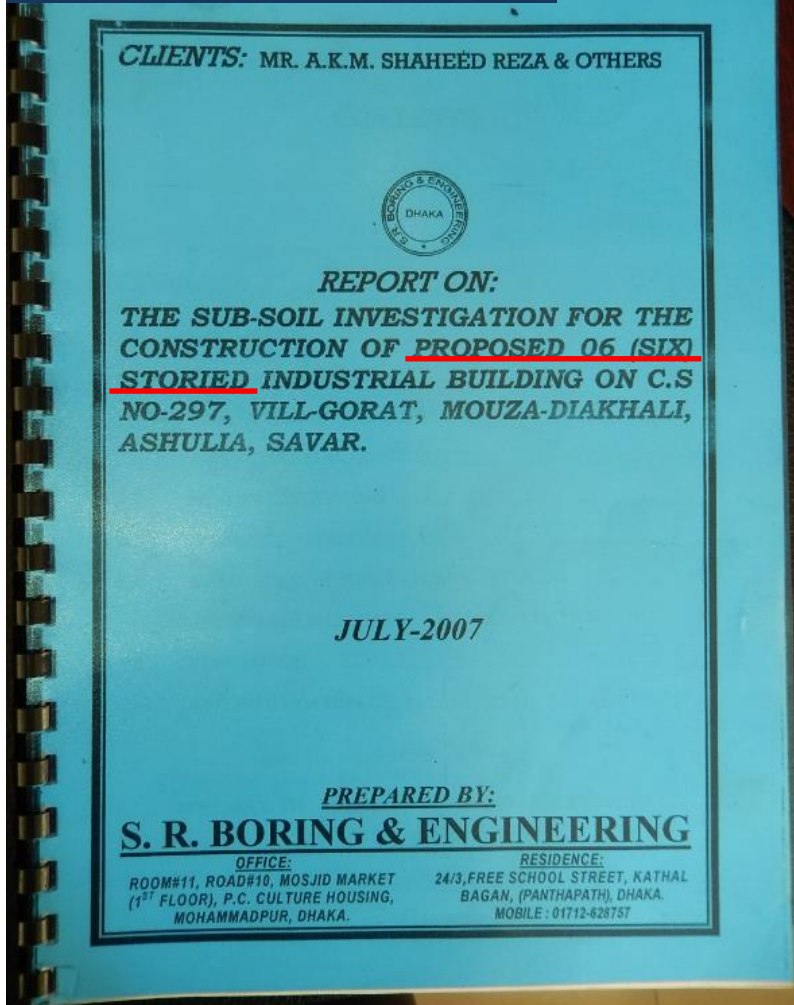
Soil investigation report
for a 6 storey building

Discrepancy of documentation

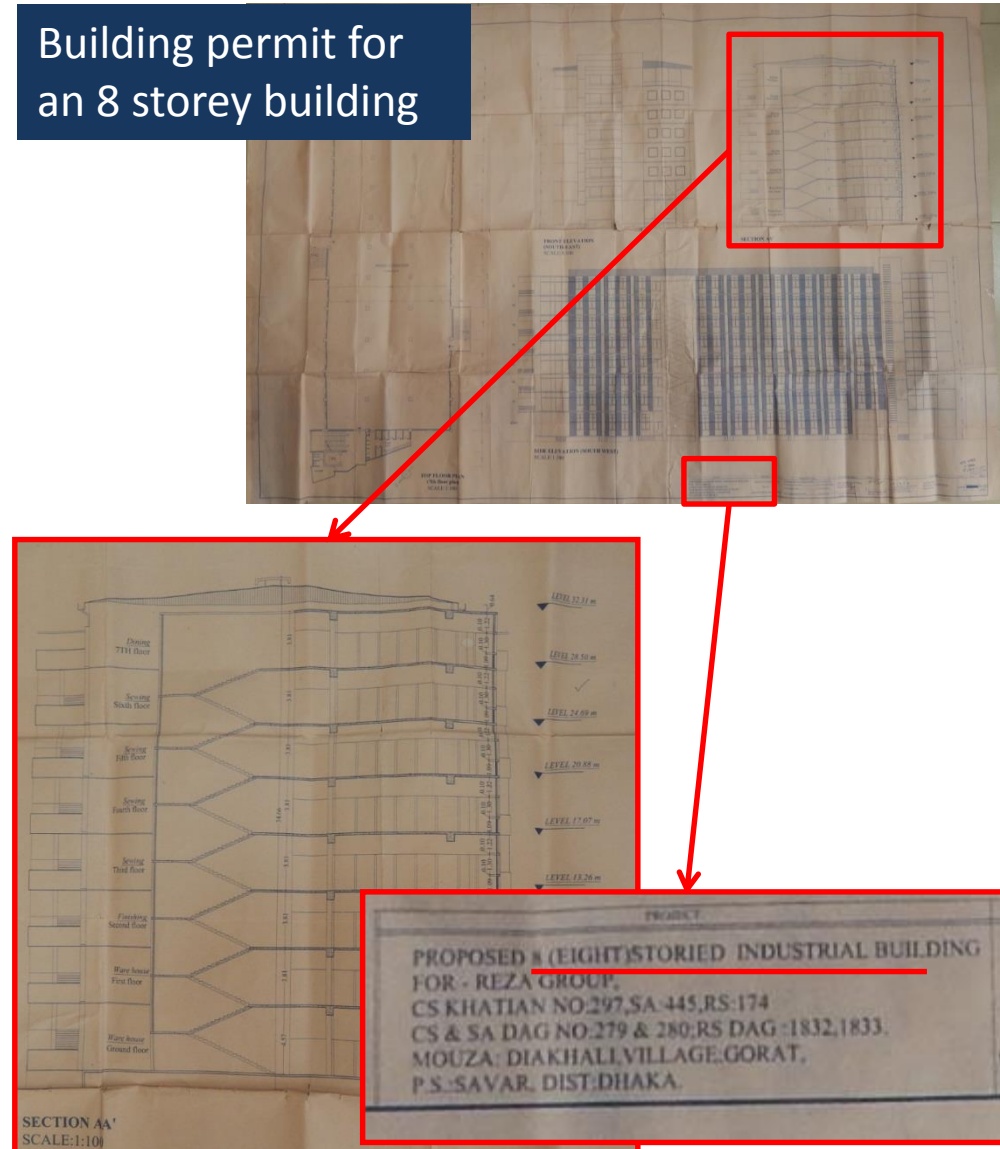
Building permit for
an 8 storey building
