# **FIRE SAFETY INSPECTION REPORT**

**RIVER SIDE SWEATER LTD**  
**HASNABAD SUPER MARKET, KERANIGONJ**

**ACCORD**  
on Fire and Building Safety in Bangladesh

June 22, 2014

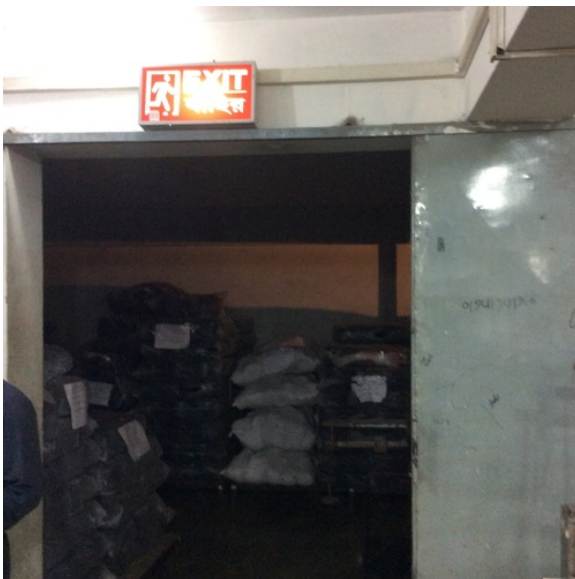
| No. | Category | Finding | Recommendation | Remediation Timeframe |
|---|---|---|---|---|
| F-1 | Fire Rated Construction | Areas used for combustible storage in the basement and on floor 2 are not separated by fire-rated construction. | <p>Provide dedicated storage rooms separated by minimum 1-hr fire-rated construction.</p> <p>Where separate storage rooms are not feasible, provide defined storage areas and limit the storage arrangement as follows:</p> <ul style="list-style-type: none"> <li>- Maximum height of 2.4m and maximum area of 23m<sup>2</sup></li> <li>- If sprinkler protected: maximum height of 3.66m and maximum area of 93m<sup>2</sup></li> </ul> <p>Separate areas of unenclosed combustible storage by a minimum clear distance of 3m.</p> | Within 3 months |

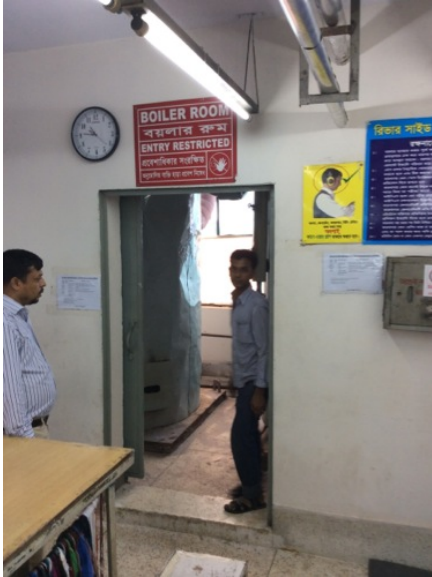
| F-2 | Fire Rated Construction | The boiler room is not separated by fire-rated construction from the production area of floor 2. | Separate the boiler room by a minimum 1-hr fire-rated construction. Seal and/or protected all openings to maintain the required fire separations | Within 3 months |

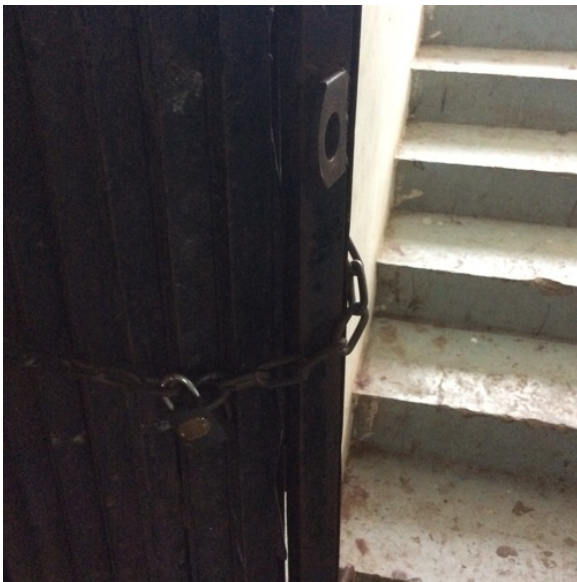
| F-3 | Fire Rated Construction | The exit stairs and the internal stair 2 are not separated from the production areas on each floor by fire-rated separations . | <p>Provide minimum 1.5-hr fire rated doors and seal all unprotected openings to separate the exit stairs from work areas and other building spaces on all floor levels. Ensure that the fire doors are self-closing and positive latching and that they are provided with fire exit (panic) hardware where serving production floors.</p> <p>If fire doors are required to be held open for functional reasons, provide automatic-closing devices tied to the fire alarm system.</p> | Within 3 months |

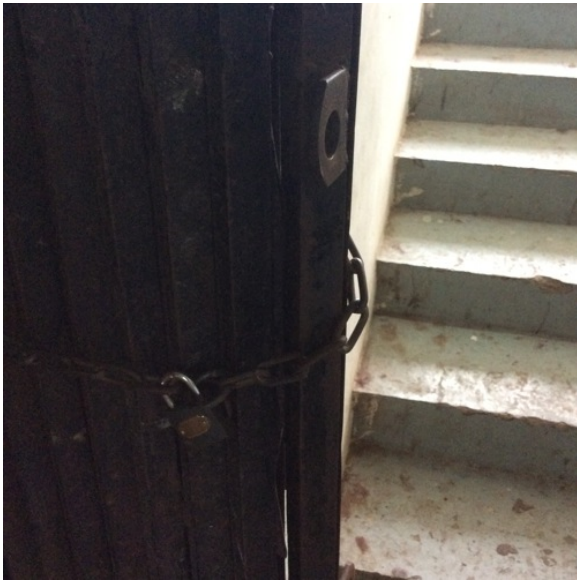
| F-4 | Egress | Egress gates with locking features are provided at most stairs and discharges. | <p>Remove locking features from all egress doors / gates.</p> <p>If locks are required for security reasons, utilize special door locking features complying with NFPA 101.</p> | Immediate |

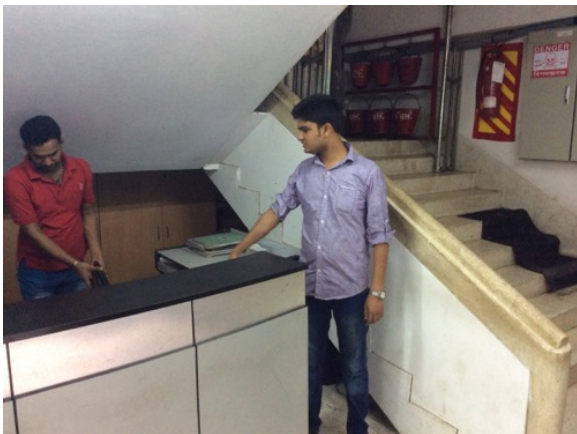
| F-5 | Egress | A security desk with combustible storage was located in stair 1 at floor 2. | Remove all storage from exit stairs and egress paths. | Immediate |

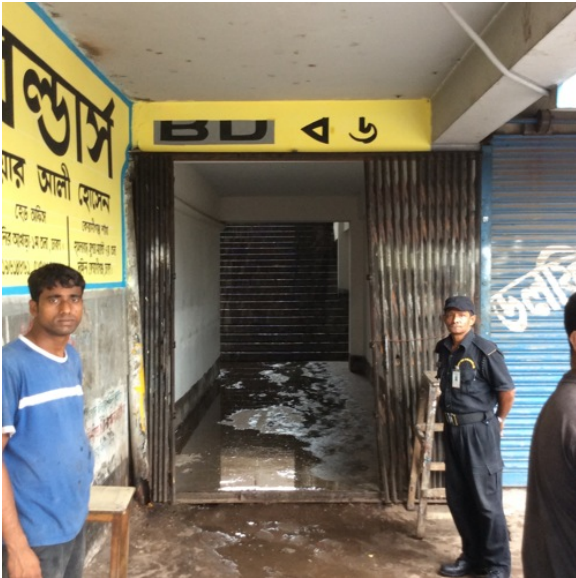
| F-6 | Egress | Collapsible and sliding gates are provided at most stairs and discharges. | <p>Replace all collapsible gates along the means of egress with side-hinged, swinging egress doors.</p> <p>If locks are required for security reasons, utilize special door locking features complying with NFPA 101.</p> | Within 3 months |

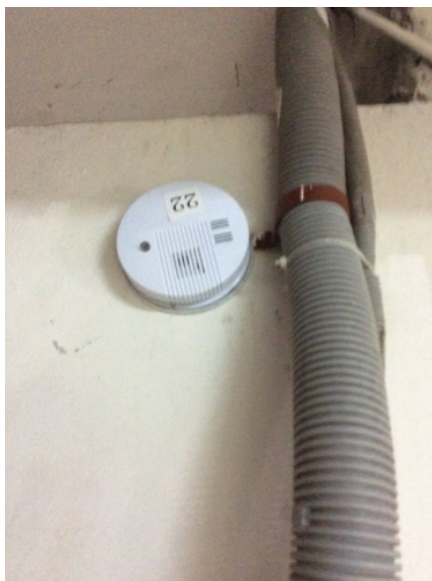
| F-11 | Fire Protection | The building is equipped with single-station smoke alarms. Smoke alarm activation sounds only a local alarm and does not provide automatic fire alarm notification of occupants. | Remove single-station smoke alarms. Provide automatic smoke detection throughout the building, tied into the fire alarm system, in accordance with NFPA 72. | Within 6 months |

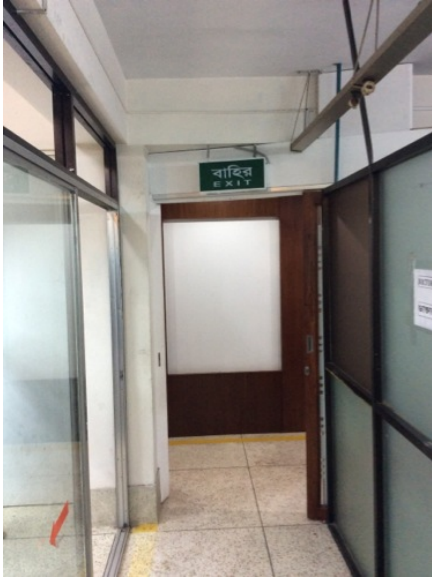
| F-12 | Egress Lighting | Exit signage not illuminated (burned out, broken, etc.) on floor 2. | Regularly inspect all exit signage and replace/install lights as needed to illuminate signs. | Within 1 month |

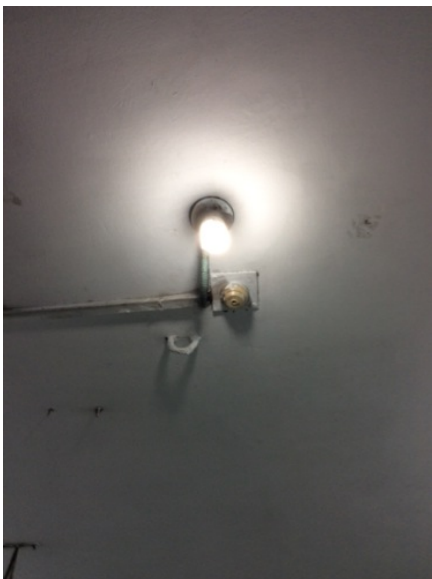
| F-13 | Egress Lighting | Inspection, testing, and maintenance records for the emergency lighting system were not in accordance of the ACCORD standards. | Inspect, test and maintain the emergency lighting system in accordance with The ACCORD standard. Keep written records on-site. | Within 3 months |
