# **FIRE SAFETY INSPECTION REPORT**

**The Cloth & Fashion Ltd**

**Date: 25 April, 2016**

## Fire Safety Inspection Report

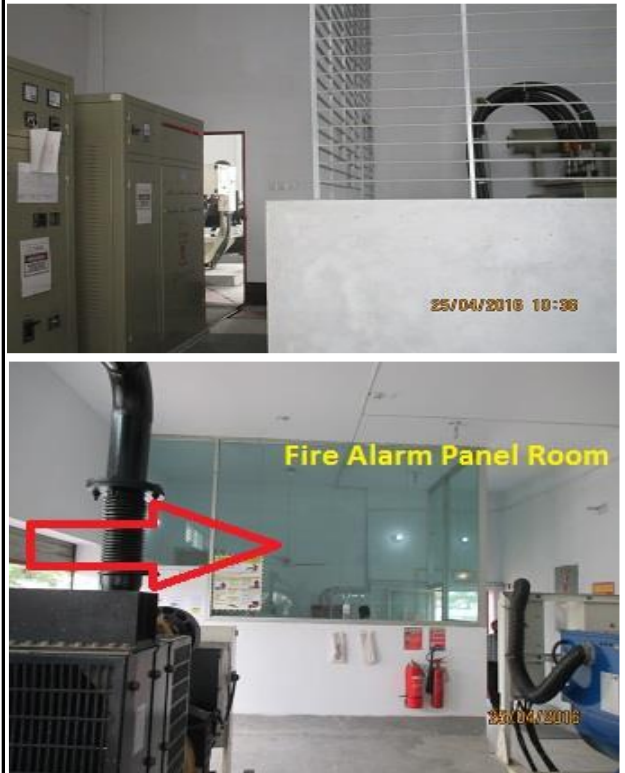
| SI No. | Category | Findings | Required Action | Remediation Time Frame | Pictorial Evidence |
|---|---|---|---|---|---|
| 1 | Fire Rated Construction | Generator, transformer, LT/HT panel and fire alarm control panel are not separated from each other by proper fire rated construction ( non rated doors, unsealed penetrations and openings etc.). | Separate the generator, transformer, LT/HT panel and fire alarm control panel room from each other by a minimum 2-hr fire rated construction. Provide minimum 1.5 hour fire rated door in between generator and LT/HT panel room if required. Seal and/or protect all penetrations and openings to maintain the required fire separations. | Within 3 months | |

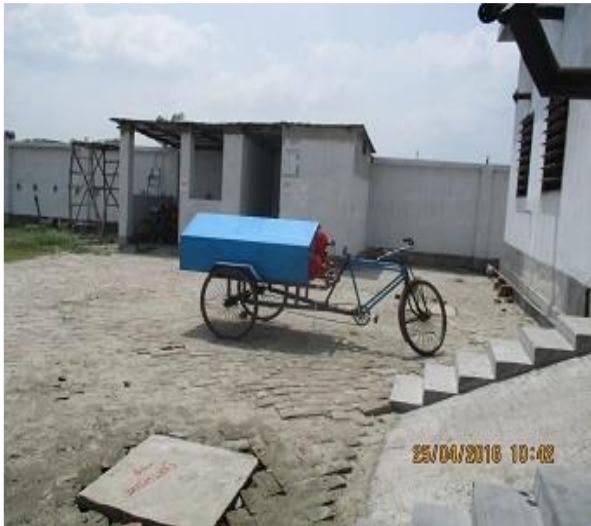
| Sl No. | Category | Findings | Required Action | Remediation Time Frame | Pictorial Evidence |
|---|---|---|---|---|---|
| 2 | Fire Rated Construction | Liquefied or compressed gas cylinders were located in front of utility building (east side of boiler room) near means of egress without any protection. | The storage or use of liquefied or compressed flammable gas cylinders shall be prohibited within the factory building. In the case of storage those shall be protected with at least 2 hour fire rated construction barrier with compliant and sufficient ventilation. | Within 3 months | A photograph showing a blue gas cylinder mounted on a bicycle, parked in an outdoor area next to a building. The timestamp in the bottom right corner reads "25/04/2016 10:42". |

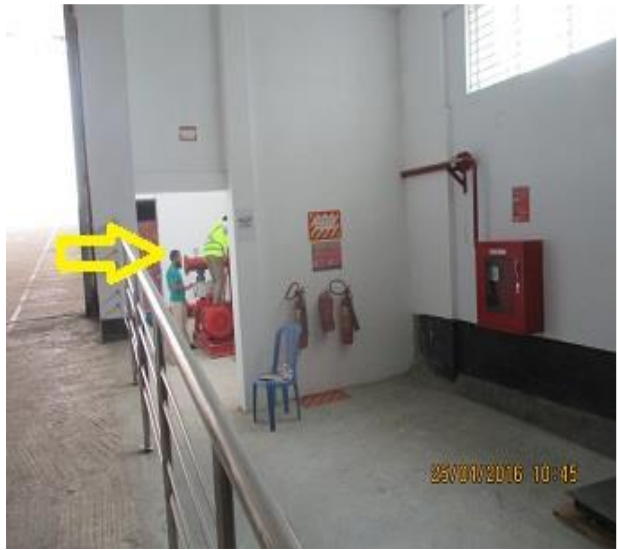
| Sl No. | Category | Findings | Required Action | Remediation Time Frame | Pictorial Evidence |
|---|---|---|---|---|---|
| 3 | Fire Rated Construction | The fire pump room located in the north side of basement floor is not provided with adequate fire separation. | Provide fire pump room with 2 hr rated fire separation when not sprinklered and 1 hr rated fire separation when provided with automatic sprinklers, in accordance with NFPA 20. | Within 3 months | A photograph showing the interior of a fire pump room. A yellow arrow points to the entrance area. The room contains various equipment and a fire extinguisher. The timestamp in the bottom right corner reads "25/04/2016 10:45". |

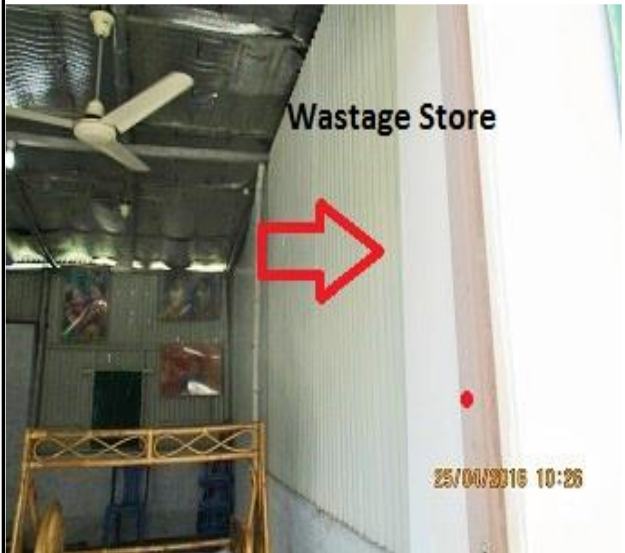
| Sl No. | Category | Findings | Required Action | Remediation Time Frame | Pictorial Evidence |
|---|---|---|---|---|---|
| 4 | Fire Rated Construction | Day-care room located in the CI sheet shed area is not separated from adjacent wastage store by fire rated construction (non rated barrier). | Provide 2 hour fire rated protection in between daycare room and wastage store OR Relocate Day-care room on the ground floor with a maximum travel distance of 9 m (30 ft) or located one story above level of exit discharge with direct access to an exit enclosure. If the above is not possible provide a minimum 2-hr fire rated exit corridor between the day-care room and exit stair with ACCORD approval. | Within 3 months | |

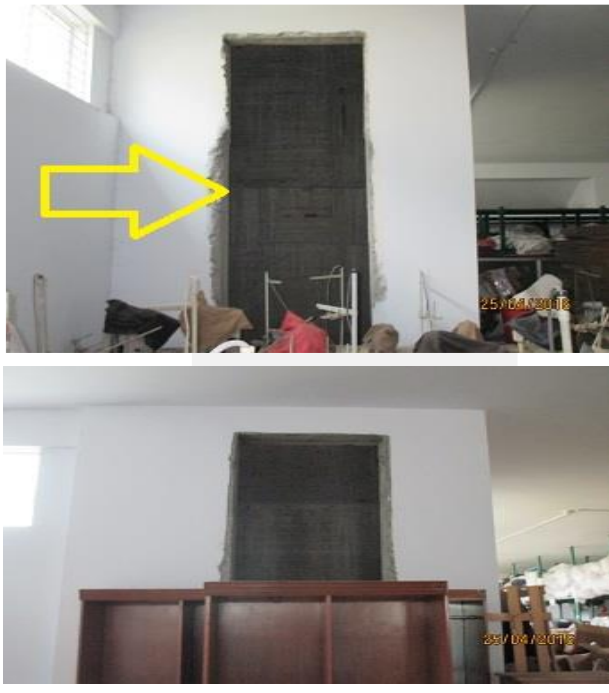
| Sl No. | Category | Findings | Required Action | Remediation Time Frame | Pictorial Evidence |
|---|---|---|---|---|---|
| 5 | Fire Rated Construction | The north and northwest elevator shafts discharge inside basement floor's warehouse are not separated by fire rated construction (unsealed penetrations and openings). | Separate the elevator shafts by a minimum 2-hr fire rated construction. Seal all penetrations and openings to maintain required fire separation. | Within 3 months | |

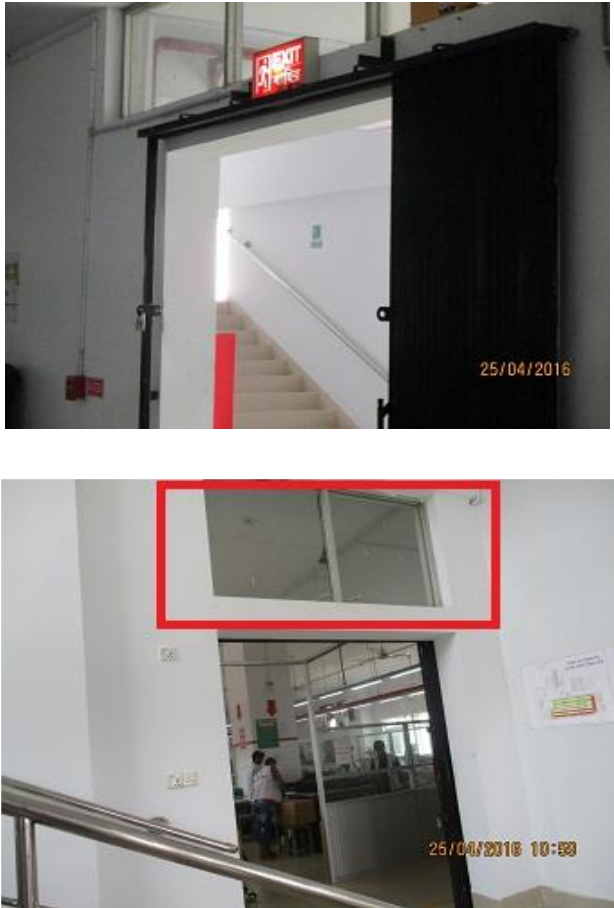
| Sl No. | Category | Findings | Required Action | Remediation Time Frame | Pictorial Evidence |
|---|---|---|---|---|---|
| 6 | Fire Rated Construction | The north, north-east, south-west exit stairs are not separated from work areas and other spaces such as time section, reception, doctor room, machine room on each floor by fire rated construction( non rated doors, unsealed penetrations and openings etc.) | Provide minimum 1.5-hr fire rated doors and seal all unprotected openings to separate the exit stairs from work areas and other building spaces on all floor levels by 2-hr fire rated construction. Ensure that the fire rated doors are self-closing and positive latching and that they are provided with fire exit (panic) hardware where serving production floors. If fire rated doors are required to be held open for functional reasons, provide automatic closing devices tied to the fire alarm system. | Within 3 months | |

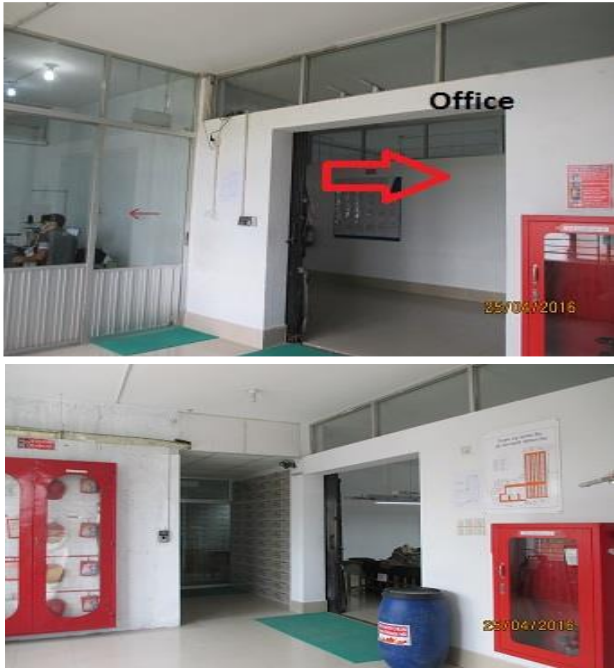
| Sl No. | Category | Findings | Required Action | Remediation Time Frame | Pictorial Evidence |
|---|---|---|---|---|---|
| 7 | Fire Rated Construction | The office area located in the east side of first floor more than 10 percent of entire floor area is not properly separated from production area by fire rated construction (unsealed penetrations and opening, non rated door). | Provide minimum 1.5-hr fire rated doors and seal all unprotected openings to separate the exit stairs from work areas and other building spaces on all floor levels by 2-hr fire rated construction. Ensure that the fire rated doors are self-closing and positive latching and that they are provided with fire exit (panic) hardware where serving production floors. | Within 3 months | |

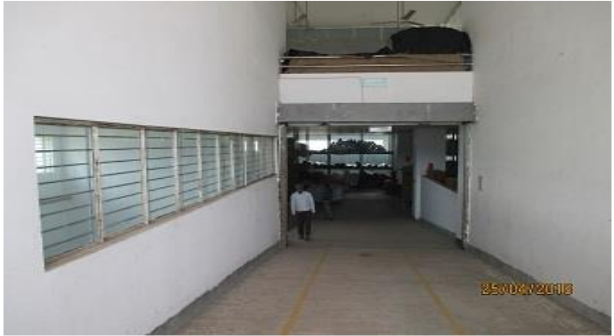
| Sl No. | Category | Findings | Required Action | Remediation Time Frame | Pictorial Evidence |
|---|---|---|---|---|---|
| 8 | Fire Rated Construction | Room used for combustible storage at basement floor is not separated by fire rated construction (unsealed penetrations and openings, non rated doors etc.). | Provide dedicated storage rooms separated by minimum 1-hr fire-rated construction. | Within 3 months | |

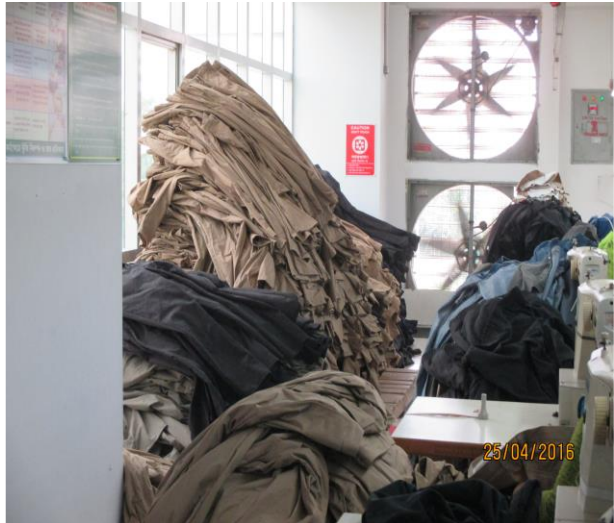
| Sl No. | Category | Findings | Required Action | Remediation Time Frame | Pictorial Evidence |
|---|---|---|---|---|---|
| 9 | Fire Rated Construction | Areas used for combustible storage on the second floor are not separated by fire-rated construction. | <p>Provide dedicated storage rooms separated by minimum 1-hr fire-rated construction.</p> <p>Where separate storage rooms are not feasible, provide defined storage areas and limit the storage arrangement as follows:-</p> <p>Maximum height of 2.4m and maximum area of 23m<sup>2</sup>- If sprinkler protected: maximum height of 3.66m and maximum area of 93sqm.</p> <p>Separate areas of unenclosed combustible storage by a minimum clear distance of 3m.</p> | Within 3 months | |

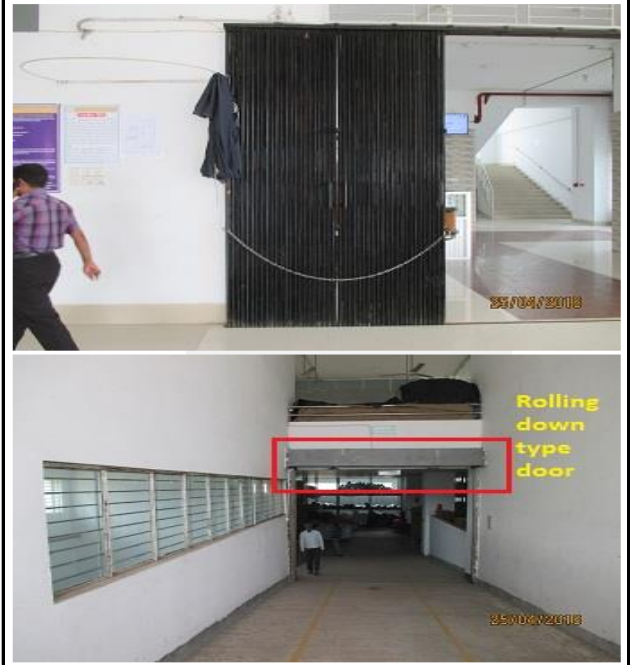
| Sl No. | Category | Findings | Required Action | Remediation Time Frame | Pictorial Evidence |
|---|---|---|---|---|---|
| 10 | Egress | Collapsible gates /rolling down type doors are provided at building exits, exit discharge on all areas. | <p>Replace all non-compliant gates (collapsible, rolling down, sliding) doors along the means of egress with side-hinged, swinging egress doors.</p> <p>If locks are required for security reasons, utilize special door locking features complying with NFPA 101.</p> | Within 1 month | |

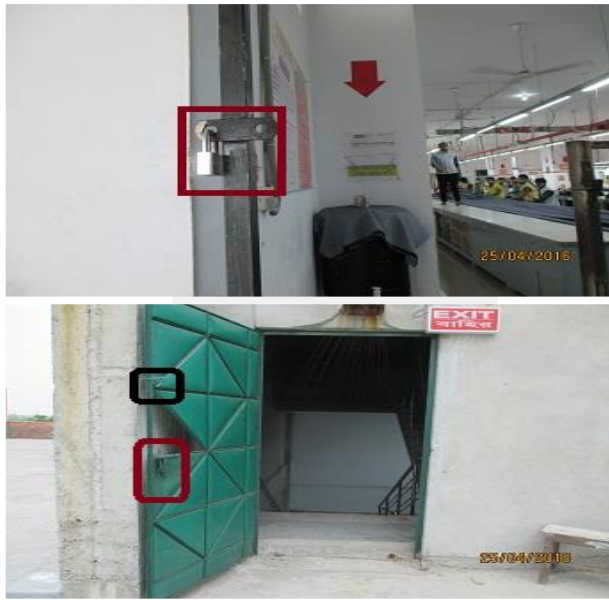
| Sl No. | Category | Findings | Required Action | Remediation Time Frame | Pictorial Evidence |
|---|---|---|---|---|---|
| 11 | Egress | Egress doors and gates with locking features are provided at building exits, exit stairs, along egress routes and exit discharge on all floors. All doors and gates were open and unlocked during inspection. | Remove locking features from all egress doors and gates. If locks are required for security reasons, utilize special door locking features complying with NFPA 101 and ACCORD standard 6.8.2. | Immediate | |

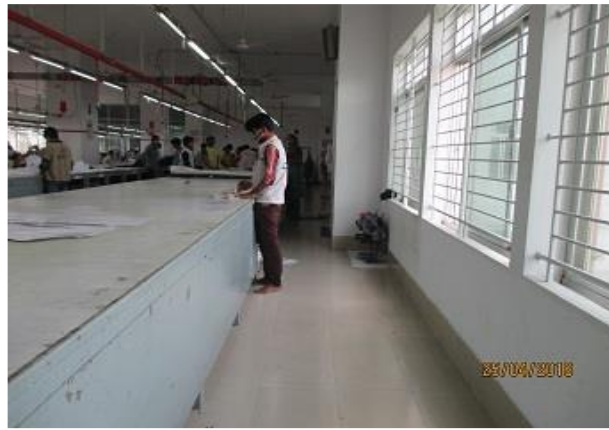
| Sl No. | Category | Findings | Required Action | Remediation Time Frame | Pictorial Evidence |
|---|---|---|---|---|---|
| 12 | Egress | The width of egress aisles is less than 36-in on ground floor (North side of cutting section). | Provide minimum unobstructed aisle with width of 36-in. | Within 1 month | |

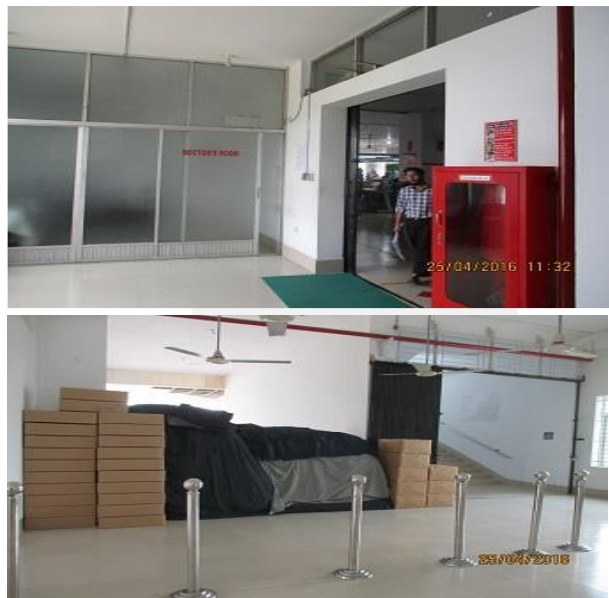
| Sl No. | Category | Findings | Required Action | Remediation Time Frame | Pictorial Evidence |
|---|---|---|---|---|---|
| 13 | Egress | Storage was located in the exit stairs. [Ground Floor: Time section and reception on NW stair and combustible materials on North stair, 1st Floor: Mechanical room on North stair and sitting arrangement for NW stair, 2nd Floor: Doctor's room on North stair, Roof: water pump on SE stair). | Keep egress paths and stairs clear of storage or any other occupancy. | Immediate | |

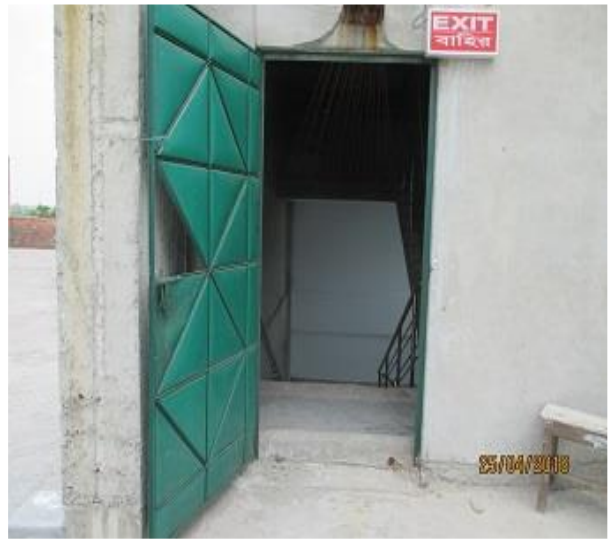
| Sl No. | Category | Findings | Required Action | Remediation Time Frame | Pictorial Evidence |
|---|---|---|---|---|---|
| 14 | Egress | The exit doors for roof does not swing in the direction of egress travel. | Ensure the direction of swinging for exit door in the direction of egress when the occupant load is more than 49. | Within 1 month | |

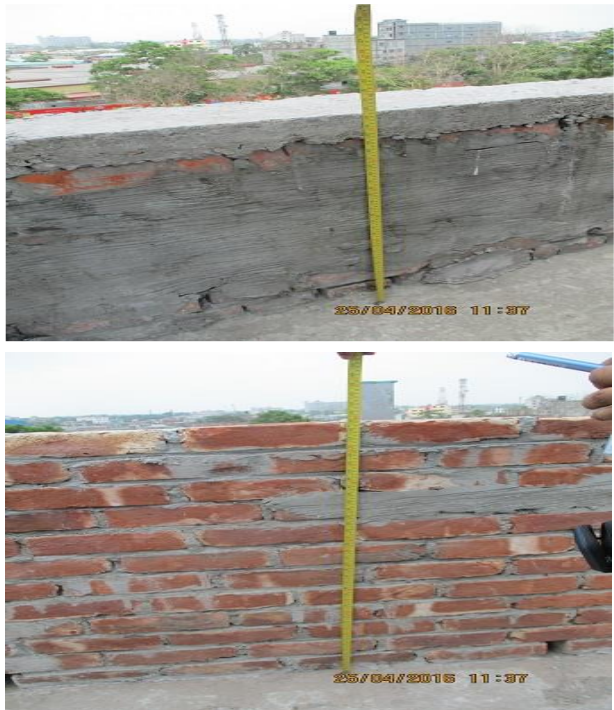
| Sl No. | Category | Findings | Required Action | Remediation Time Frame | Pictorial Evidence |
|---|---|---|---|---|---|
| 15 | Egress | The height of parapet wall is less than 42 inch. | The parapet wall shall be with minimum 42 inch high for occupiable roof. | Within 1 month | |

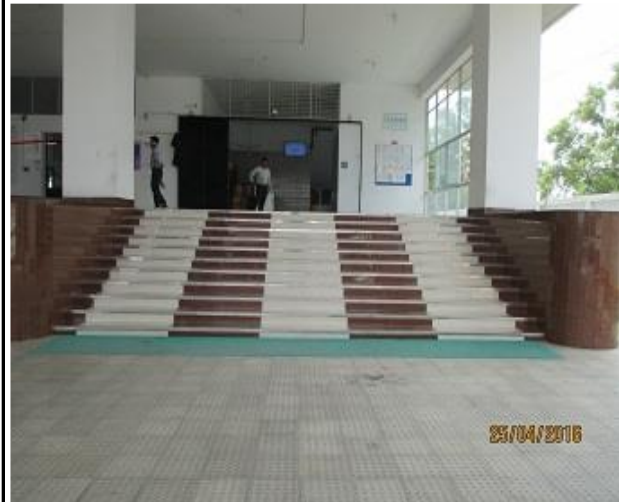
| Sl No. | Category | Findings | Required Action | Remediation Time Frame | Pictorial Evidence |
|---|---|---|---|---|---|
| 16 | Egress | Stair width more than 2.2 m but handrail not provided. [Exit discharge for NW stair]. | Provide handrails on both sides of the exit stair. New handrails shall have a minimum height of 865 mm (34 in.) and a maximum height of 965 mm (38 in.) as measured from the leading edge of the tread. Intermediate handrails shall be provided when the stair width exceeds 2.2 m (87 in.) | Within 1 month | |

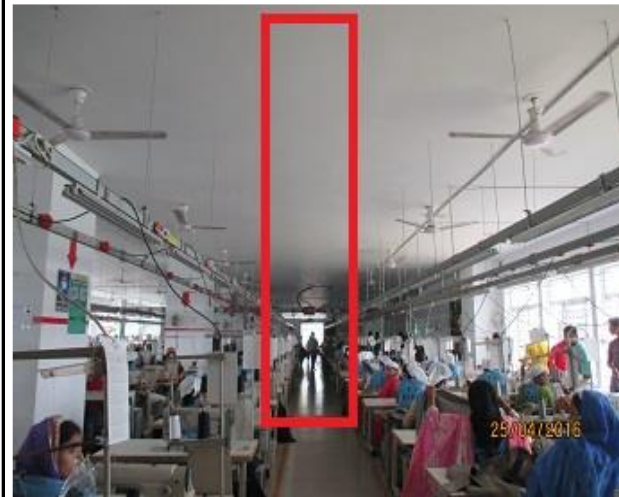
| Sl No. | Category | Findings | Required Action | Remediation Time Frame | Pictorial Evidence |
|---|---|---|---|---|---|
| 17 | Egress Lighting | Based on the number and location of emergency lights observed, adequate illumination levels are not anticipated along egress routes and at exit stairs on all floors. | Test the emergency lighting system on each floor and provide additional emergency fixtures to supply adequate illumination along the means of egress. Provide a minimum illumination of 10 lux at the floor level within exit stairs and along exit discharge paths and a minimum 2.5 lux along exit access aisles. | Within 3 months | |

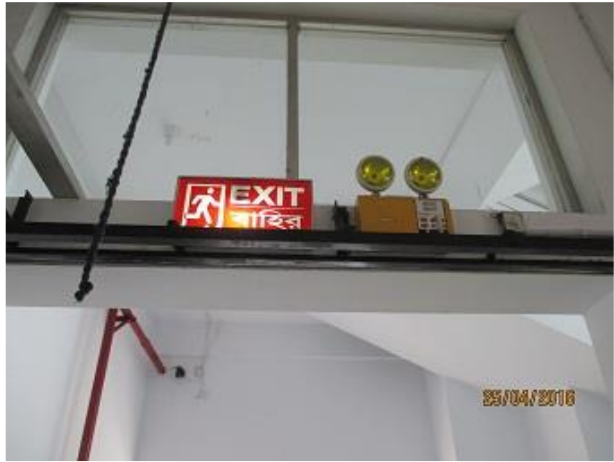
| Sl No. | Category | Findings | Required Action | Remediation Time Frame | Pictorial Evidence |
|---|---|---|---|---|---|
| 18 | Exit Signage | Exit signage was provided at all the exit doors but not sufficient along a path of egress where direction is changed. | Provide exit signs above all building exits to the exterior, all doors to the exit stairs and along all paths of travel where a change of direction is not obvious. | Within 3 months | |

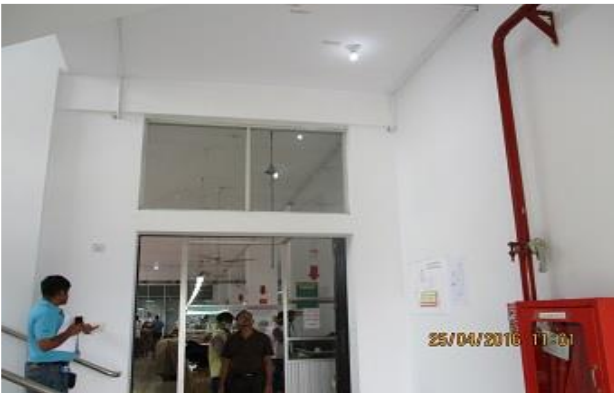
| Sl No. | Category | Findings | Required Action | Remediation Time Frame | Pictorial Evidence |
|---|---|---|---|---|---|
| 19 | Egress Lighting | Manual on-off switch is provided for emergency lights. | Remove manual on/off switches from emergency lighting units to prevent them from being switched off. | Within 1 month | |

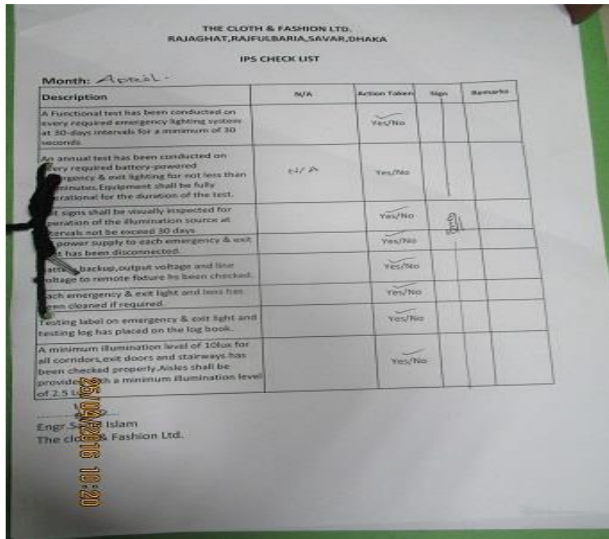
| Sl No. | Category | Findings | Required Action | Remediation Time Frame | Pictorial Evidence |
|---|---|---|---|---|---|
| 20 | Egress Lighting | Inspection, testing, and maintenance for the exit sign and emergency lighting system was not in accordance with The ACCORD standard. | Inspect, test and maintain the exit sign and emergency lighting system in the accordance with The ACCORD standard. Keep written records on-site. | Within 3 months | |

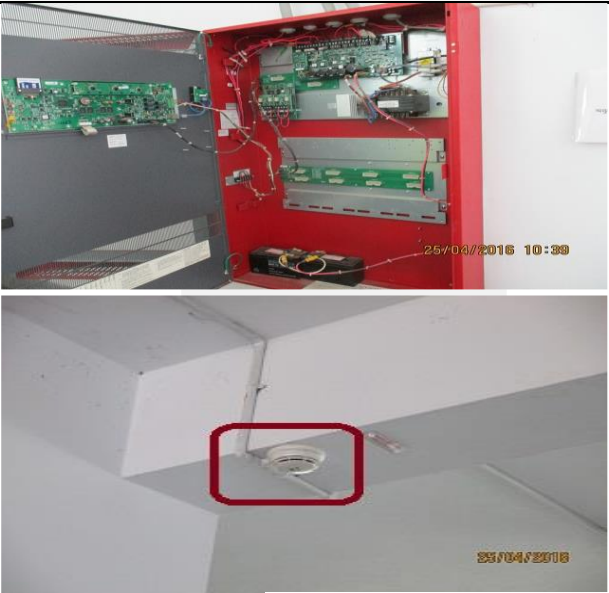
| Sl No. | Category | Findings | Required Action | Remediation Time Frame | Pictorial Evidence |
|---|---|---|---|---|---|
| 21 | Fire Protection | Automatic fire alarm system is available for the main and utility building but wastage godown shed is not under the coverage of detection system, moreover installation process of detector is not appropriate for the main building. Ordinary cable used for fire alarm system. | Modify the fire alarm system in accordance with NFPA 72. The cable for fire alarm system shall be third party certified. Fire pump controls, fire door, exhaust fan HVAC system shall have to be interfaced with FACP. | Within 3 months | |

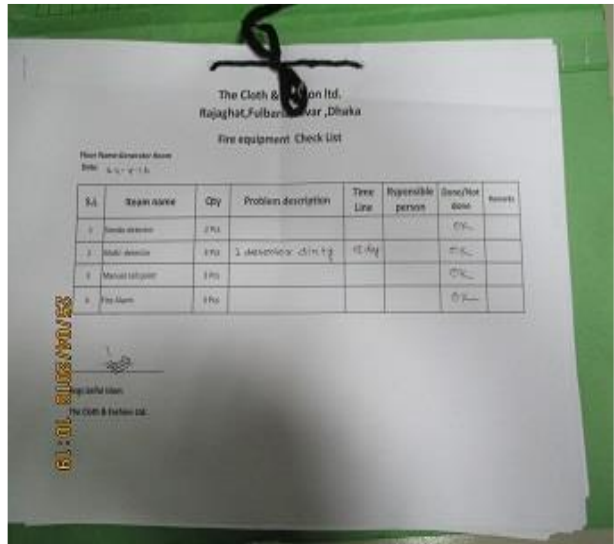
| Sl No. | Category | Findings | Required Action | Remediation Time Frame | Pictorial Evidence |
|---|---|---|---|---|---|
| 22 | Fire Protection | Inspection, testing and maintenance for the fire alarm system is not in accordance with NFPA 72. | Inspect, test and maintain the fire alarm system and keep written records on-site, in accordance with NFPA 72. | Within 3 months | |

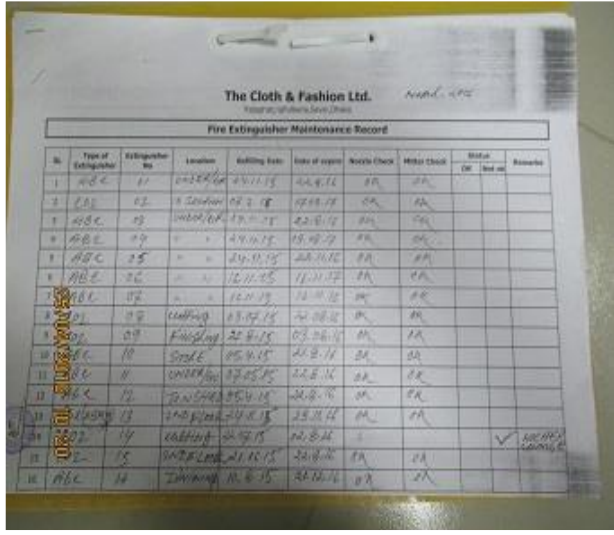
| Sl No. | Category | Findings | Required Action | Remediation Time Frame | Pictorial Evidence |
|---|---|---|---|---|---|
| 23 | Fire Protection | Inspection, testing and maintenance of portable fire extinguishers is not in accordance with NFPA 10. | Inspect, test and maintain the portable fire extinguishers and keep written records onsite, in accordance with NFPA 10. | Within 3 months | |

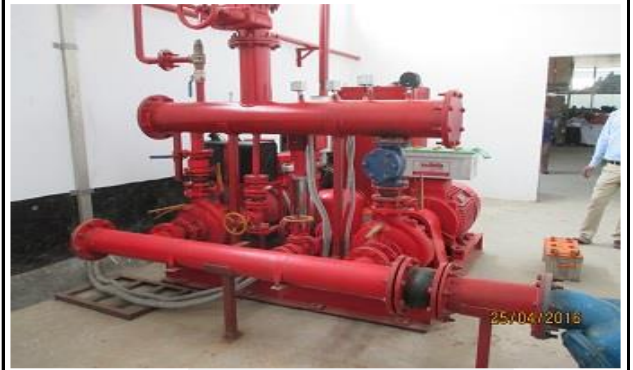
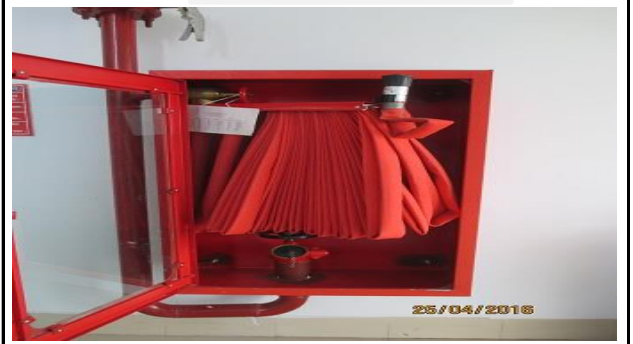
| Sl No. | Category | Findings | Required Action | Remediation Time Frame | Pictorial Evidence |
|---|---|---|---|---|---|
| 24 | Fire Protection | Roof is not under the coverage of standpipe system. The fire pumps are not certified and installation of fire pump is also not as per NFPA-20 | Modify the standpipe system following NFPA-14. The fire pump shall be third party certified. | Within 3 months | |
