# Majumder Garments Ltd

Majumder Center, 113/1, Mudafa Paschim Para, Tongi, Gazipur  
(23.901012, 90.367305)

19 May, 2016

## Client Summary Report

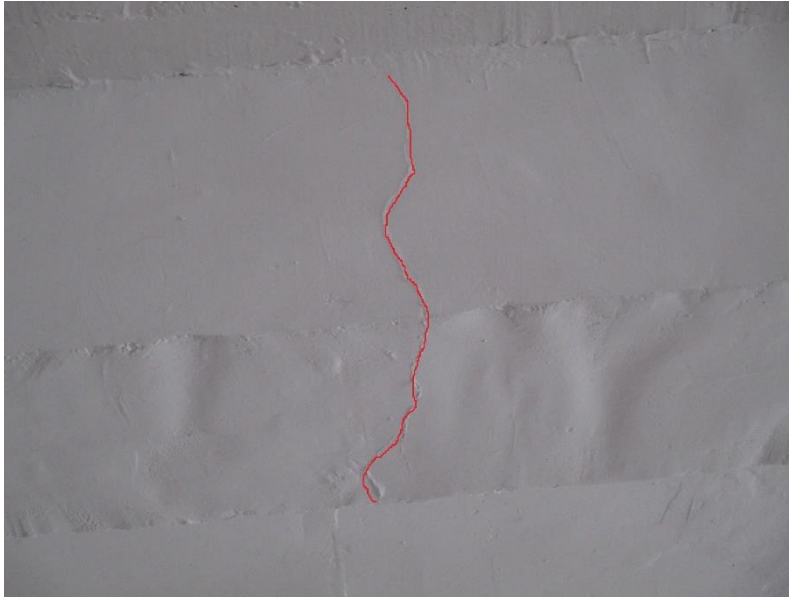
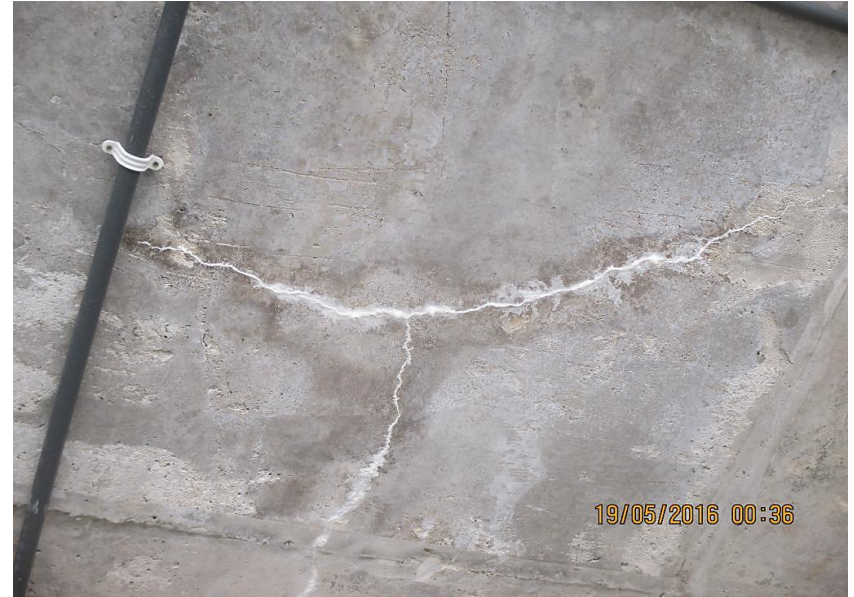
**Crack in 4<sup>th</sup> floor beam, slab and  
sagging in beam**

Cracks observed in 4<sup>th</sup> floor beams and slab over proposed office area. Sign of seepage found in slab.

- Factory Engineer to check the sagging limit of the beam and suggest remedial measure, if necessary
- Factory Engineer to check the cause of crack in beam and slab and suggest repair, if required

- Carry out repair work if needed
- Produce and actively manage a loading plan for all floor plates within the factory giving consideration to floor capacity and column capacity

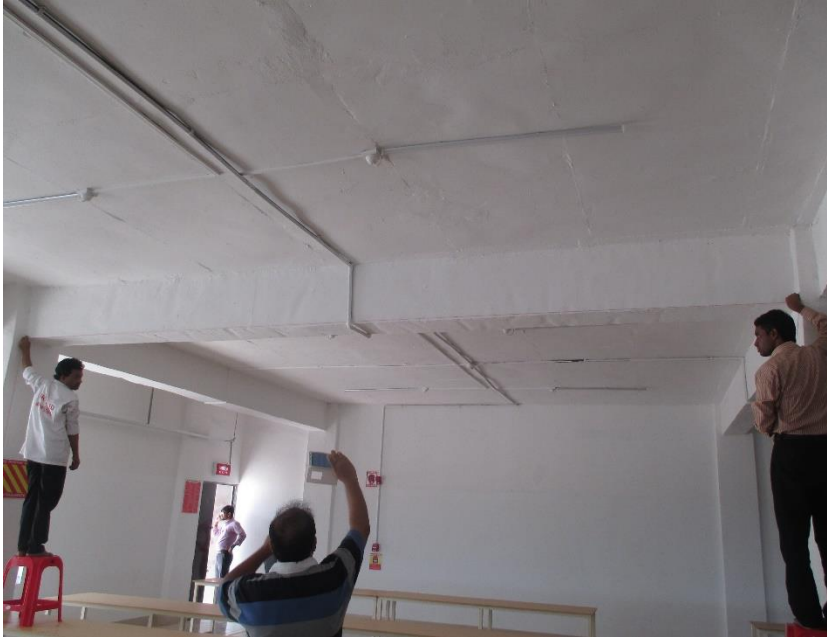
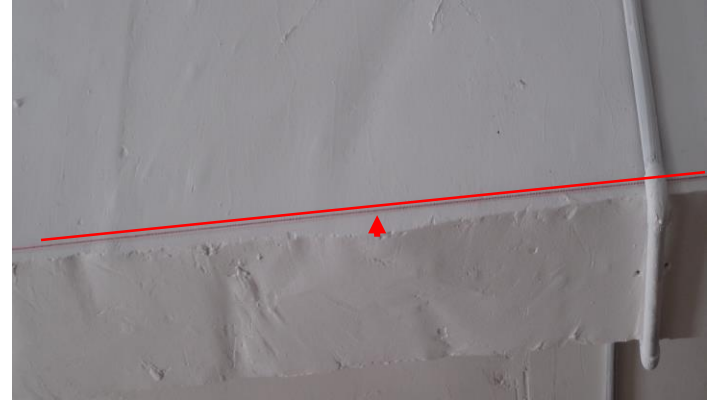
**Crack in 4<sup>th</sup> floor beam, slab and sagging in beam**

Sag found in 4<sup>th</sup> floor beam.
