# Madinaple Fashions Craft Ltd.

Holding #44/1, Ward #7, Chandra, Kaliakoir, Gazipur

05 June, 2016

## Client Summary Report

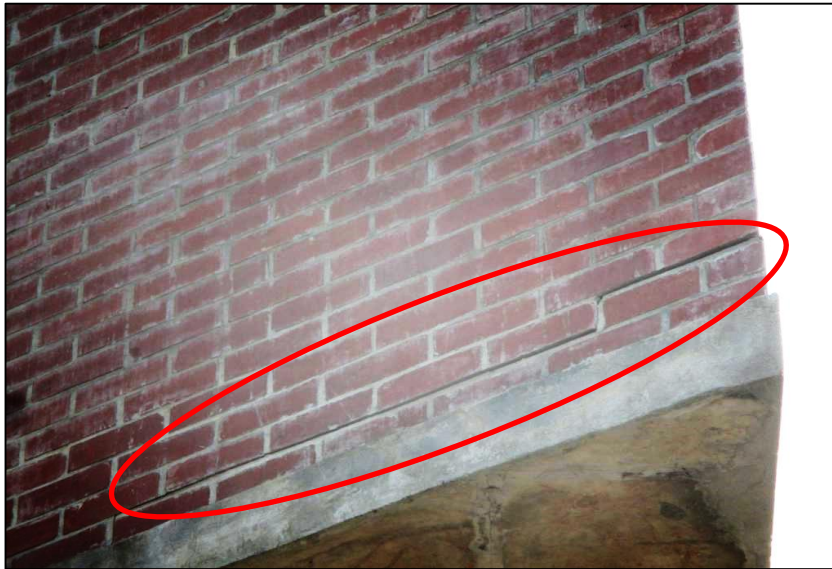
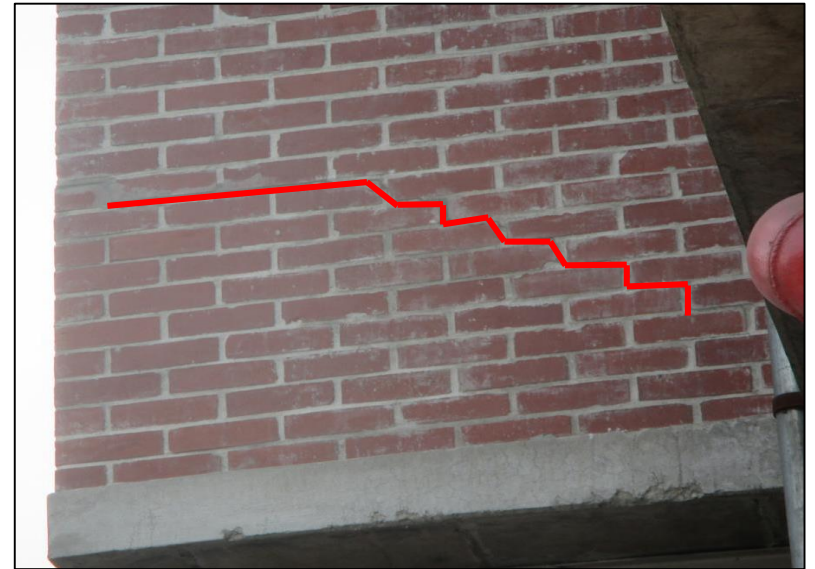
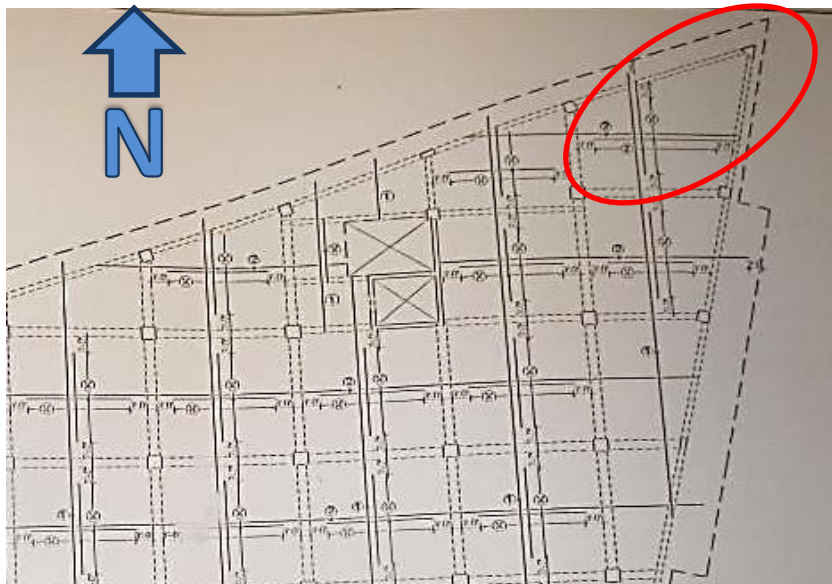
## Crack on North-west facade

Crack found on North-west corner in cantilever façade. Crack may be caused due to deflection in cantilever slab. Factory engineer to check the cause and suggest remedial measure.

- Building engineer to check the cause of cracking and suggest repair, if needed

- Carry out repair work, if needed

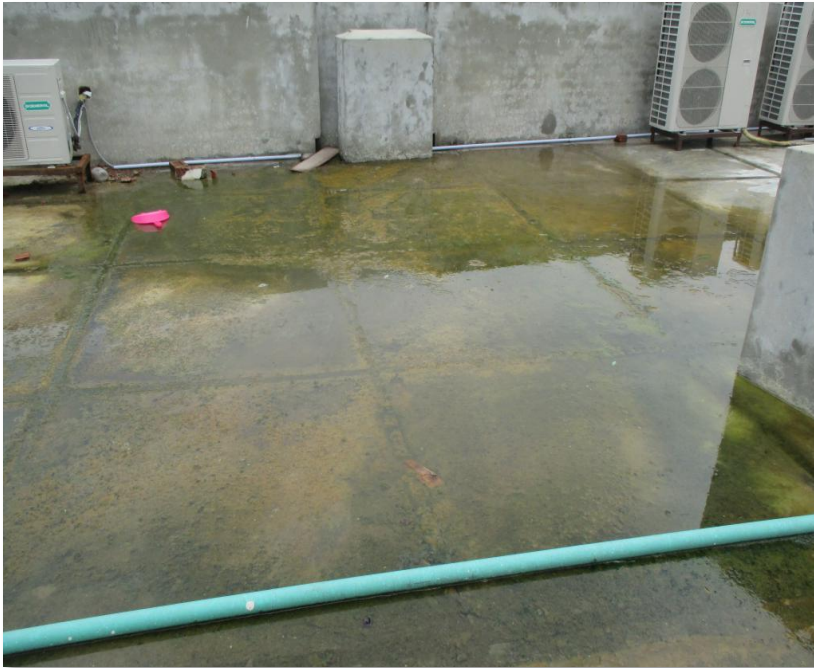
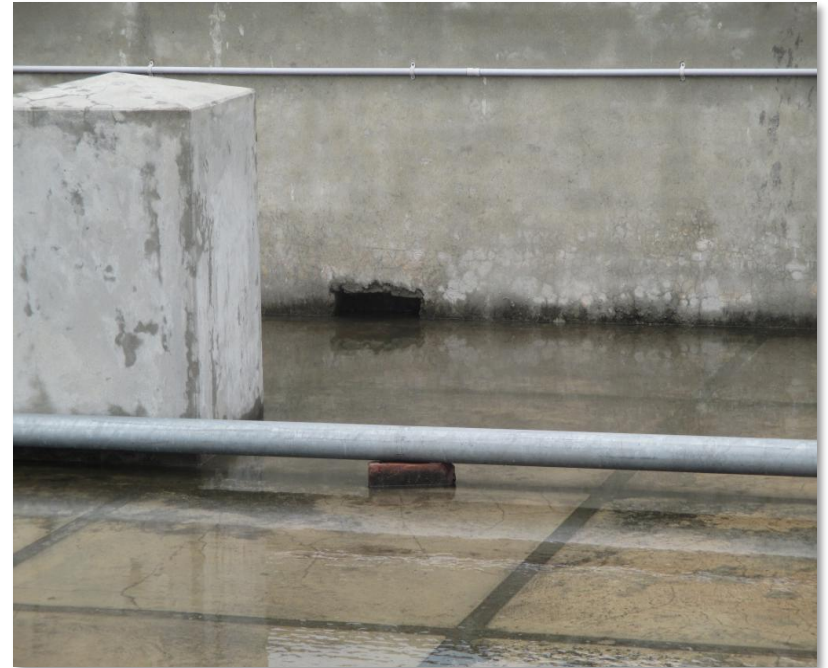
# Water ponding on roof

Water ponding observed on roof which is resulting in algae on roof. Drainage system has to be updated so that water can be drained out easily.

- Update roof drainage system

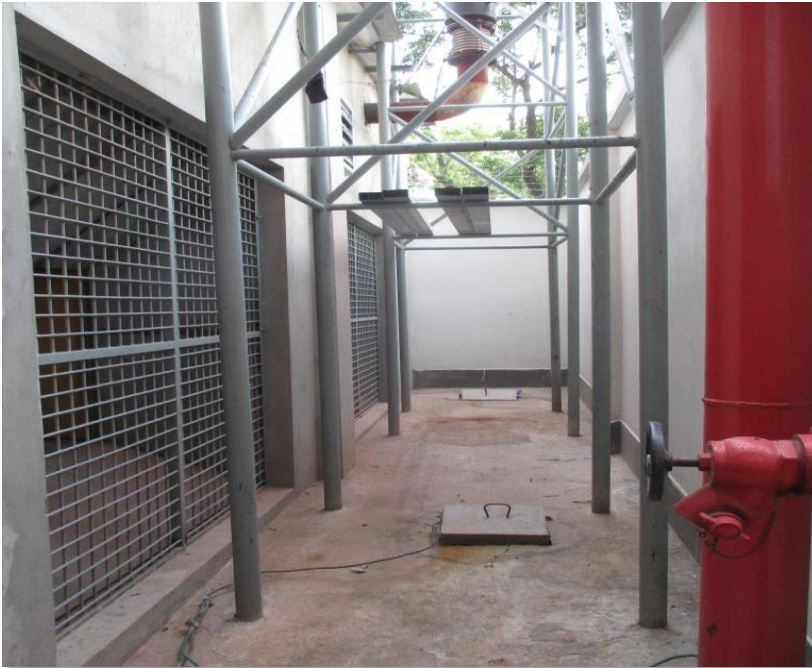
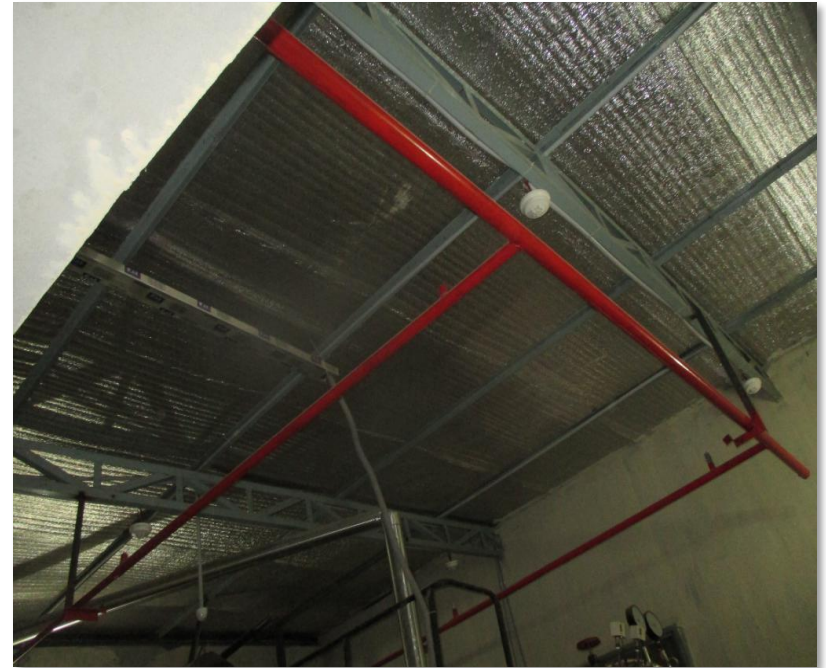
**No documents of Utility building**

No documents provided for Utility building

- Prepare a set of As-built drawing for Utility building
