Probridhi Apparels Ltd

Kawya, Chonnapara, Sreepur, Gazipur
(24.201027, 90.429663)

12 June, 2016

Client Summery Report

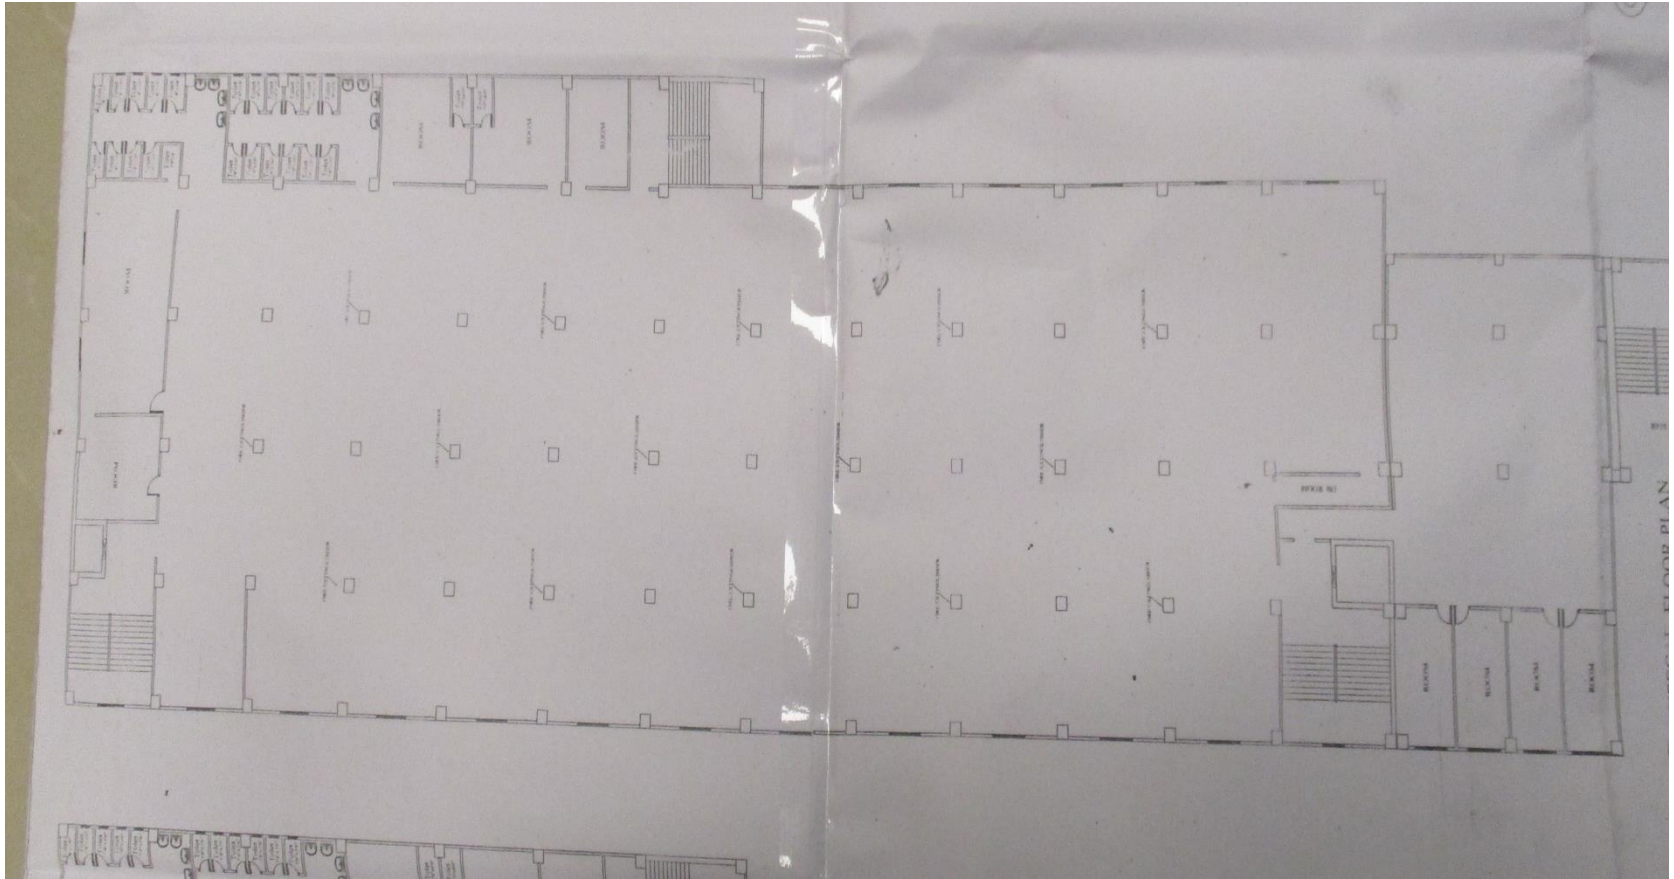
Stability against lateral loading

Main Building is narrow on plan. Lateral stability is primarily provided by moment frames. Lateral stability of the building should be checked to ensure it can withstand design lateral loadings.

- Building engineer to perform stability check for main building against lateral loading

- Implement strengthening measures in the building, if required

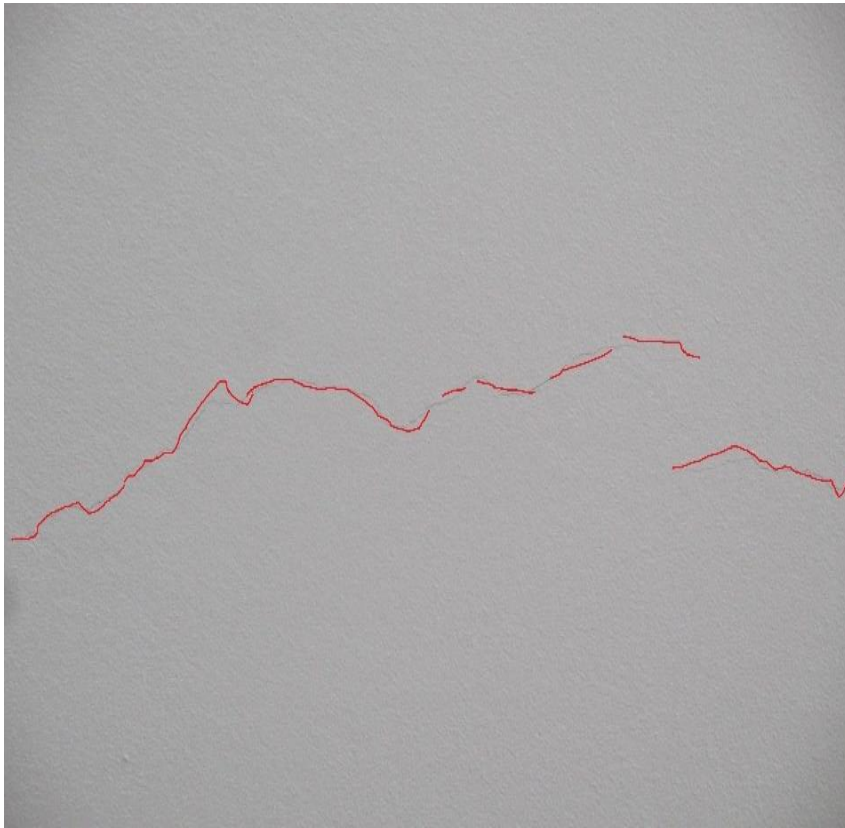
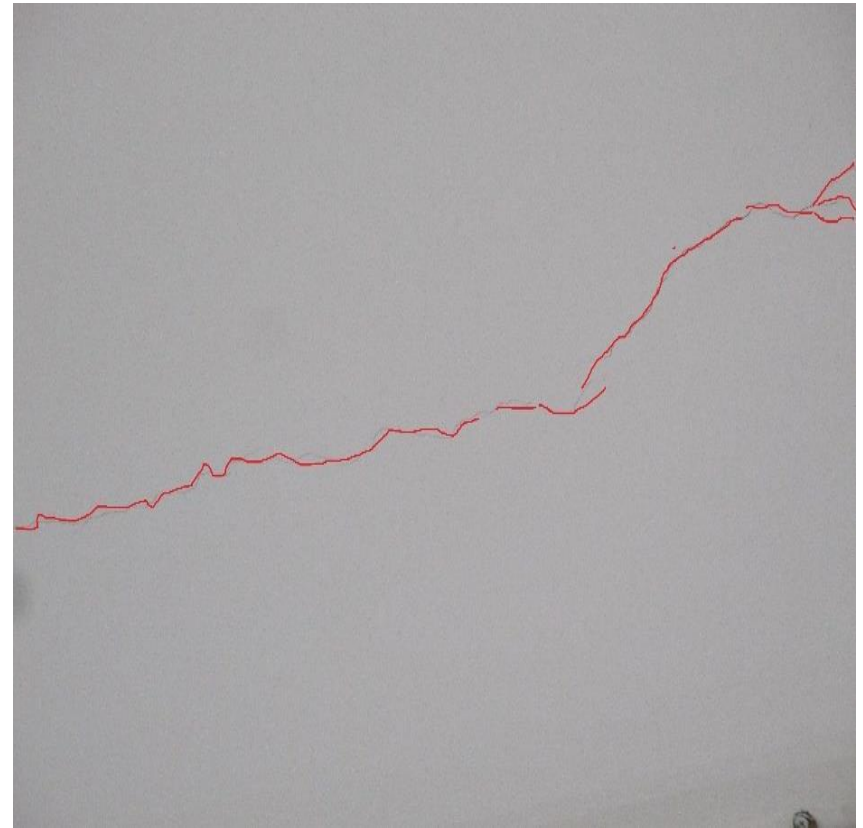
Cracks in slab and beam

Cracks in 4th floor slab soffit

- Factory Engineer to survey and identify the cause of cracking

- Repair the cracks with suitable method, if required
- Produce and actively manage a loading plan for all floor plates within the factory giving consideration to floor capacity and column capacity.

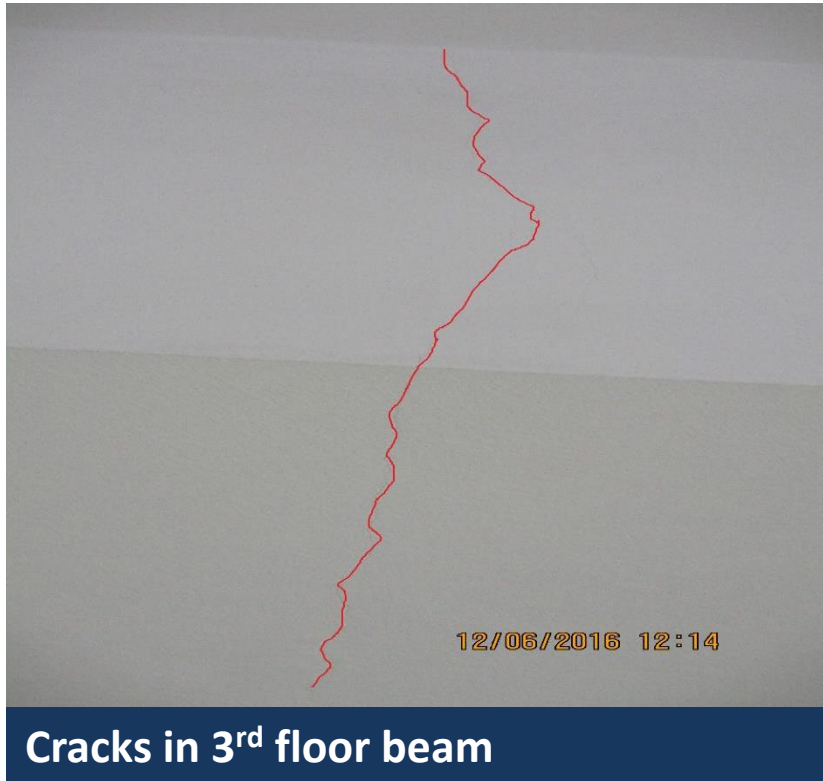
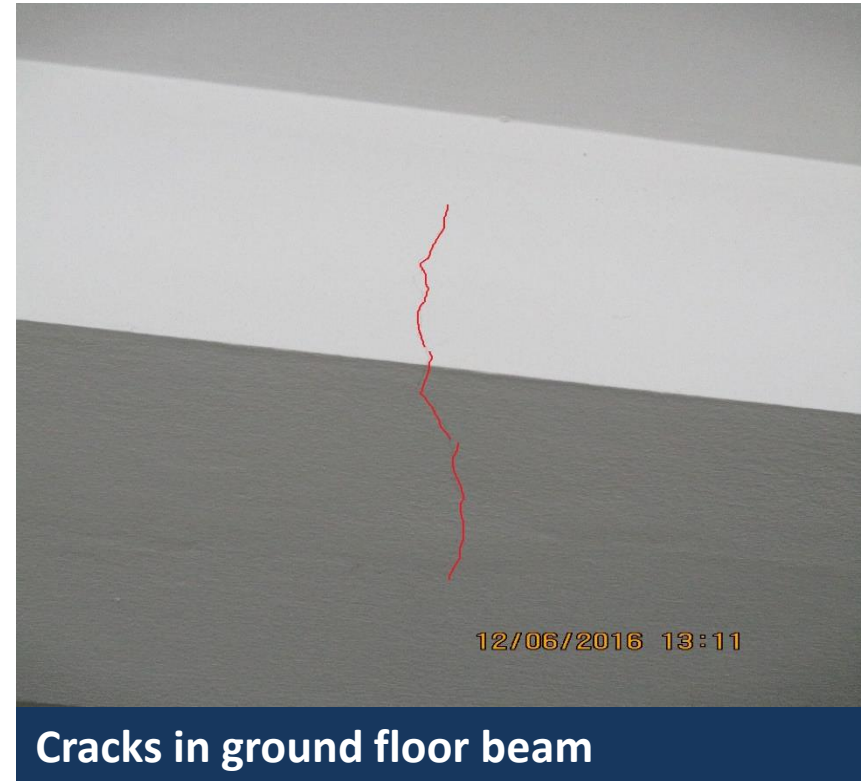
Cracks in slab and beam

Cracks found in beam and slab soffits in part-A. The cause of cracking must be checked if the slab is adequate or not to bear loading from floor.

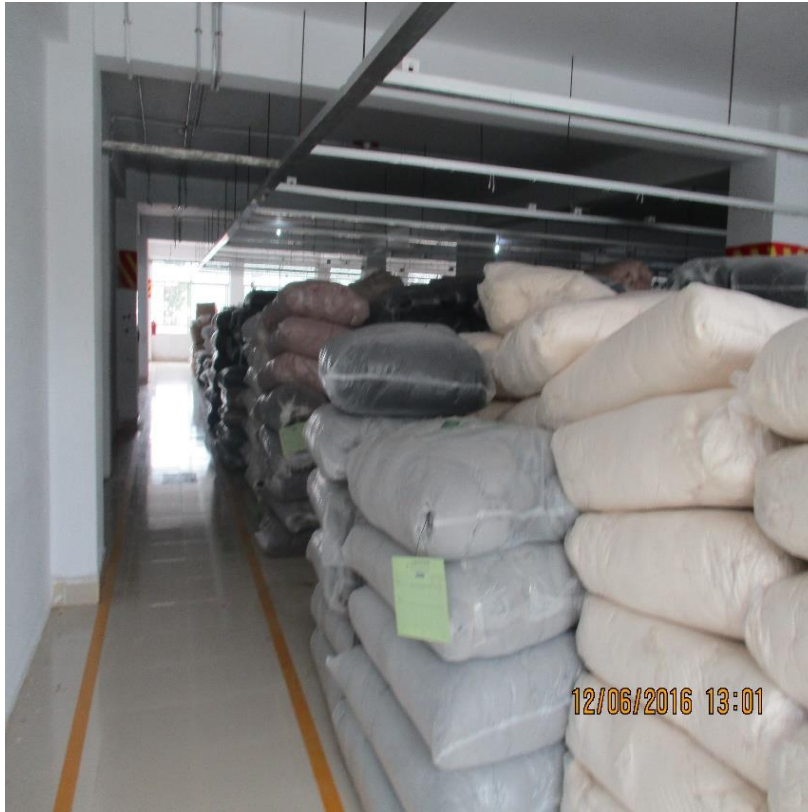
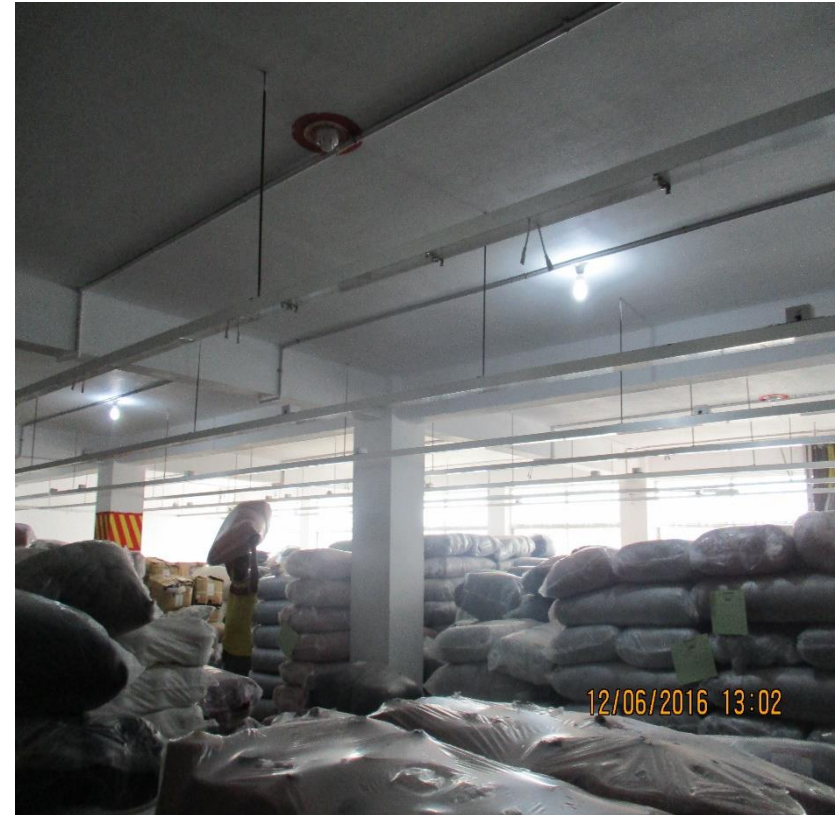
Localized areas of High Loading

We observed loading was more than 2Kpa in Finished Goods area at 3rd floor and Yarn Store at 2nd floor. Factory provided us a copy of certificate which shows load is within allowable limit but this certificate doesn't show design load. Therefore factory engineer to produce load plan for all floors.

- Produce and actively manage a loading plan for all floor plates within the factory giving consideration to floor capacity and column capacity.

- Continue to implement load plan.

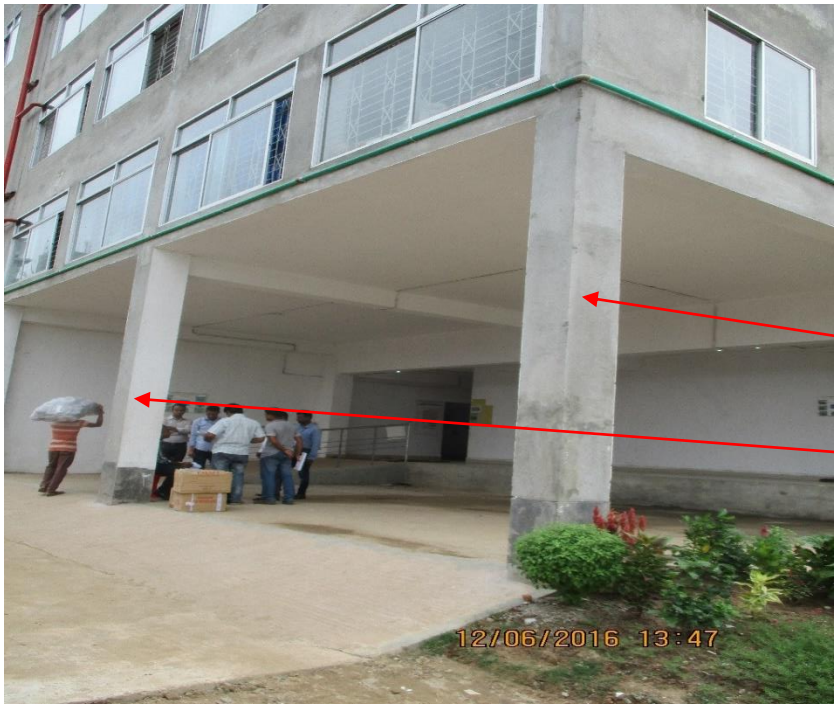
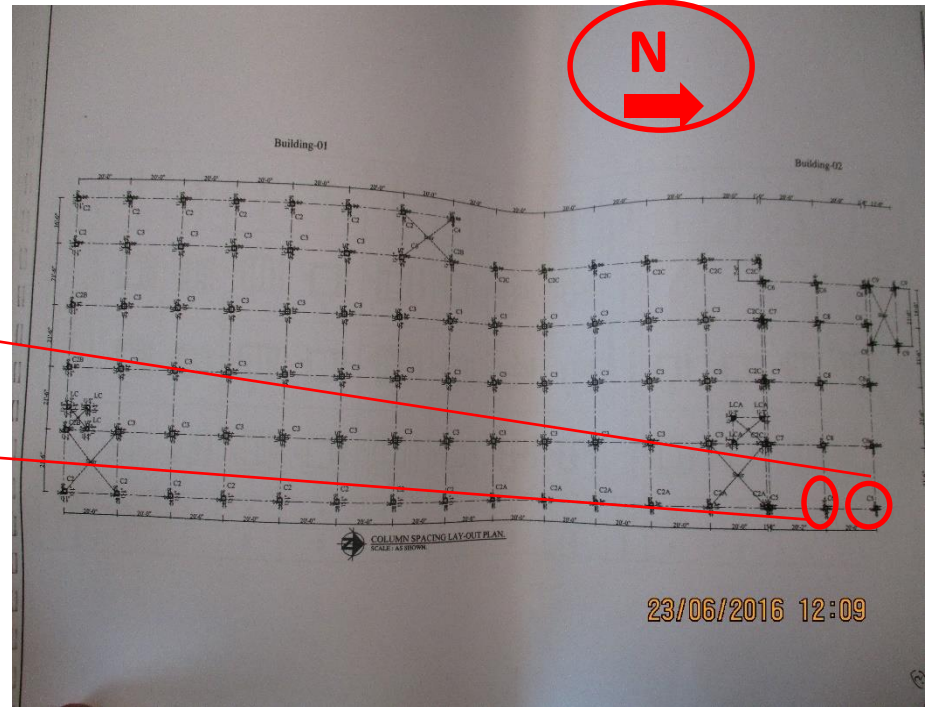
Columns at risk of vehicle impact

Column at ground floor level of part-B are susceptible to impact loading from vehicles. Marked columns (which carry the building above) have no protection against vehicle impact.

- Building engineer to survey and install protection against vehicle impact loading

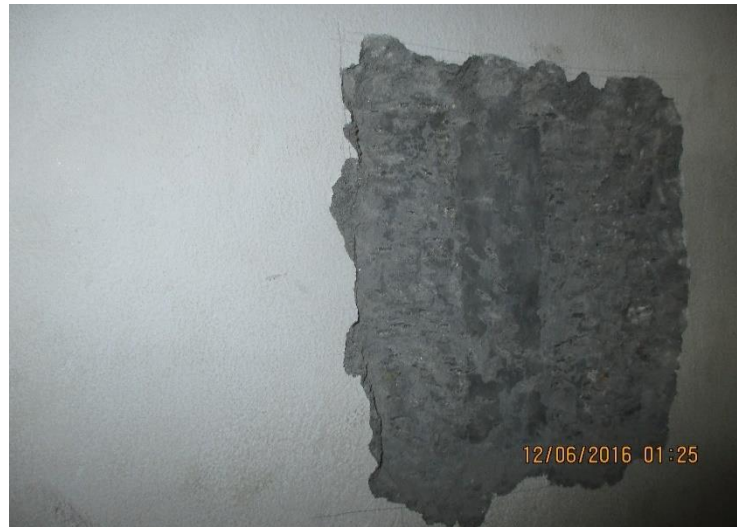
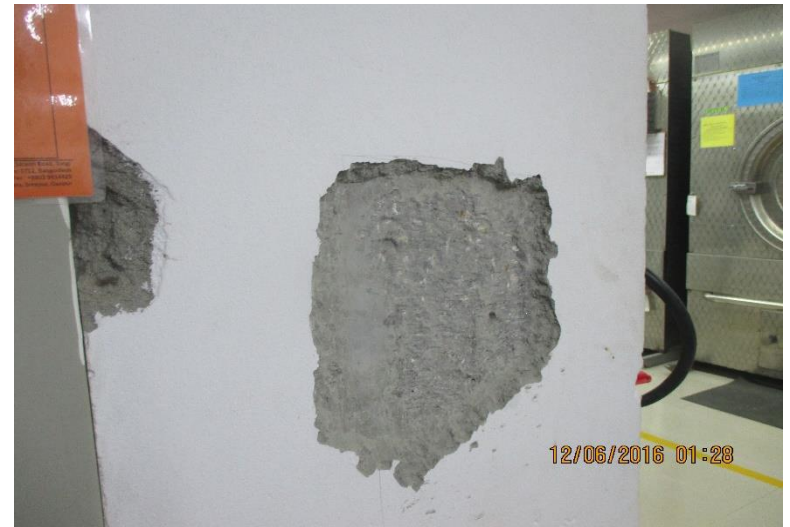
Aggregate type checking for Main building

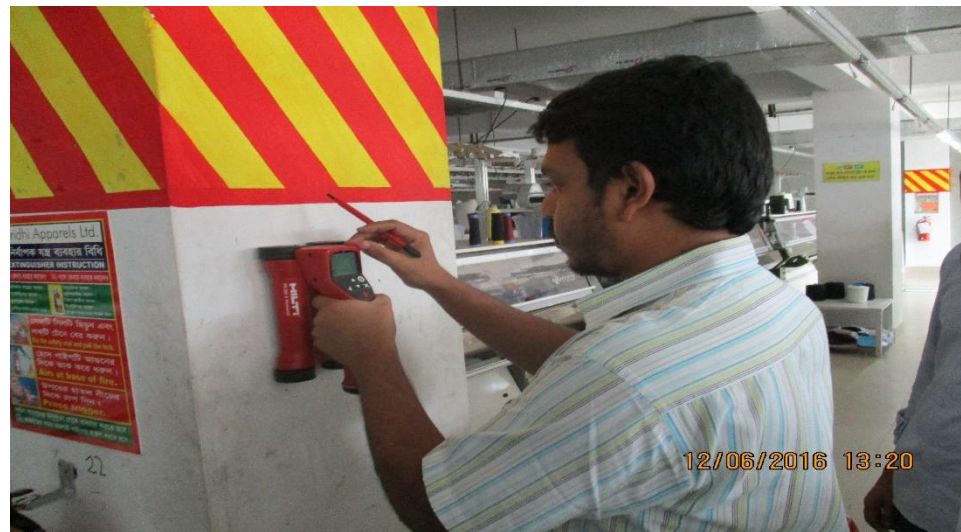
Column rebar checking
