FIRE SAFETY INSPECTION REPORT

**HARRY FASHION LTD.
VORDOBA, VALUKA**

ACCORD
on Fire and Building Safety in Bangladesh

June 28, 2014

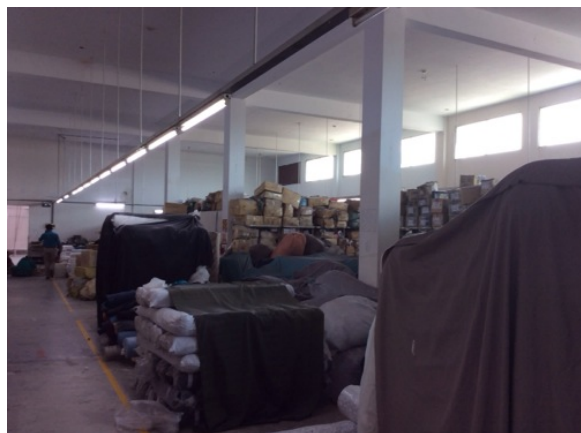
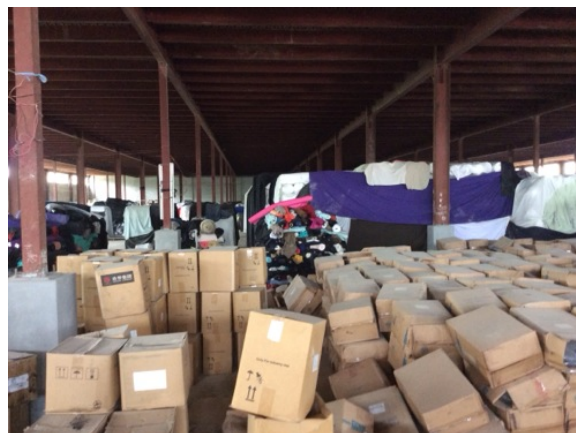
No.	Category	Finding	Recommendation	Remediation Timeframe
F-1	Fire Rated Construction	The dedicated storage areas on the ground floor was not separated from the adjacent working areas by means of fire rated construction (non-rated door).	Provide dedicated storage rooms separated by minimum 1-hr fire-rated construction.	Within 3 months

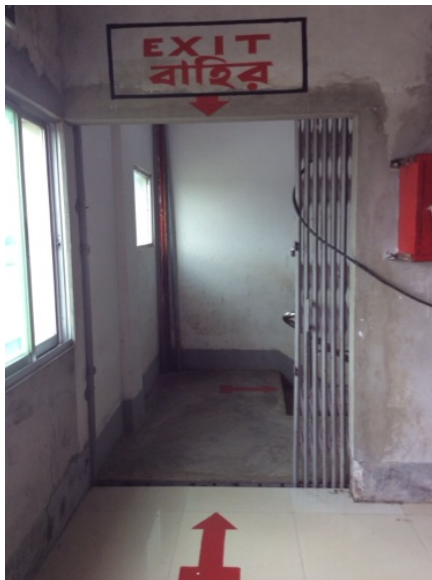
F-2	Fire Rated Construction	Exit stairs on all floors were not separated from work areas by fire-rated construction.	Provide minimum 1.5-hr fire rated doors and seal all unprotected openings to separate the exit stairs from work areas and other building spaces on all floor levels. Ensure that the fire doors are self-closing and positive latching and that they are provided with fire exit (panic) hardware where serving production floors.	Within 3 months
-----	-------------------------	--	--	-----------------

If fire doors are required to be held open for functional reasons, provide automatic-closing devices tied to the fire alarm system.

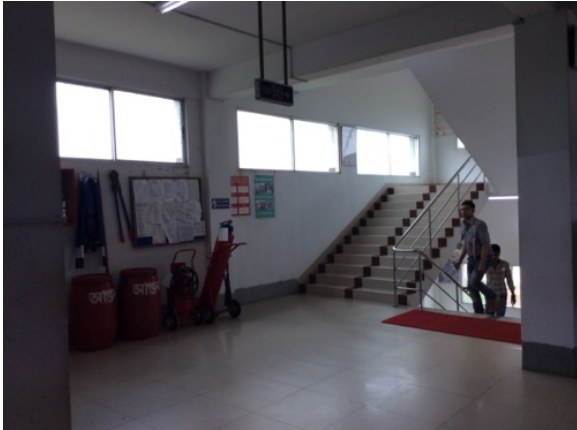
F-3	Fire Rated Construction	Unsealed penetrations and openings were observed in the western and eastern exit stairwells on all floors.	Seal all penetrations and openings in exit stair enclosure walls to maintain the fire separation.	Within 3 months
-----	-------------------------	--	---	-----------------

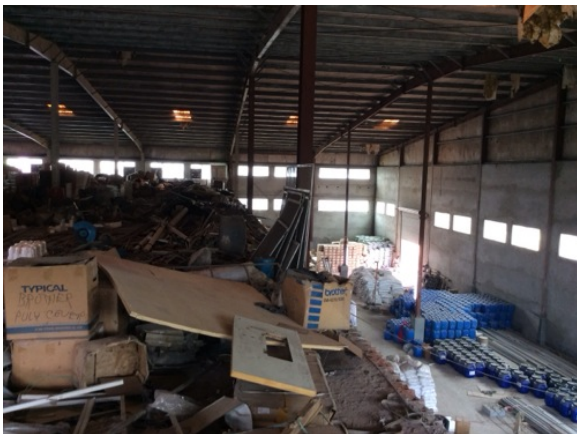
F-4	Fire Rated Construction	Unsealed penetrations and openings are located in the fire-rated floor/ceiling assemblies on the 1st floor.	Seal all penetrations and openings in floor/ceiling assemblies to maintain the fire separation.	Within 3 months
-----	-------------------------	---	---	-----------------

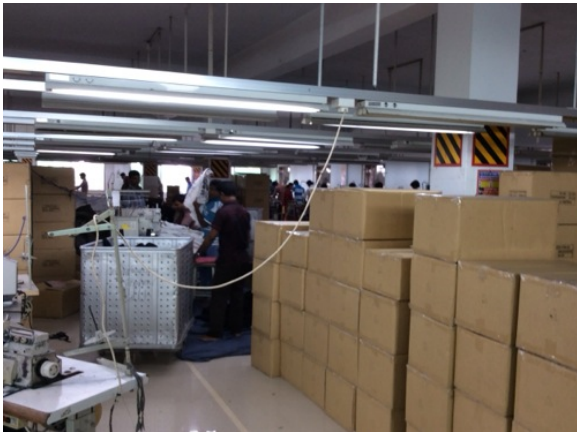
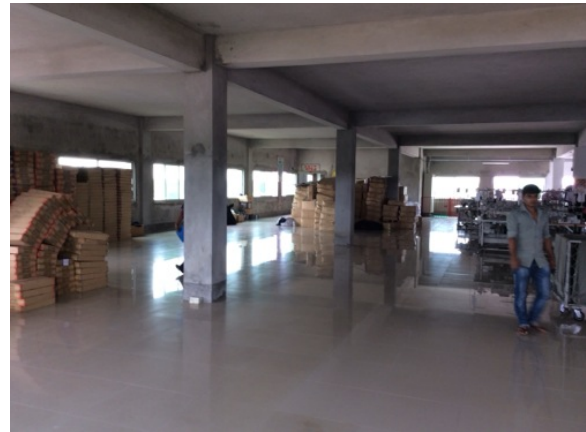
F-5	Fire Rated Construction	Transient storage areas on the 1st, 2nd and 3rd floors were not separated from the adjacent working areas by means of fire rated construction.	<p>Provide dedicated storage rooms separated by minimum 1-hr fire-rated construction.</p> <p>Where separate storage rooms are not feasible, provide defined storage areas and limit the storage arrangement as follows:</p> <ul style="list-style-type: none">- Maximum height of 2.4m and maximum area of 23m²- If sprinkler protected: maximum height of 3.66m and maximum area of 93m² <p>Separate areas of unenclosed combustible storage by a minimum clear distance of 3m.</p>	Within 3 months
-----	-------------------------	--	---	-----------------

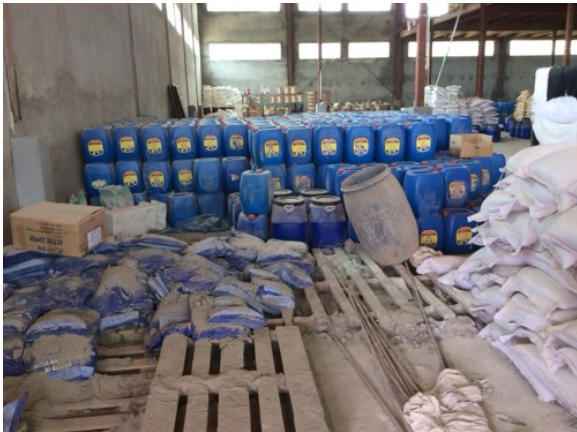
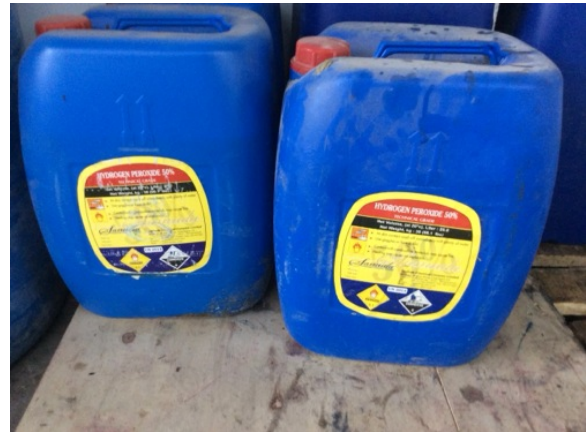
F-6	Fire Rated Construction	Hazardous materials storage area on the ground floor is not separated by fire-rated construction (openings, non-rated doors, penetrations).	Separate the hazardous materials / flammable liquid storage room by a minimum 2-hr fire-rated construction. Seal and/or protected all openings to maintain the required fire separations.	Within 3 months
-----	-------------------------	---	---	-----------------

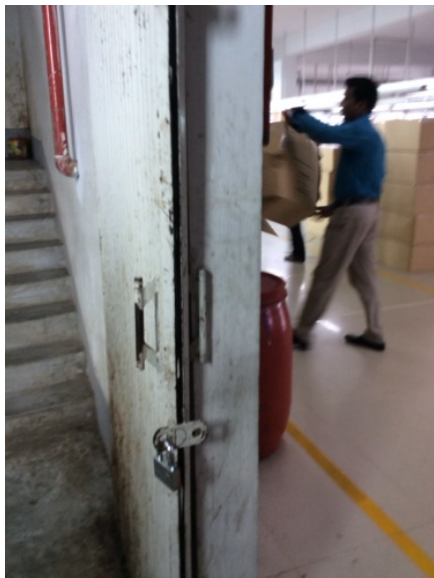
F-7	Egress	Egress doors and gates with locking features are provided at all exit stairs, building exits, along egress routes and exit discharges.	Remove locking features from all egress doors / gates. If locks are required for security reasons, utilize special door locking features complying with NFPA 101.	Immediate
-----	--------	--	--	-----------

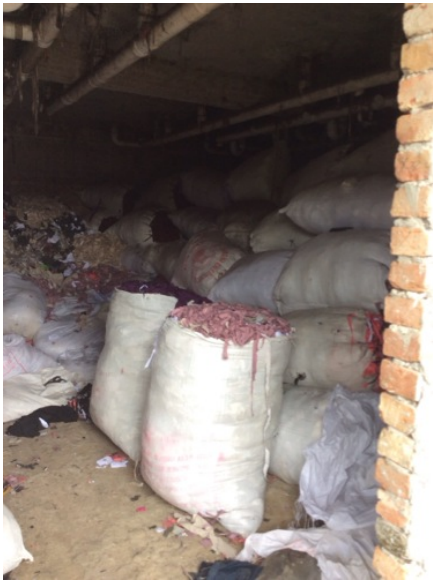
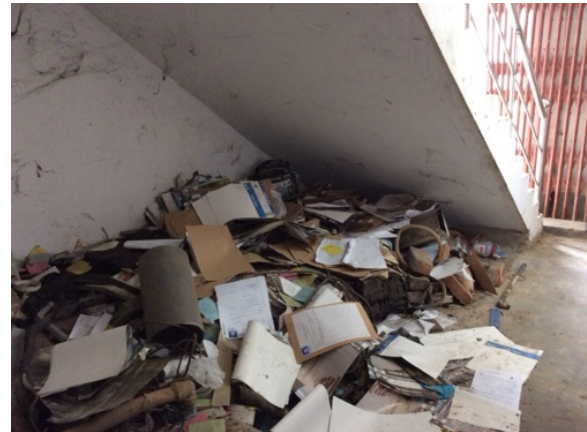
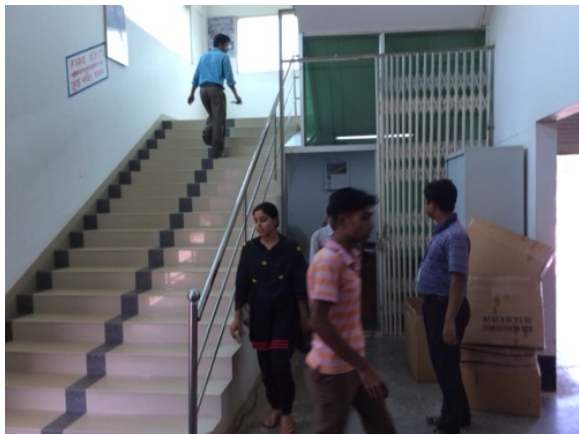
F-8	Egress	Storage was located inside all the exit stair enclosures on the ground floor.	Remove all storage from exit stairs and egress paths.	Immediate
-----	--------	---	---	-----------

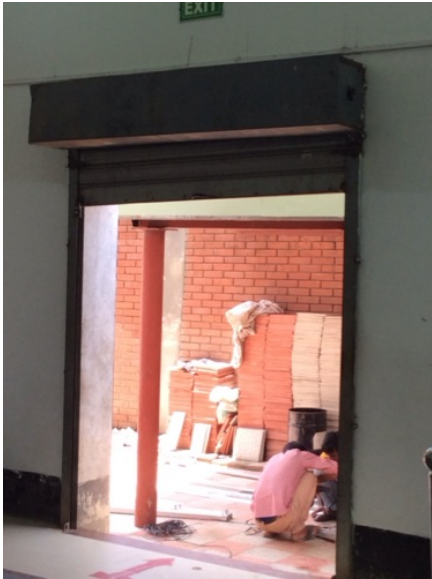
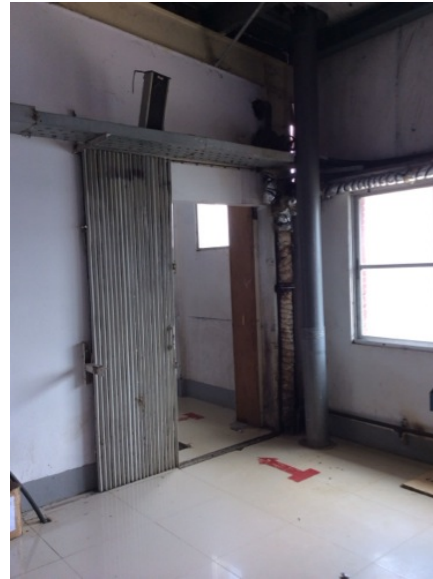
F-10	Egress	The exit capacity of the 1st, 2nd, 3rd and 4th floors (540, 387) is insufficient for the maximum occupant loads (1410, 520, 1000).	Reduce occupant load to not more than available exit capacity (540, 387). Or Provide additional exits.	Immediate
F-11	Egress	Collapsible gates / sliding doors are provided at all building exits, exit stairs, along egress routes and exit discharges.	Replace all gates / sliding doors along the means of egress with side-hinged, swinging egress doors. If locks are required for security reasons, utilize special door locking features complying with NFPA 101.	Within 1 month

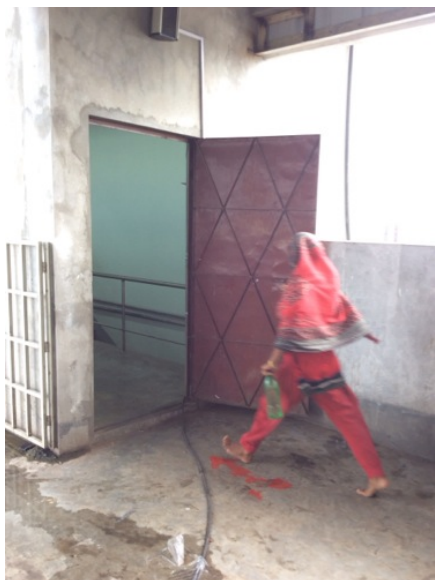
F-12	Egress	The northern exit stair door on the 4th floor did not swing in the direction of egress travel.	Modify the egress door to swing in the direction of egress travel.	Within 3 months
------	--------	--	--	-----------------

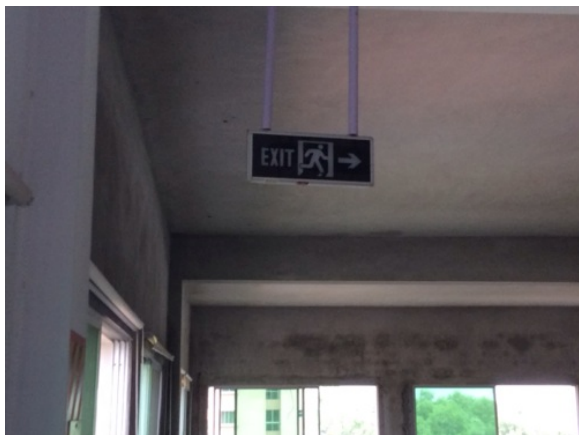
F-16	Fire Protection	Inspection, testing, and maintenance for the fire alarm system were not in accordance with NFPA 72.	Inspect, test and maintain the fire alarm system, and keep written records on-site, in accordance with NFPA 72.	Within 3 months
F-17	Fire Protection	The building is equipped with single-station smoke alarms. Smoke alarm activation sounds only a local alarm and does not provide automatic fire alarm notification of occupants.	Remove single-station smoke alarms. Provide automatic smoke detection throughout the building, tied into the fire alarm system, in accordance with NFPA 72.	Within 6 months
F-18	Egress Lighting	Exit signage were found to be not illuminated (burned out, broken, etc.) on the 3rd floor.	Regularly inspect all exit signage and replace/install lights as needed to illuminate signs.	Within 1 month

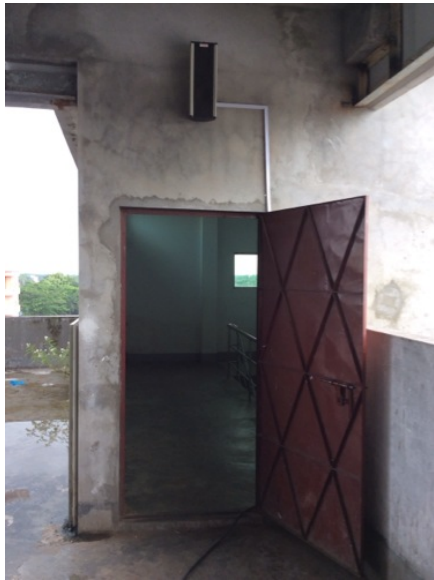
F-19	Egress Lighting	Exit signs were not provided at exits on the 4th floor.	Provide exit signs above all exits to the exterior and all doors to the exit stairs.	Within 1 month
------	-----------------	---	--	----------------
