Shad Fashion Limited

Gorat, Ashulia, Savar, Dhaka
(23.9444492, 90.303822)
18 May, 2016

Client Summary Report

Observations & Actions

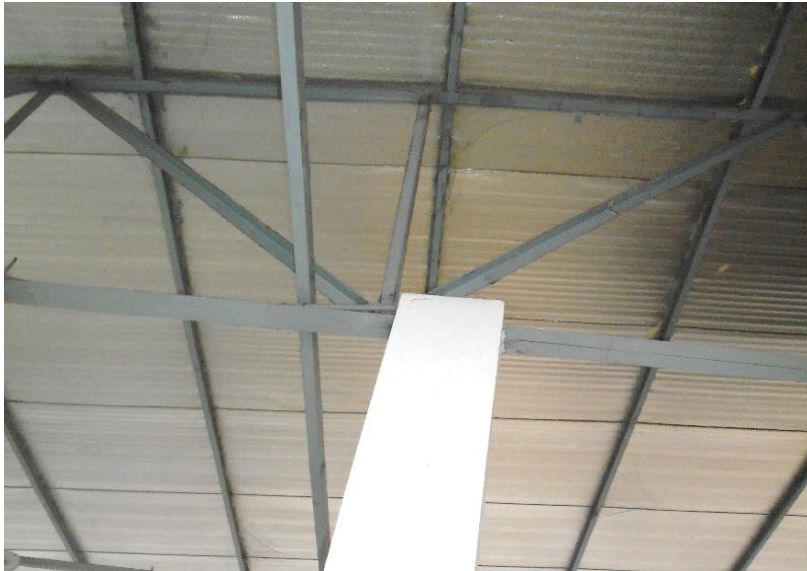
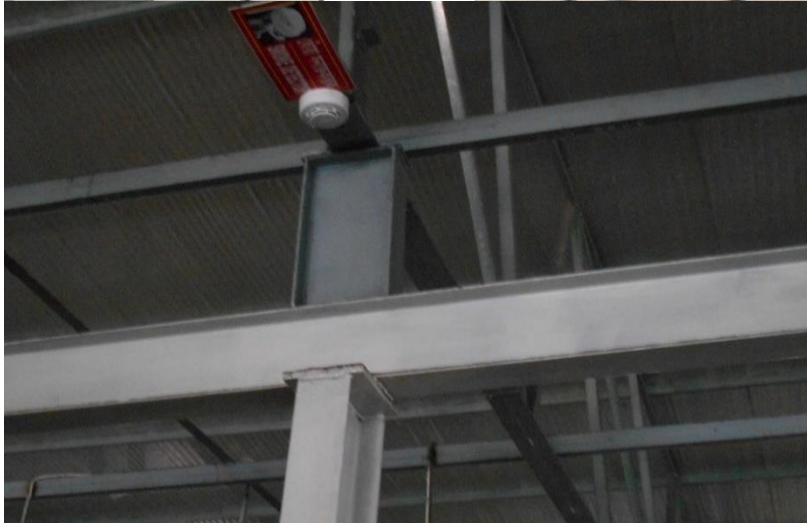
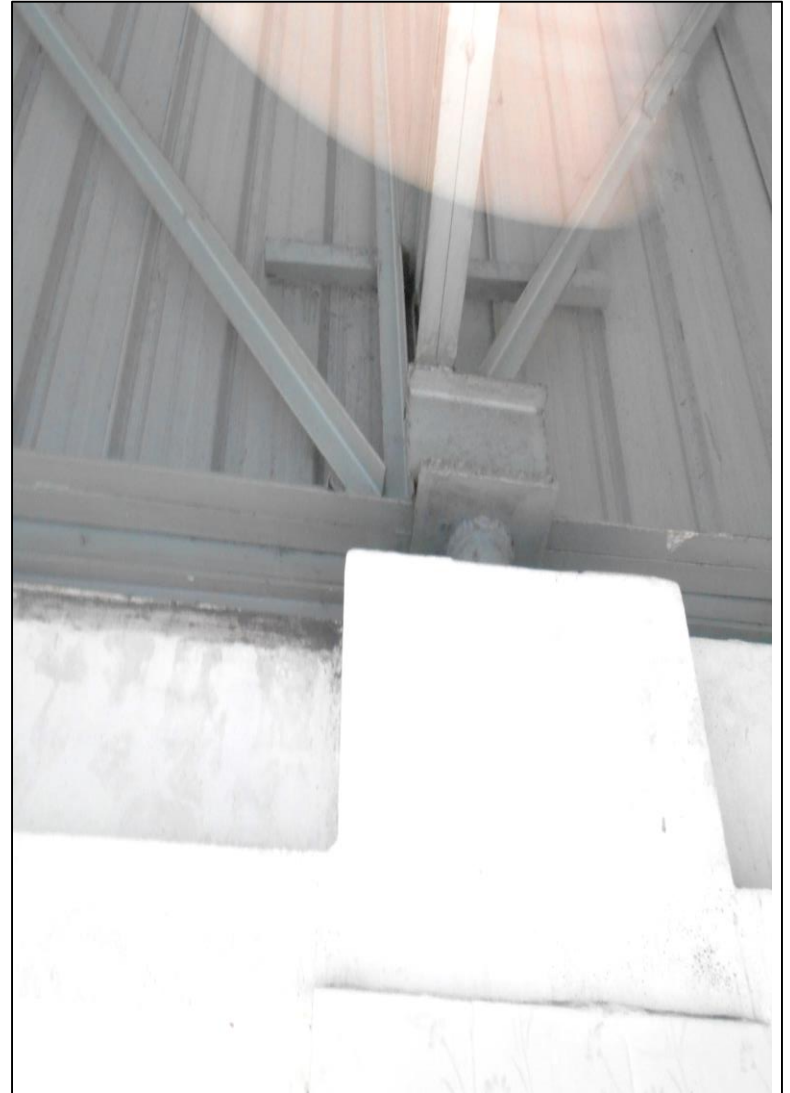
No obvious stability system to Main production Sheds

Lack of engineered connection details between steelwork & concrete structure/ brick wall

Item No.	Observation	Recommended action plan	Recommended timeline
1	No obvious stability system of Main Production Sheds	Carry out design check on the main production sheds to analyze that it is stable under code vertical & lateral loading	6 - Week
2	No obvious stability system of Main Production Sheds	Produce and actively manage a loading plan for all the mezzanine floors within the main shed giving consideration to floor capacity and column capacity	6 - Week
3	No obvious stability system of Main Production Sheds	Continue to implement load plan	6 - Month
4	No obvious stability system of Main Production Sheds	Carry out necessary strengthening work if required after analysis	6 - Month

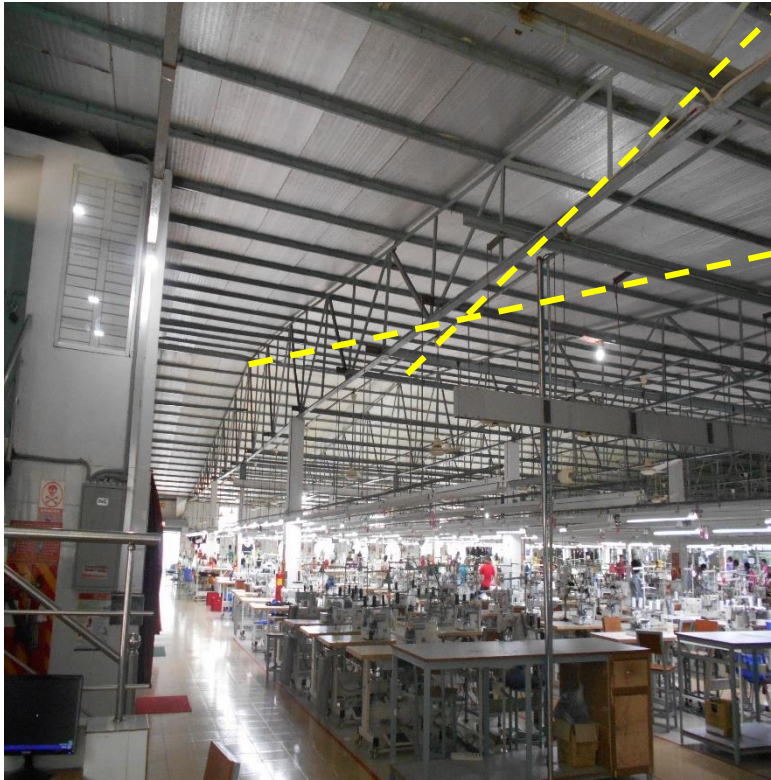
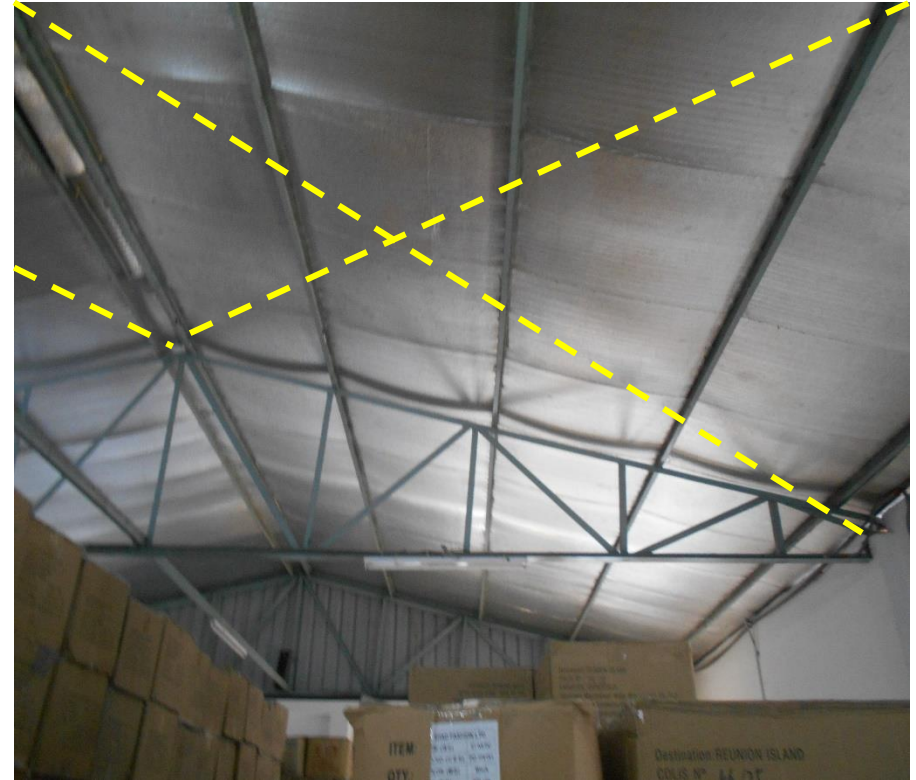
No lateral bracing system

Lateral bracing has been omitted from the shed structure. We require that the necessity of bracing system and section adequacy of structural components must be verified by the Building Engineer and upgraded as necessary to ensure adequacy for code vertical and lateral loads.

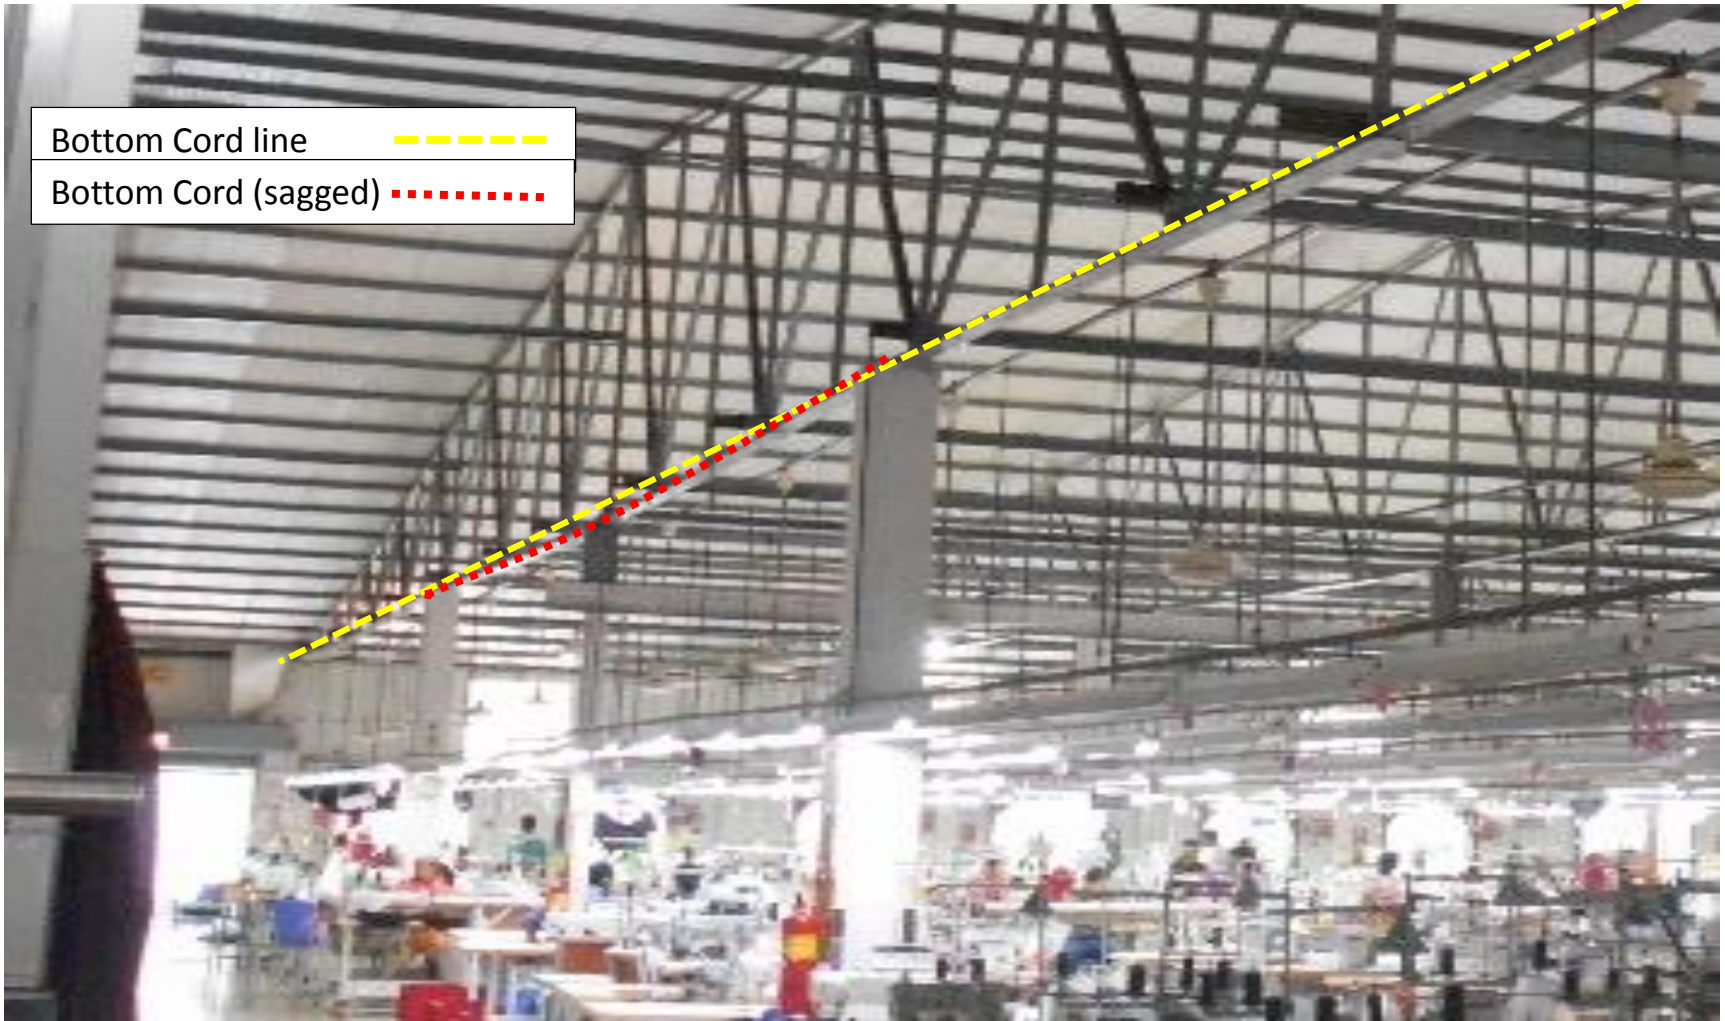
Prominent sign of previous sagging of Main
Production Shed

Bottom Cord line	— — — — —
Bottom Cord (sagged)	• • • • •

Prominent sign of previous sagging

Item No.	Observation	Recommended action plan	Recommended timeline
5	Prominent sign of previous sagging of Main production Shed	Carry out sagging limit check for the trusses.	6 - Week
6	Prominent sign of previous sagging of Main production Shed	Carry out necessary strengthening work if required after analysis	6 - Month
7	Inconsistencies of drawings and As-built construction	Building Engineer to produce a set of As built drawings incorporating actual condition of all the structures in factory premises	6 - Week
8	Lack of engineered connection in Office Building	Building engineer to check the stability of office building & the adequacy of beam-column connection considering code vertical and lateral load	6 - Week

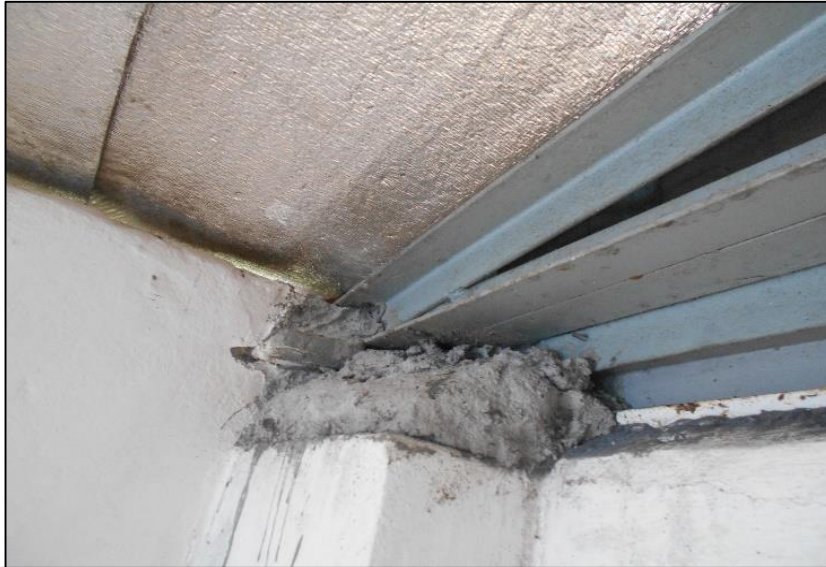
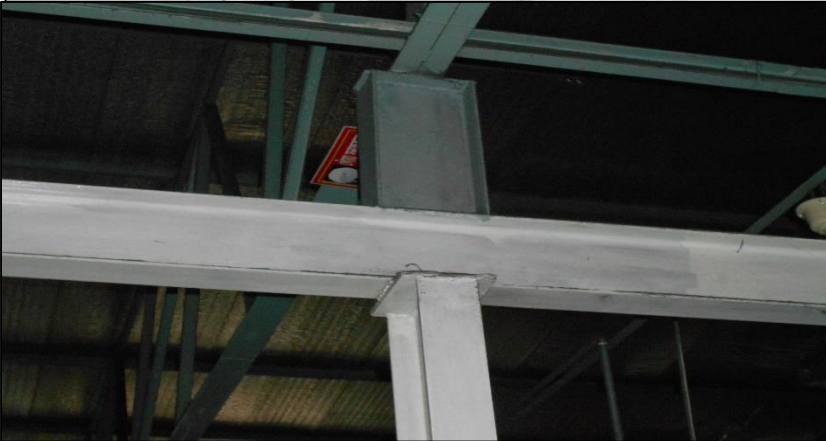
Main Shed: No connection details were shown in as-built drawings.

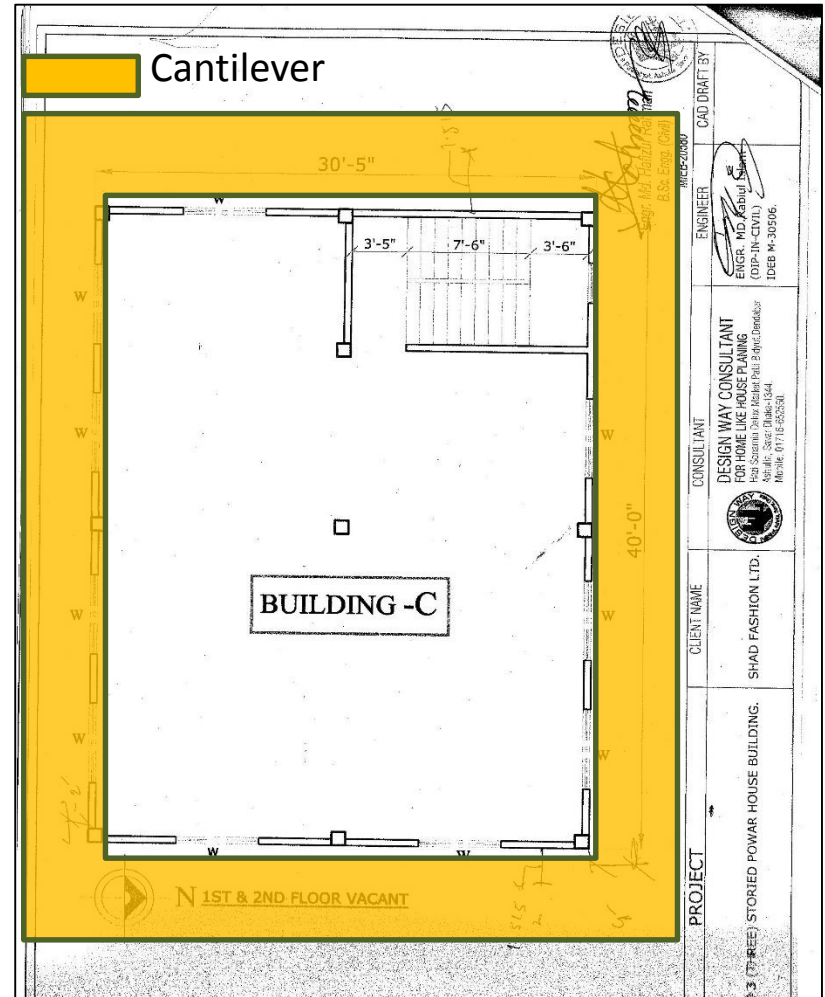
Utility Building: Cantilever on four sides of the building was not shown.

Discrepancies in As-built Drawing

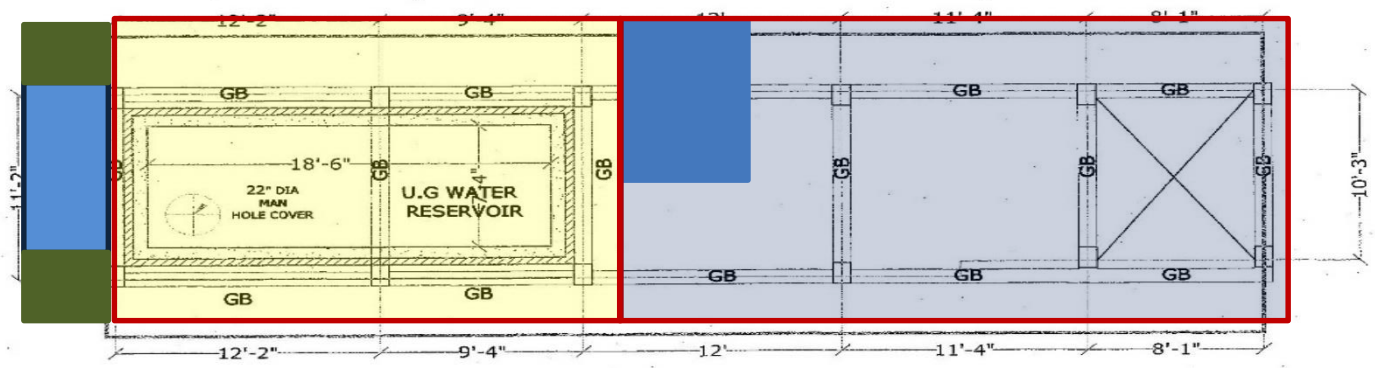
N GRADE BEAM LAY-OUT PLAN

Not Constructed Steel Stair Cantilever Constructed Portion

Sample Section: Two steel stair at north-west and south of the building, no drawing found.

Discrepancies in As-built Drawing

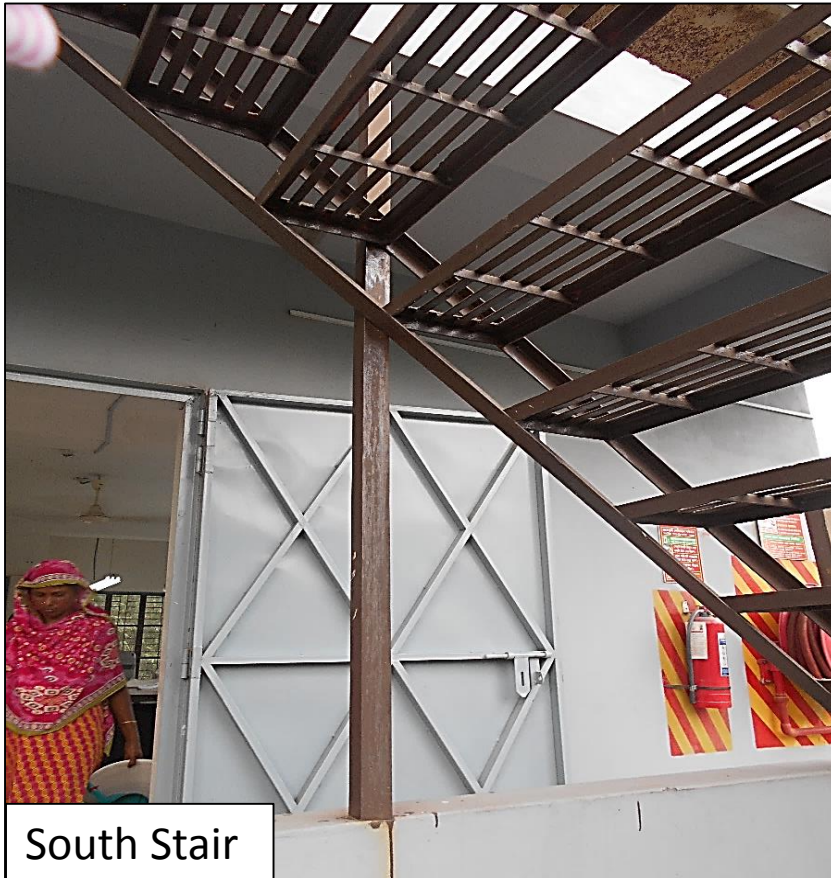
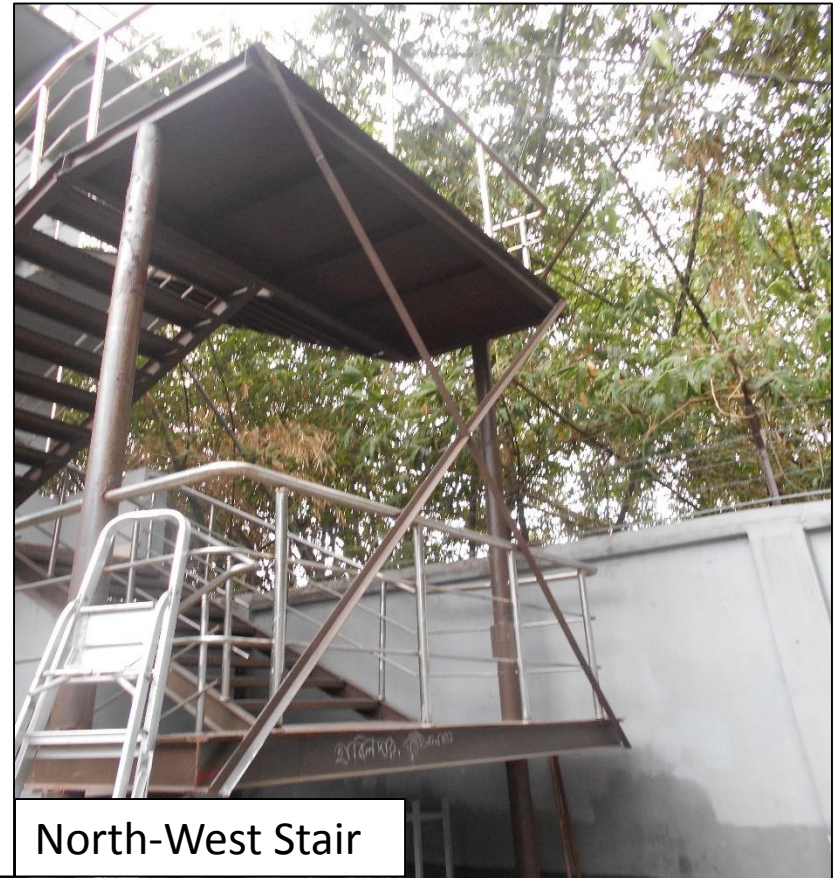
Apparently non-engineered external steel stairs

The steel stairs of Sample Section building are apparently non-engineered & poorly constructed

Item No.	Observation	Recommended action plan	Recommended timeline
13	Apparently non-engineered external steel stairs in Sample Section Building	Building engineer to check the design adequacy of steel stairs considering code vertical and lateral load	6 - Week
14	Apparently non-engineered external steel stairs in Sample Section Building	Carry out necessary remedial action if required after analysis	6 - Month
15	Apparently non-engineered external steel stairs in Sample Section Building	Produce and actively manage a loading plan for all the floors within the sample section building giving consideration to floor capacity and column capacity	6 - Month

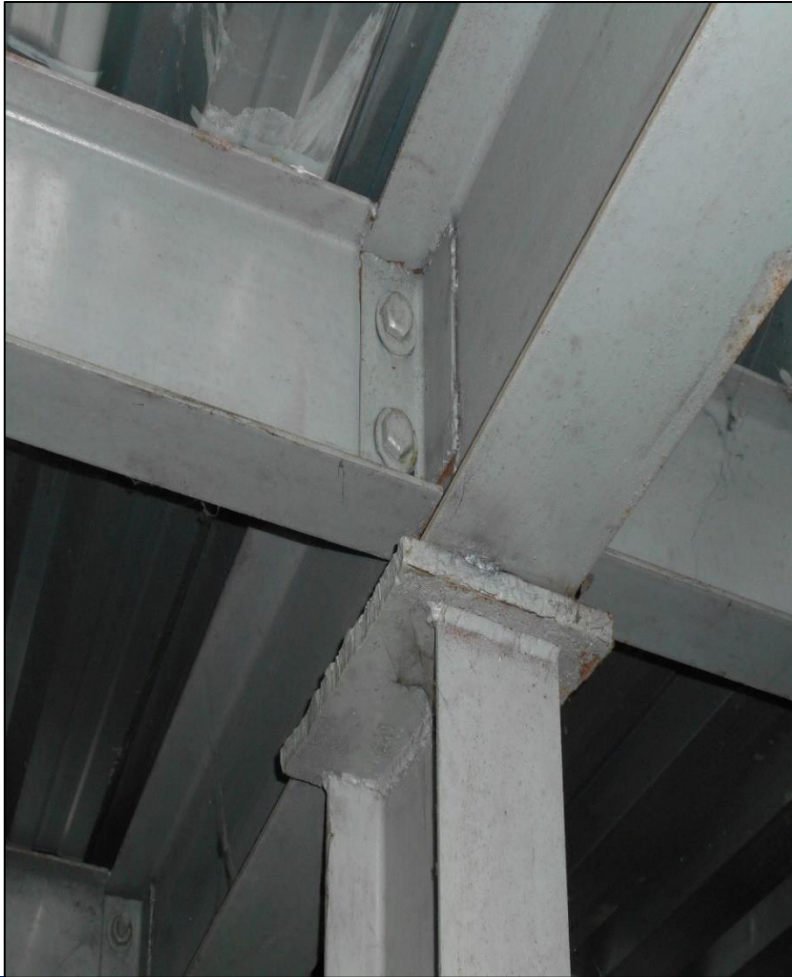
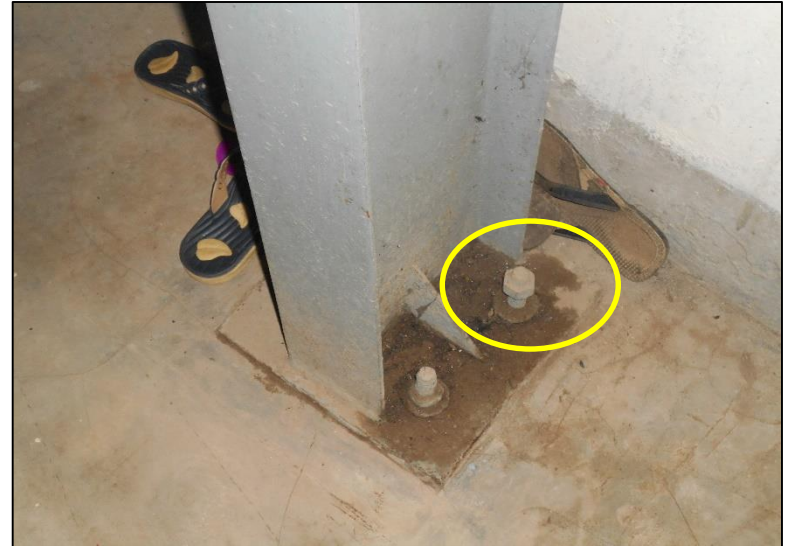
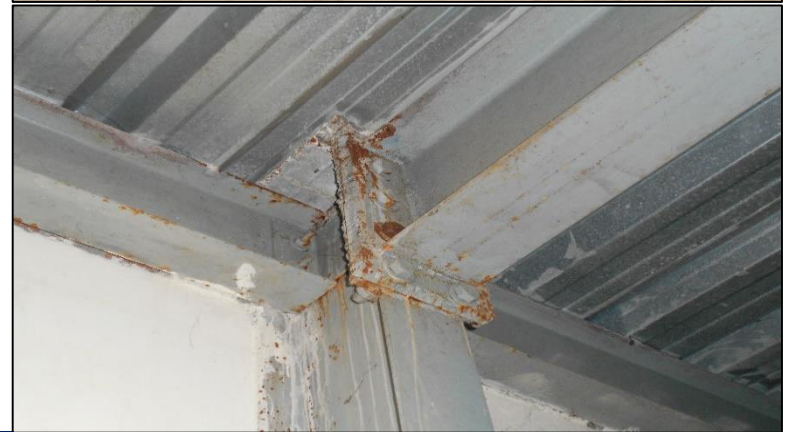
Office building

Lack of engineered connection in Office Building

Lack of engineered connection between columns & beams
and loose bolts at column base

Item No.	Observation	Recommended action plan	Recommended timeline
9	Lack of engineered connection in Office Building	Building engineer to check the minimum edge distance of connection bolts	6 - Week
10	Lack of engineered connection in Office Building	Carry out necessary remedial action if required after analysis	6 - Month
11	Lack of engineered connection in Office Building	Produce and actively manage a loading plan for all the floors within the office building giving consideration to floor capacity and column capacity	6 - Month
12	Apparently non-engineered external steel stairs in Sample Section Building	Building engineer to produce As-built drawings	6 - Week

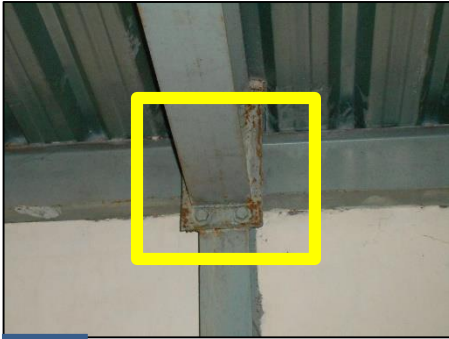
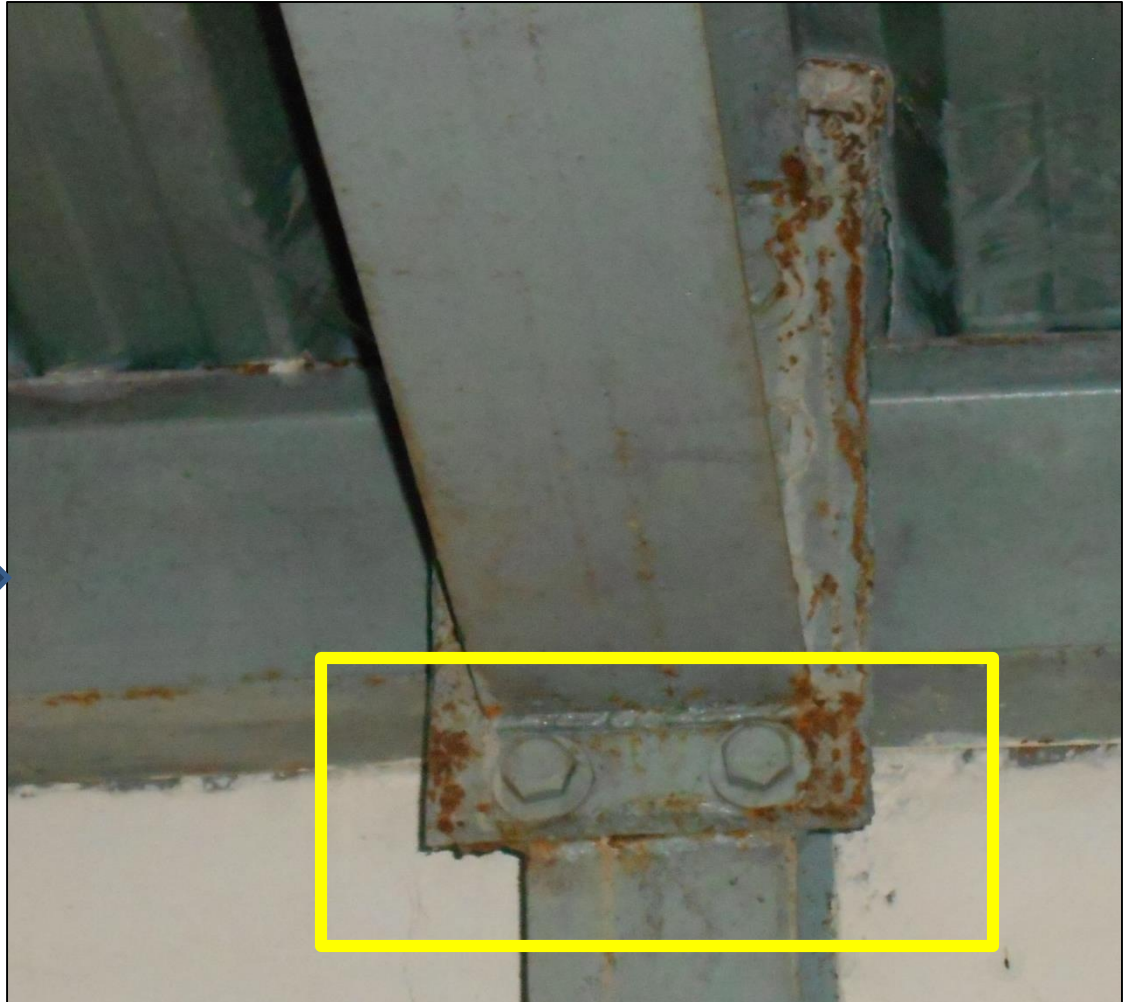
Office building

Blow-Up

Lack of minimum edge distance for bolt

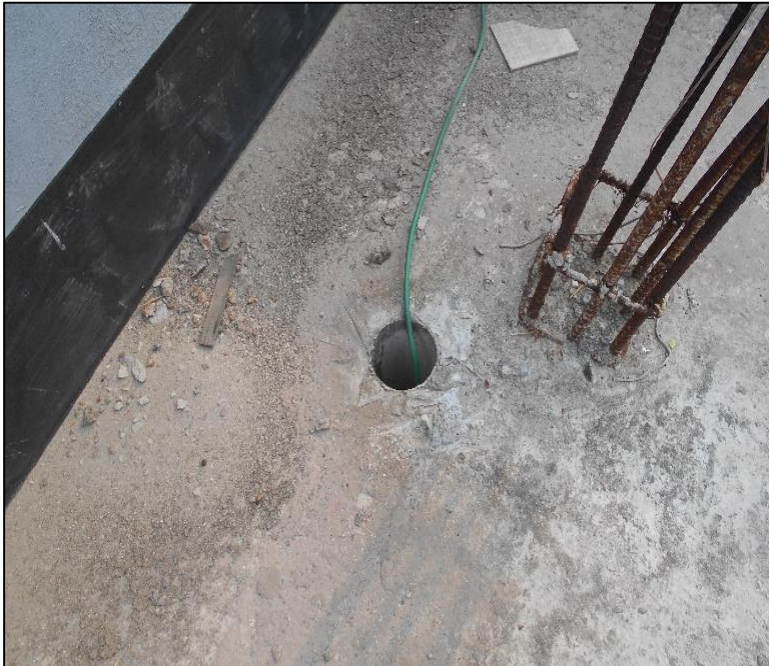
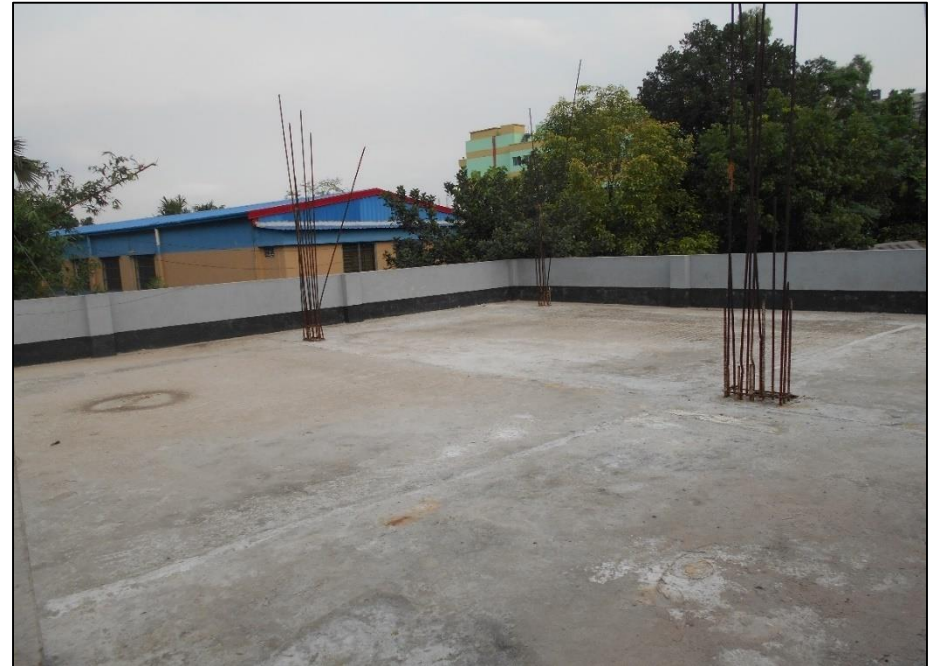
Utility Building

No water proofing membrane appears on roof &
Exposed reinforcement of column & slab

No waterproofing membrane was visible on the concrete roofs of the buildings. This means that any cracks in the surface finishes on the roof will allow water to seep into the concrete slab beneath the finishes, and cause corrosion of the reinforcing steel.

Item No.	Observation	Recommended action plan	Recommended timeline
16	No water proofing membrane appears on roof & exposed reinforcement of column & slab	Necessary measures shall be taken to protect exposed reinforcements from corrosion	6 - Week
17	No water proofing membrane appears on roof & exposed reinforcement of column & slab	Cover the concrete roofs with a suitable waterproofing membrane, e.g. waterproof screed.	6 - Month

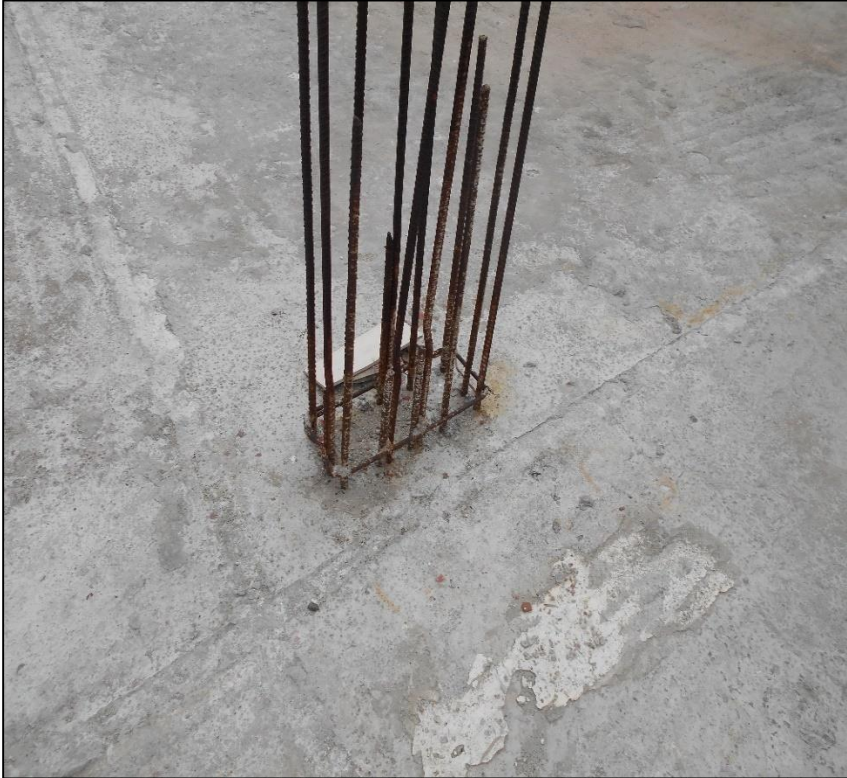
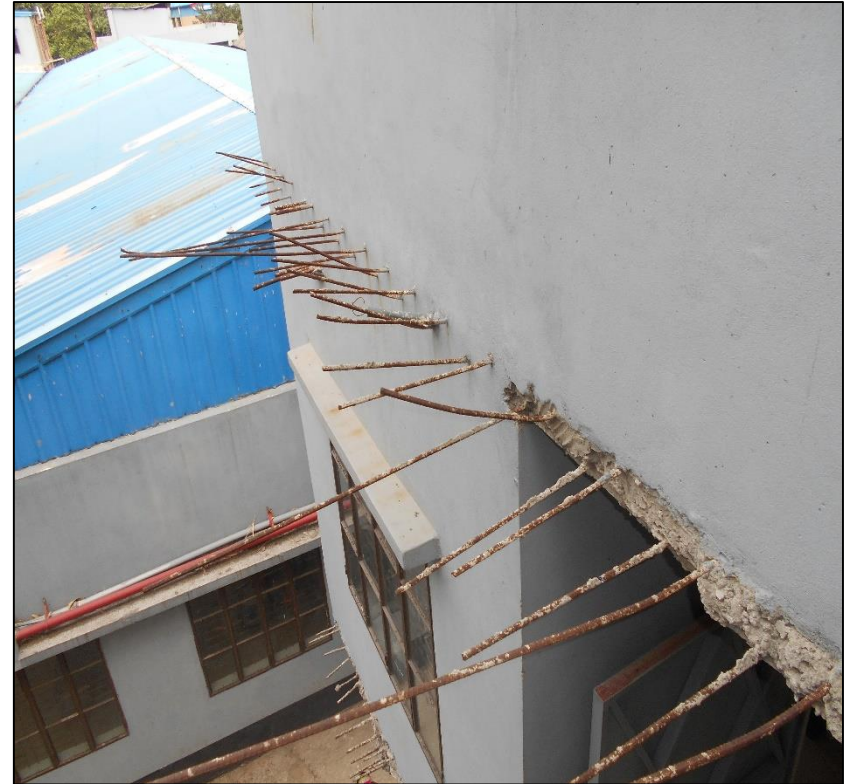
Utility Building and Sample Section Building

Corrosion in exposed reinforcement. Steel reinforcement projects from roof slab.
