# **FIRE SAFETY INSPECTION REPORT**

**Factory Name: REMI HOLDINGS LIMITED**

**ACCORD ID: 12508**

**Date: 22 June, 2016.**

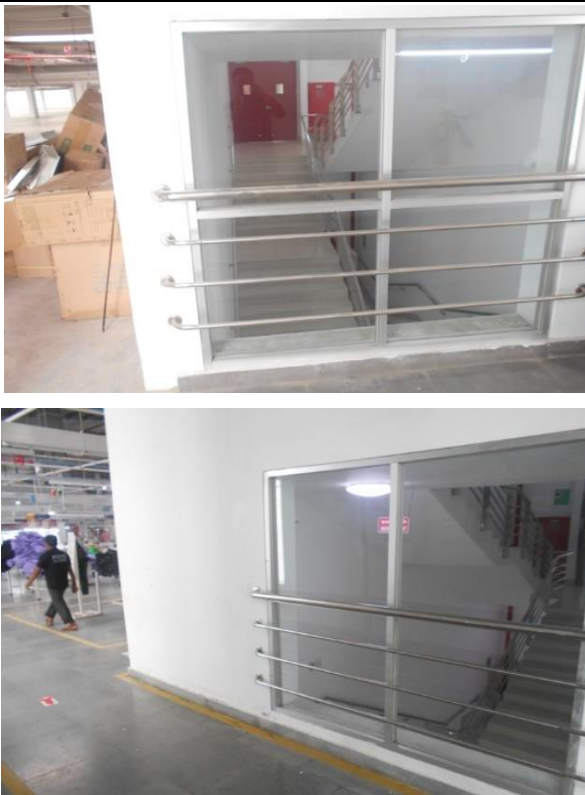
| Sl No. | Category | Findings | Required Action | Remediation Time Frame | Pictorial Evidence |
|---|---|---|---|---|---|
| 1 | Fire Rated Construction | <p>The exit stairs are not separated from [work areas, other spaces] on each floor by fire-rated construction.</p> <p>*Fire pump room is directly open to stair-7.</p> | <p>Stair shall be enclosed with a minimum 2-hr fire-rated construction. Seal all unprotected openings and provide minimum 1.5-hr fire rated doors to separate the exit stairs from work areas and other building spaces on all floor levels. Ensure that the fire doors are self-closing, positive latching and that they are provided with fire exit (panic) hardware where serving production floors.</p> <p>If fire doors are required to be held open for functional reasons, provide automatic-closing devices tied to the fire alarm system.</p> <p>*Either pump room shall be relocated or be separated from stair</p> | Within 3 months | |

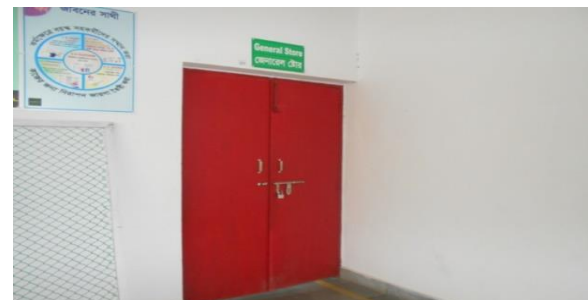
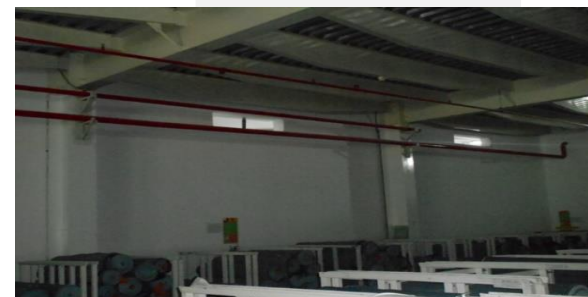
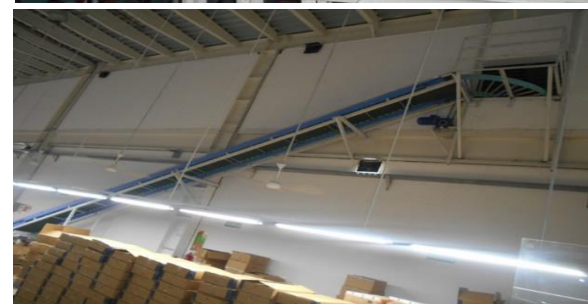
| 2 | Fire Rated Construction | Rooms used for storage of combustible materials are not separated from the surrounding occupancy/areas | Rooms used for storage of combustible materials shall be separated from the surrounding occupancy with a minimum 1 hour construction. |

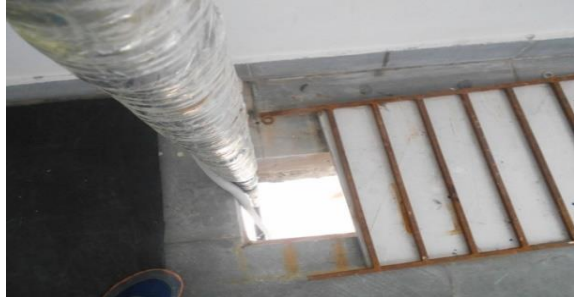
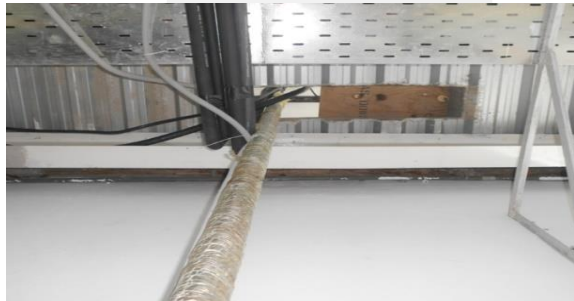
| Sl No. | Category | Findings | Required Action | Remediation Time Frame | Pictorial Evidence |
|---|---|---|---|---|---|
| 3 | Fire Rated Construction | Penetrations through floor/ceiling assemblies are found unsealed. | <p>Seal all penetrations and openings in floor/ceiling (full thickness of the floor/ceiling) assemblies by fire rated materials to maintain the fire resistance rating.</p> <p>Or</p> <p>Provide a minimum 2-hr fire rated shaft to separate the utility risers from each floor if required.</p> | Within 3 months | |

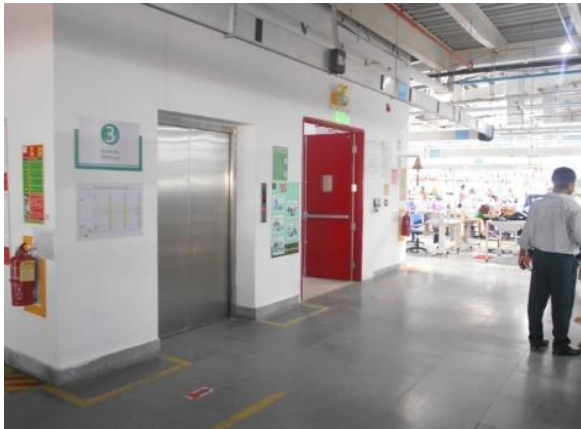
| Sl No. | Category | Findings | Required Action | Remediation Time Frame | Pictorial Evidence |
|---|---|---|---|---|---|
| 4 | Fire Rated Construction | The openings of the elevator shaft toward the processing floor are not fire rated. Though lift's door typically fire rated, but no credible fire rated certificate found for the lift's doors. | Provide a shaft enclosure of 2-hr rating by constructing the enclosure with rated material of required thickness. Protect the openings of shaft enclosure by providing 1.5 hr rated opening protectives. | Within 3 months | |
