# The Cloth and Fashion Ltd.

Raja Ghat, Rajfulbaria, Savar, Dhaka-1304  
(23.808840N, 90.259530E)

## Client Summary Report

### Observations & Actions

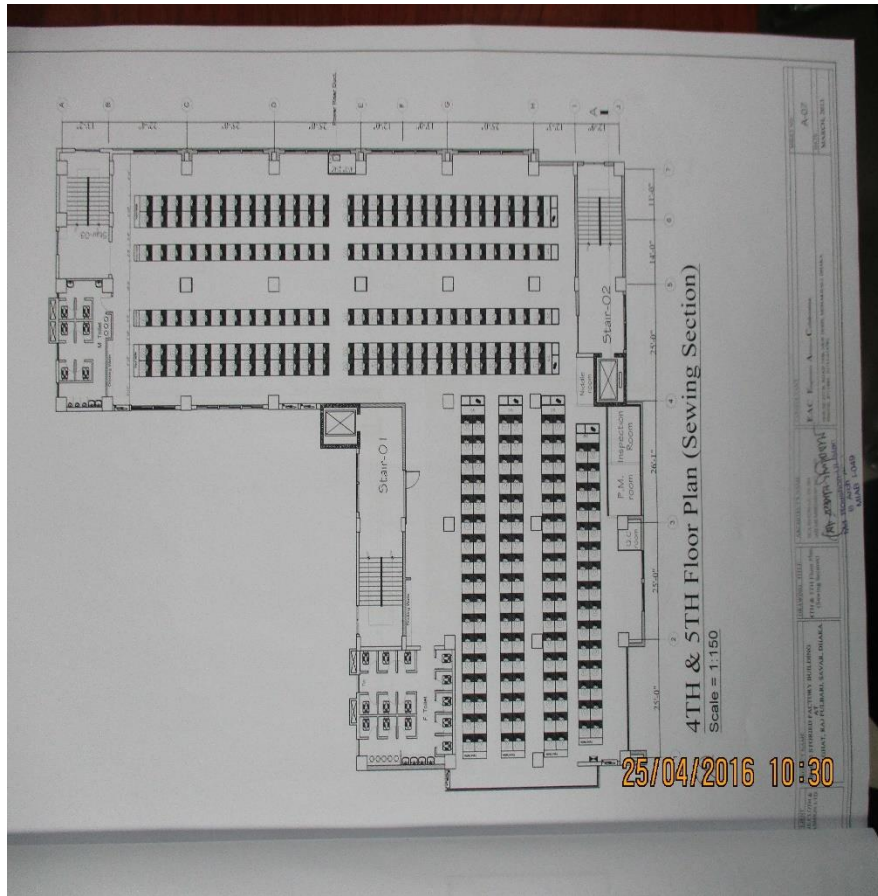
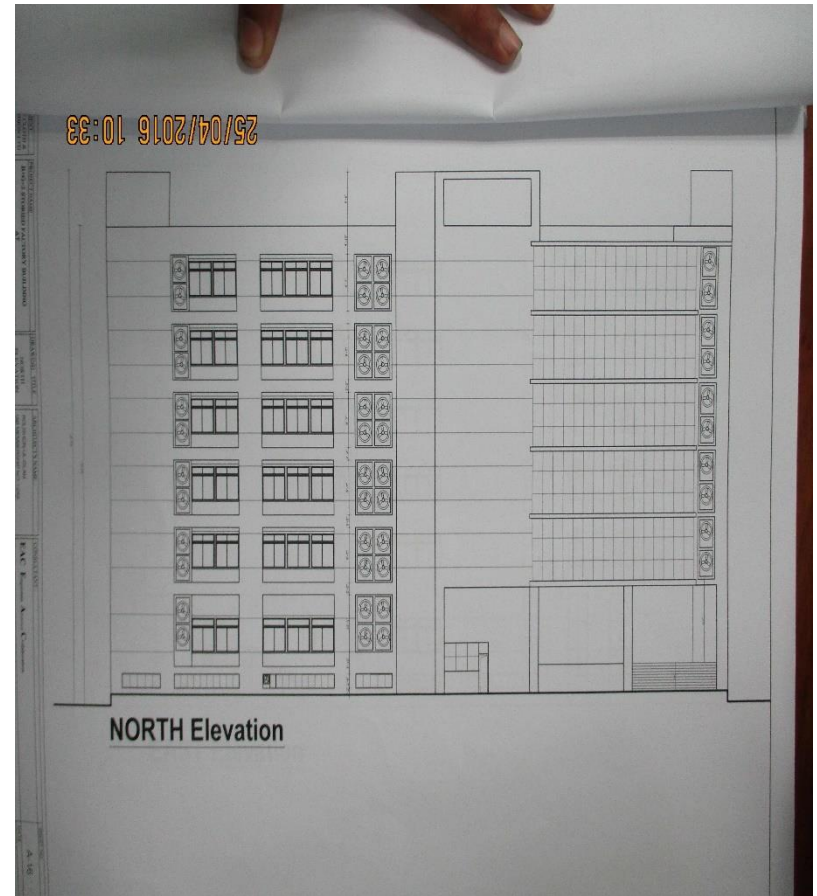
**Observation : Main Factory Building.**

In Architectural and Structural drawing there was no specific position and section of overhead water tank.

- Produce and actively manage a loading plan for all floor plates within the factory giving consideration to floor capacity and column capacity.
- Update as built drawing of main factory building considering position and section of Overhead water tank.

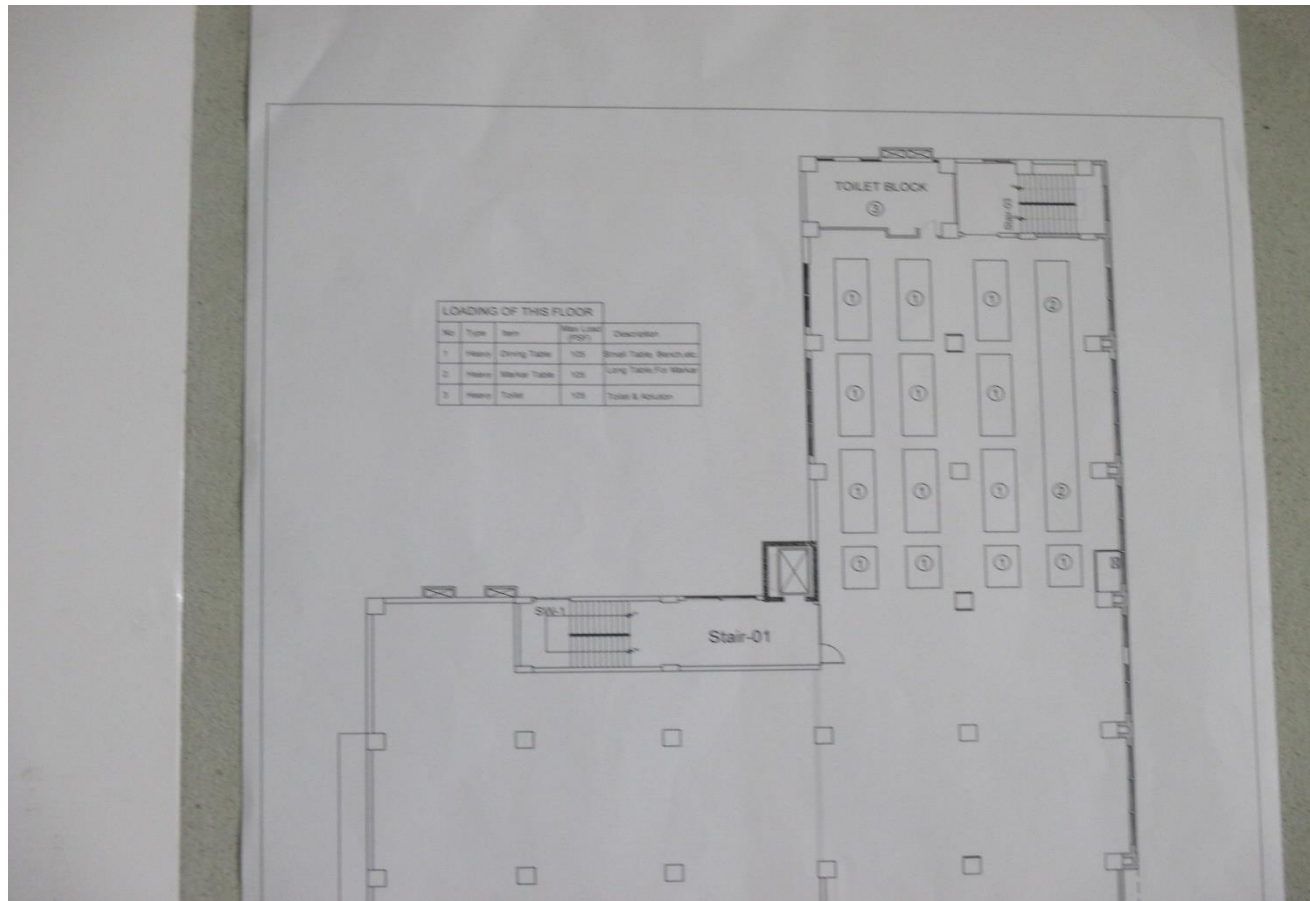
**Observation : Main Factory Building.**

Load plan for 105 Psf was posted at each floors but relevant document was not found

- Implement load plan.

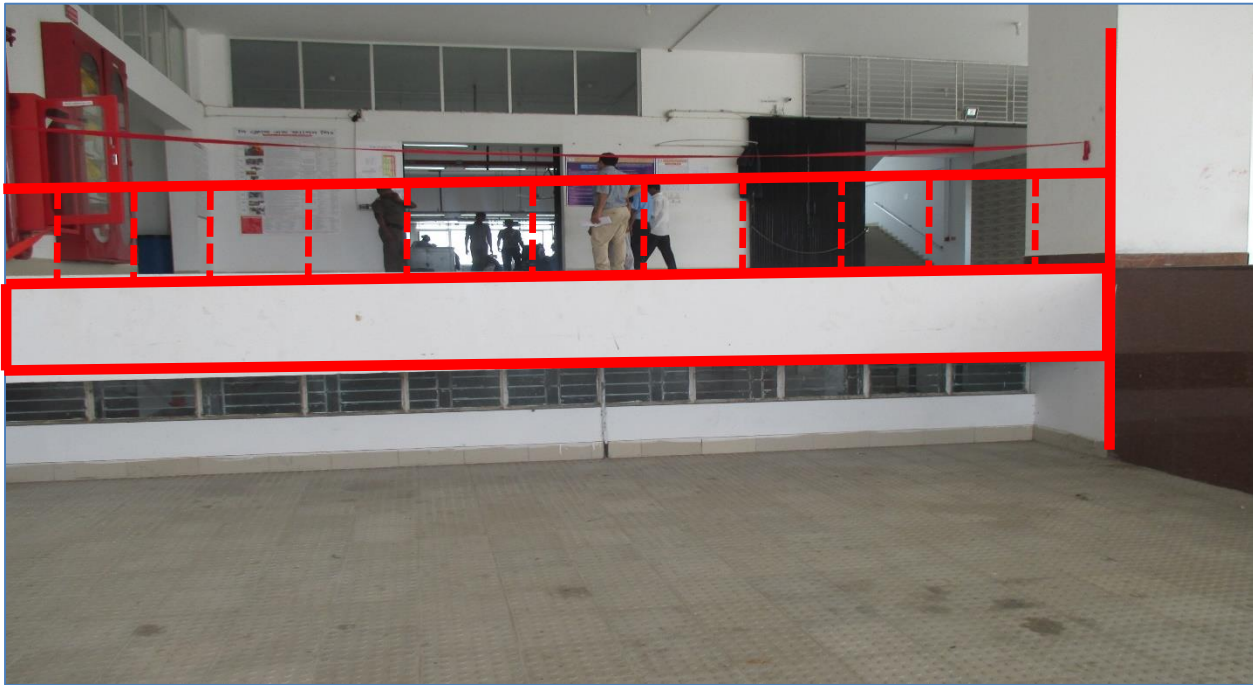
**Observation : Main Factory Building.**

## **Missing edge protection and protection for vehicle impact loading at ground floor at loading and unloading area**

There was no protection around beam and column at loading-unloading zone at ground floor for vehicle impact load. Furthermore there was no barrier on the floor edge.

- Protection must be provided around beam and column so that it is not affected by vehicle impact loading . Furthermore edge protection is also required to provide at ground floor slab edge at loading-unloading zone.

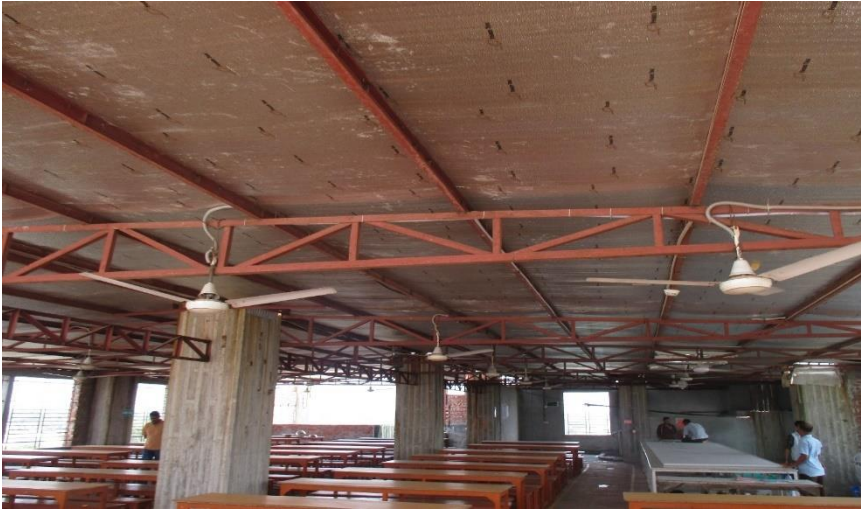
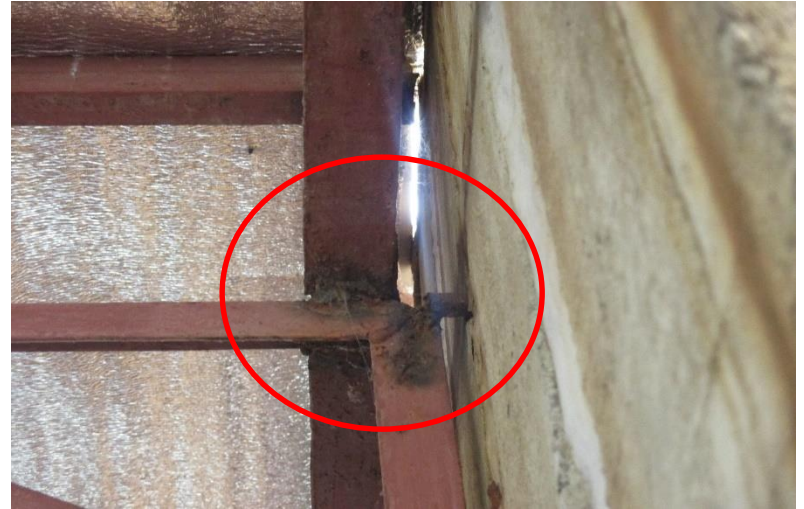
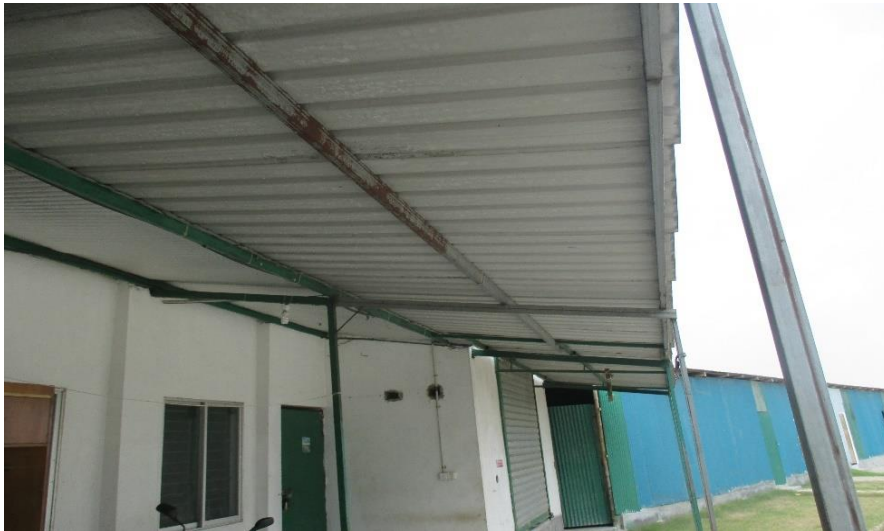
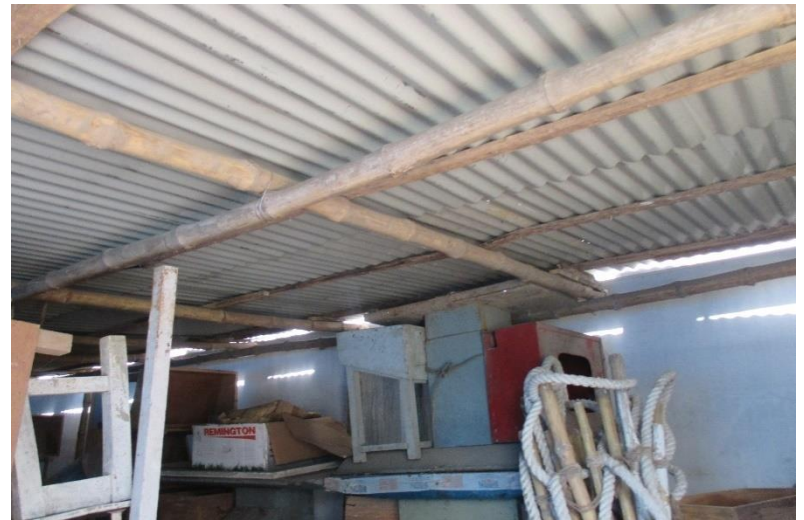
**Observation : Shed 1, Shed 2 and Shed 3.**

# Poor Detailing And Lateral Stability System Of Sheds

Roof top shed ,Shed 1 and Shed 2 are vulnerable against wind load due to it's poor connection details and construction.

- Building engineer to review lateral stability and connection details of sheds.
- Implement any remedial works coming out from engineering assessment.
