# Fabrica Knit Composite Ltd.

16<sup>th</sup> June, 2016

## Client Summary Report

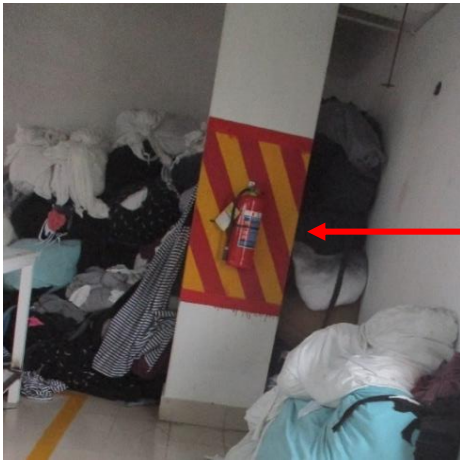
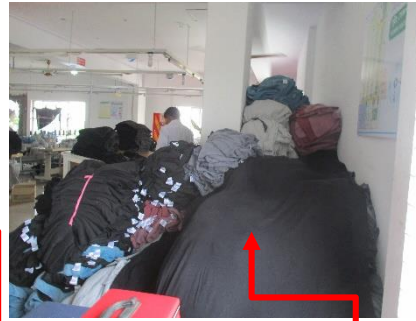
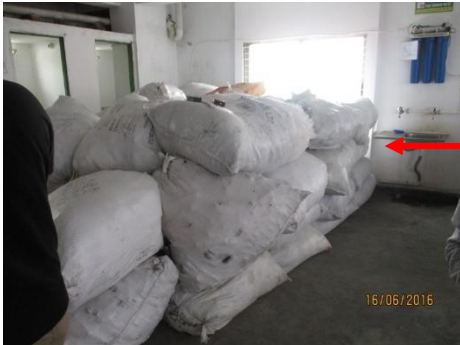
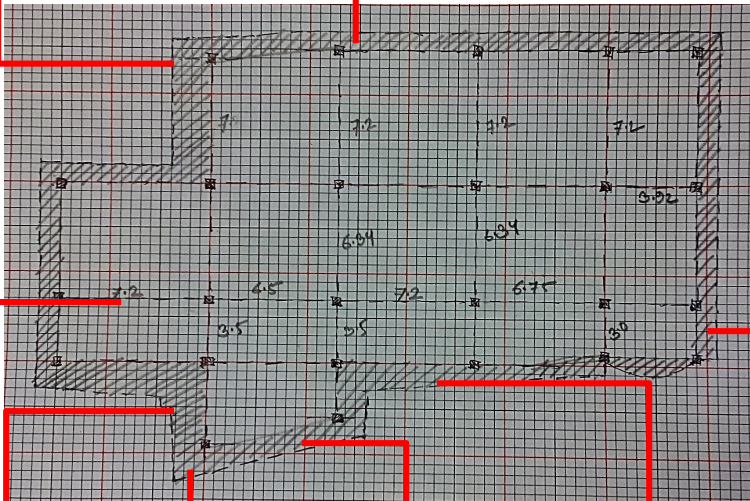
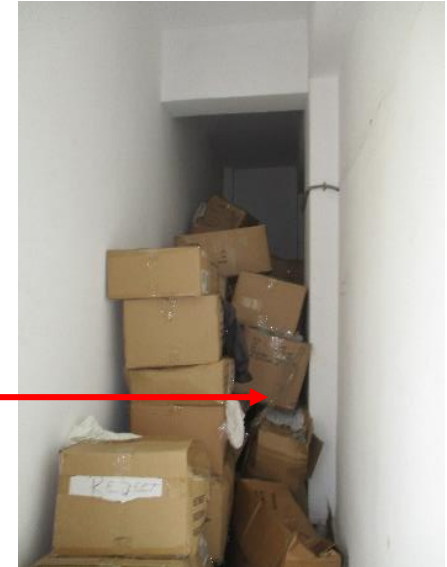
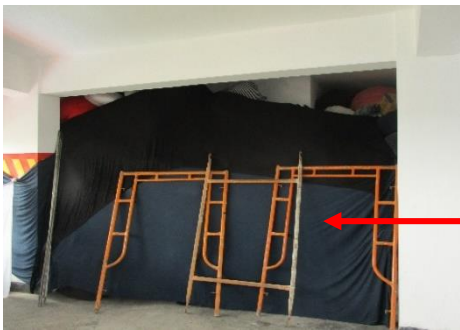
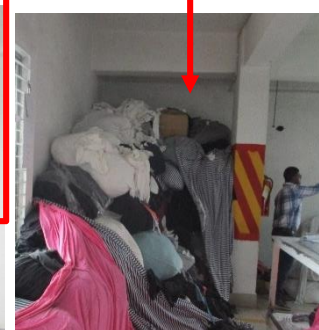
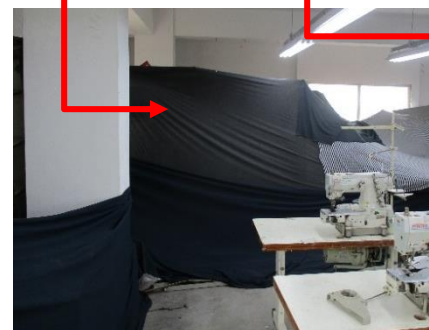
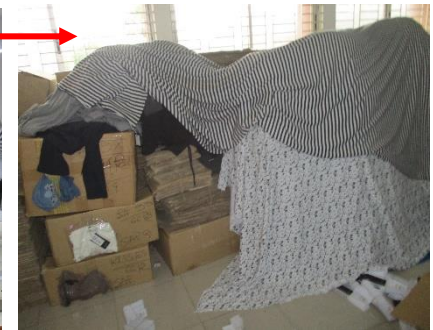
Locally heavy floor loading in some storage areas and cantilevers.

Heavy loads was appeared most of the cantilever area and floor built-ups are found in each toilet zone.

Item No.	Observation	Recommended Action Plan	Recommended Time Line
2	<b>Locally heavy floor loading in some storage areas and cantilevers</b>	Detail Engineering Assessment to be completed.	within 6-weeks
2	<b>Locally heavy floor loading in some storage areas and cantilevers</b>	Continue to implement load plan	within 6-months
3	<b>Foundations of extra columns in ground floor.</b>	Check the foundations of the extra columns either it is exist or not	within 6-weeks
2	<b>Foundations of extra columns in ground floor.</b>	Building engineer to check the adequacy of the foundations as a part of DEA.	within 6-months

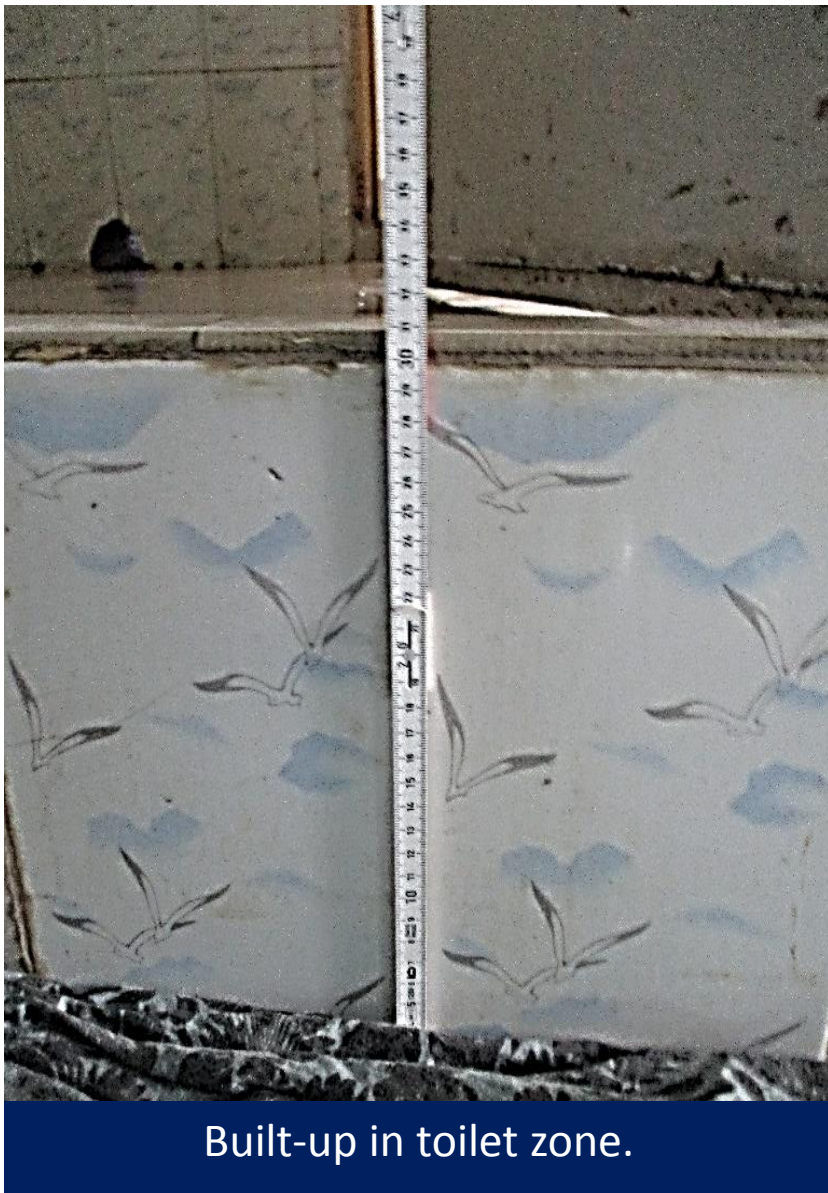
Built-up in toilet zone.

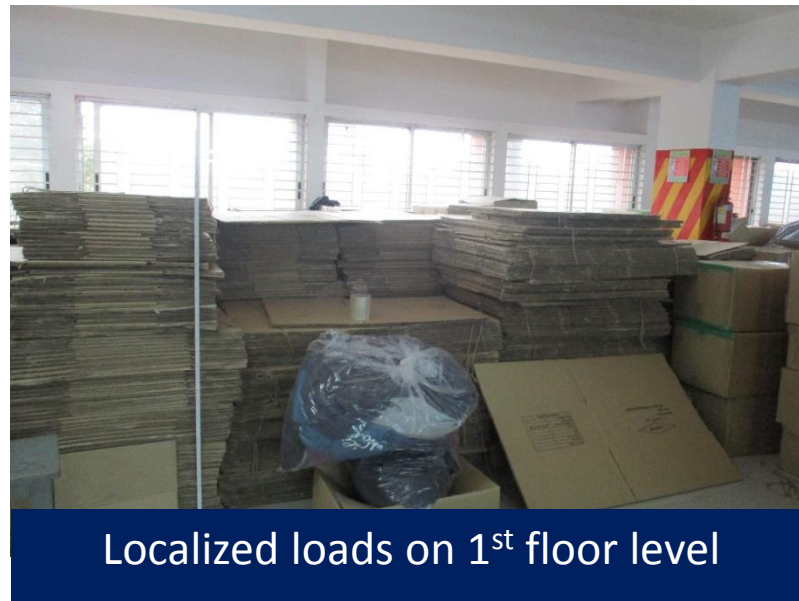
Localized loads on 1<sup>st</sup> floor level

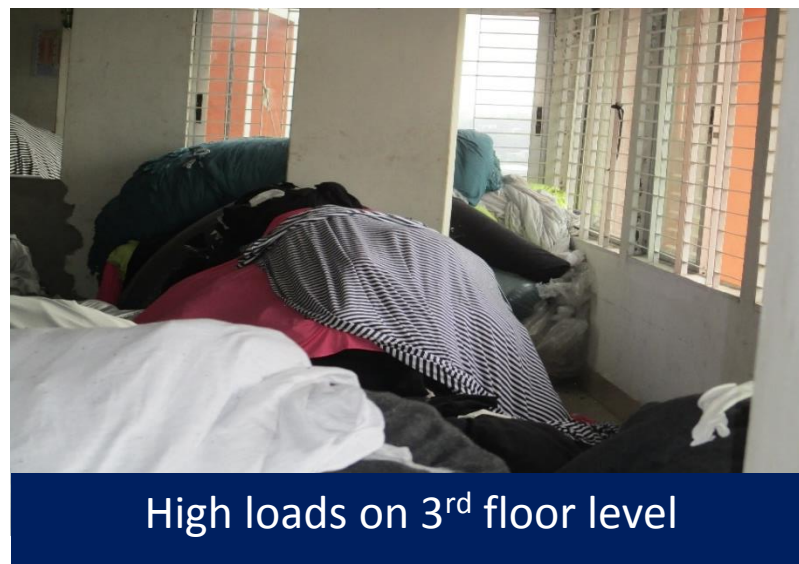
High loads on 3<sup>rd</sup> floor level

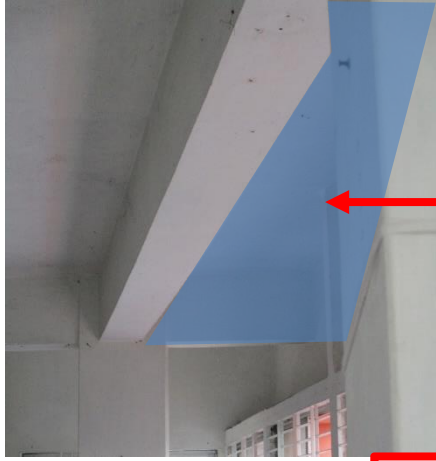
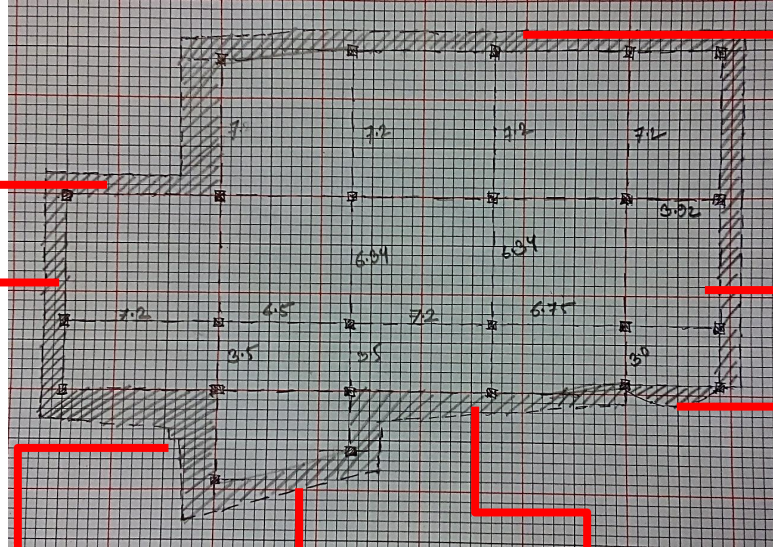
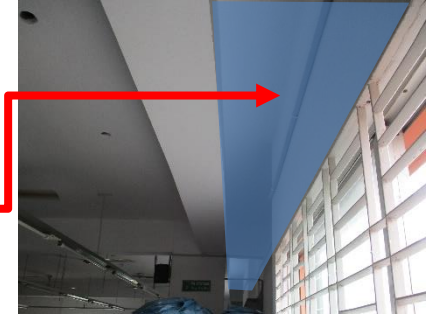
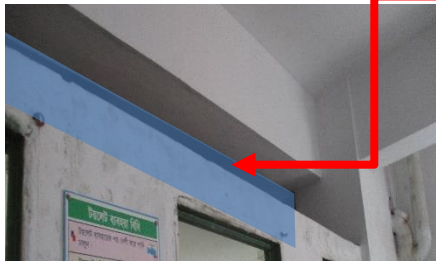
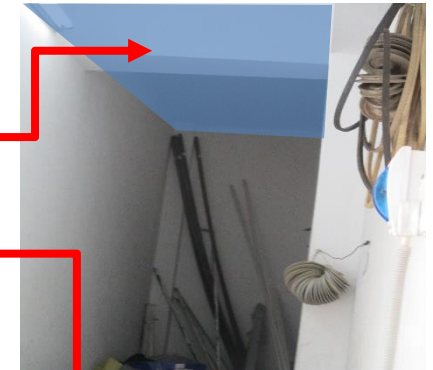
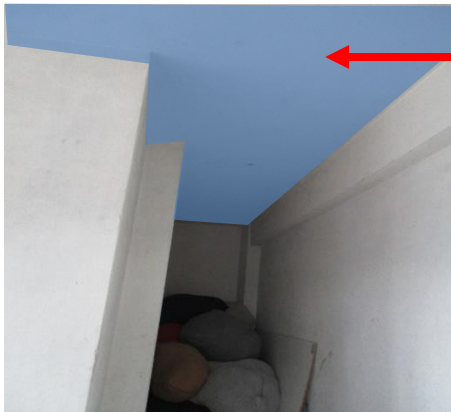
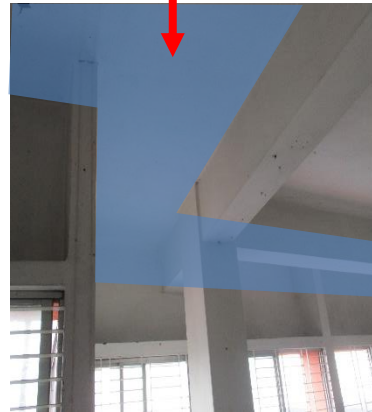
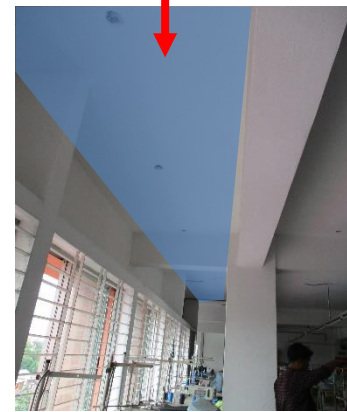
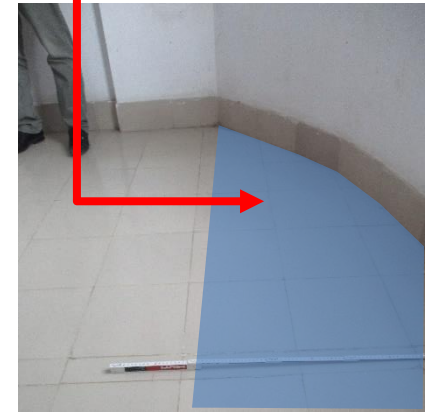
Additional Cantilevers in all sides of the building ranging 1.7 m to 1 m

Item No.	Observation	Recommended Action Plan	Recommended Time Line
3	<b>Foundations of extra columns in ground floor.</b>	Any action raised by DEA should be implemented.	within 6-weeks
4	<b>Discrepancies in the as constructed drawings.</b>	Engage a Building Engineer to survey the structure and prepare a full set of “as-constructed” drawings.	within 6-weeks
4	<b>Discrepancies in the as constructed drawings.</b>	Produce and actively manage a loading plan for all floor plates within the factory giving consideration to floor capacity and column capacity.	within 6-weeks
5	<b>Poor connection detailing between steel roof and RCC.</b>	Produce “As-constructed” drawings of steel shed	Immediate - Now

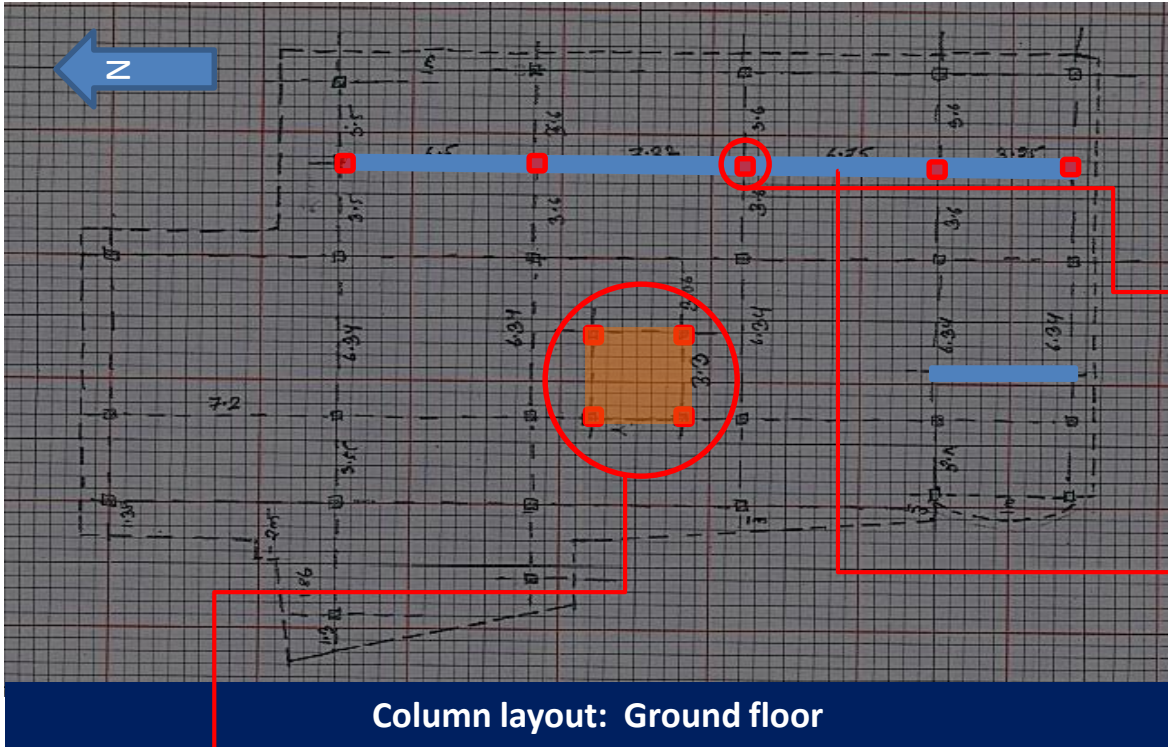
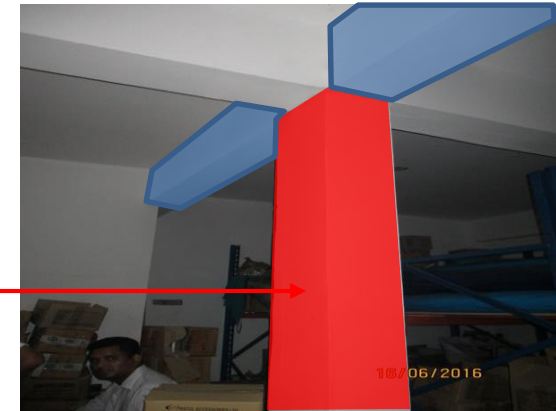
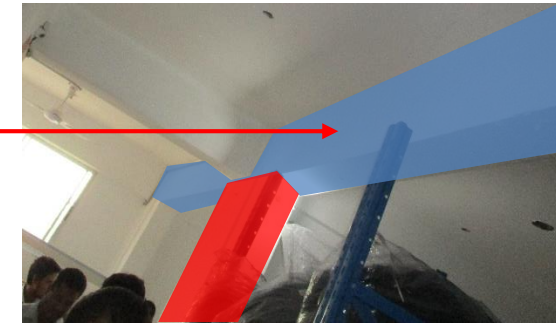
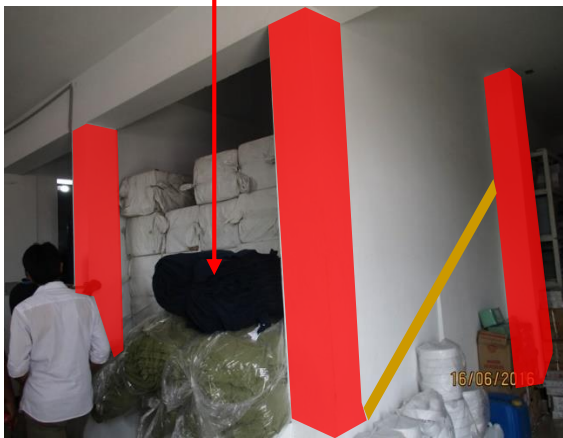
Additional framing at Ground Floor which is not included in approval drawings and structural drawings.

- Additional columns on Ground Floor
- Additional Beams on Ground Floor
- Undocumented ramp on ground floor

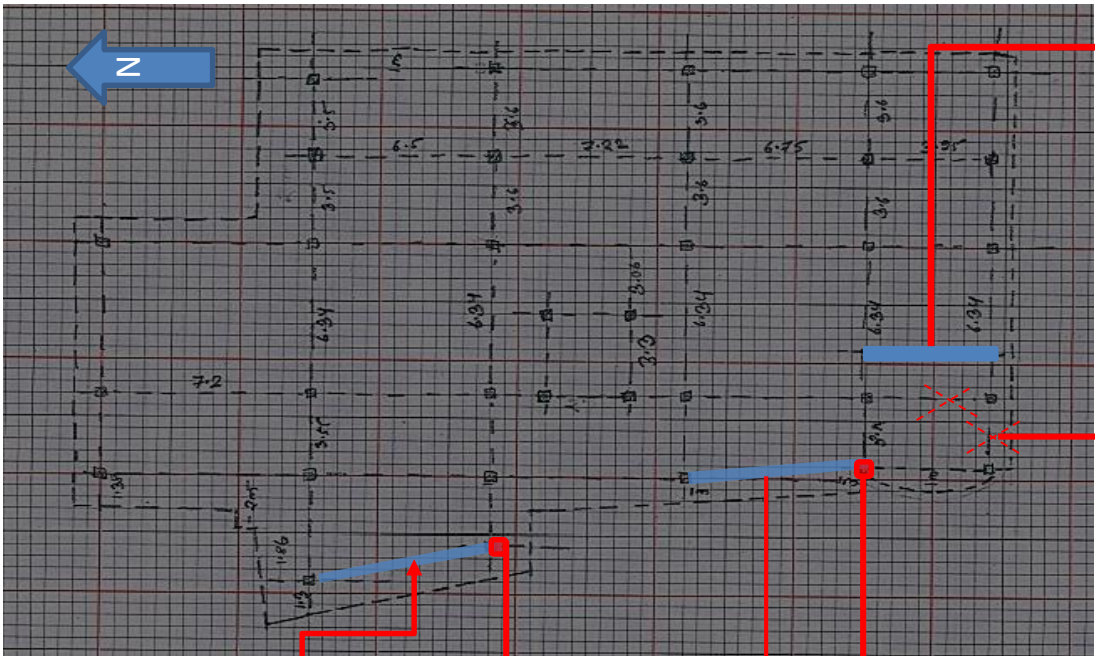
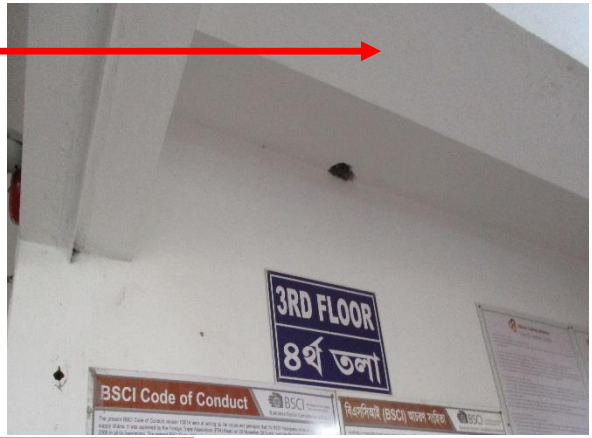
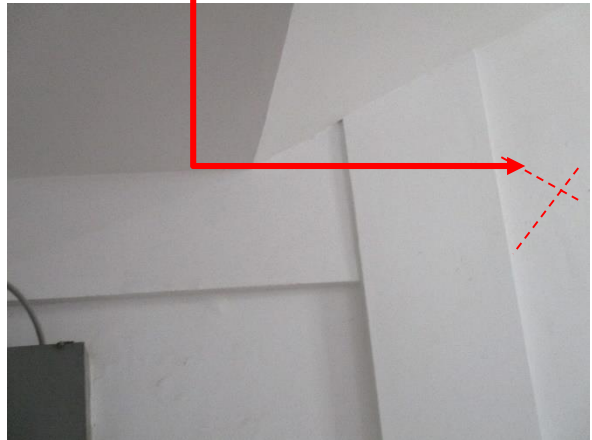
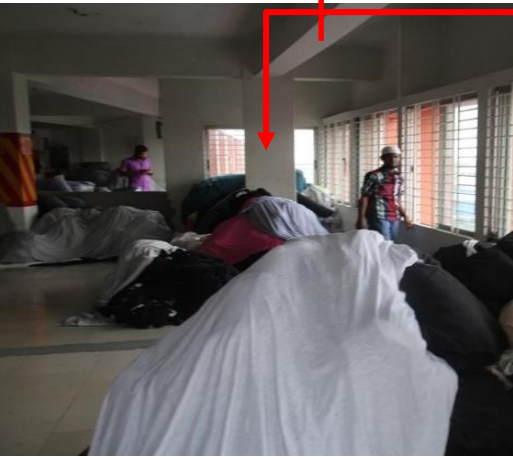
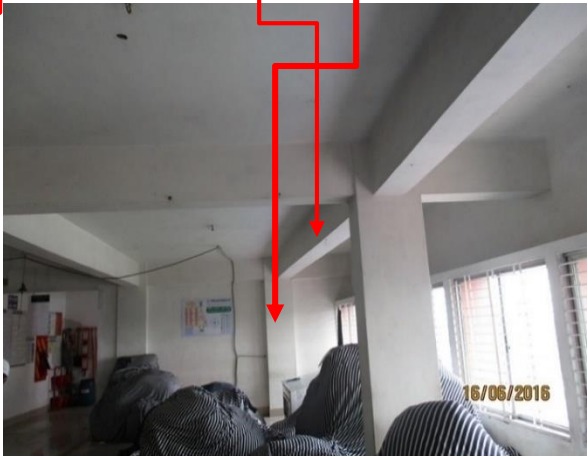
- Deviated columns on typical floor from actual drawing
- Actual arrangement of floor beam
- ✗ Missing Beams in stair core.
- Additional Beam resting on main beam

Beams and columns deviated from original layout in every floor

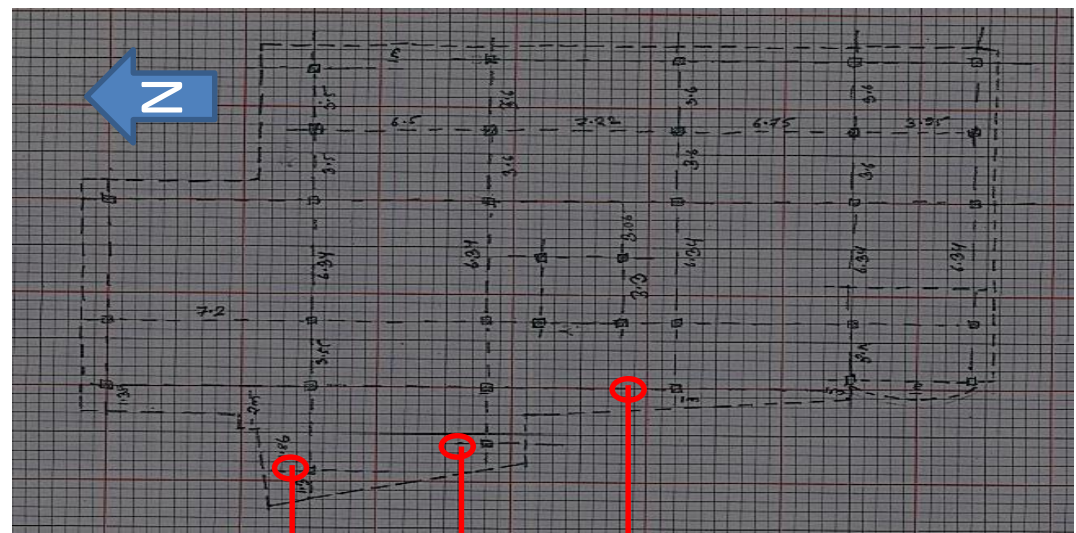
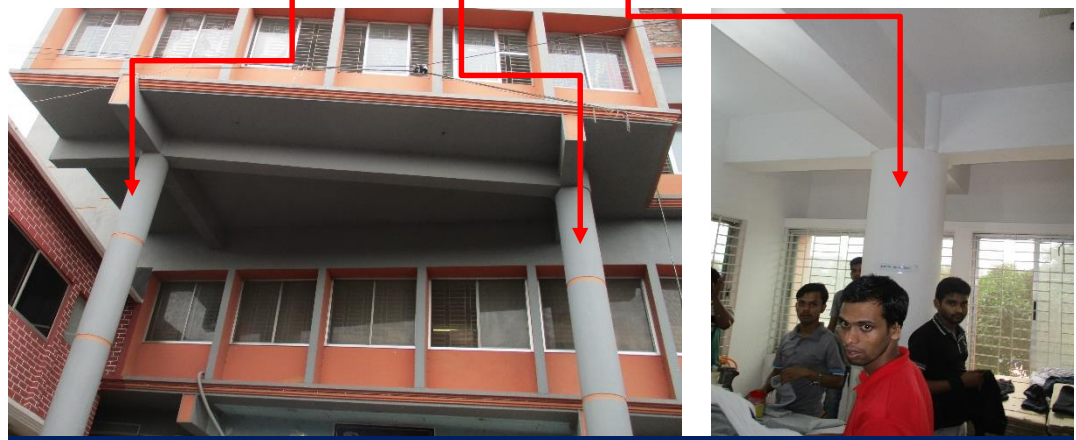
Circular columns in 1<sup>st</sup> and 2<sup>nd</sup> floor

Some columns are found as in circular shape in ground and 1<sup>st</sup> floor which is not shown in structural drawings .

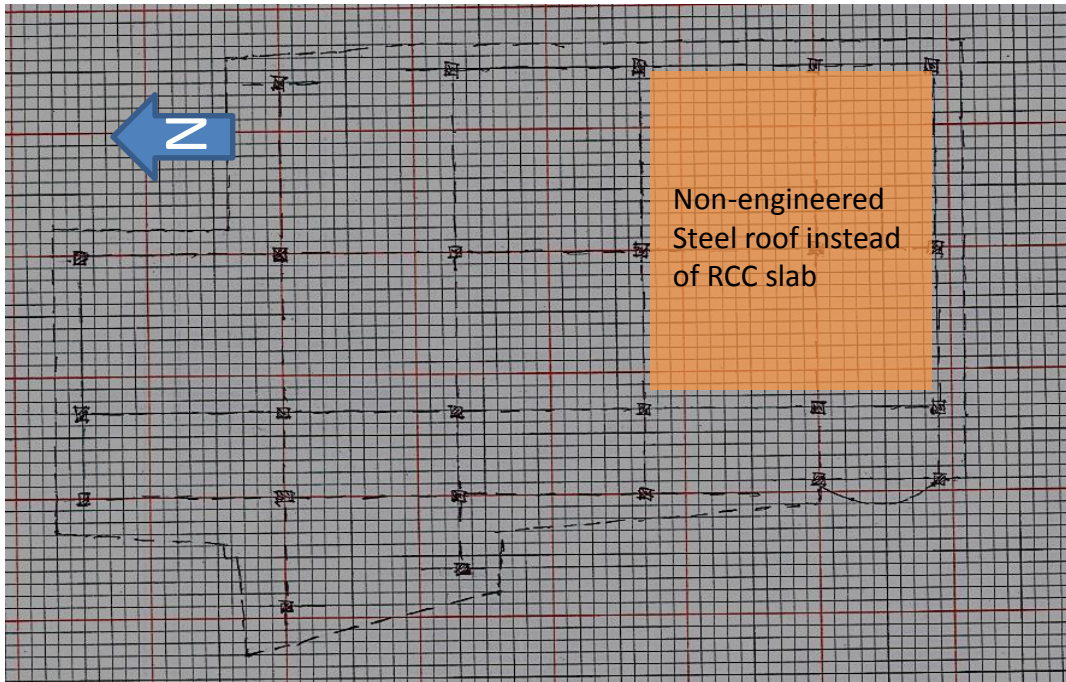
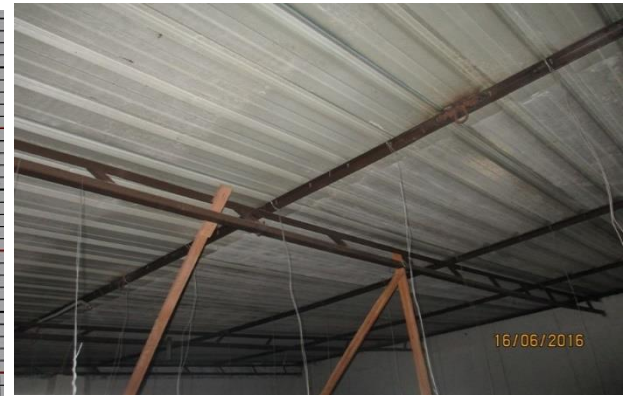
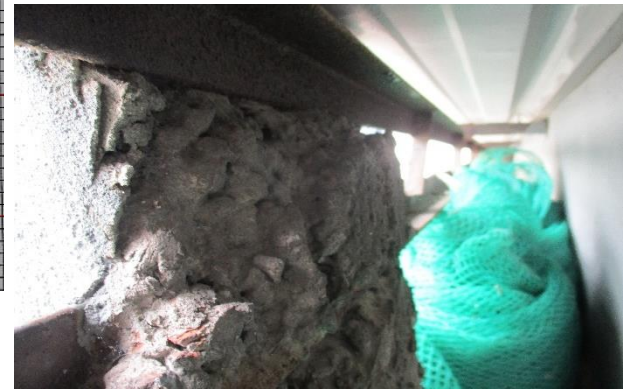
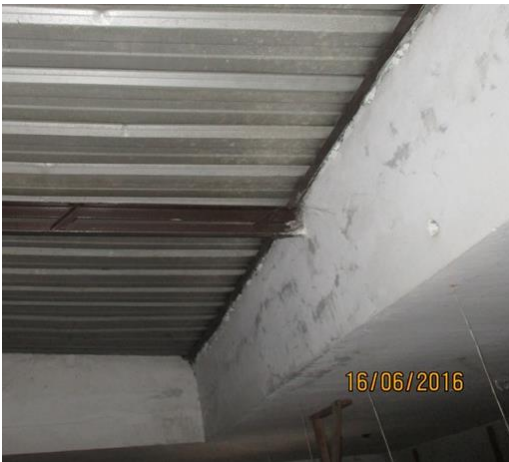
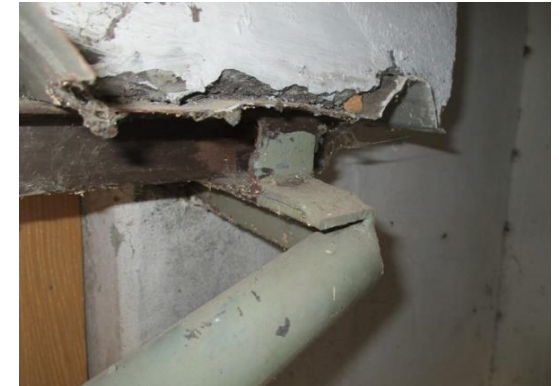
Apparently non engineered steel shed on roof with trapezoidal sheet over steel angel. Poor welded steel connection appeared.

Item No.	Observation	Recommended Action Plan	Recommended Time Line
5	<b>Poor connection detailing between steel roof and RCC.</b>	Engage a Building Engineer to check the capacity of the lightweight steel roof structure/connection details and wall/connection details.	within 6-weeks
5	<b>Poor connection detailing between steel roof and RCC.</b>	Carry out necessary strengthening works if required any arise from Assessment	within 6-months
6	<b>Apparently non-engineering stair connecting 6<sup>th</sup> floor to roof.</b>	Engage a Building Engineer to check the capacity of the lightweight steel roof structure/connection details and wall/connection details	within 6-weeks
6	<b>Apparently non-engineering stair connecting 6<sup>th</sup> floor to roof.</b>	Make any necessary alterations as required.	within 6-months

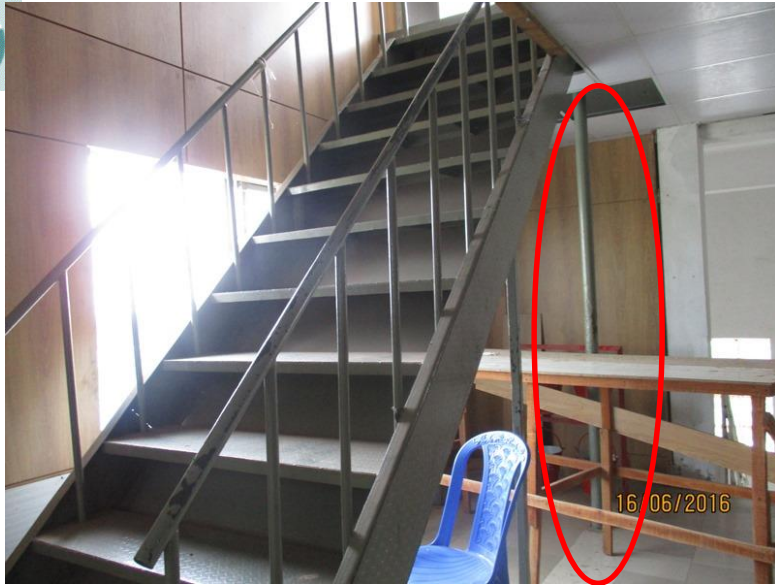
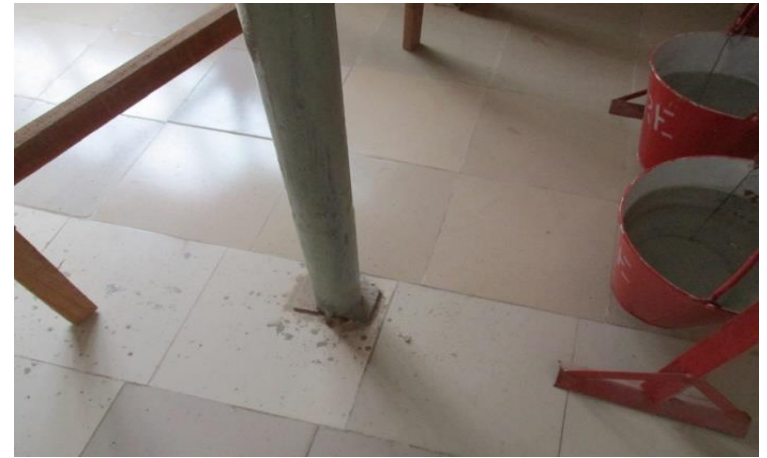
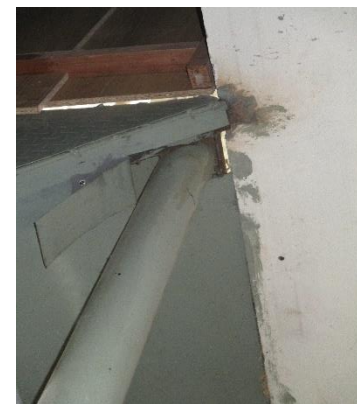
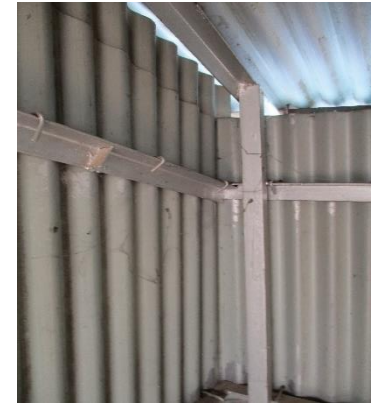
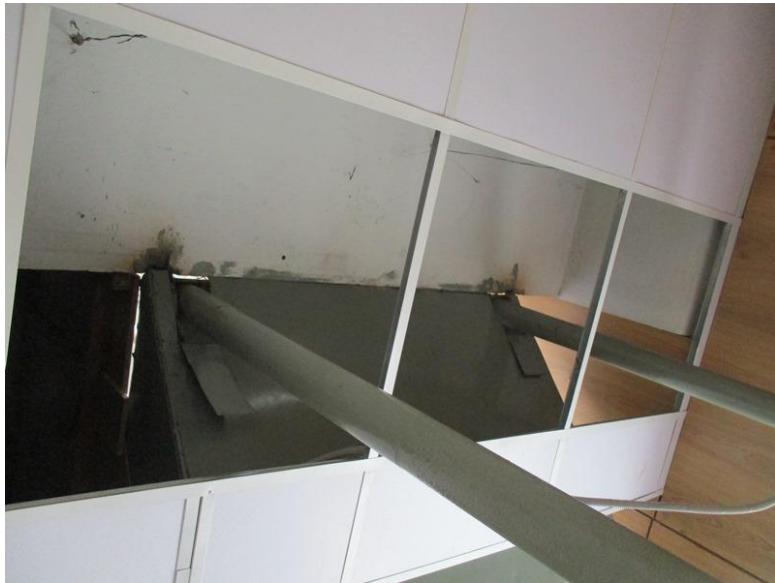
Light weight steel stair between 6<sup>th</sup> floor and roof. Stair supporting steel box column of 40mm X 40mm & Pipe of 75mm columns appeared poorly connected on the floor slab.

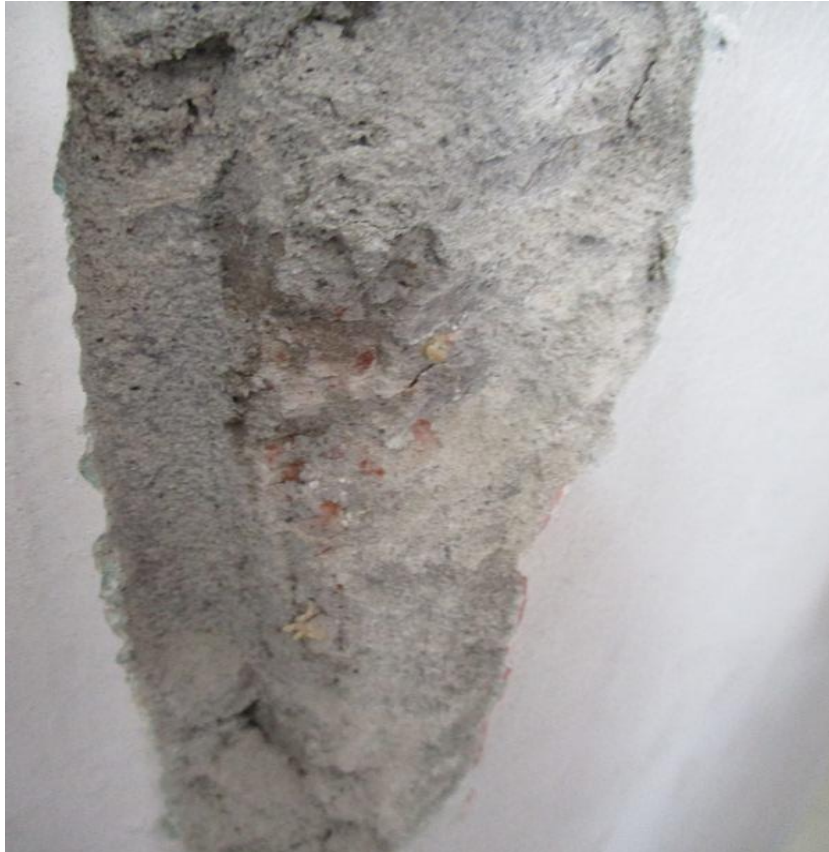
Brick chip aggregate observed
