# Remi Holdings Ltd.

Plot No. 244-245 & 250-251, Road-01, Adamjee Nagar, EPZ, P.S.  
Shiddhirganj, Narayanganj  
(23.681092N, 90.517714E)

22 June 2016

# Observations

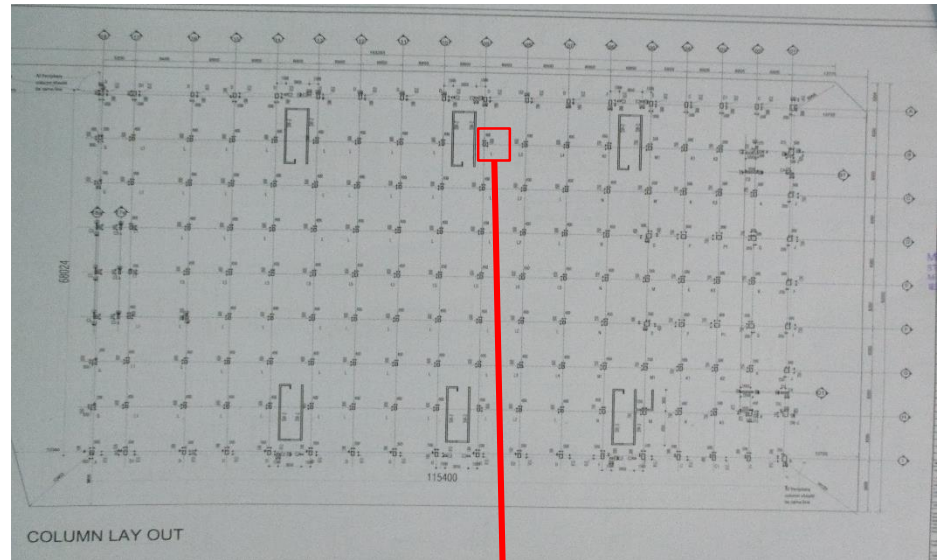
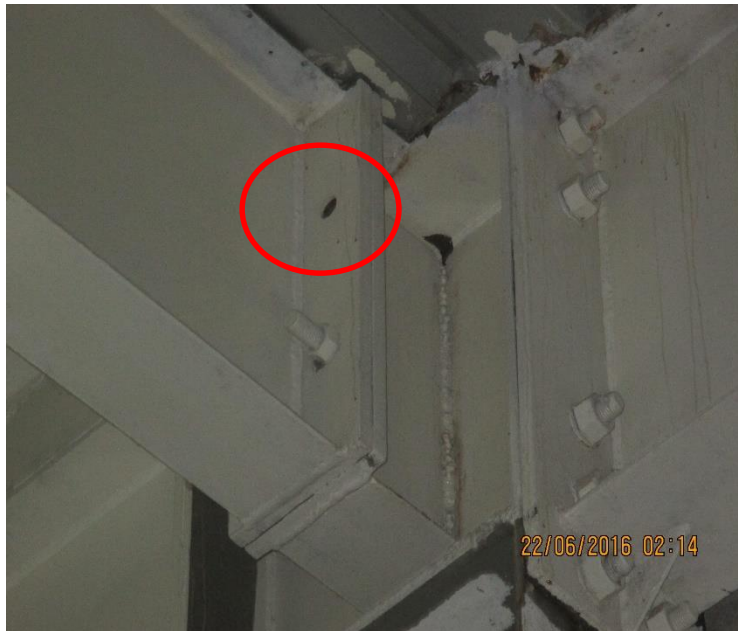
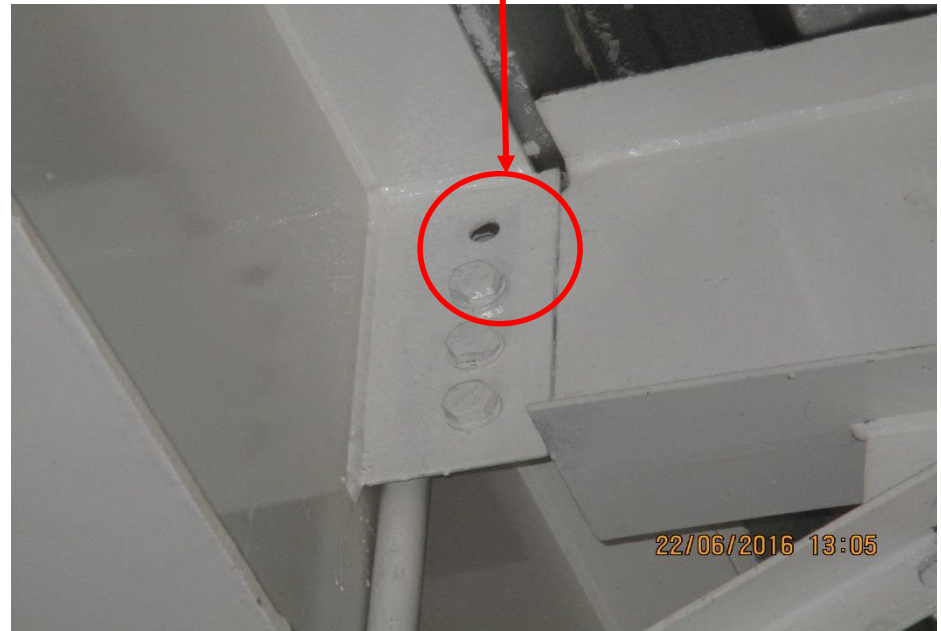
# **Missing Connection bolts in the Roof steel frame of the B1 (Main Production building)**

Missing Connection bolts  
in the Roof steel frame  
connection observed of  
the B1 (Main Production  
building)

Missing Connection bolts in the Roof steel frame of the B1  
(Production building)

| Item No. | Observation | Recommended Action Plan | Recommended Timeline |
|---|---|---|---|
| 1 | Building 1.<br>Missing Connection bolts in the Roof steel frame of the Main Production building | Building Engineer to identify all the omissions and supervise remedial works to the missing bolts in the connections. | 6-months |

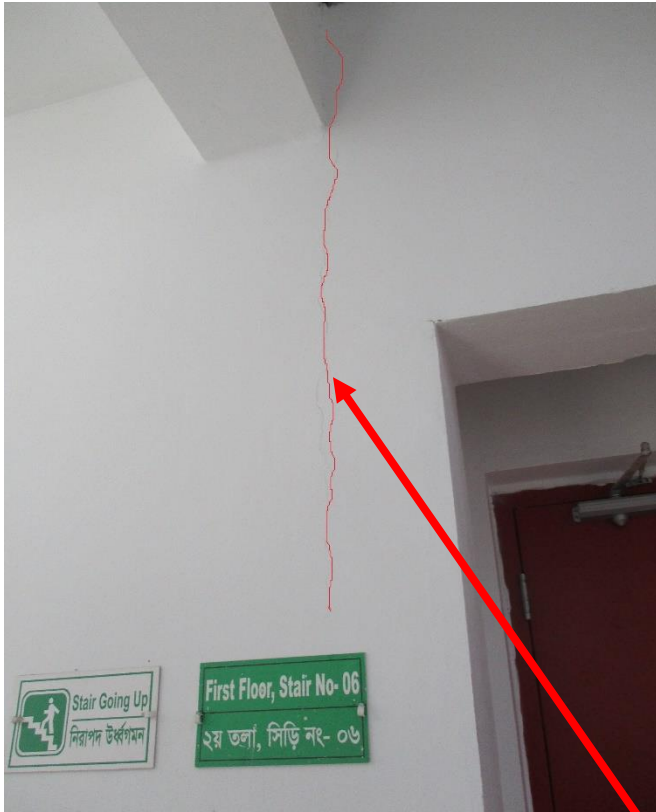
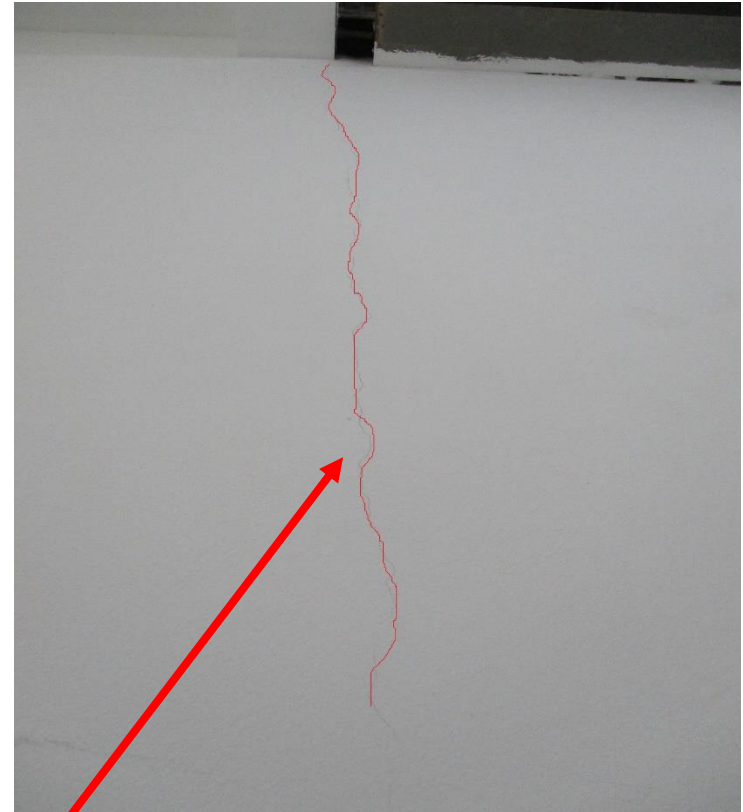
## **Cracks in interior brick walls of Main production building.**

Cracks in interior brick  
walls observed in several  
location

## Cracks in interior brick walls

| Item No. | Observation | Recommended Action Plan | Recommended Timeline |
|---|---|---|---|
| 2 | Building 1:<br>Cracks in interior brick walls of main production building. | Building engineer investigate extent of cracks. | 6-months |

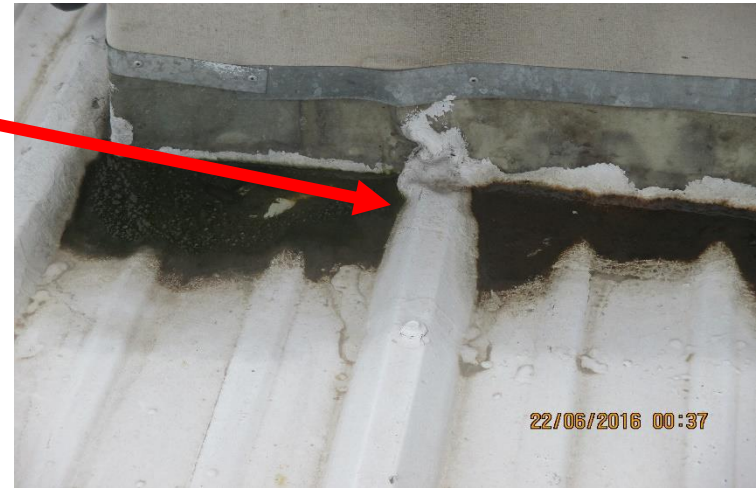
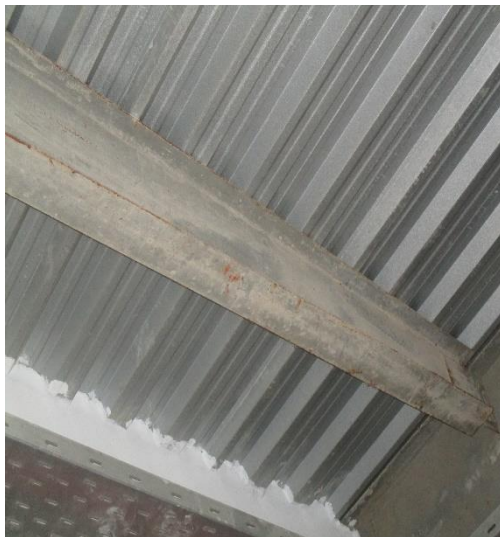
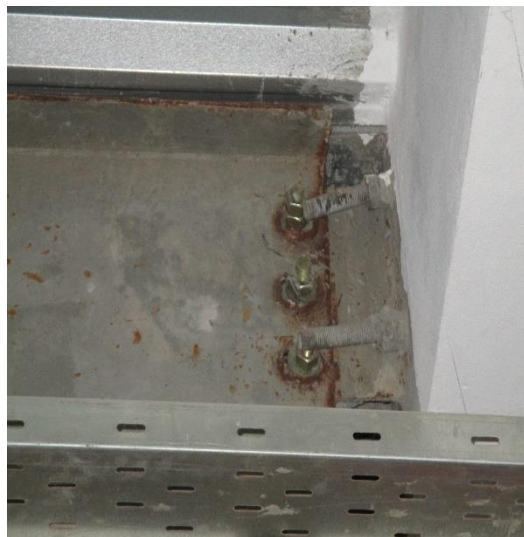
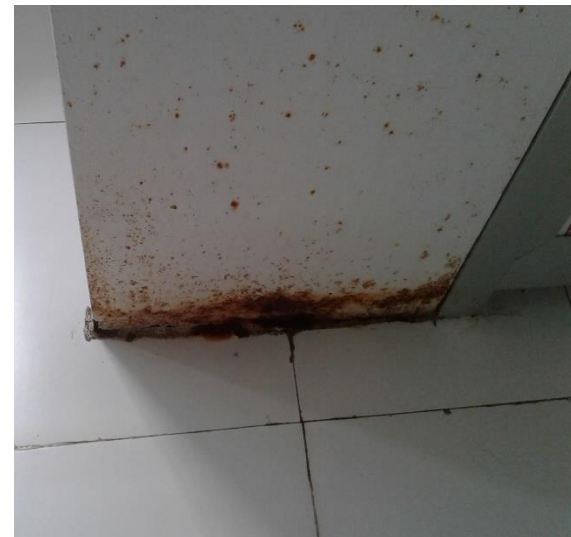
# **Corrosion in sheeting and structural members of production building.**

## Corrosion & Leakage in roof sheeting member

## Corrosion in steel member

## Corrosion in sheeting and structural members

| Item No. | Observation | Recommended Action Plan | Recommended Timeline |
|---|---|---|---|
| 3 | Building 1.<br>Corrosion in sheeting and structural members of main production building | Building Engineer to issue a schedule of remedial works for bracing reinstatement and corrosion protection. | 6-weeks |
| 4 | Building 1.<br>Corrosion in sheeting and structural members of main production building | Remedial works to be carried out. | 6-months |
