FIRE SAFETY INSPECTION REPORT

LOUIETEX MANUFACTURING LTD
SHARIFPUR, GAZIPUR SADAR, GAZIPUR

ACCORD
on Fire and Building Safety in Bangladesh

June 29, 2014

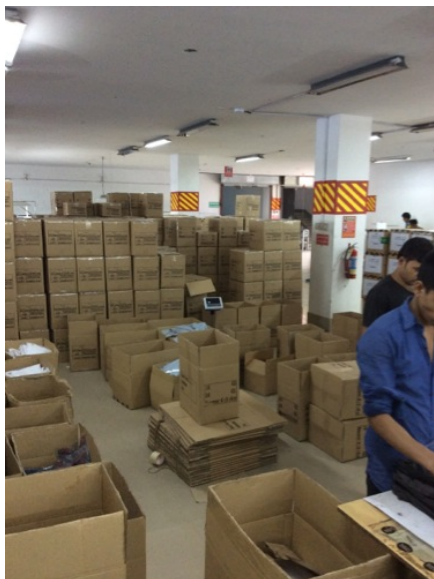
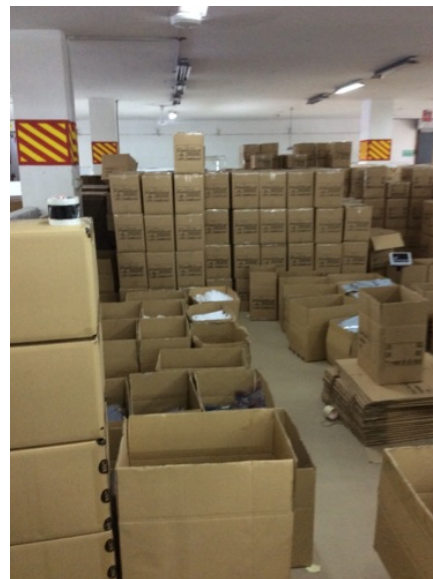
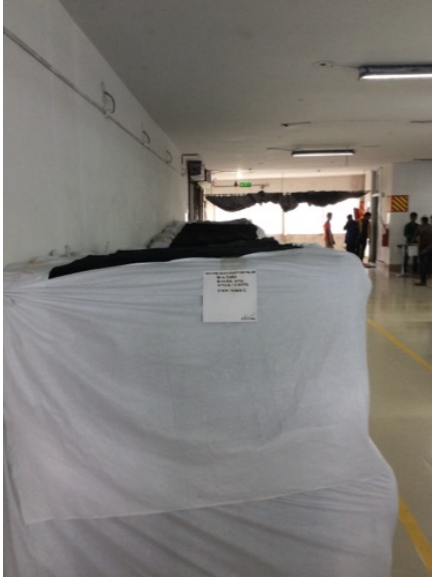
No.	Category	Finding	Recommendation	Remediation Timeframe
F-1	Fire Rated Construction	Areas used for combustible storage are not separated by fire- rated construction. Location: On first and second floor.	Provide dedicated storage rooms separated by minimum 1-hr fire-rated construction. Where separate storage rooms are not feasible, provide defined storage areas and limit the storage arrangement as follows: - Maximum height of 2.4m and maximum area of 23m ² - If sprinkler protected: maximum height of 3.66m and maximum area of 93m ² Separate areas of unenclosed combustible storage by a minimum clear distance of 3m.	Within 3 months

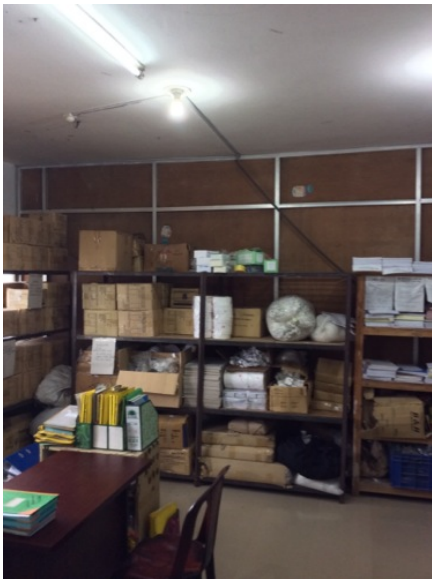
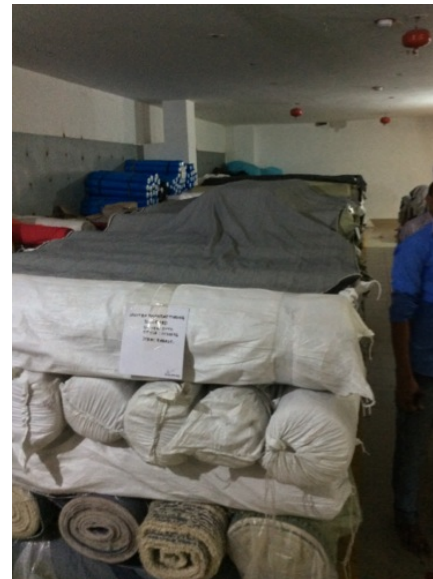
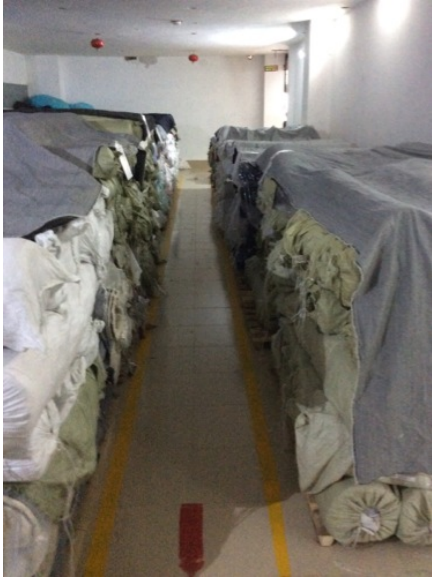
F-2	Fire Rated Construction	Rooms used for combustible storage are not separated by fire-rated construction. Location: First and second floors.	Provide dedicated storage rooms separated by minimum 1-hr fire-rated construction.	Within 3 months
-----	-------------------------	--	--	-----------------

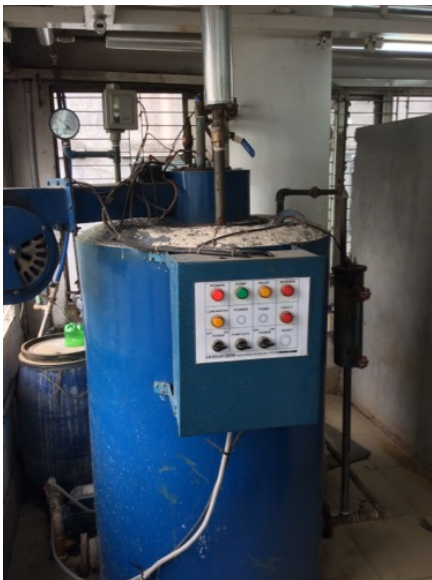
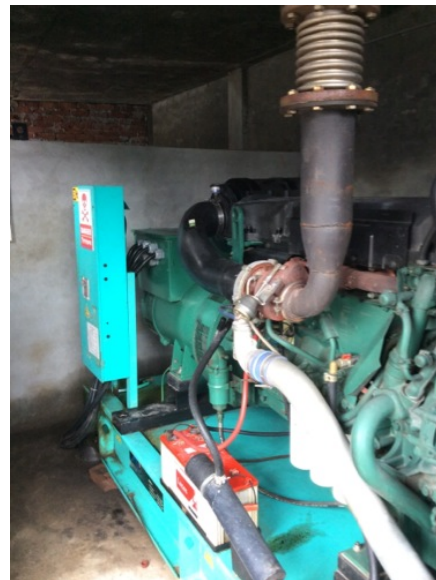
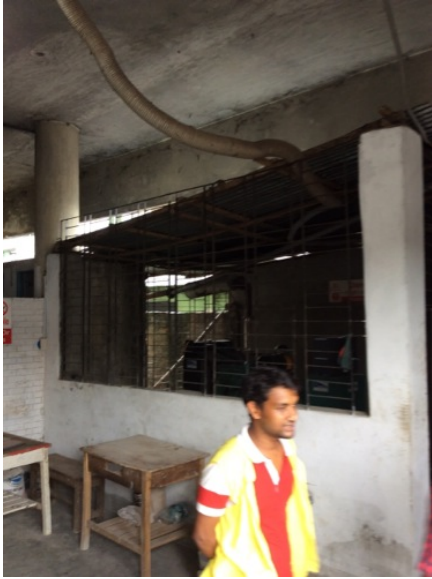
F-3	Fire Rated Construction	The boiler, generator and transformer, rooms is not separated by fire-rated construction (openings, non-rated doors, penetrations). Location: Ground and first floor.	Separate the boiler and generator, transformer rooms by a minimum 2-hr fire-rated construction. Seal and/or protected all openings to maintain the required fire separations	Within 3 months
-----	-------------------------	---	--	-----------------

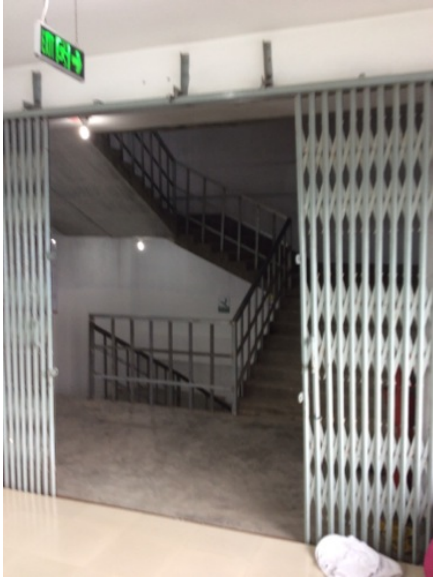
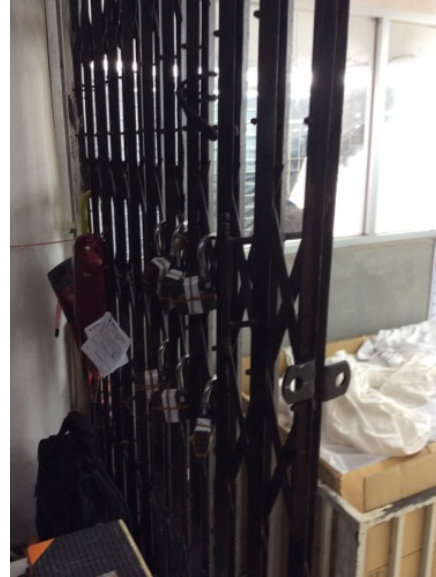
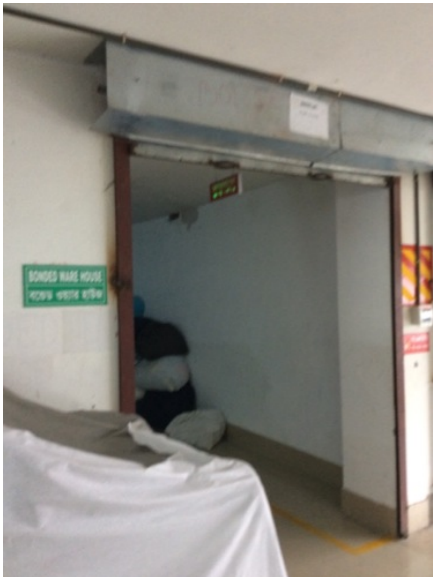
F-4	Egress	Exit capacity is not adequate for the occupant load. Location: Second floor available capacity is 506 and the occupancy is 553	Reduce occupant load to not more than available exit capacity. Provide additional exits.	Immediate
F-5	Egress	Egress doors / gates with locking features are provided at building exits, exit stairs, along egress routes, exit discharge. Location: On all floors all gates/doors were open and unlocked during the inspection.	Remove locking features from all egress doors / gates. If locks are required for security reasons, utilize special door locking features complying with NFPA 101.	Immediate

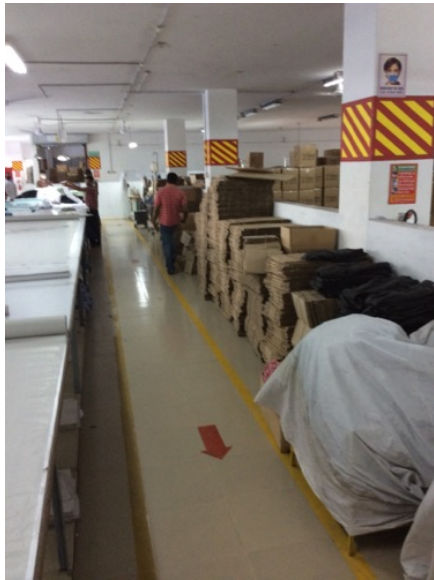
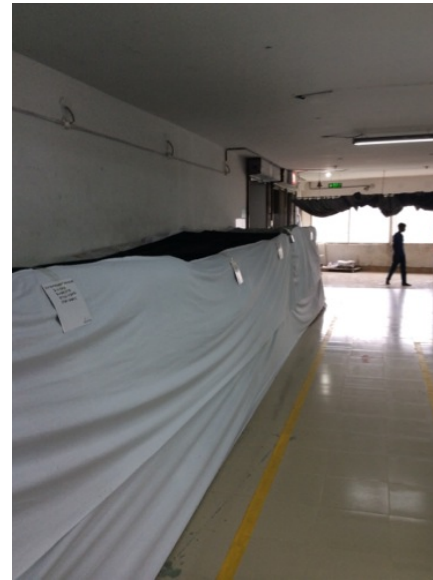
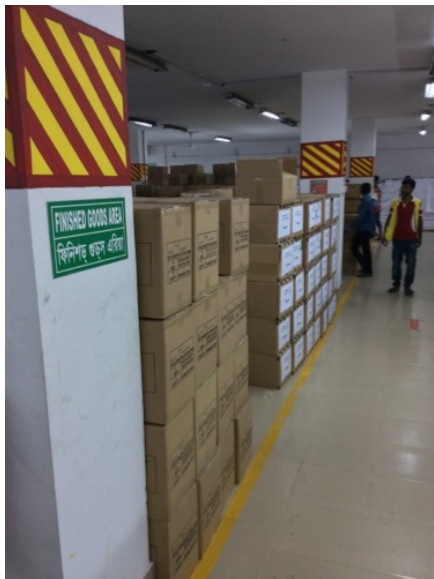
F-6	Egress	Storage was located in the egress path. Location: First and second floor.	Keep egress paths and stairs clear of storage.	Immediate
-----	--------	--	--	-----------

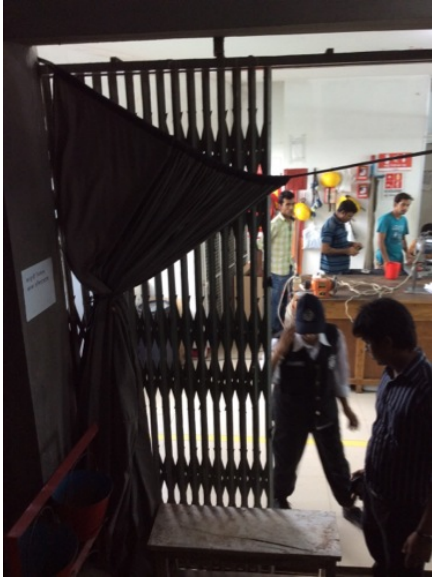
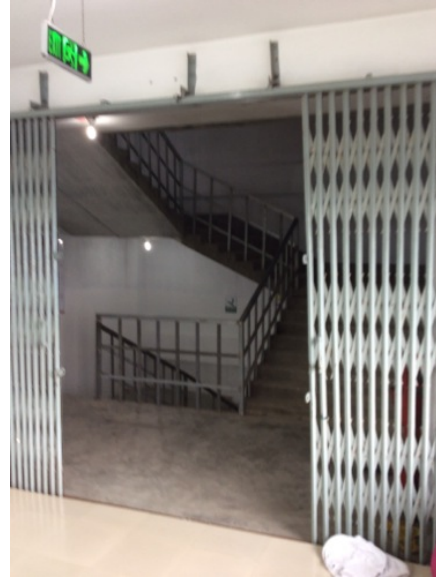
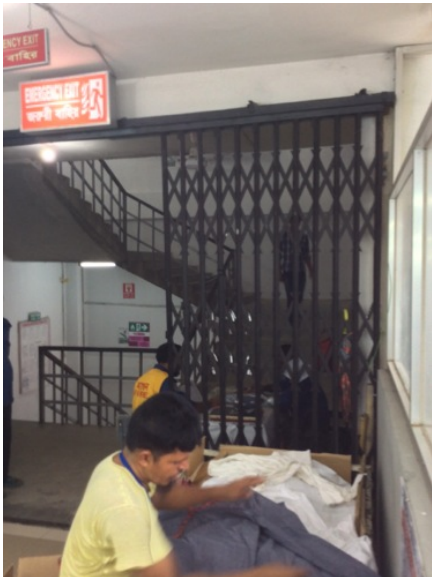
F-7	Egress	Collapsible gates / sliding doors are provided at building exits, exit stairs, along egress routes, exit discharge. Location: On all floors.	Replace all gates / sliding doors along the means of egress with side-hinged, swinging egress doors. If locks are required for security reasons, utilize special door locking features complying with NFPA 101.	Within 1 month
-----	--------	---	--	----------------

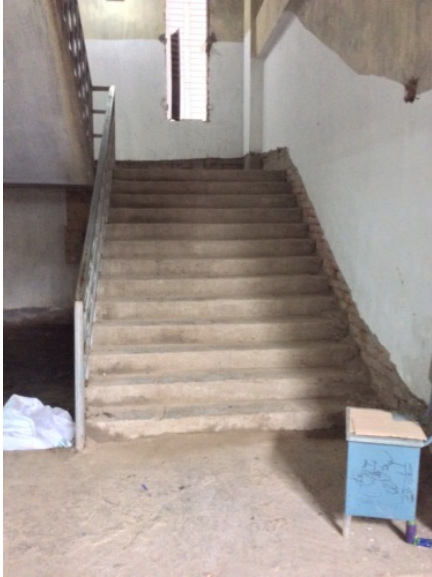
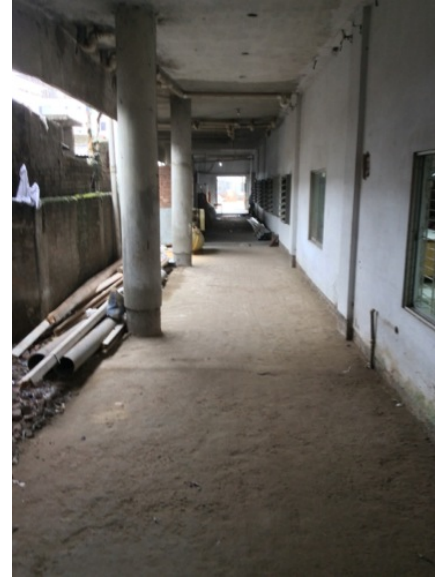
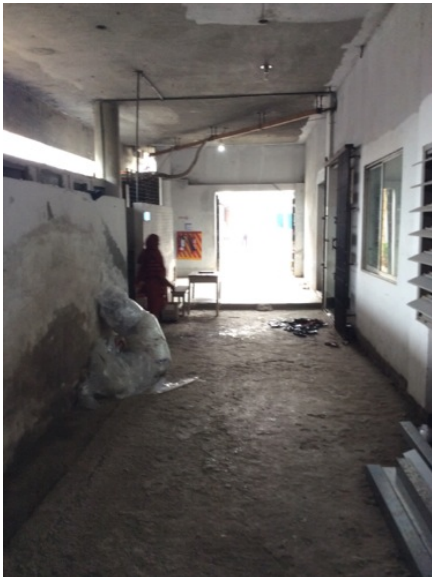
F-8	Egress	Exit stairs discharge inside the building. Location: Ground floor west stairwell discharges by factory floor with no fire rated construction and discharges out next to generator and transformer rooms with non fire rated construction.	Provide 2-hr fire-rated exit passageway leading directly outside (vestibules to separate any storage areas).	Within 6 months
-----	--------	--	--	-----------------
