Hop Lun Apparel Ltd. (Unit-2)

9 June, 2016

Client Summary report

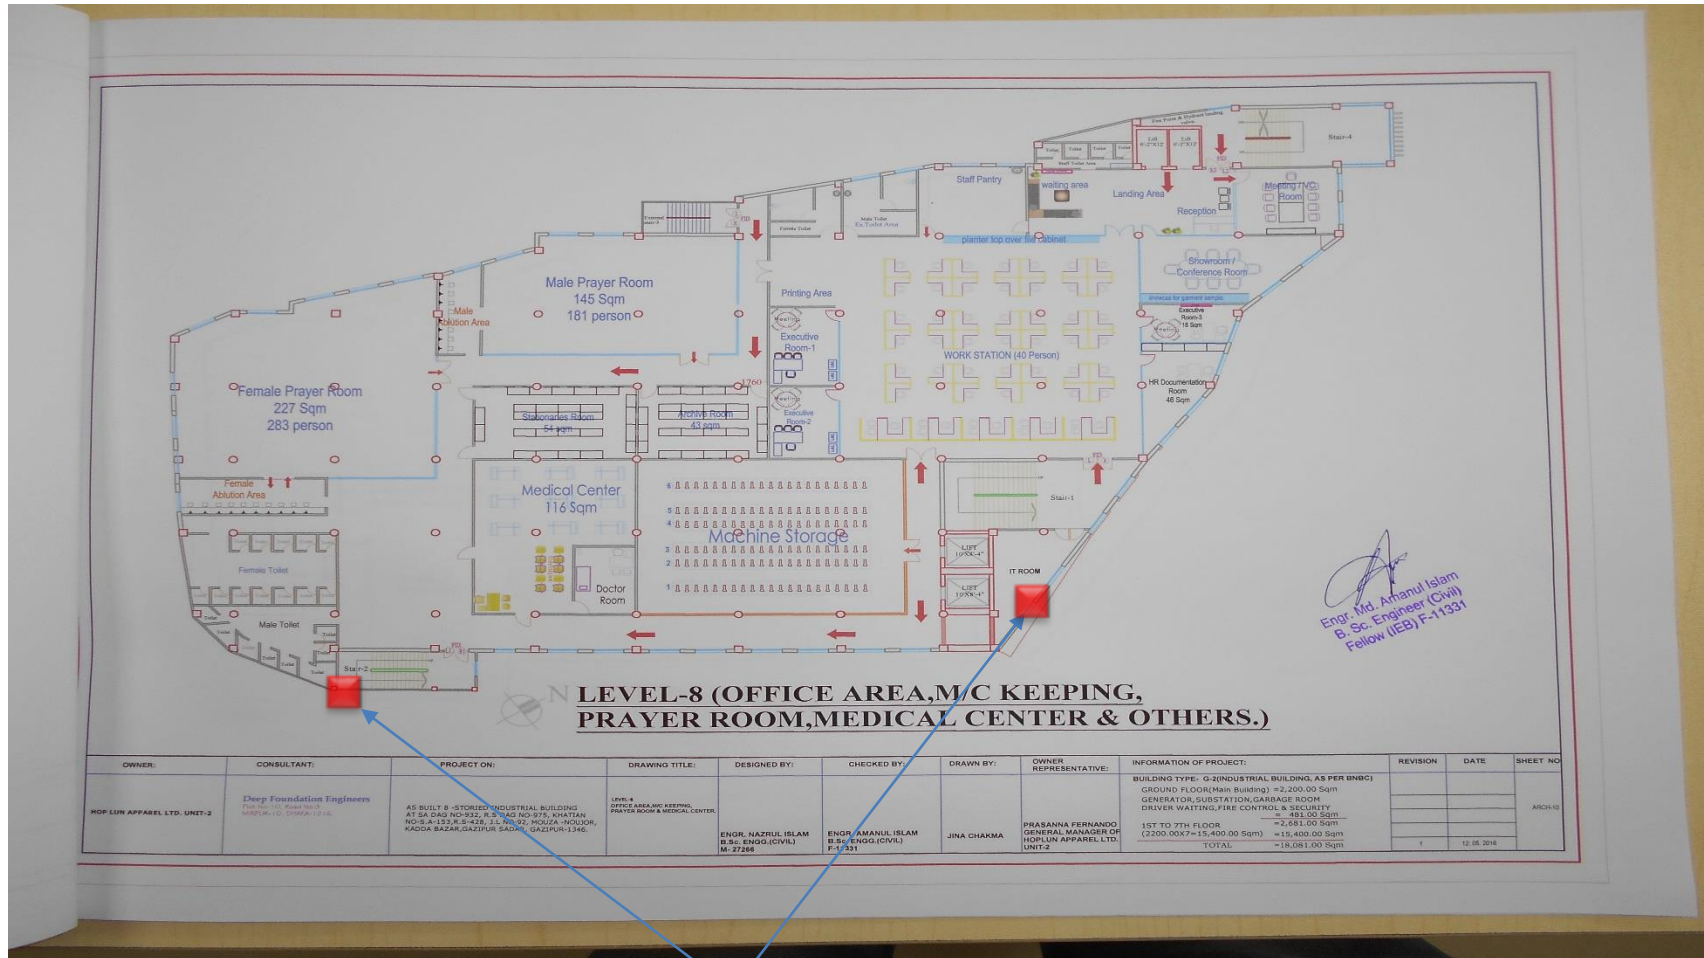
High stress in columns

Cursory calculation indicates that identified column stress exceeds allowable limit.

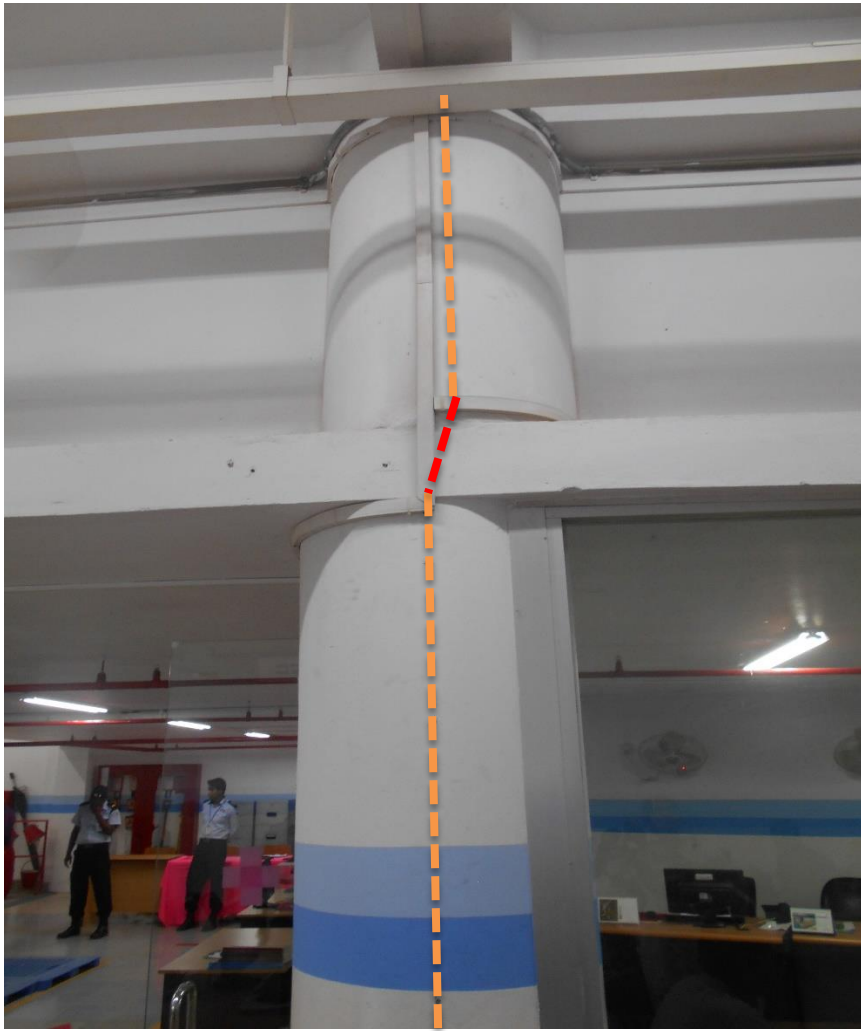
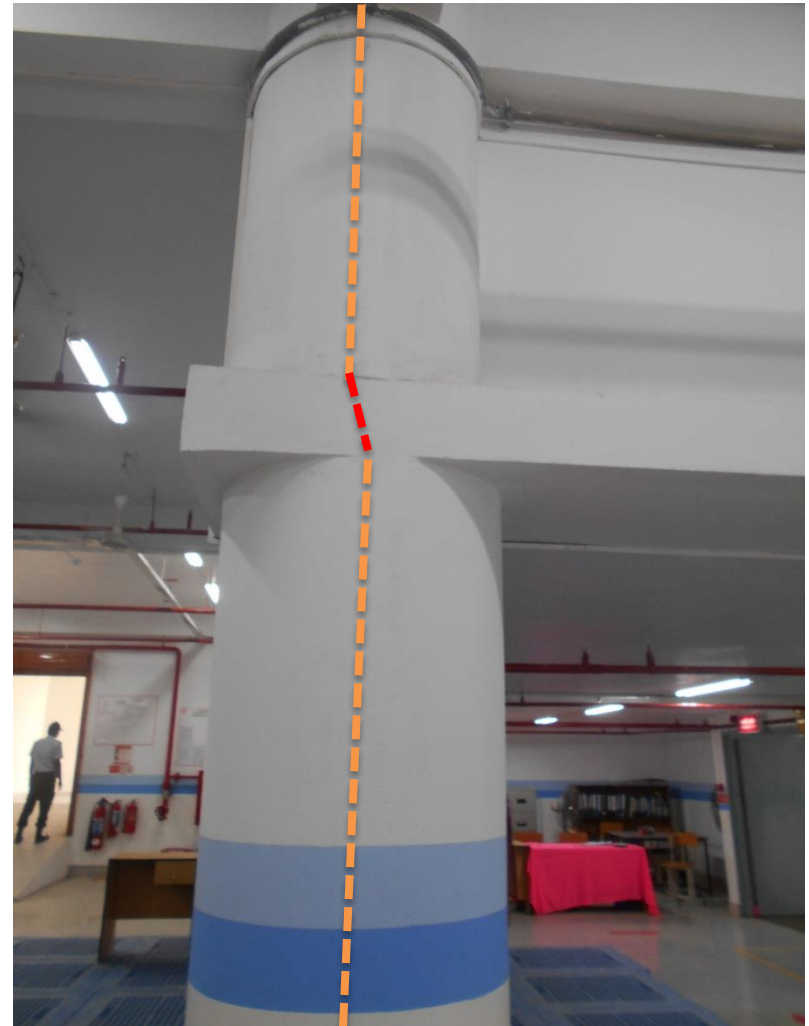
Offset column above mezzanine floor.

Columns above mezzanine floor were found offset from the ground floor columns. Column adequacy check is required for the eccentric load path.

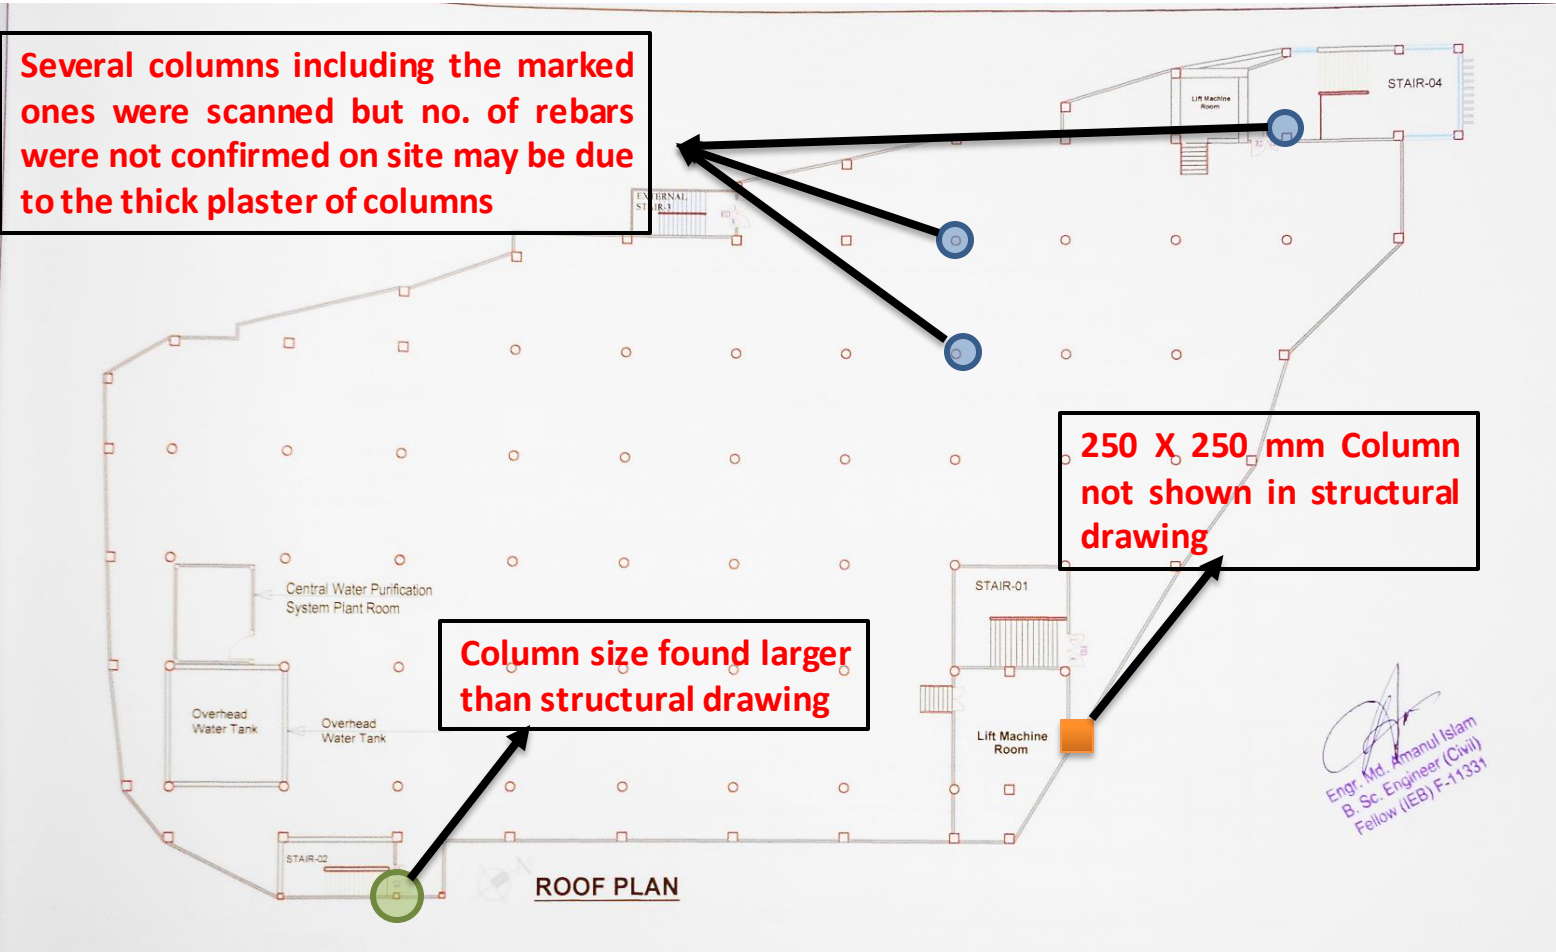
Inconsistencies between existing drawings and As built condition

Several columns including the marked ones were scanned but no. of rebars were not confirmed on site may be due to the thick plaster of columns

250 X 250 mm Column not shown in structural drawing

Column size found larger than structural drawing

Discrepancies between existing drawing & as built condition. In addition, no structural documents were found for the ancillary structures.
