# ELECTRICAL SAFETY INSPECTION REPORT

UHM LTD

Plot No: 240, 241, 242, 243 & 255, Adamjee Export Processing Zone,  
Siddhirgang, Narayanganj

Inspected on : August 7, 2016

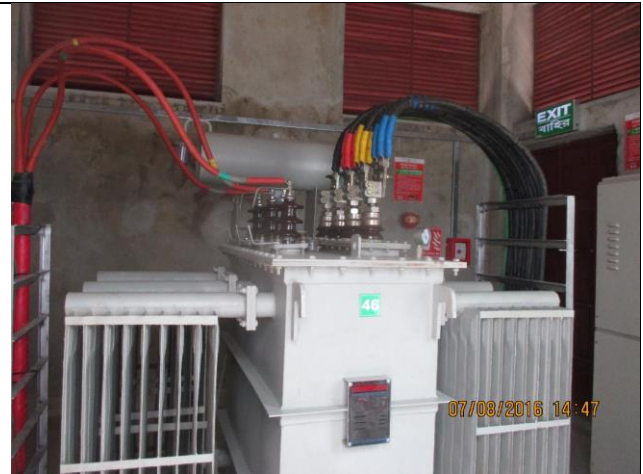
| <b>FINDING</b> | <b>E - 3</b> |

| <b>FINDING:</b><br><br>Substation room has inadequate ventilation. | |

| <b>RECOMMENDATION:</b><br><br>Ensure/Arrange cross ventilation substation room; | |

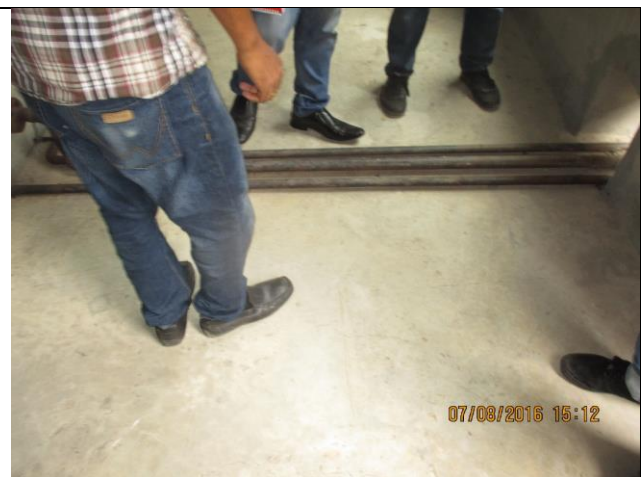
| <b>FINDING</b> | <b>E - 4</b> |

| <b>FINDING:</b><br><br>Improper and bare steam pipes formed obstacle in boiler room. | |

| <b>RECOMMENDATION:</b><br><br>Make the trench bearing floor height and cover it by appropriate materials. Again insulate the steam pipe properly. | |

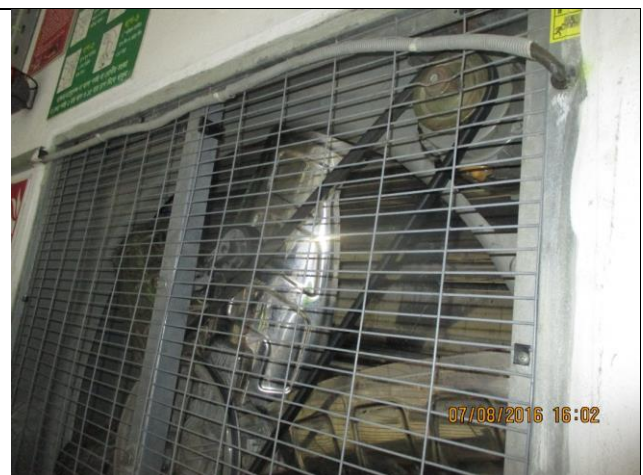
| <b>FINDING</b> | <b>E - 5</b> |

| <b>FINDING:</b><br><br>Exhaust fan body and metal enclosure has no earth connection. | |

| <b>RECOMMENDATION:</b><br><br>Ensure earth collection for exhaust fan motor frame and metal enclosures. | |
