# Bellissima Apparels Ltd

BSCIC, Inds Estate, Tungi, Gazipur, Bangladesh  
(23.8933359N,90.4099056E)

30 April 2014

# Building Observations

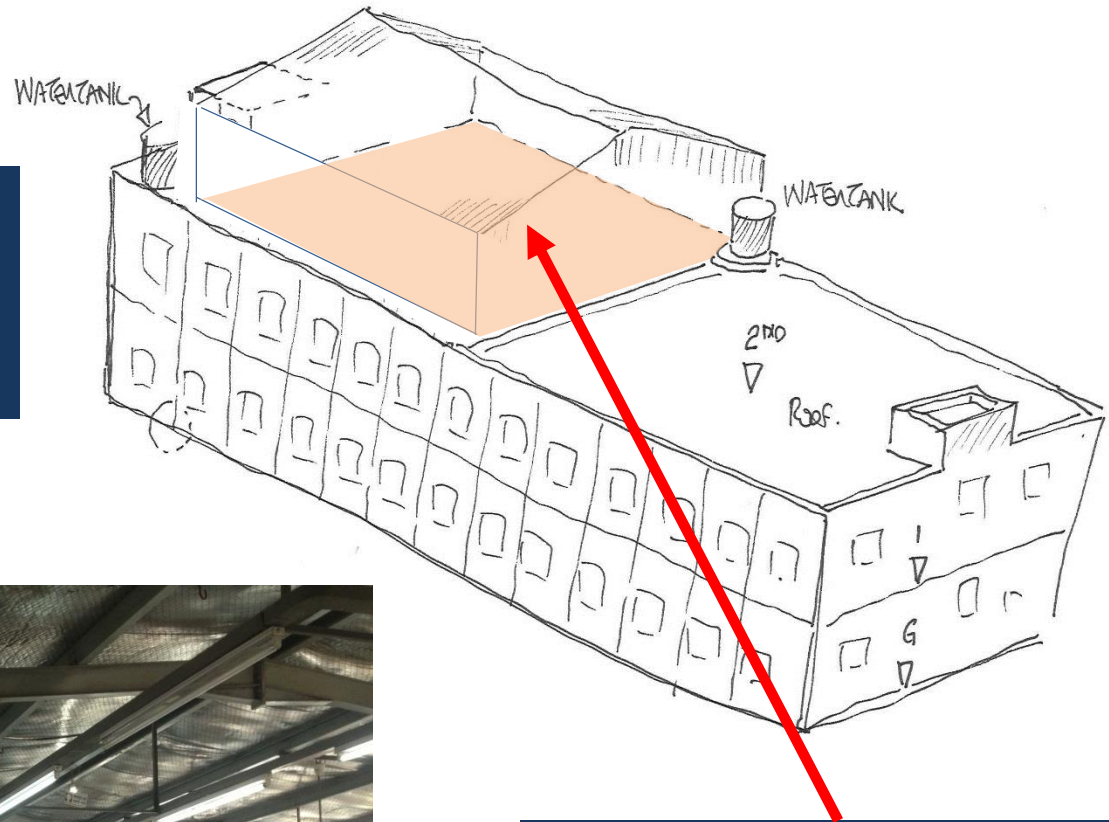
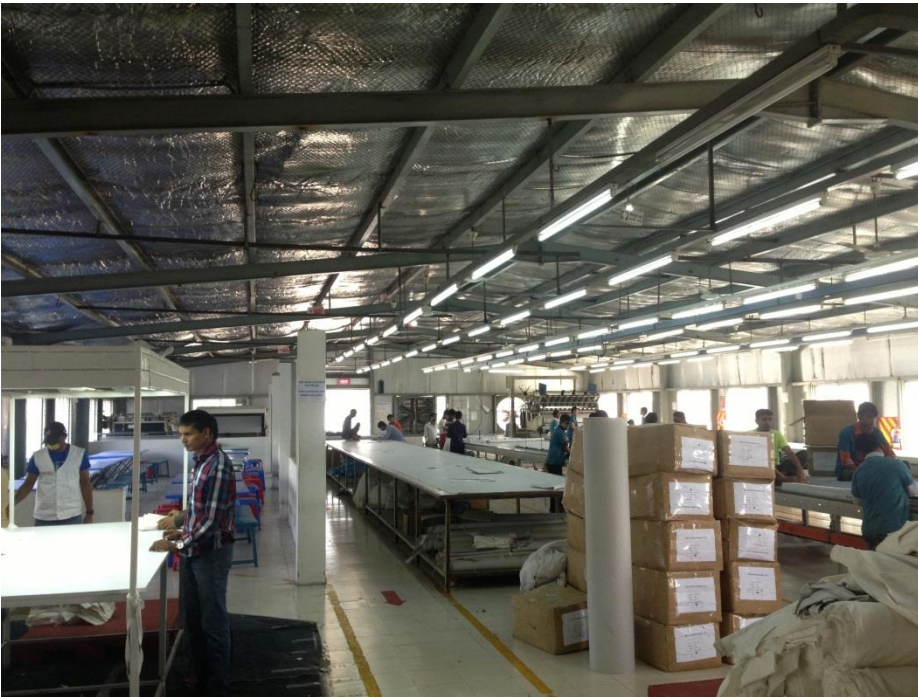
The use of a previously designed external roof area for production and propose canteen

The steel roof is recent and the roof is now a factory, with heavier loading including finishes.

Note: Beams and slab depths to level 2 are less than level 1.

| Item No. | Observation | Recommended Action Plan | Recommended Timeline |
|---|--|---|---|
| 1 | level 2 used for production, canteen, water tanks and toilet block when it appears that this level was designed as a roof area originally and without the current Steel Portal Framed roof | Limit all 2nd floor storage to 0.5m at max 50% floor area within single bay. | 6-weeks |
| 2 | level 2 used for production, canteen, water tanks and toilet block when it appears that this level was designed as a roof area originally and without the current Steel Portal Framed roof | Produce calculations for the 2nd floor slab and beams for new loading in steel frame area including factory activities, additional screed and steel column point load on beam below | 6-weeks |
| 5 | level 2 used for production, canteen, water tanks and toilet block when it appears that this level was designed as a roof area originally and without the current Steel Portal Framed roof | Implement a load plan for 2nd floor | 6-months |

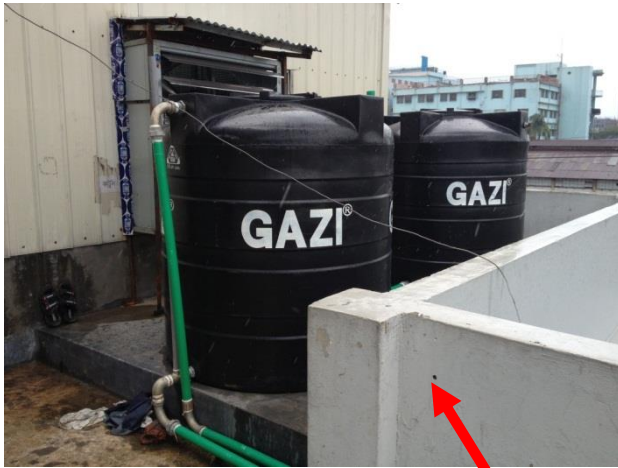
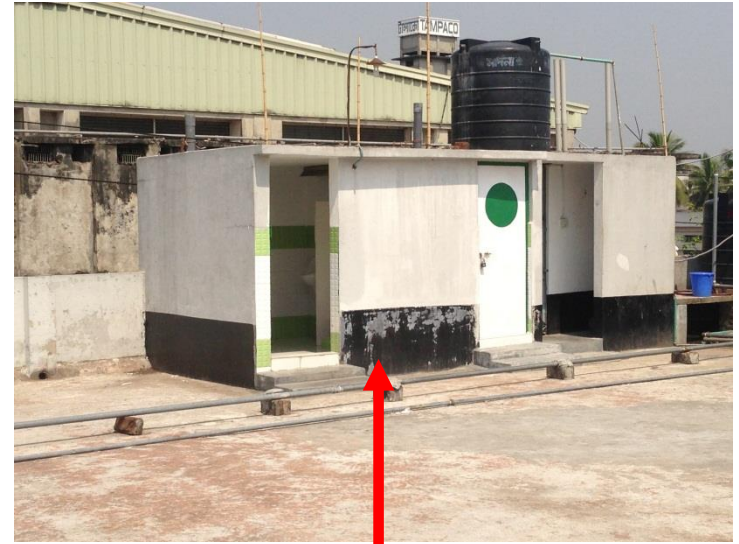
Concentrated loads due to additional toilet block + water tank located on roof slab

| Item No. | Observation | Recommended Action Plan | Recommended Timeline |
|---|--|---|---|
| 3 | level 2 used for production, canteen, water tanks and toilet block when it appears that this level was designed as a roof area originally and without the current Steel Portal Framed roof | Produce 2nd floor calculations for concentrate load such as water tank areas and toilet block (including plinth mounting). | 6-weeks |

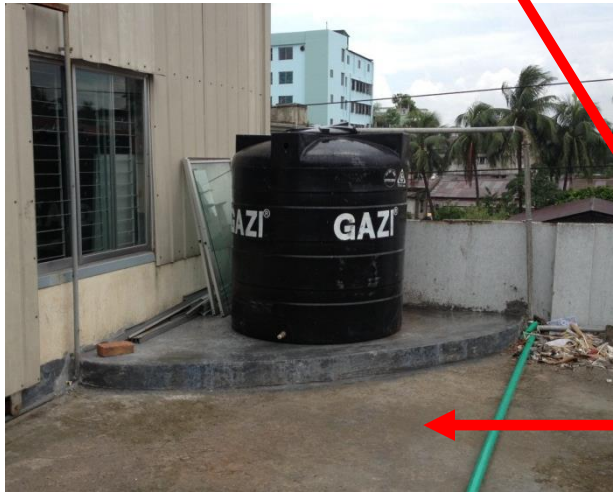
Concentrated loads due to water tanks located on roof slab

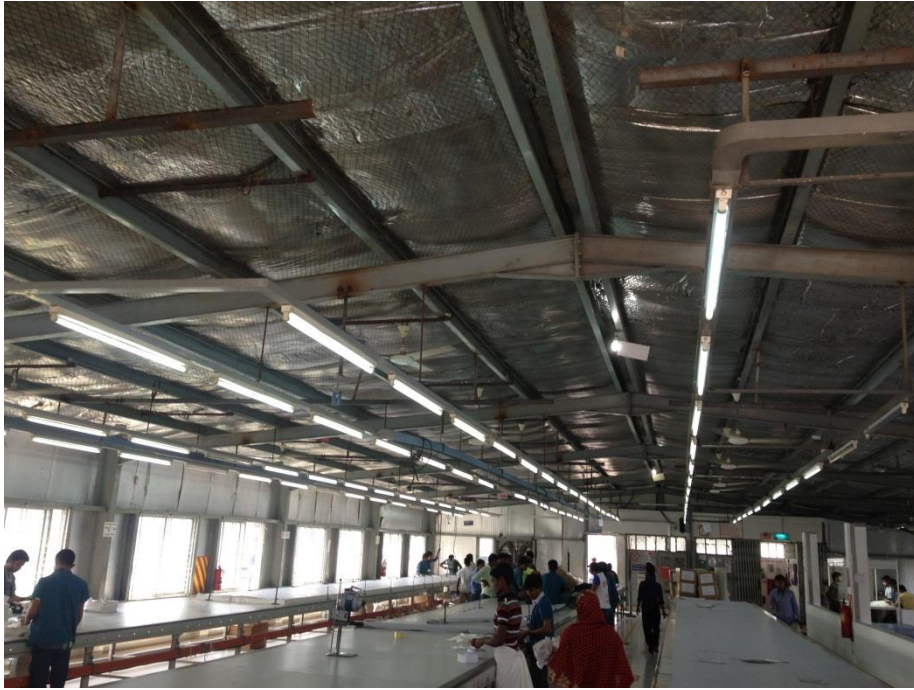
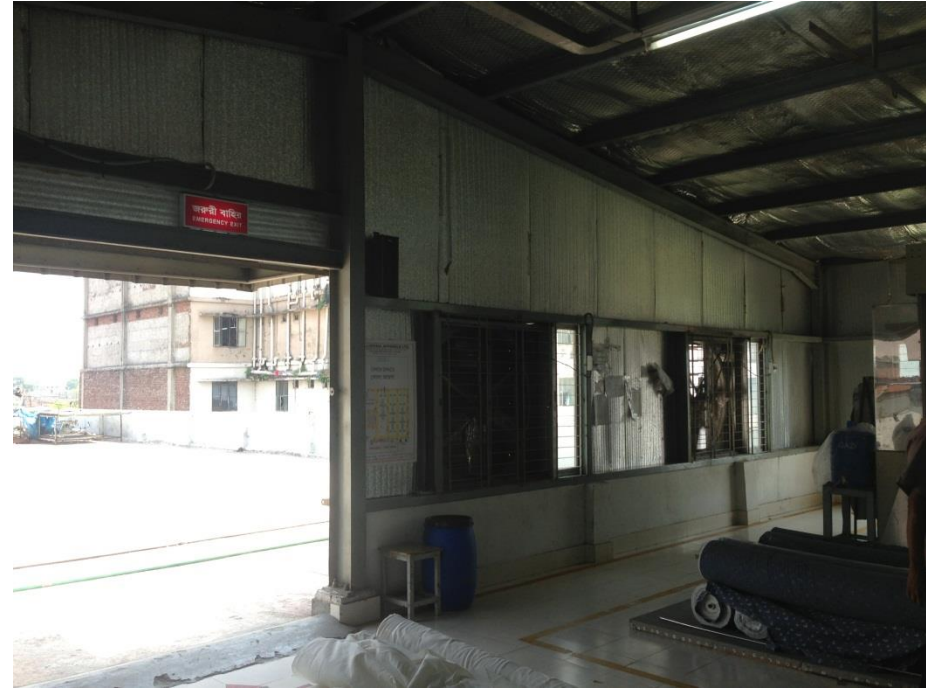
Addition of a new steel frame to the roof area (design check of steel frame including roof bracing requirement required)

| Item No. | Observation | Recommended Action Plan | Recommended Timeline |
|---|--|---|---|
| 6 | Addition of a new steel frame to the roof area (design check of steel frame including roof bracing requirement required) | Inspect and confirm adequacy of portal frame design including bracing in north south direction and base bolt connections. | <b>6-weeks</b> |
| 7 | Addition of a new steel frame to the roof area (design check of steel frame including roof bracing requirement required) | Implement any strengthening specified by the building engineer. | <b>6-months</b> |

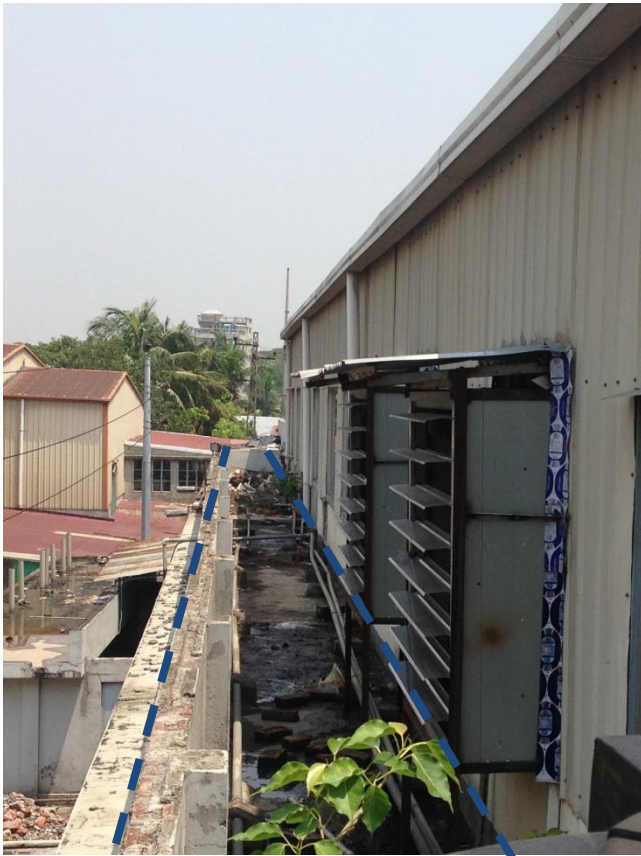
Column under alignment

Steel portal alignment

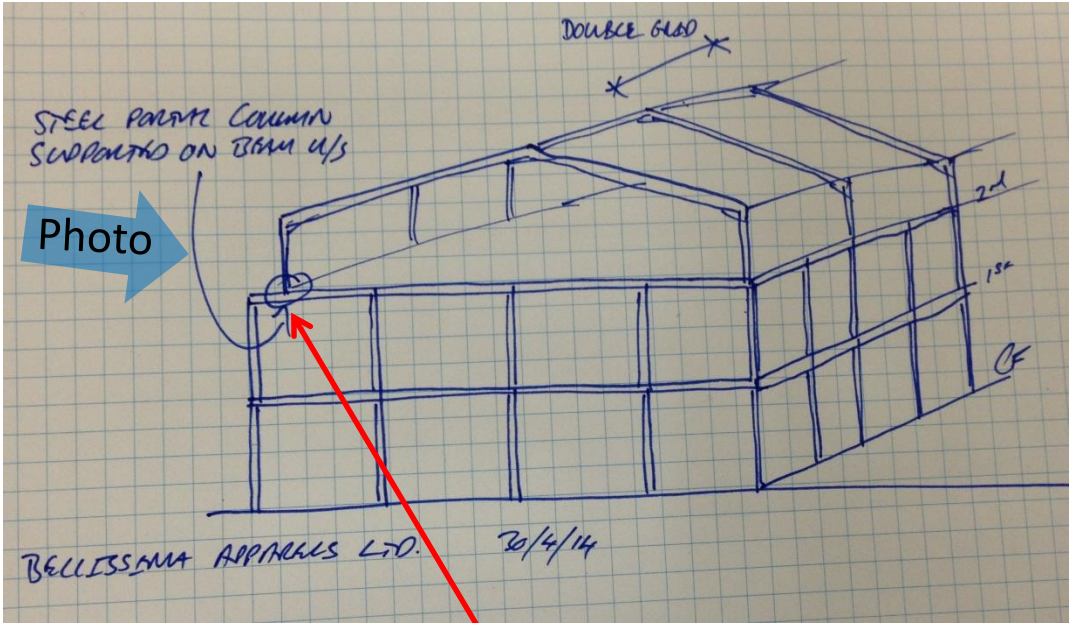
Existing concrete beams, acting as effective transfer beams, support new steel roof portal columns

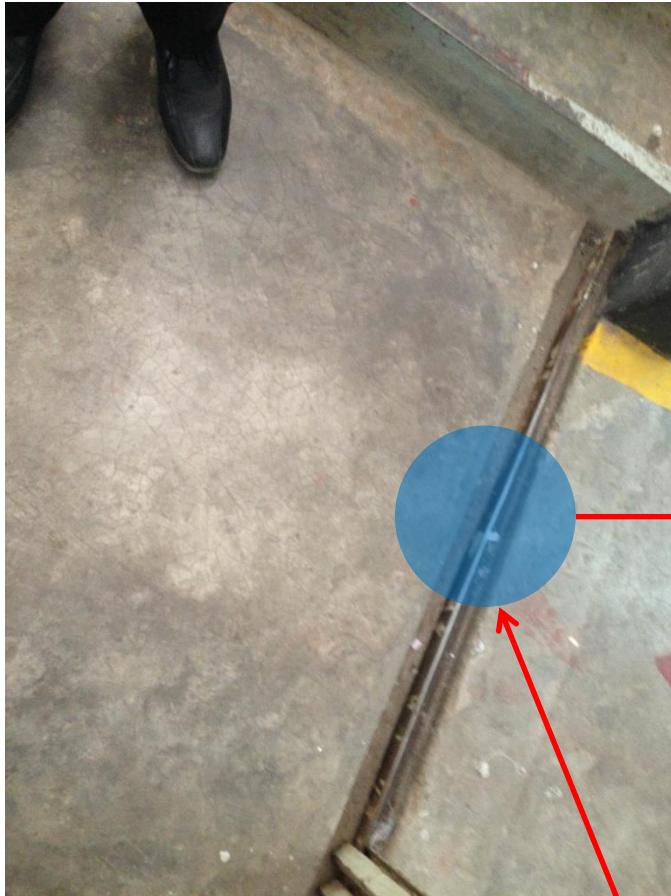
**Chasing in concrete slab for door sill guide.**

| Item No. | Observation | Recommended Action Plan | Recommended Timeline |
|---|--|---|---|
| 8 | As-Built Drawings do not match what was observed on Site | Review rebate and determine adequacy of slab depth and reinforcement cover | <b>6-weeks</b> |

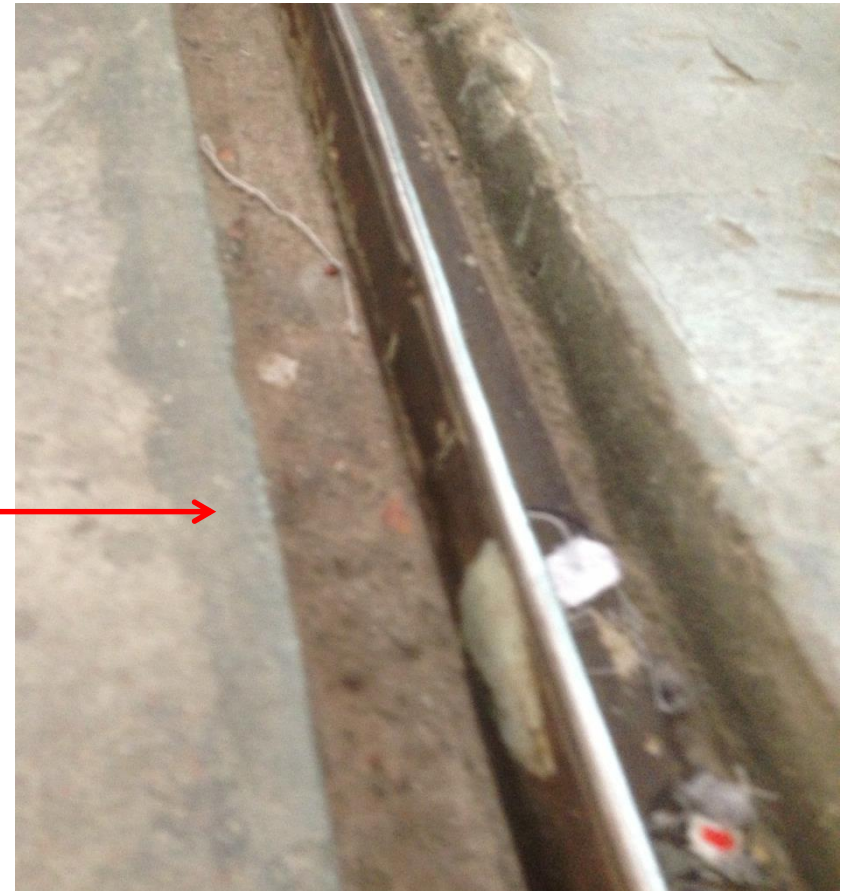
Detail

Chasing in concrete slab for door sill rail (check rebate has not compromised the reinforced concrete slab and beam)

| Item No. | Observation | Recommended Action Plan | Recommended Timeline |
|---|--|---|---|
| 9 | As-Built Drawings do not match what was observed on Site | Implement any strengthening specified by the building engineer. | <b>6-months</b> |
