Baridhi Garments Limited

SFB#7, Comilla Export Processing Zone, Comilla, Bangladesh
(23.444001N, 91.183039E)

20th June 2016

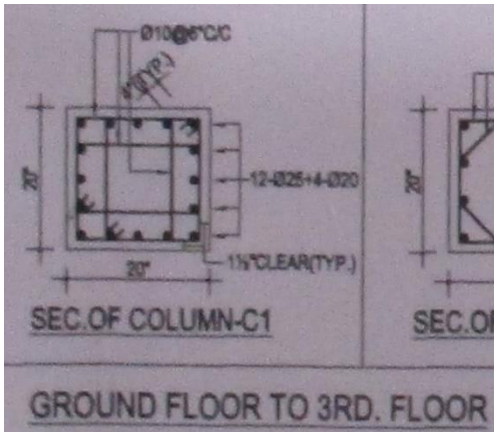
Detail scan found 4 rebar on one side but column schedule shows 5 rebar on both side.

Item No.	Observation	Recommended Action Plan	Recommended Timeline
1	Discrepancies between as-built drawings and site observations	Produce a set of as built drawings	6-weeks
2	Discrepancies between as-built drawings and site observations	Produce an actively managed load plan considering slab, beam and column capacity	6-weeks
3	Discrepancies between as-built drawings and site observations	Implement load plan.	6-months
4	No water proofing at roof	Provide Water Proofing layer on roof.	6-months
5	Damp on ground floor slab under toilet area	Take proper action to prevent water ingress in slab to protect slab from possible corrosion.	6-months
6	Poor connection between roof shed and brick column	Connection of roof shed and wall should be checked for uplift force.	6-months

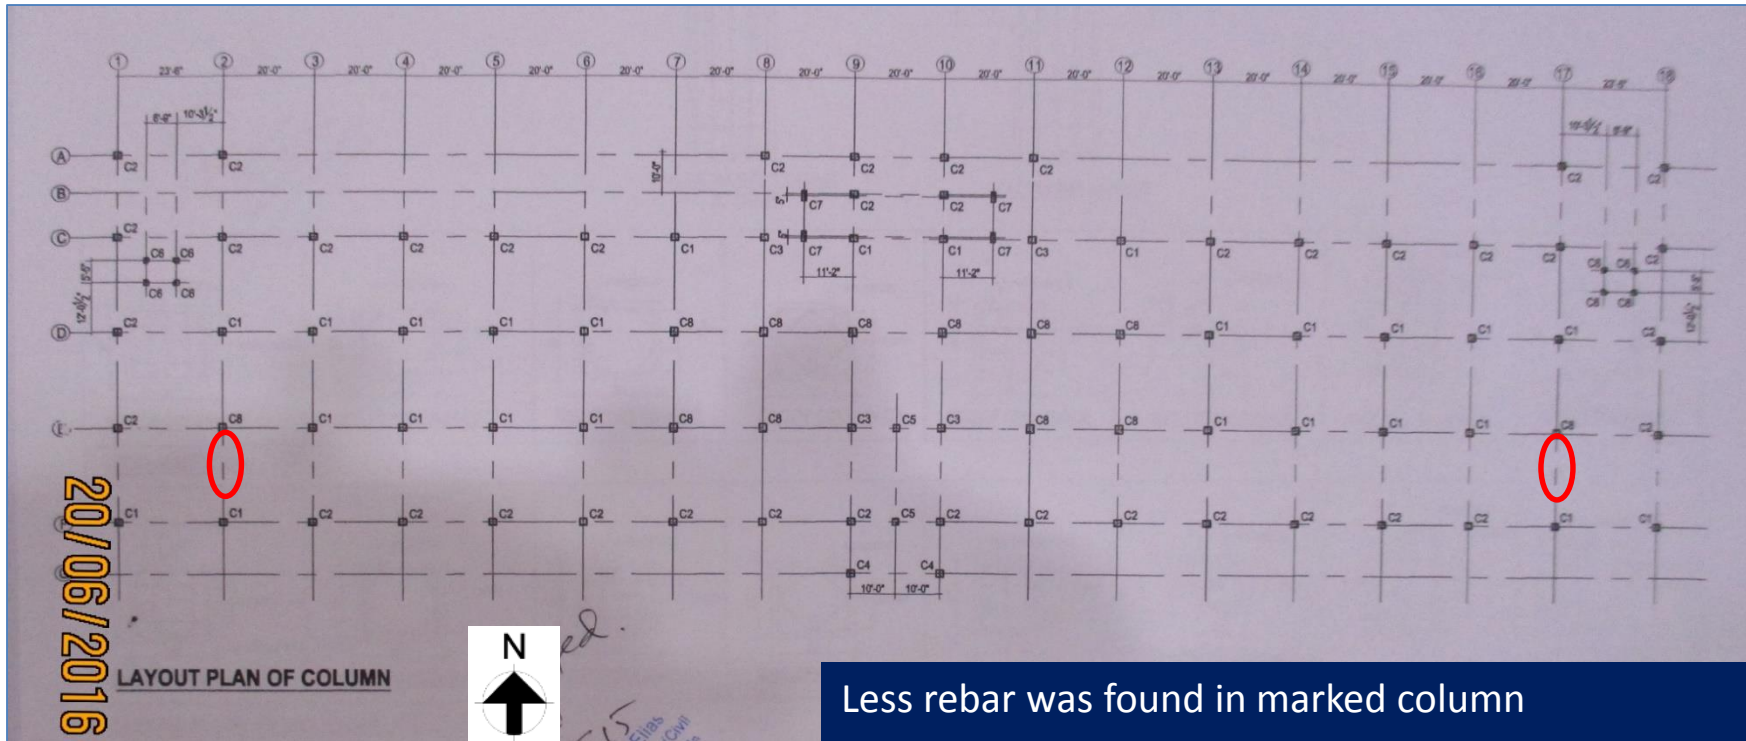
Less rebar was found in marked column

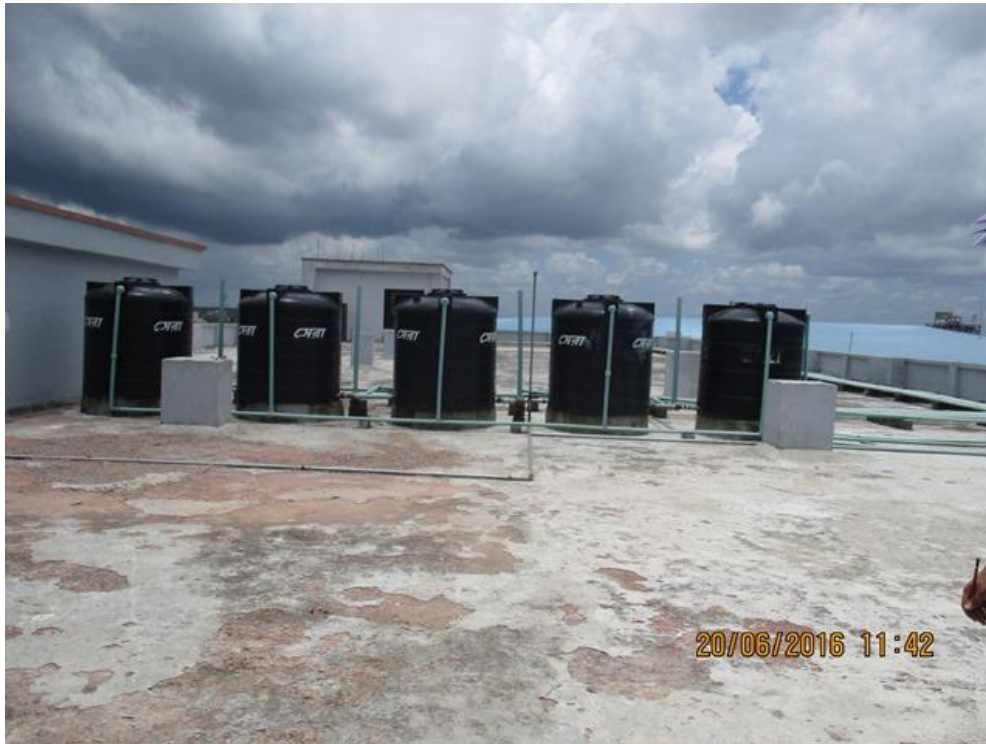
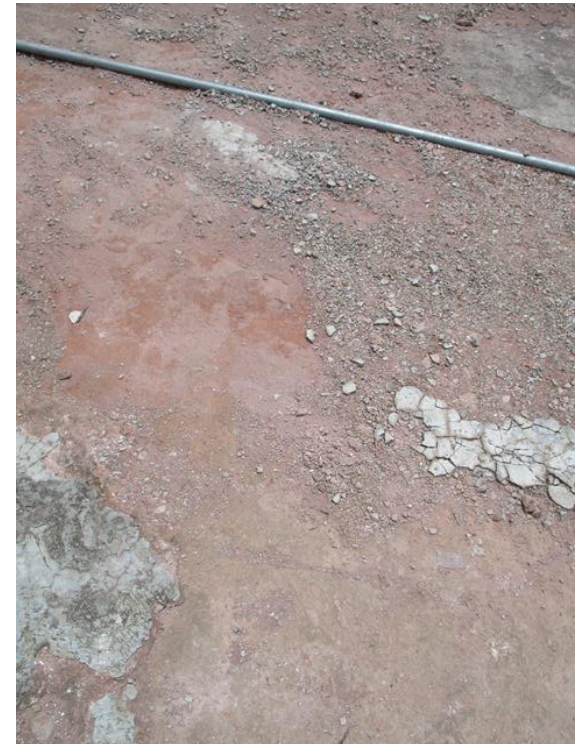
No water proofing at roof.

Damaged water proofing material at roof.

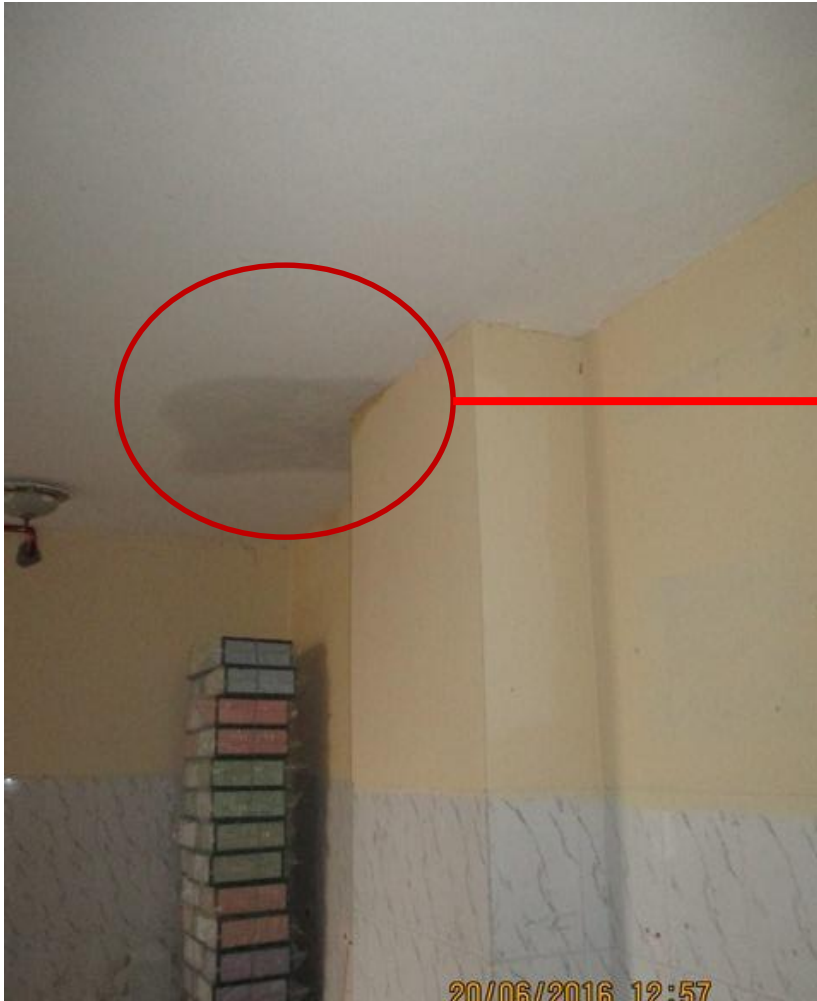
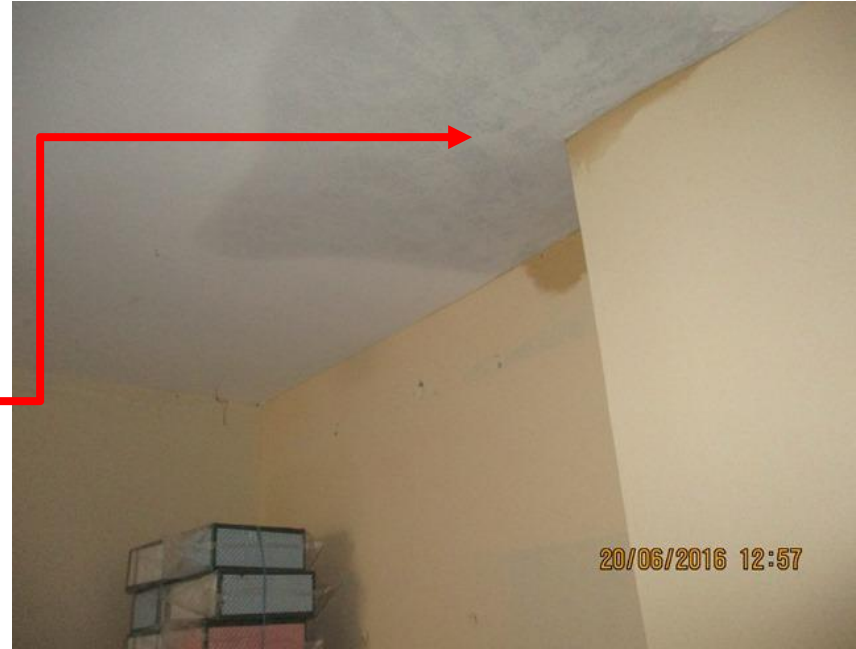
Damp on ground floor slab under toilet area.

Dampness observed at GF floor slab under toilet area.

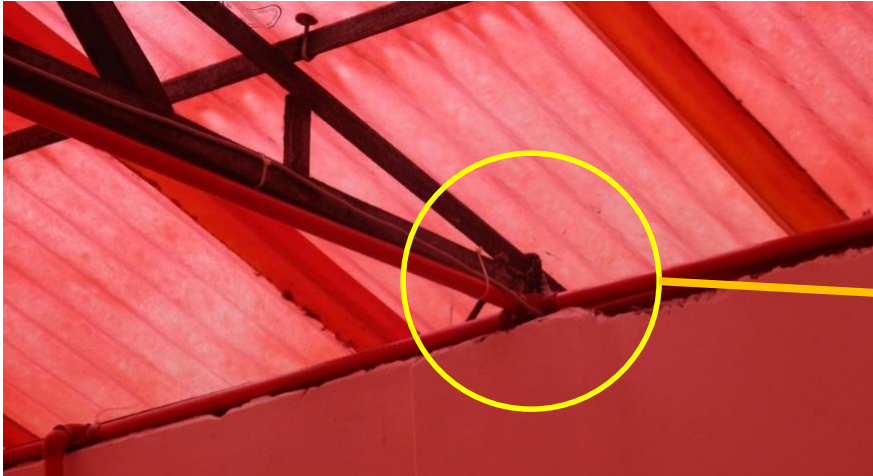
Poor connection with brick wall and roof shed..

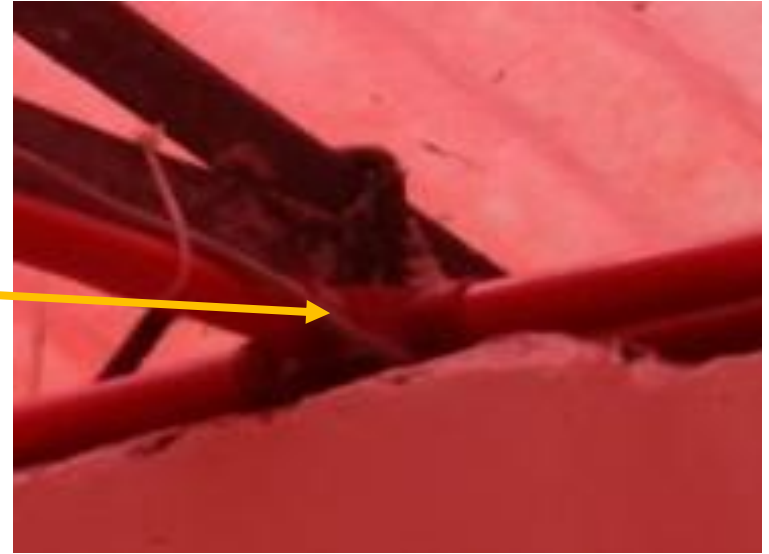
Improper connection was found between roof shed and wall.

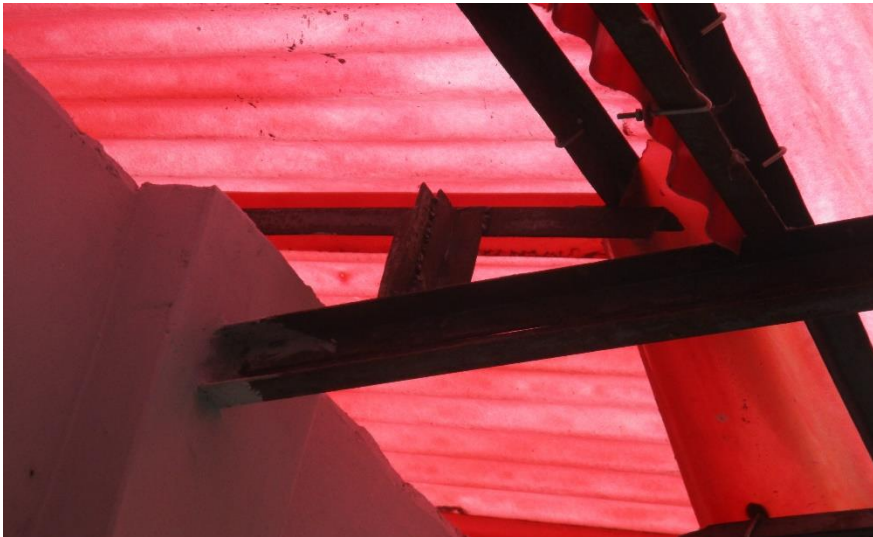
Poor connection with brick wall and roof shed..
