# **FIRE SAFETY INSPECTION REPORT**

**KANIZ FASHIONS LTD**  
**228/A, TEJGAON INDUSTRIAL AREA**

**ACCORD**  
on Fire and Building Safety in Bangladesh

April 5, 2014

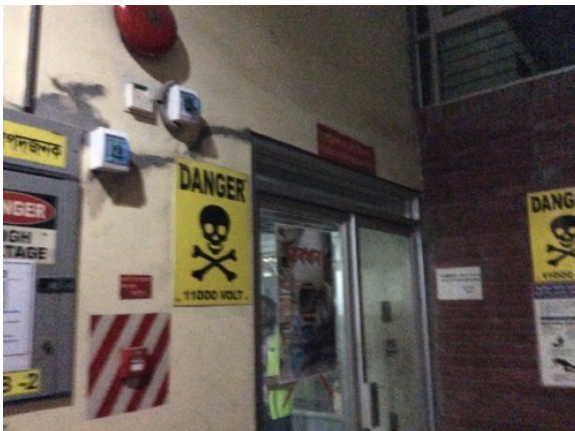
| No. | Category | Finding | Recommendation | Remediation Timeframe |
|---|---|---|---|---|
| F-1 | Fire Rated Construction | The Boiler/Generator/Transformer room is not separated by fire-rated doors from the surrounding areas. | Separate the Boiler/Generator/Transformer room by a minimum 2-hr fire-rated construction. Seal and/or protected all openings to maintain the required fire separations | Within 3 months |

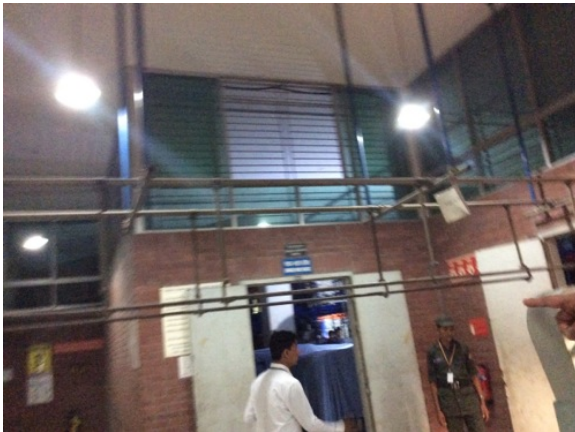
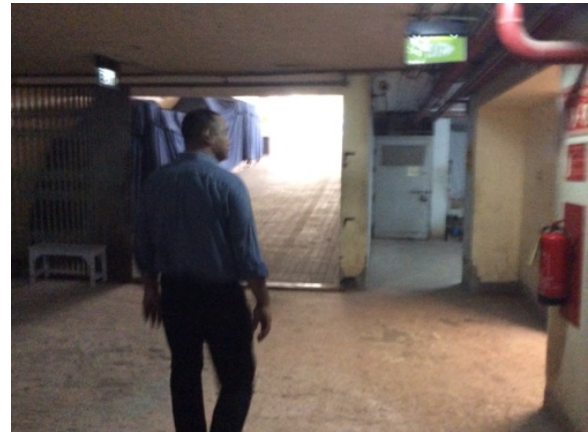
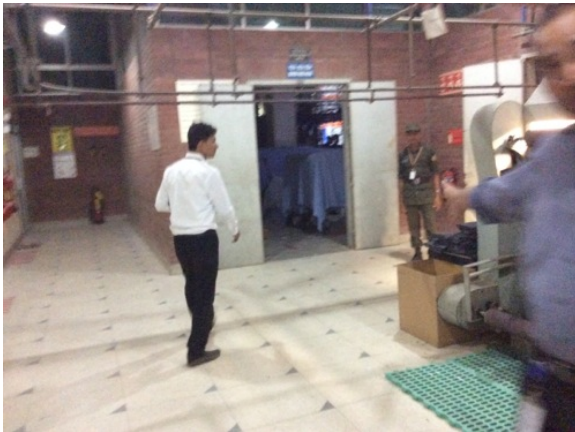
| F-2 | Fire Rated Construction | Areas used for combustible storage are not separated by fire-rated construction, due to non-fire-rated doors and vent openings. | <p>Provide dedicated storage rooms separated by minimum 1-hr fire-rated construction.</p> <p>Where separate storage rooms are not feasible, provide defined storage areas and limit the storage arrangement as follows:</p> <ul style="list-style-type: none"><li>- Maximum height of 2.4m and maximum area of 23m<sup>2</sup></li><li>- If sprinkler protected: maximum height of 3.66m and maximum area of 93m<sup>2</sup></li></ul> <p>Separate areas of unenclosed combustible storage by a minimum clear distance of 3m.</p> | Within 3 months |

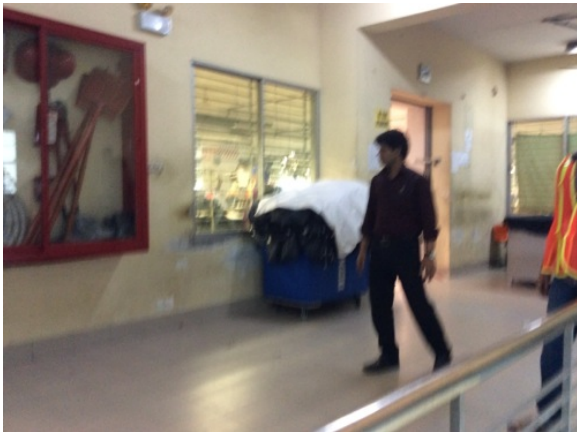
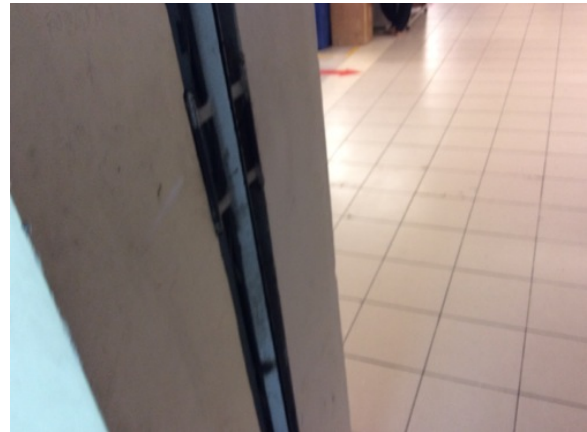
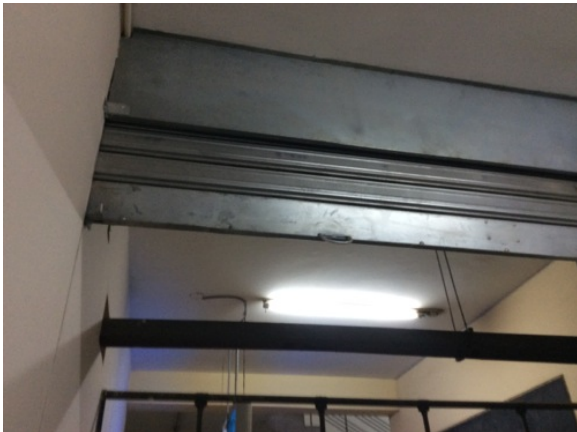
| F-3 | Fire Rated Construction | The North and Southwest exit stairs are not separated from work areas and other spaces on each floor by fire-rated construction. Non-fire-rated doors and unprotected window openings connect the stairs to the factory floor. | <p>Provide minimum 1.5-hr fire rated doors and seal all unprotected openings to separate the exit stairs from work areas and other building spaces on all floor levels. Ensure that the fire doors are self-closing and positive latching and that they are provided with fire exit (panic) hardware where serving production floors.</p> <p>If fire doors are required to be held open for functional reasons, provide automatic-closing devices tied to the fire alarm system.</p> | Within 3 months |

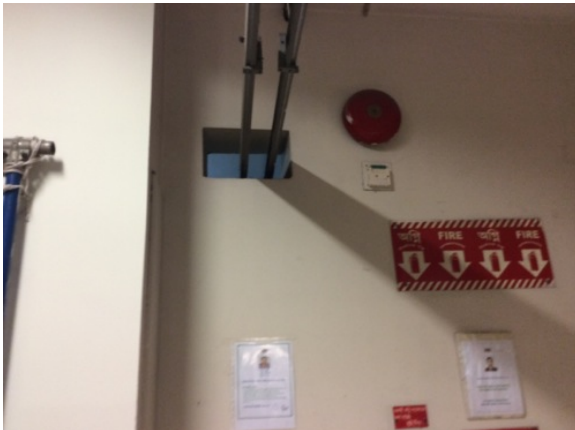
| F-4 | Fire Rated Construction | Unsealed penetrations and openings are located in exit stair enclosures. | Seal all penetrations and openings in exit stair enclosure walls to maintain the fire separation. | Within 3 months |

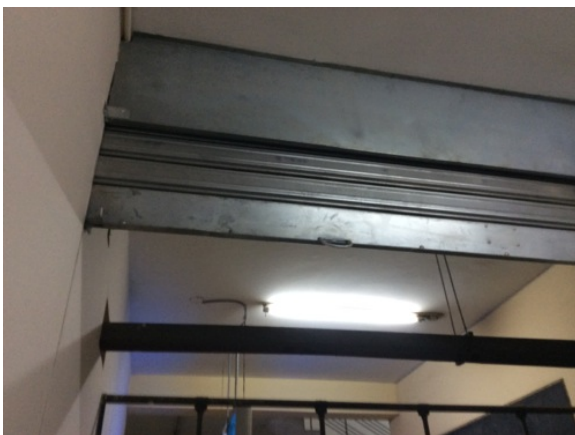
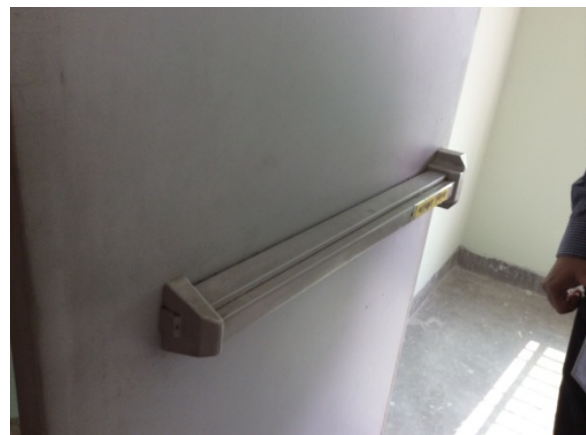
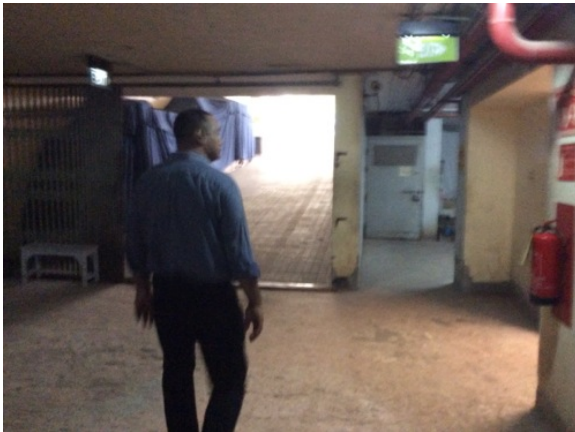
| F-5 | Egress | <p>Egress doors and gates with locking features were provided at building exits, exit stairs, and exit discharge.</p> <p>Only the doors on the Southeast stair were provided with panic hardware.</p> | <p>Remove locking features from all egress doors and gates.</p> <p>If locks are required for security reasons, utilize special door locking features complying with NFPA 101.</p> | Immediate |

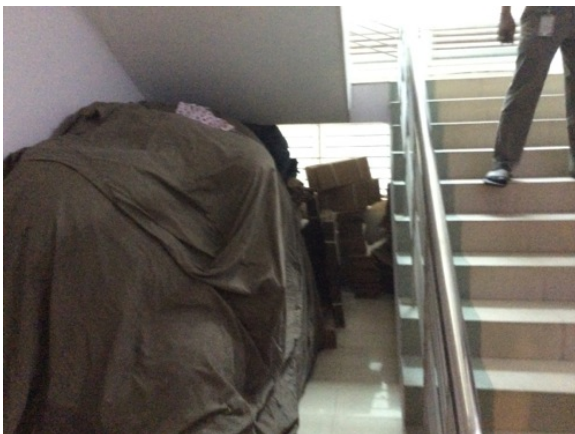
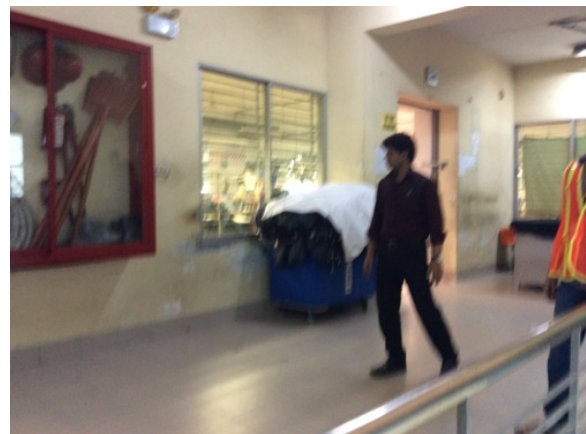
| F-6 | Egress | Storage was located in the exit stair. | Remove all storage from exit stairs and egress paths. | Immediate |
| | | A large pile of combustible storage was located at the base of the Southwest exit stair on the 1st floor landing. Multiple carts of combustible items were observed on exit stair landings. | | |

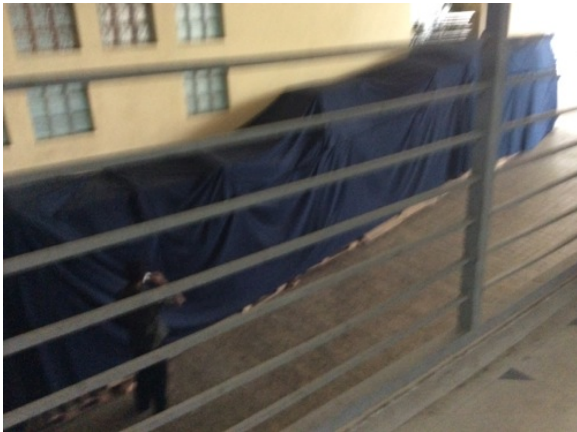
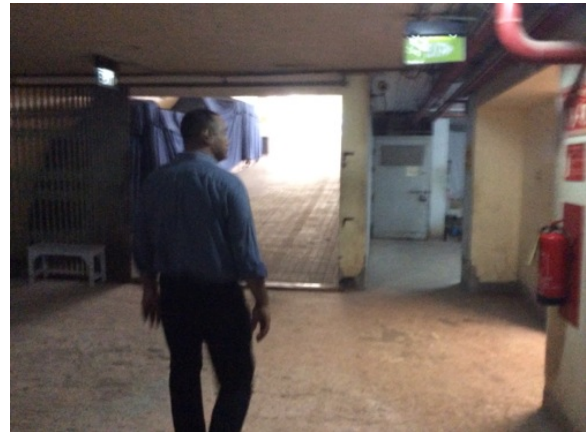
| F-7 | Egress | A significant amount of storage was located on the ramp from the basement storage. | Keep egress paths and stairs clear of storage. | Immediate |

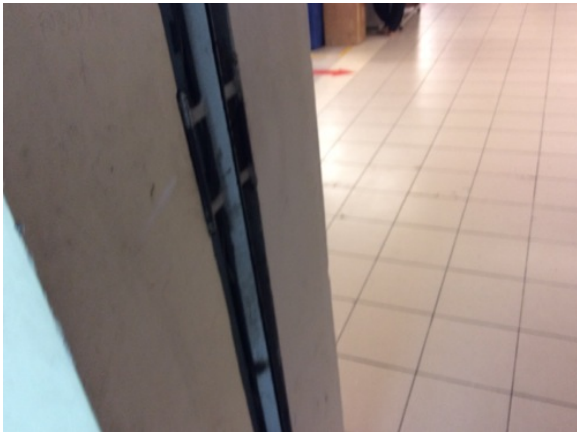
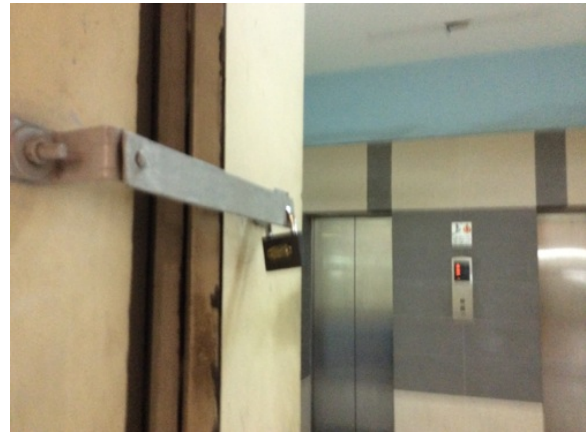
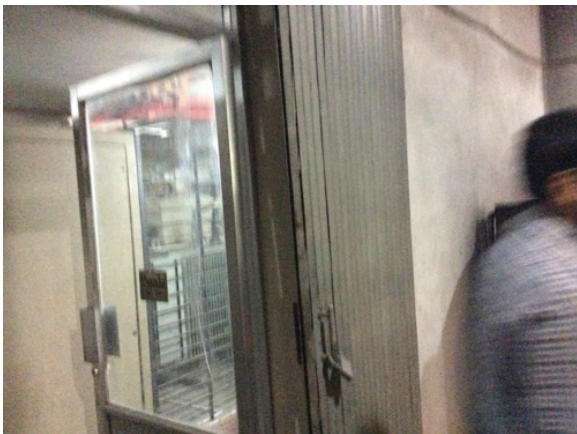
| F-8 | Egress | Collapsible gates and sliding doors are provided at North and Southwest exit stair openings. | Replace all gates / sliding doors along the means of egress with side-hinged, swinging egress doors.<br><br>If locks are required for security reasons, utilize special door locking features complying with NFPA 101. | Within 3 months |
