# Scarlet Knitwears Ltd.

Plot #B-160-163, Bscic Industrial Estate, Fatullah, Narayangonj, Dhaka

26 April 2014

# Building Observations

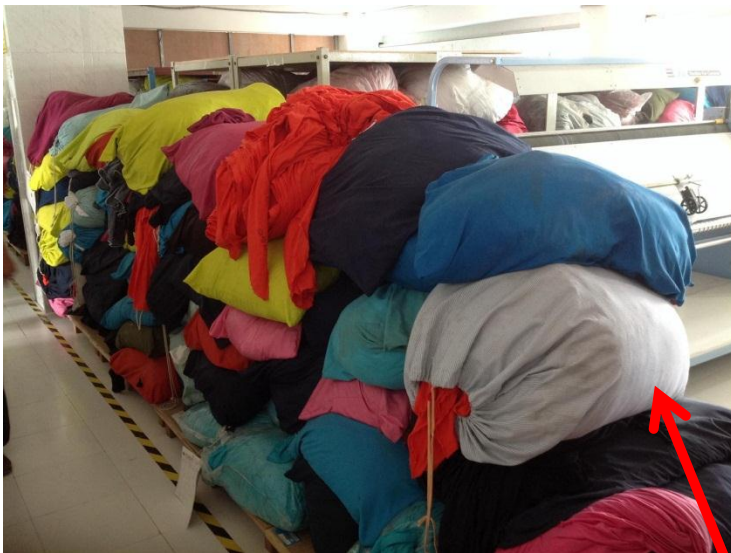
9<sup>th</sup> floor storage area

**Uncontrolled stacking  
of materials.**

**Areas of high loading on suspended  
structure. Floor load management  
system incomplete as no loading plans  
or loading height limits displayed.**

- Produce and actively manage a loading plan for all floor plates within the factory giving consideration to floor capacity and column capacity.
- Continue to implement load management plan

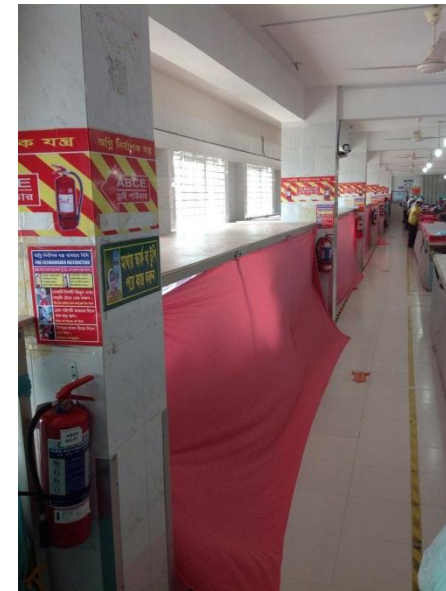
8<sup>th</sup> Floor - Possible storage space on cantilever

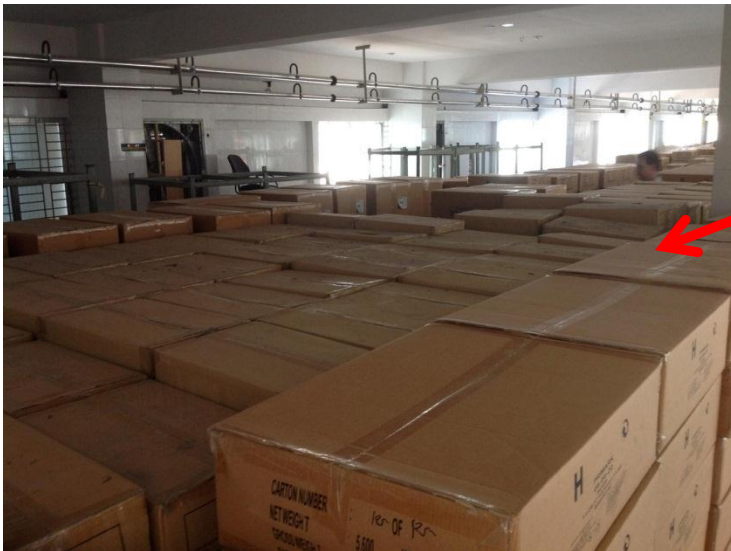
1<sup>st</sup> Floor Storage Area

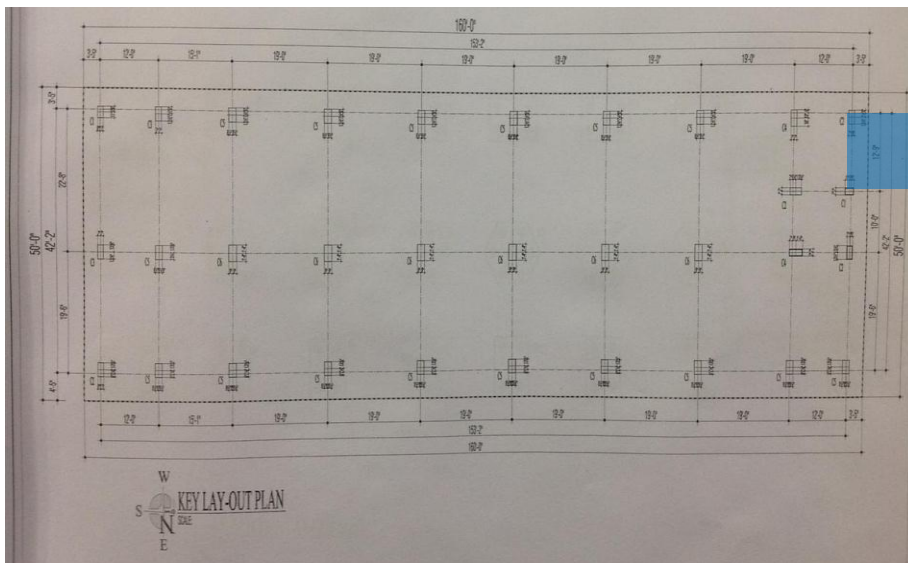
**Lateral stability of  
external hoist surround  
not apparent. Engineer  
to review.**

- The stability of the surround to the external hoist should be reviewed by the Building Engineer and, if required, upgraded to support code vertical and wind loads or the assembly should be removed.

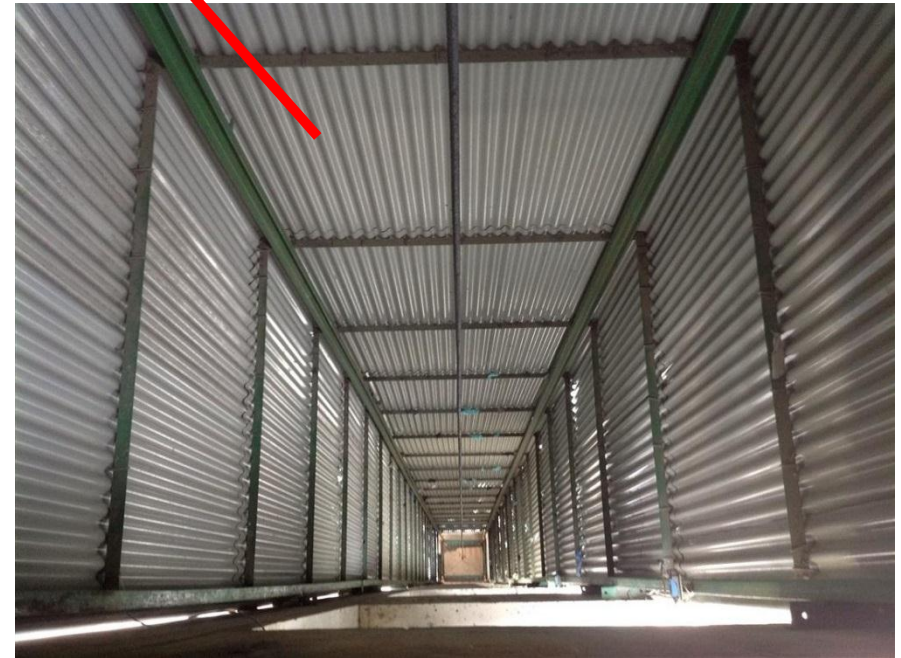
**External hoist**

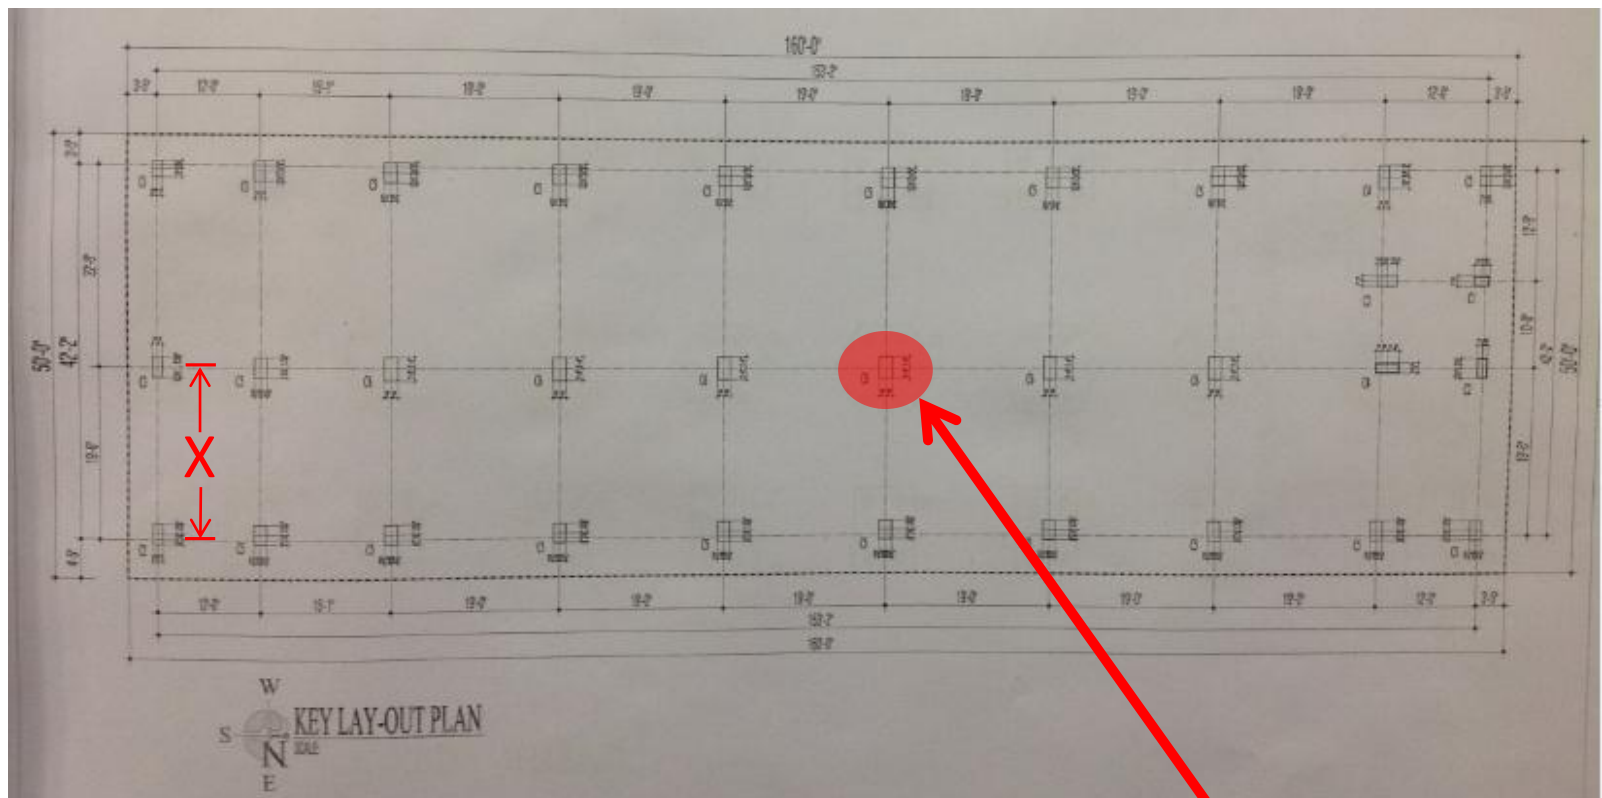
**Structural drawings not consistent with the  
as-constructed arrangement of the factory**

There appeared to be a discrepancy in dimension "X" above.

Documented size  $\approx 406 \times 762$  mm  
Actual size  $\approx 380 \times 762$  mm

**Drawings are not as per the constructed building.**

- Building Engineer to verify dimensions noted above and update drawings if required.

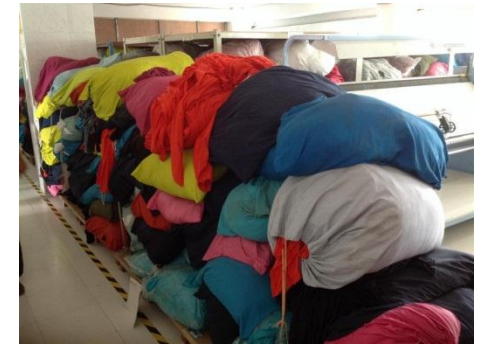
Management of storage loads

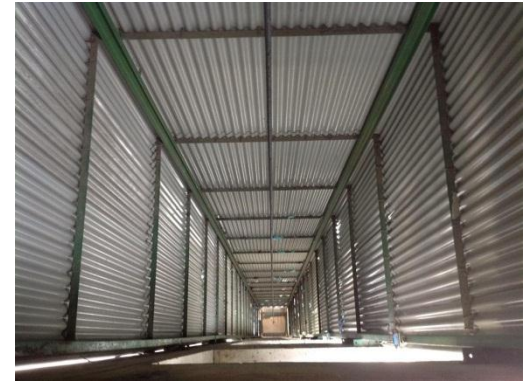
Stability of external hoist

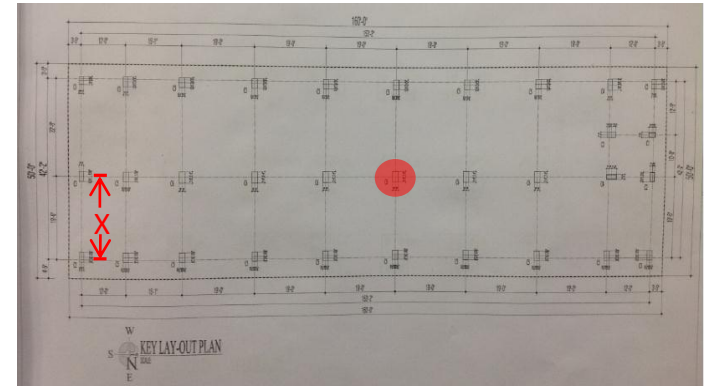
Structural drawings not consistent with the as-constructed arrangement of the factory
