FIRE SAFETY INSPECTION REPORT

RHINE DRESS LTD.

ACCORD
on Fire and Building Safety in Bangladesh

July 8, 2014

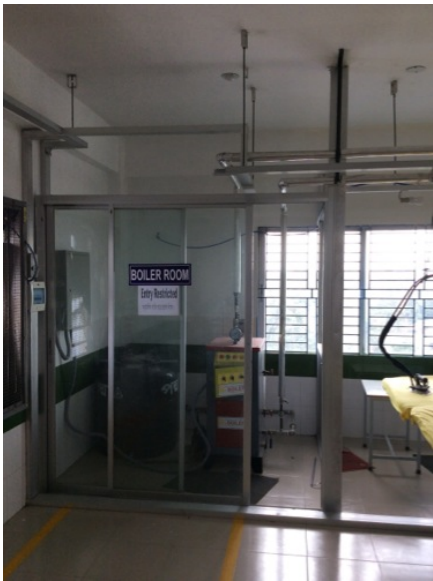
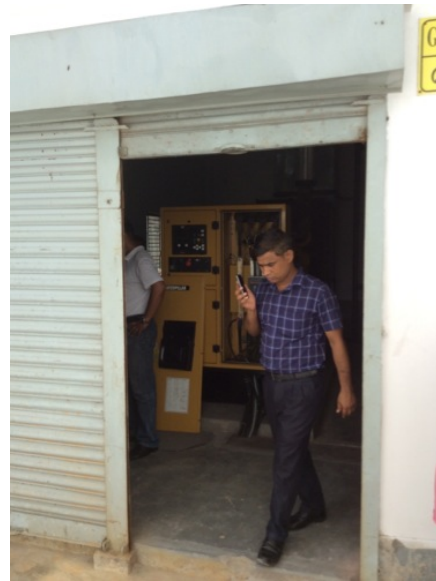
No.	Category	Finding	Recommendation	Remediation Timeframe
F-1	Fire Rated Construction	The boiler rooms on the 1st and 5th floors and the generator room in the shed building are not separated by fire-rated construction (openings, non-rated doors and penetrations).	Separate the boiler and generator rooms by a minimum 2-hr fire-rated construction. Seal and/or protected all openings to maintain the required fire separations.	Within 3 months

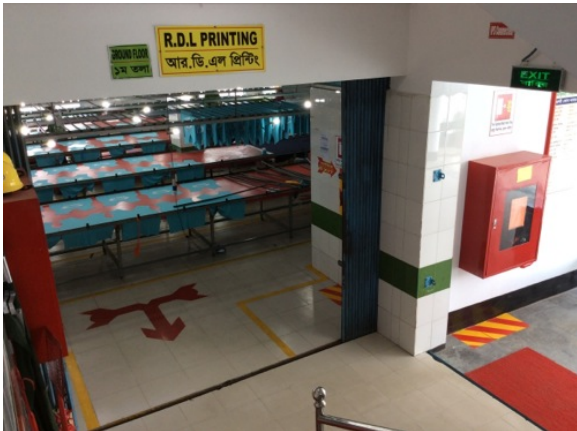
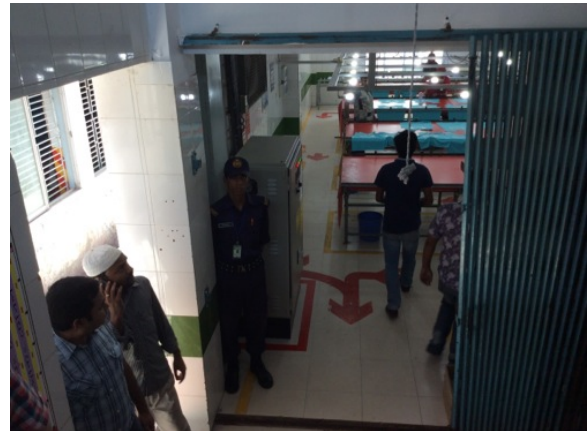
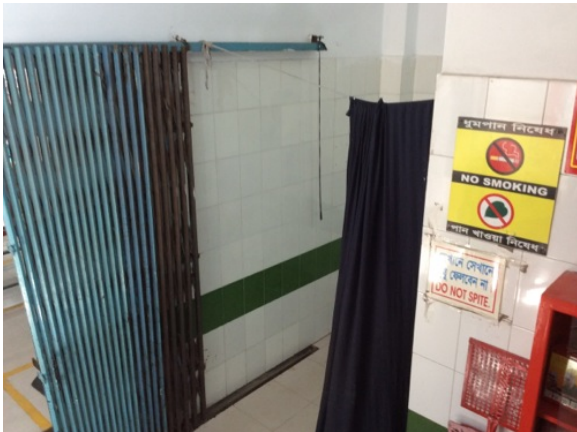
F-2	Fire Rated Construction	The exit stairs are not separated from work areas on each floor by fire-rated construction.	Provide minimum 1.5-hr fire rated doors and seal all unprotected openings to separate the exit stairs from work areas on all floor levels. Ensure that the fire doors are self-closing and positive latching and that they are provided with fire exit (panic) hardware where serving production floors.	Within 3 months
-----	-------------------------	---	--	-----------------

If fire doors are required to be held open for functional reasons, provide automatic-closing devices tied to the fire alarm system.

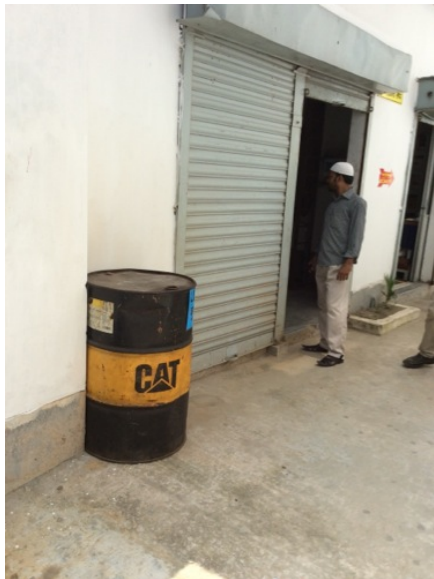
F-3	Fire Rated Construction	Diesel drum storage area on the ground floor is not separated by fire-rated construction (openings).	Separate the diesel drum storage area by a minimum 2-hr fire-rated construction or remove the diesel drum from the egress discharge path to the outside of building site.	Within 3 months
-----	-------------------------	--	---	-----------------

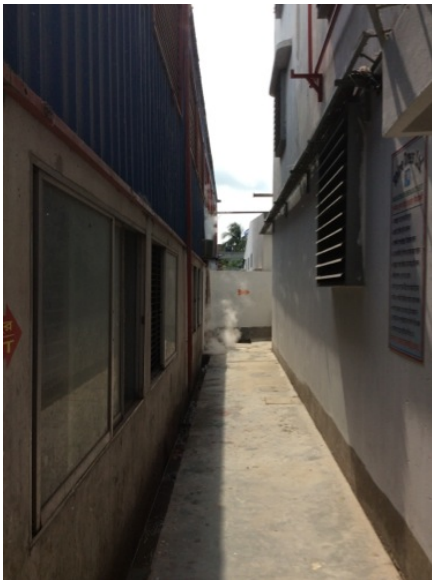
F-4	Fire Rated Construction	The exit discharge path serving north exit is less than 10 ft wide and is not separated from the building interior.	Seal all penetrations and openings to the interior of the building along the discharge path, up to a height of 10 ft., to provide a minimum 1-hr fire separation. Alternatively, provide a second remote discharge path to the public way (only include this if feasible).	Within 6 months
-----	-------------------------	---	---	-----------------

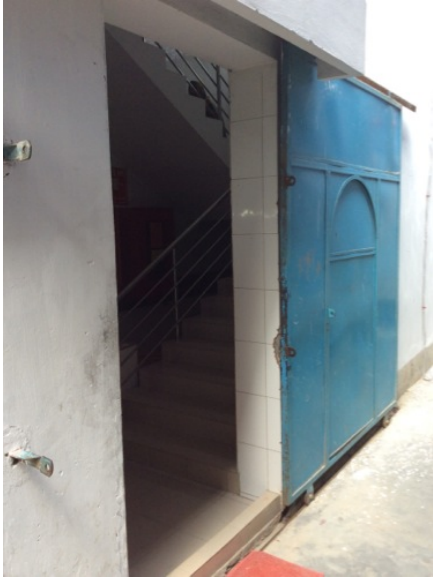
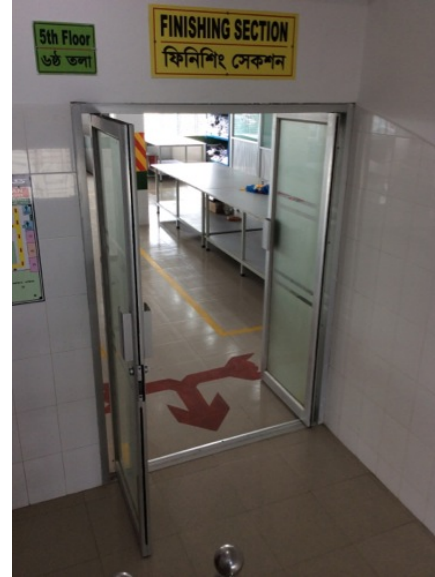
F-5	Egress	Egress gates with locking features are provided at building exits, exit stairs and exit discharge.	Remove locking features from all egress gates. If locks are required for security reasons, utilize special door locking features complying with NFPA 101.	Immediate
-----	--------	--	--	-----------

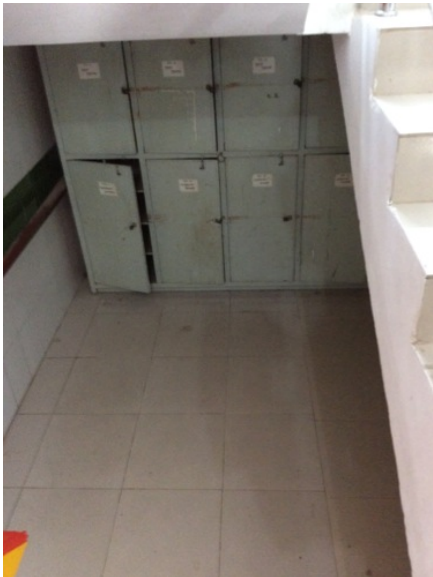
F-6	Egress	Storage was located in the north exit stair on the ground floor.	Remove all storage from exit stairs.	Immediate
-----	--------	--	--------------------------------------	-----------

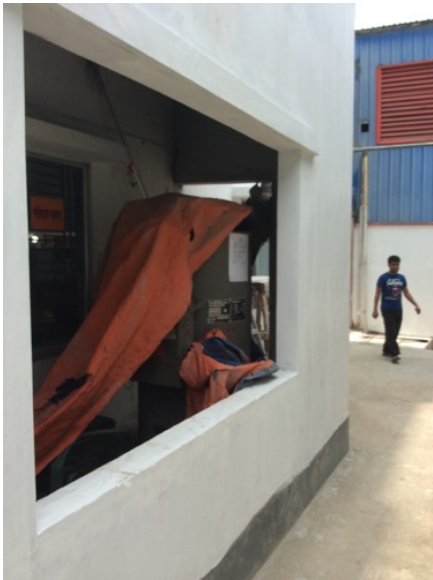
F-7	Egress	Storage was located in the egress path from the north exit on the ground floor.	Remove all storage from egress paths.	Immediate
-----	--------	---	---------------------------------------	-----------

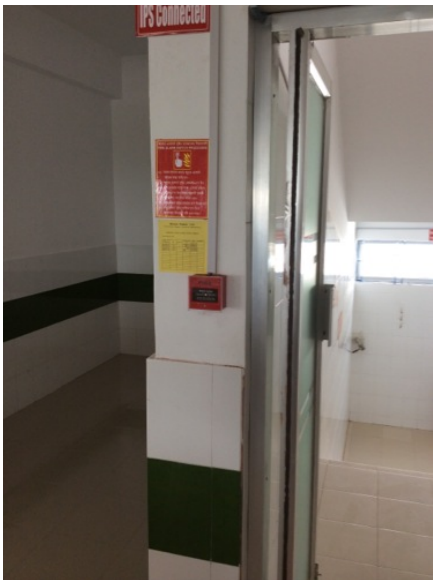
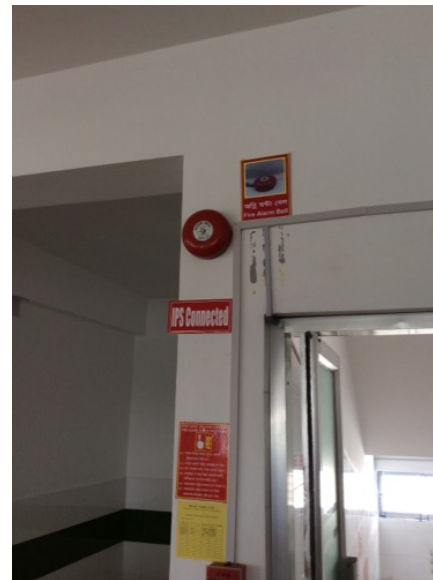
F-8	Fire Protection	The fire alarm system is antiquated, not a listed system, and does not provide alarm and notification features consistent with acceptable standards.	Replace the fire alarm system with a new, listed addressable fire alarm system in accordance with NFPA 72.	Design within 4 months, install within 9 months
-----	-----------------	--	--	---

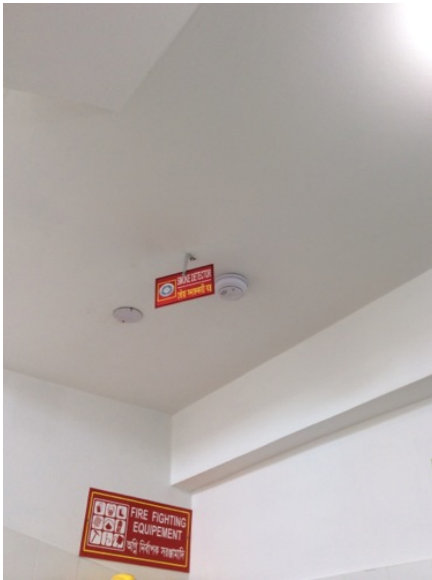
F-10	Fire Protection	The building is equipped with single-station smoke alarms. Smoke alarm activation sounds only a local alarm and does not provide automatic fire alarm notification of occupants.	Remove single-station smoke alarms. Provide automatic smoke detection throughout the building, tied into the fire alarm system, in accordance with NFPA 72.	Within 6 months
------	-----------------	--	---	-----------------
