# **Disari Apparels (Pvt) Ltd & Disari Industries (Pvt) Ltd Gold Star Fashions Ltd**

B-193, BSCIC Industrial Estate, Tongi, Gazipur, Dhaka  
(+23.89271N, 90.41537E)

1 March 2014

# Building Observations

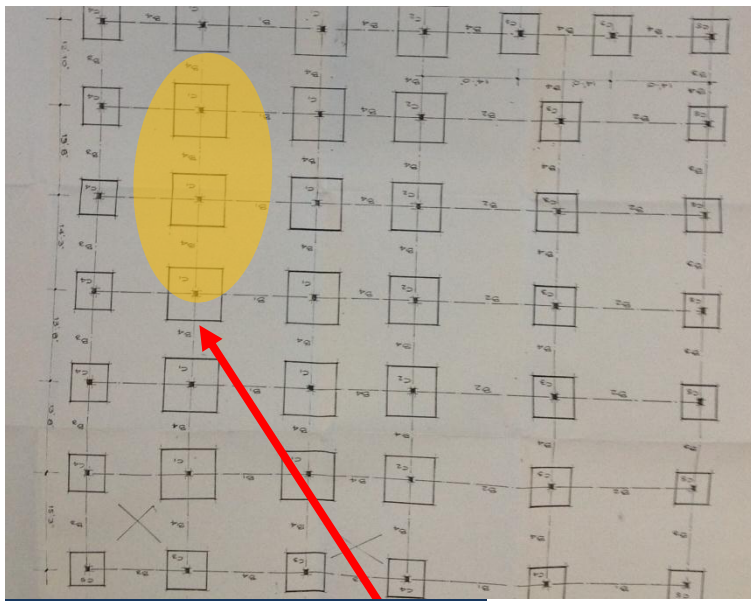
**Construction Drawing**

**Discrepancies between permit drawings, structural drawings and as-constructed grids/column locations to be reviewed by Building Engineer.**

**These columns not constructed**

| Item No. | Observation | Recommended Action Plan | Recommended Timeline |
|---|---|---|---|
| 1 | Discrepancies were noted between the column grid dimensions and column layout as shown on the permit layout/the structural drawings and the as-constructed structure. Building Engineer to review, update structural drawings to as-built status and advise on imposed load capacity of each floor | Building Engineer to survey column locations and compare with structural drawings. Updated drawings to be prepared showing the correct as constructed layout | 6-weeks |

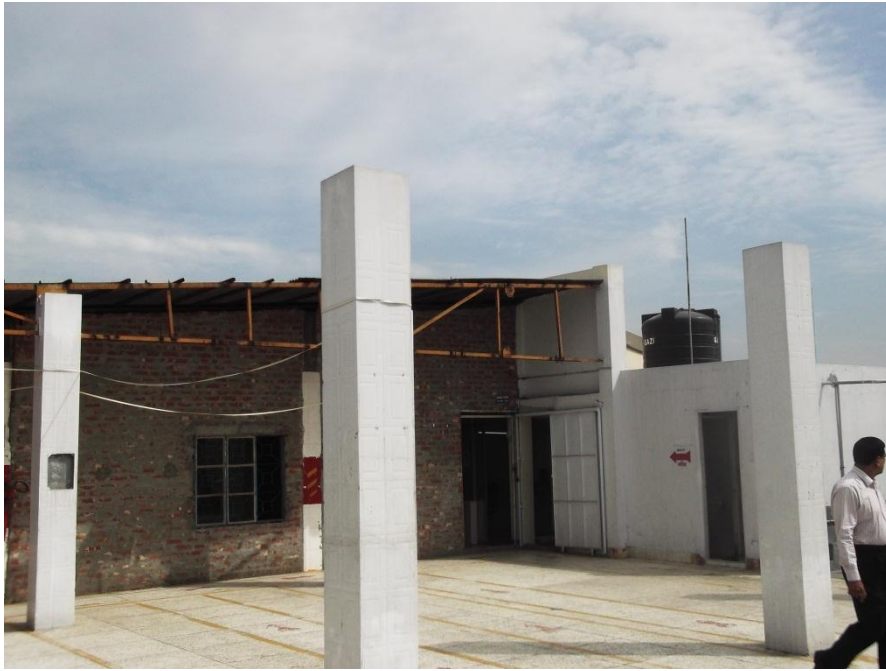
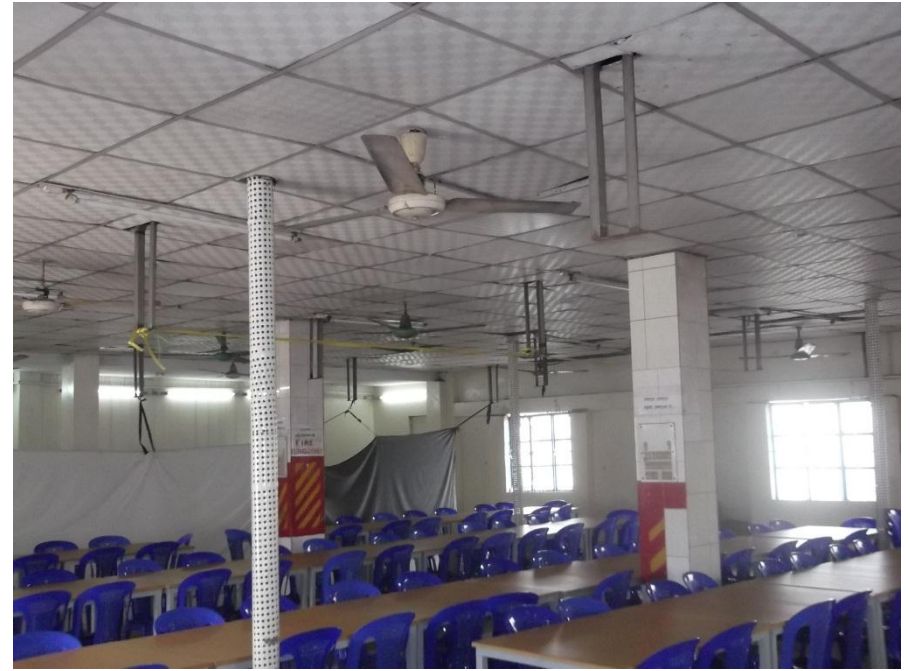
**Stability of steel roof to dining area to  
be reviewed by Building Engineer**

**Roof structure to Dining Area not shown on the structural design drawings, may be susceptible to wind uplift. Building Engineer to review.**

| Item No. | Observation | Recommended Action Plan | Recommended Timeline |
|---|---|---|---|
| 4 | Stability of steel roof to Dining Area to be reviewed by Building Engineer to confirm that it is braced and adequately designed to resist high wind loading. | The steel roof over the Dining Area should be designed by the Building Engineer and, if required, upgraded to support code vertical and wind loads or the area should be vacated and removed | 6-months |

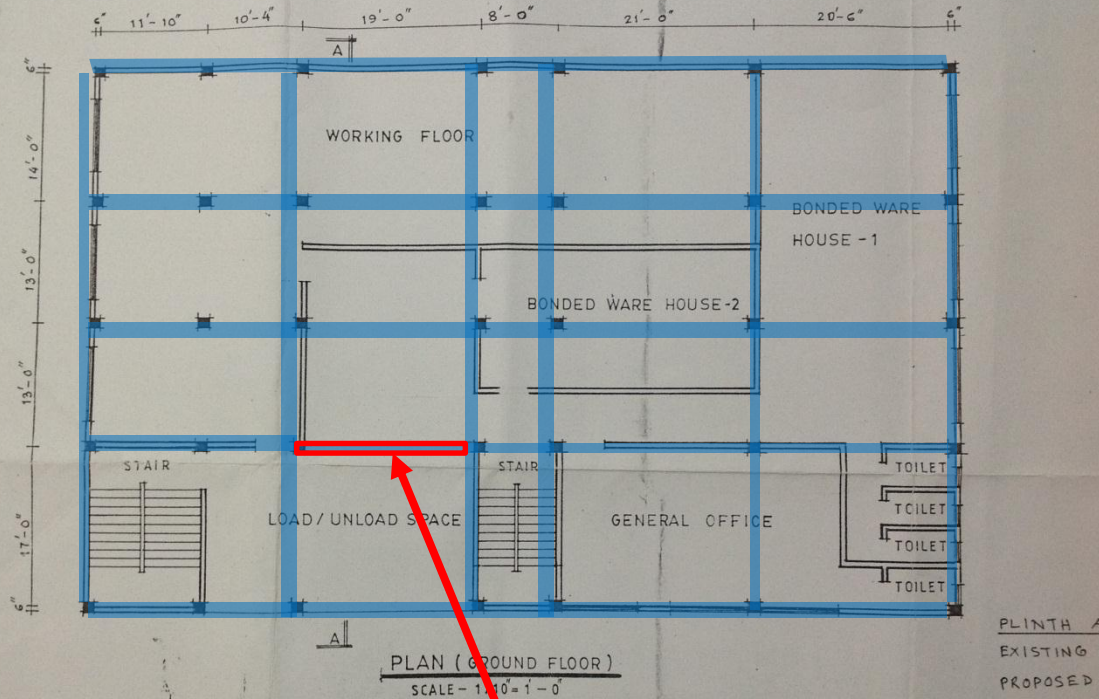
**Building Engineer to carry out detailed calculations to verify the adequacy of the structure at 1<sup>st</sup> floor slab where beam is not provided.**

**Beam provided in this location at all levels except 1<sup>st</sup> floor**

**Design Check required for 1<sup>st</sup> Floor slab**

| Item No. | Observation | Recommended Action Plan | Recommended Timeline |
|---|---|---|---|
| 5 | The beam arrangement on the 1st floor above the load/unload area does not correspond with that provided on all other floors. Building Engineer to carry out a design check on the structure in this area | Provide calculations showing the structural adequacy of the floor slab and beams at 1st floor slab level above the load/unloading area | 6-months |

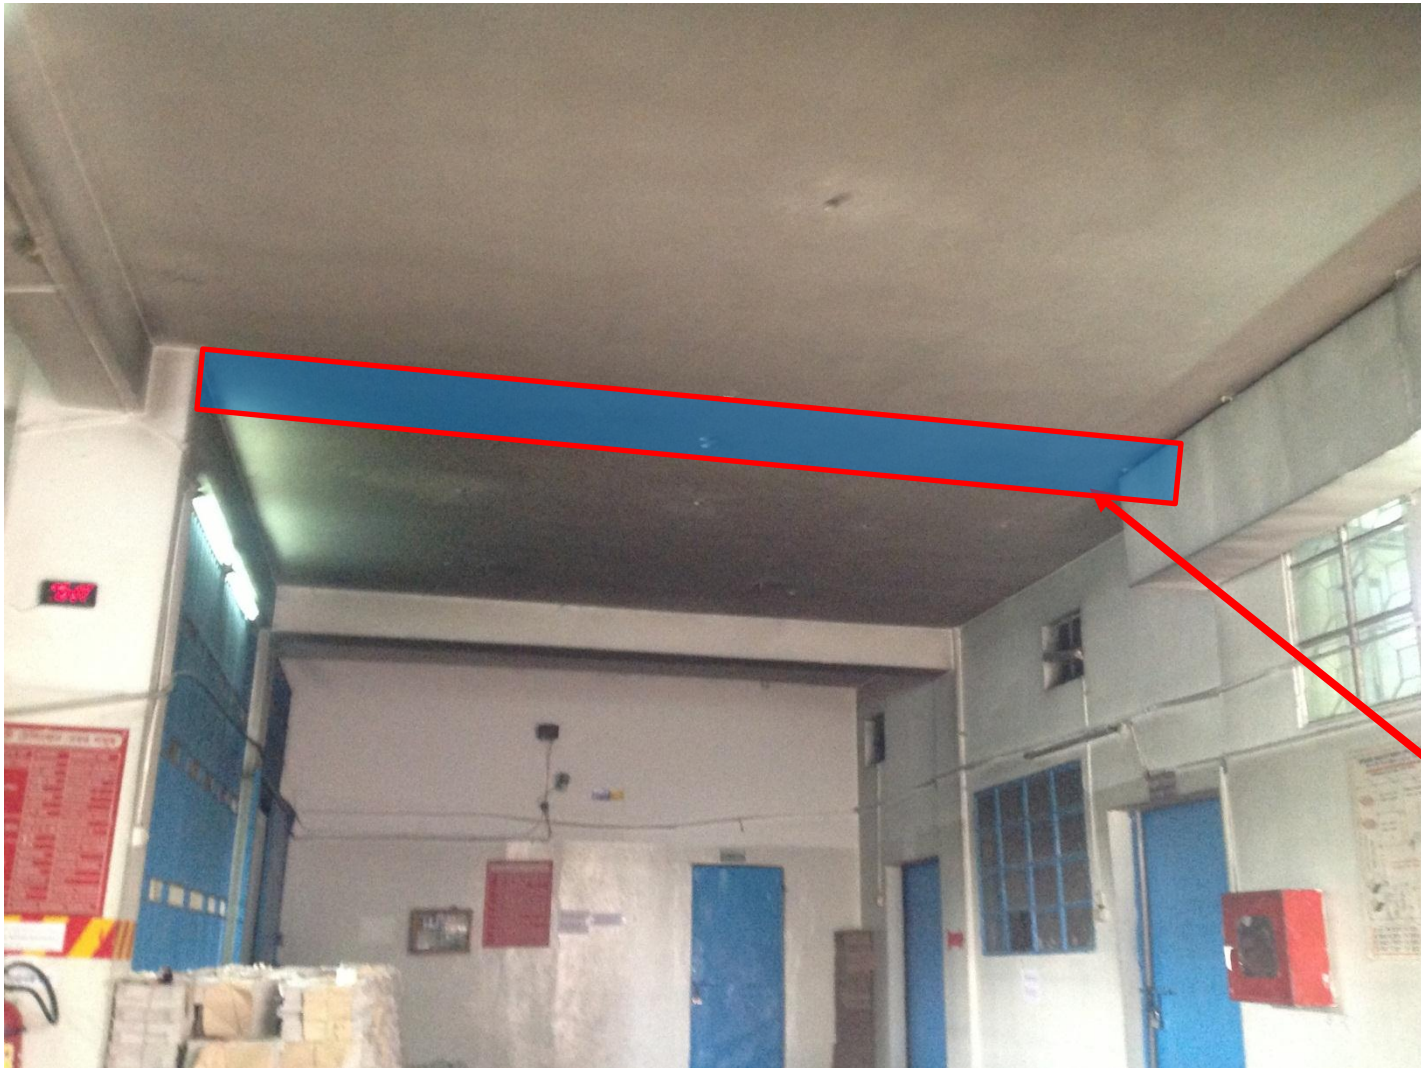
This beam is provided at all floors except to 1<sup>st</sup> floor slab.

**Design Check required  
for 1<sup>st</sup> Floor slab**
