# UHM Ltd.

Plot No: 240, 241, 242, 243 & 255, Adamjee Export Processing Zone, Siddhirgang,  
Narayanganj, Bangladesh  
(23.678313N, 90.522866E)

07 August, 2016

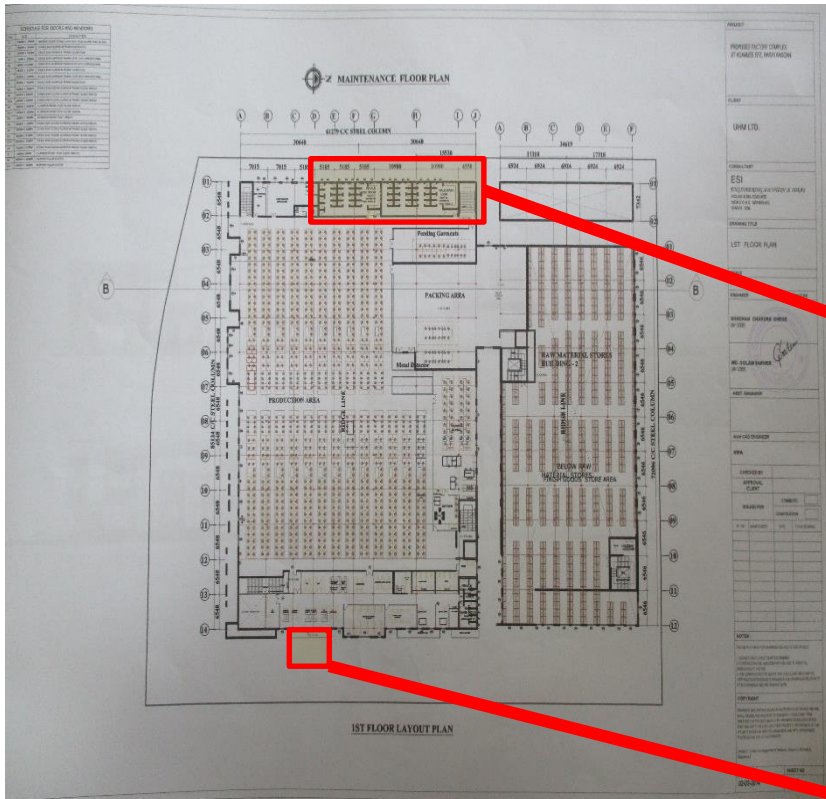
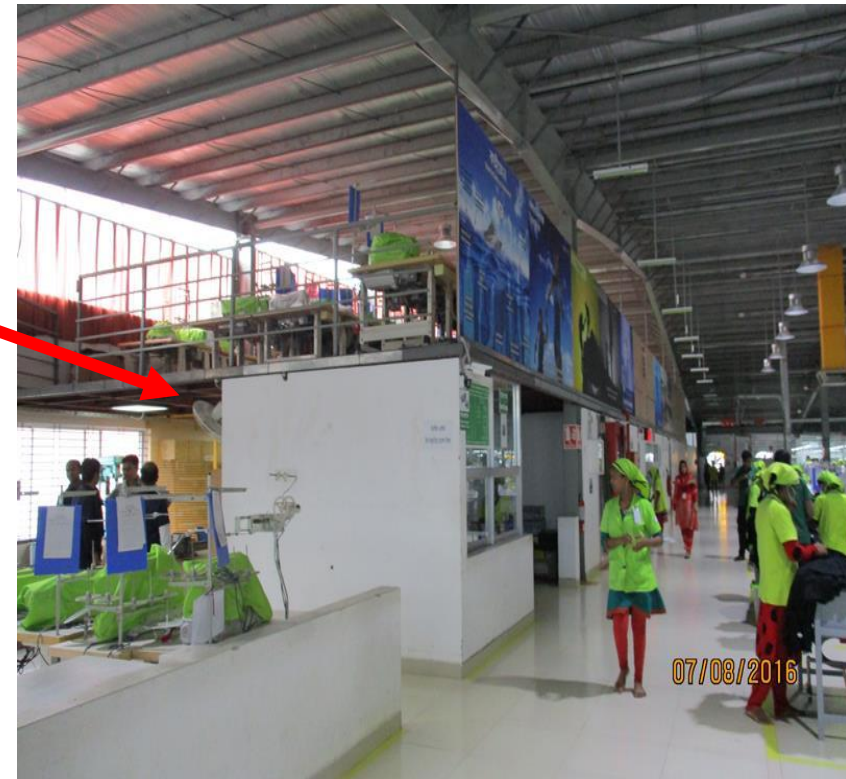
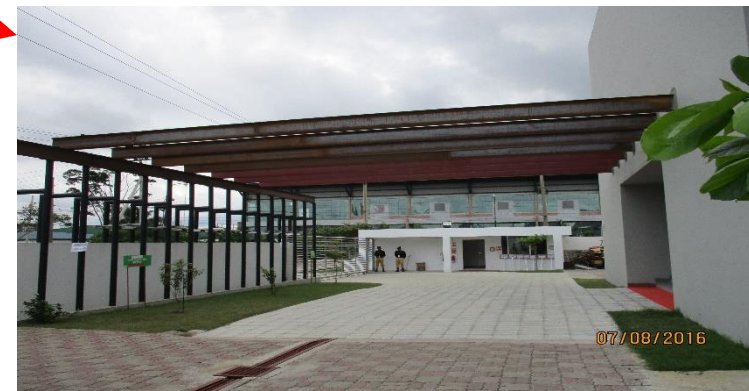
# **Undocumented mezzanine floor at Production building (Building 1).**

Mezzanine floor have observed at 1<sup>st</sup> floor & additional porch at East side of building 1. without having any documents.

**Undocumented mezzanine floor at Production building (Building 1).**

| Item No. | Observation | Recommended Action Plan | Recommended Timeline |
|---|---|---|---|
| 1 | Building 1<br>Undocumented mezzanine floor at building 1(Production Building) | Factory engineer to check, collect information and produce accurate and complete as-built documentation | 6-weeks |

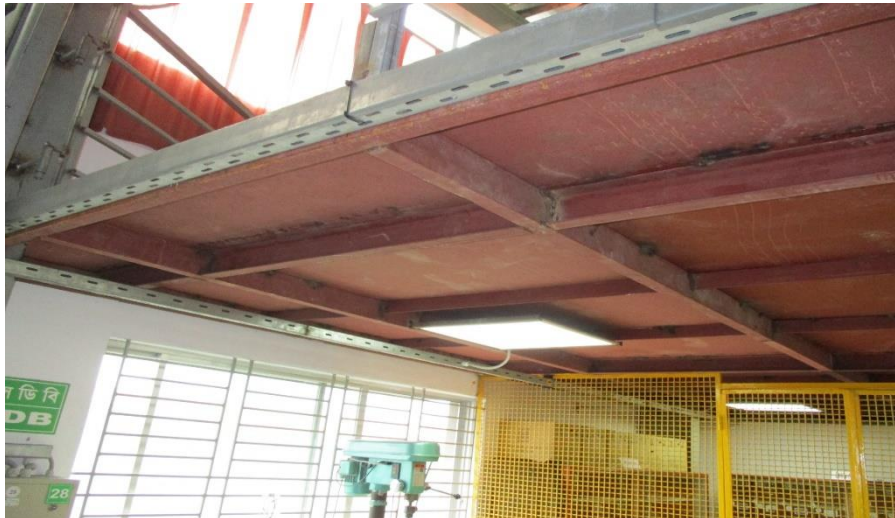
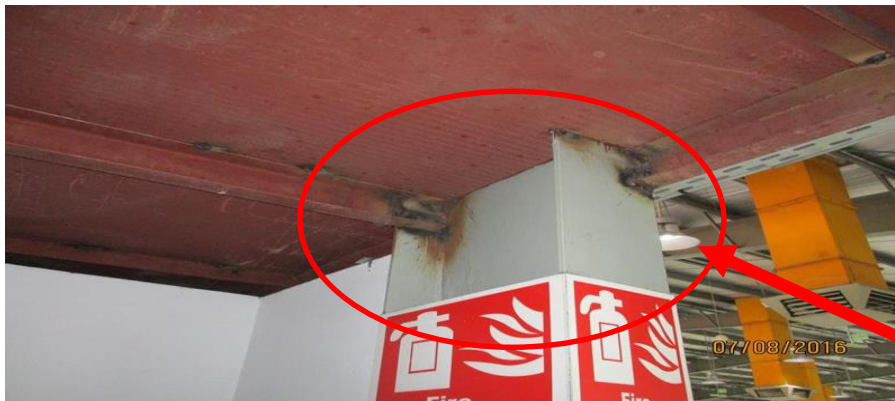
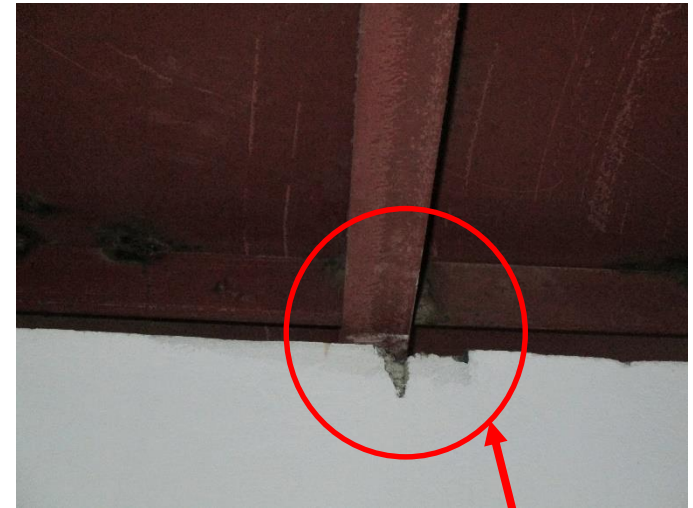
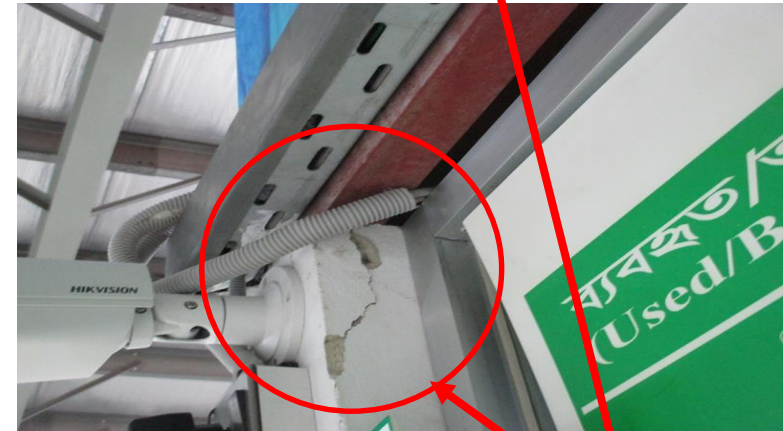
# **Adequacy check of mezzanine floor at Production building (Building 1).**

Mezzanine floor constructed by steel deck having connection with steel column and rest on toilet block brick walls. No stair have observed to evacuate.

Apparently poor connection between steel deck and brick walls, steel column

**Adequacy check of mezzanine floor at  
Production building (Building 1).**

| Item No. | Observation | Recommended Action Plan | Recommended Timeline |
|---|---|---|---|
| 2 | Building 1<br>Adequacy check of mezzanine floor at building 1 | Factory engineer to review design, loads and columns stresses and deck slab adequacy | 6-weeks |
| 3 | Building 1<br>Adequacy check of mezzanine floor at building 1 | Building engineer to check the steel connections ,adequacy check of deck supporting brick walls, propose an additional welding reinforcement if necessary. | 6-weeks |
| 4 | Building 1<br>Adequacy check of mezzanine floor at building 1 | Carry out any remedial works (if required) arise from design check. | 6-months |

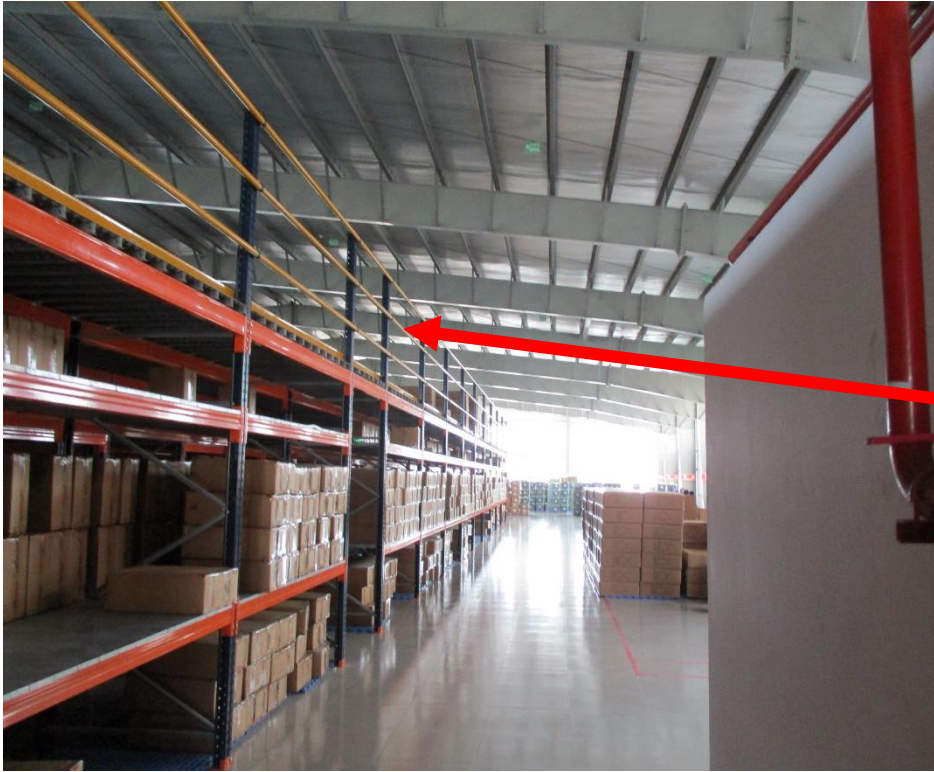
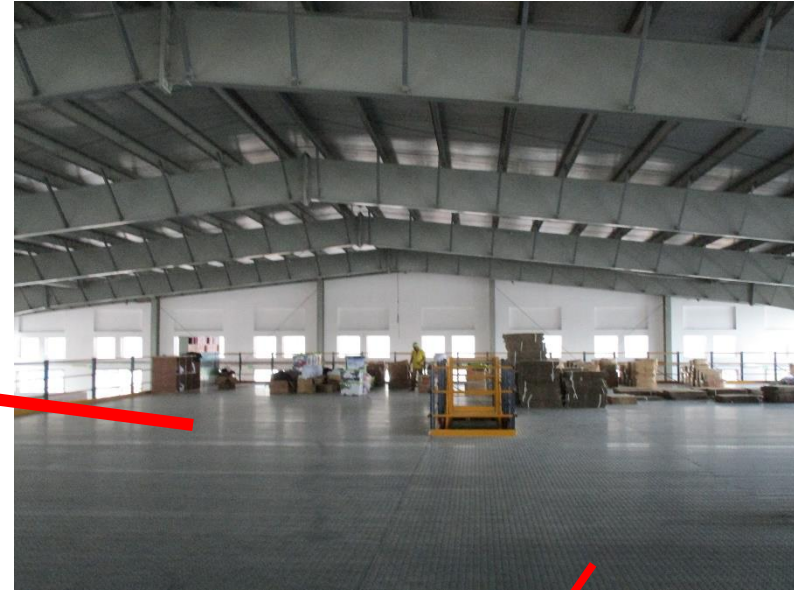
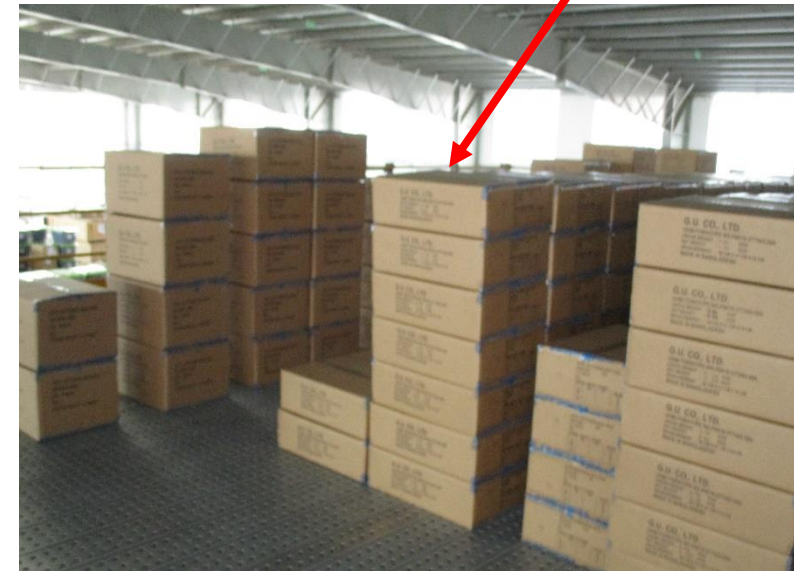
# **Deck slab adequacy check for 140 psf live load in storage building.**

An Additional storage made upon storage racks. Total floor load capacity of 140 psf shown on loading plan. Building engineers to check and review design, loads , slab & rack adequacy and column stress.

**Deck slab adequacy check for 140 psf live load in storage building.**

| Item No. | Observation | Recommended Action Plan | Recommended Timeline |
|---|---|---|---|
| 5 | Building 1<br>Deck slab adequacy check for 140 psf live load in storage building | Factory engineer to review design, loads and columns stresses | 6-weeks |
| 6 | Building 1<br>Deck slab adequacy check for 140 psf live load in storage building | Carry out any remedial works (if required) arise from design check. | 6-months |
