# KA Design Limited

3<sup>rd</sup> August 2016

## Client Summary report

Observations & Actions

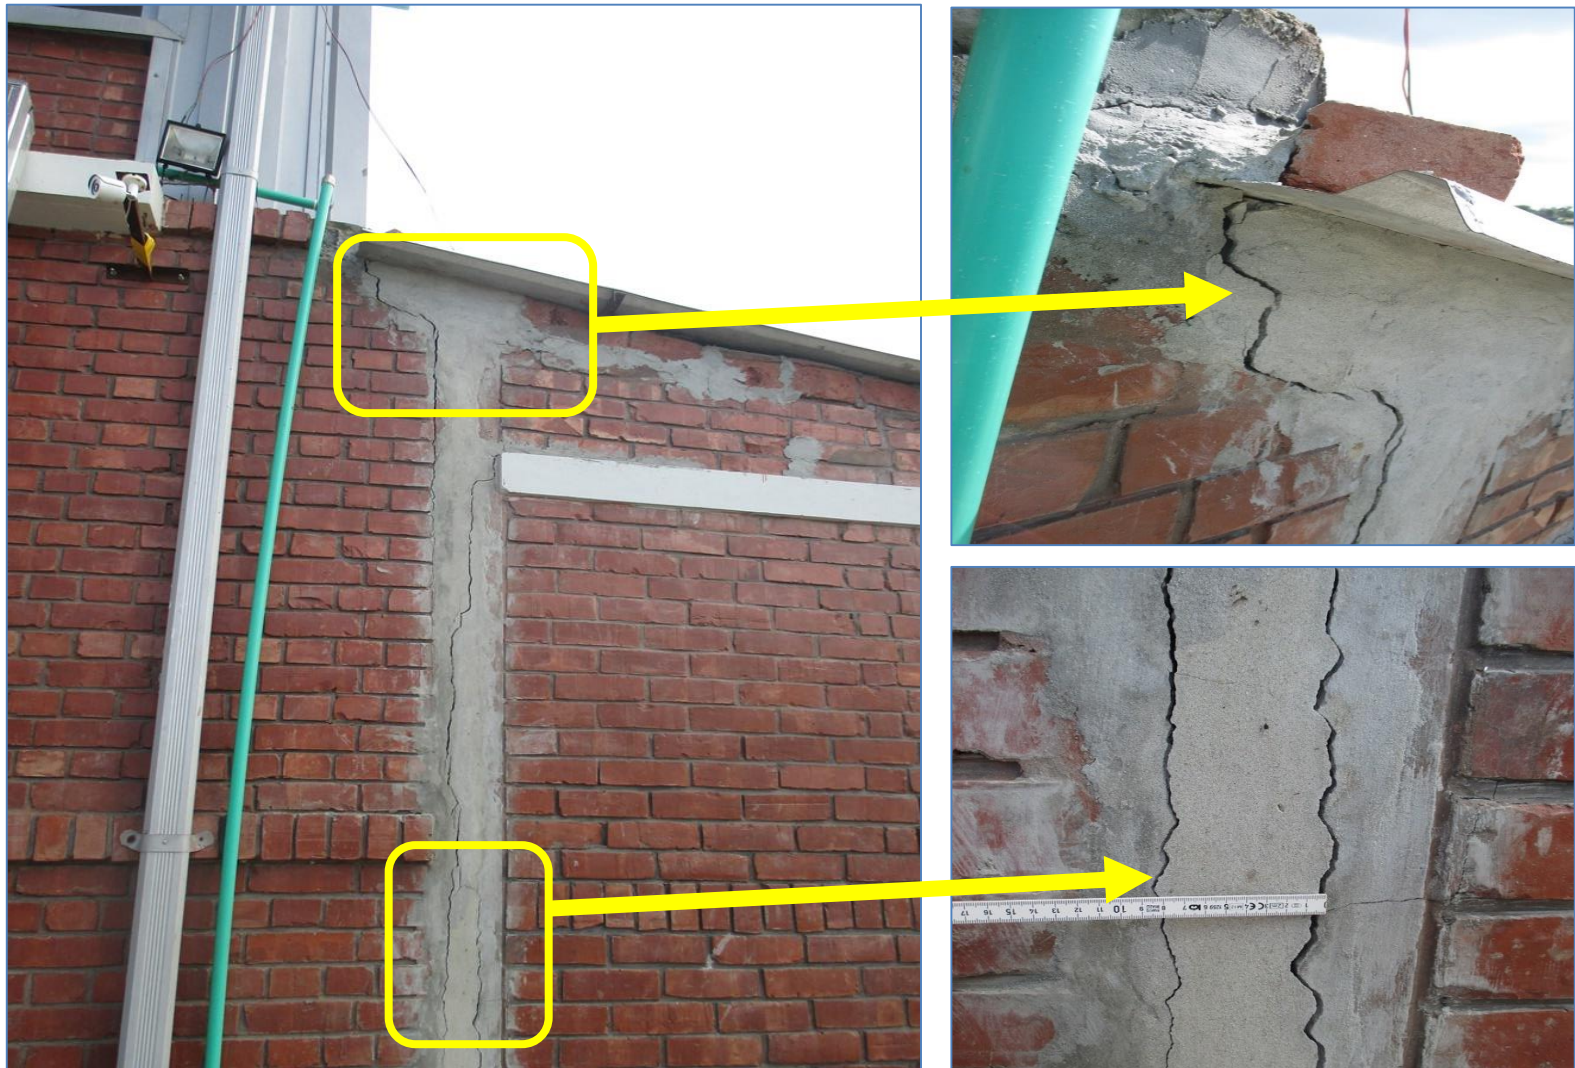
Toilet area settle down and displaced from its actual position

| Item No | Observation | Recommended action plan | Recommended timeline |
|---|---|---|---|
| 1 | <b>Displacement of toilet block attached with Main Production Shed at west</b> | Qualified Structural Engineer to investigate cause of settlement and displacement and suggest necessary remediation. | 6 Weeks |
| 2 | <b>Displacement of toilet block attached with Main Production Shed at west</b> | Remedial works to be carried out. | 6 Month |

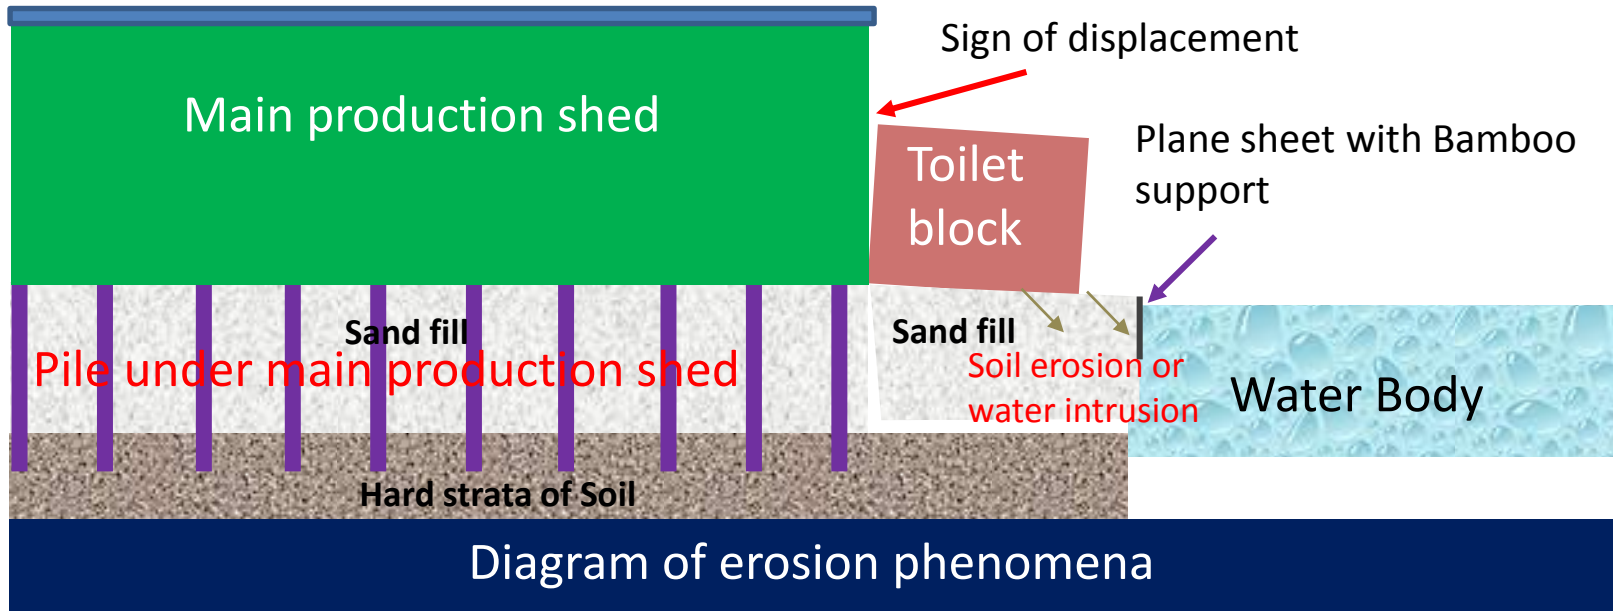
The factory was built in moorland by sand filling. The Factory buildings are surrounded by Water body. At west side it is too close, almost 6-7 feet away from toilet block shown in figure. The main production shed built with pile foundation but the toilet block has none. The protection of soil fringe is not sufficient so that soil erosion or water intrusion may occur. By this toilet block is continuously settling down and sign of displacement and continuous repair work was visible during inspection.

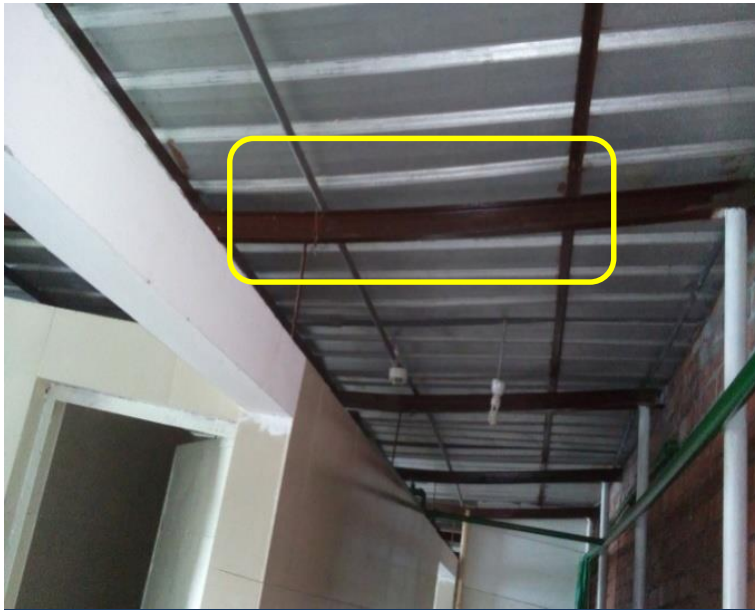
Sagged steel rafter

| Item No | Observation | Recommended action plan | Recommended timeline |
|---|---|---|---|
| 3 | <b>Poor steel joint connection at roof in toilet block</b> | Qualified Structural Engineer to investigate the connection of steel joint and suggest necessary remediation. | 6 Weeks |
| 4 | <b>Poor steel joint connection at roof in toilet block</b> | Remedial works to be carried out. | 6 Month |

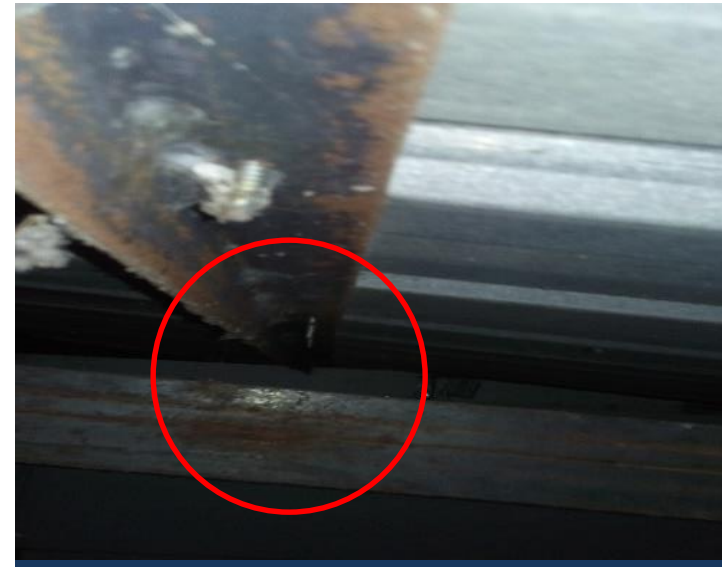
Purlins are not properly connected with steel rafter

Rafters are welded with steel bar which anchored in brick wall.

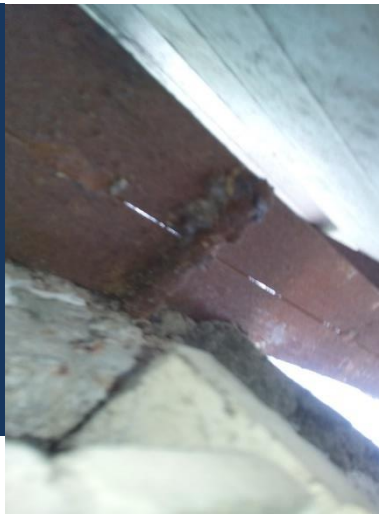
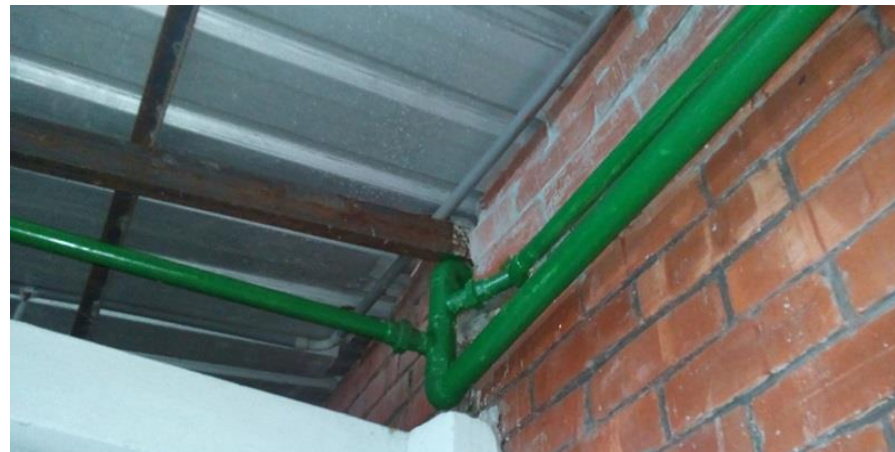
Joint with production shed

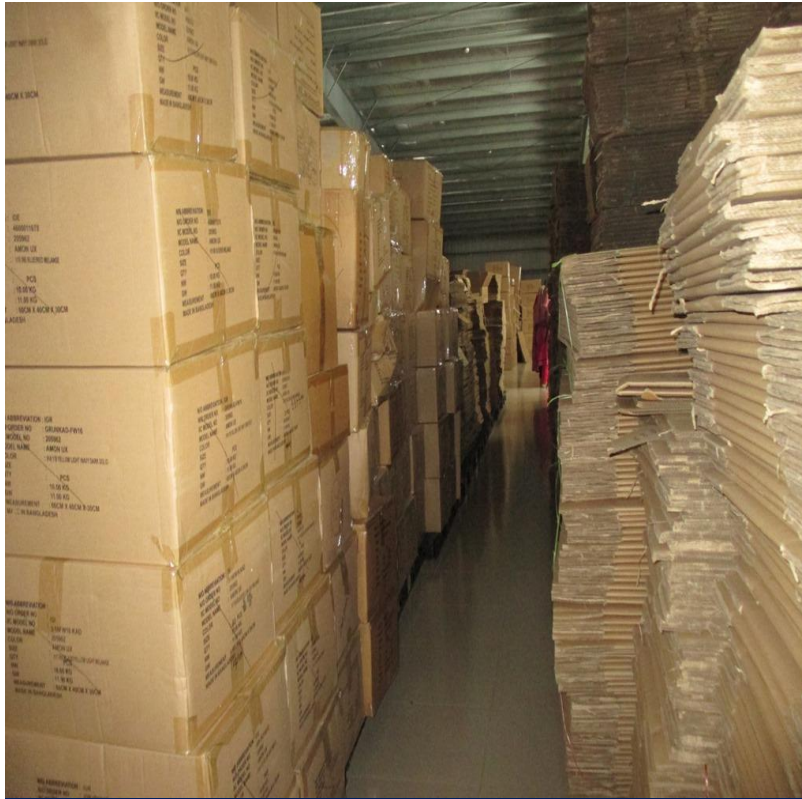
Material stacked to ceiling within storage areas at east side mezzanine floor.

| Item No | Observation | Recommended action plan | Recommended timeline |
|---|---|---|---|
| 5 | <b>Heavy load found on Mezzanine floor at West</b> | Produce and actively manage a loading plan for all elevated floor plates for all buildings within the factory complex giving consideration to floor capacity and column capacity. | 6 Month |
| 6 | <b>Heavy load found on Mezzanine floor at West</b> | Continue to implement load plan | 6 Month |

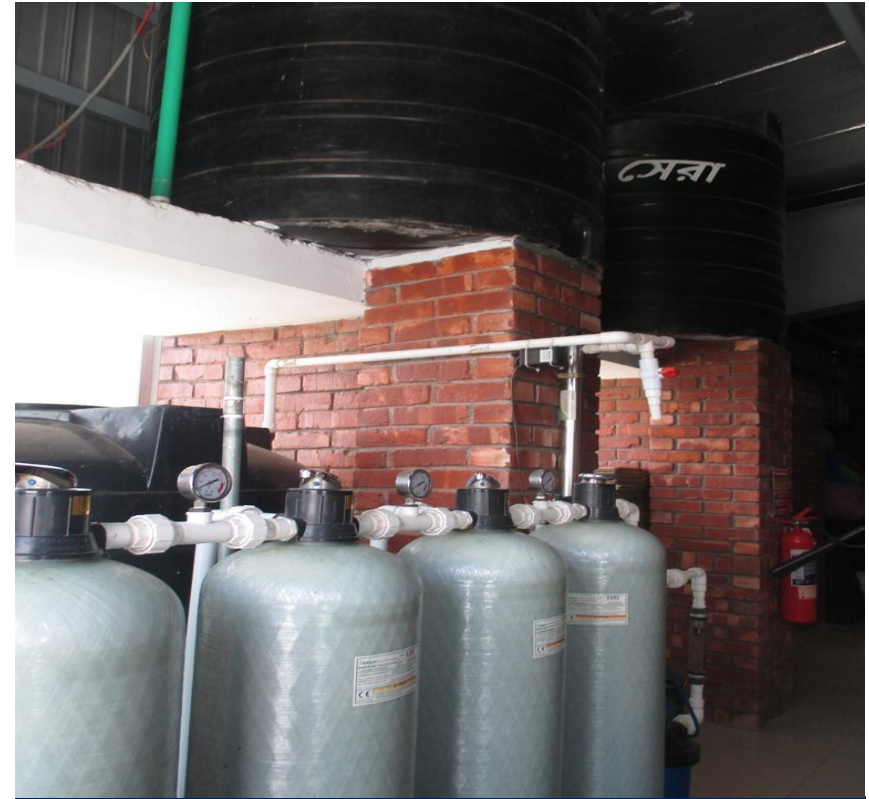
3 nos of plastic water tank found at north-west corner on mezzanine floor .

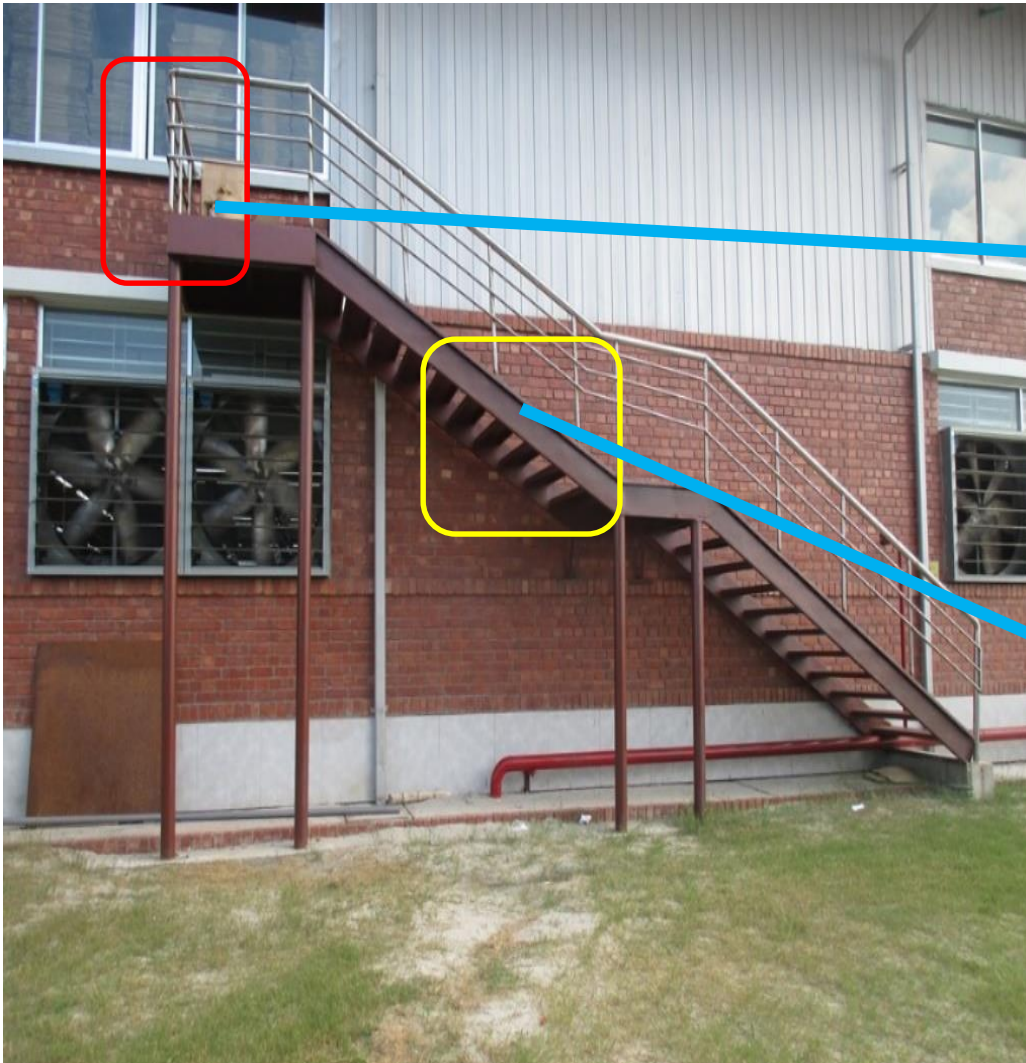
**Non-engineered steel stair at north**

| Item No | Observation | Recommended action plan | Recommended timeline |
|---|---|---|---|
| 7 | <b>Apparently Non-engineered steel stair attached with façade wall at North</b> | Factory engineer to review design and check the adequacy of connections of the lightweight fire escape stair under evacuation loading, and make any necessary alterations | 6 Weeks |
| 8 | <b>Apparently Non-engineered steel stair attached with façade wall at North</b> | Remedial works to be carried out. | 6 Month |

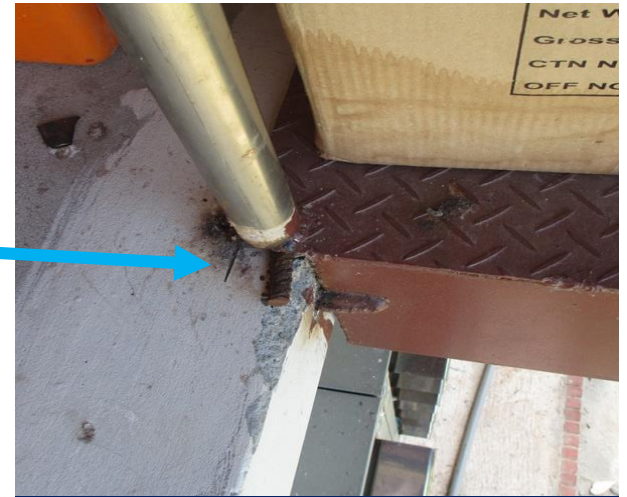
**Poorly connected with façade wall**

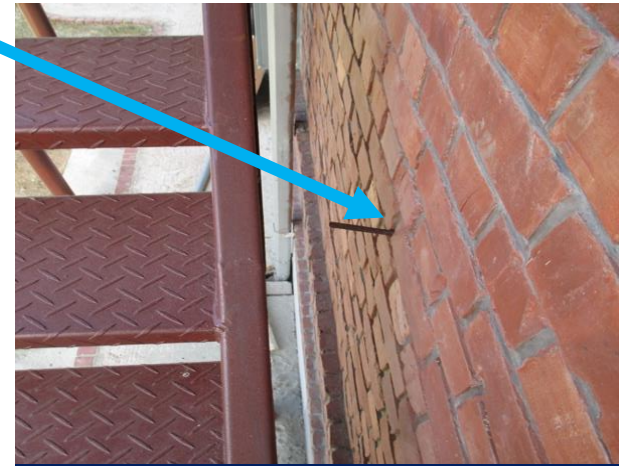
**No connected with façade wall**

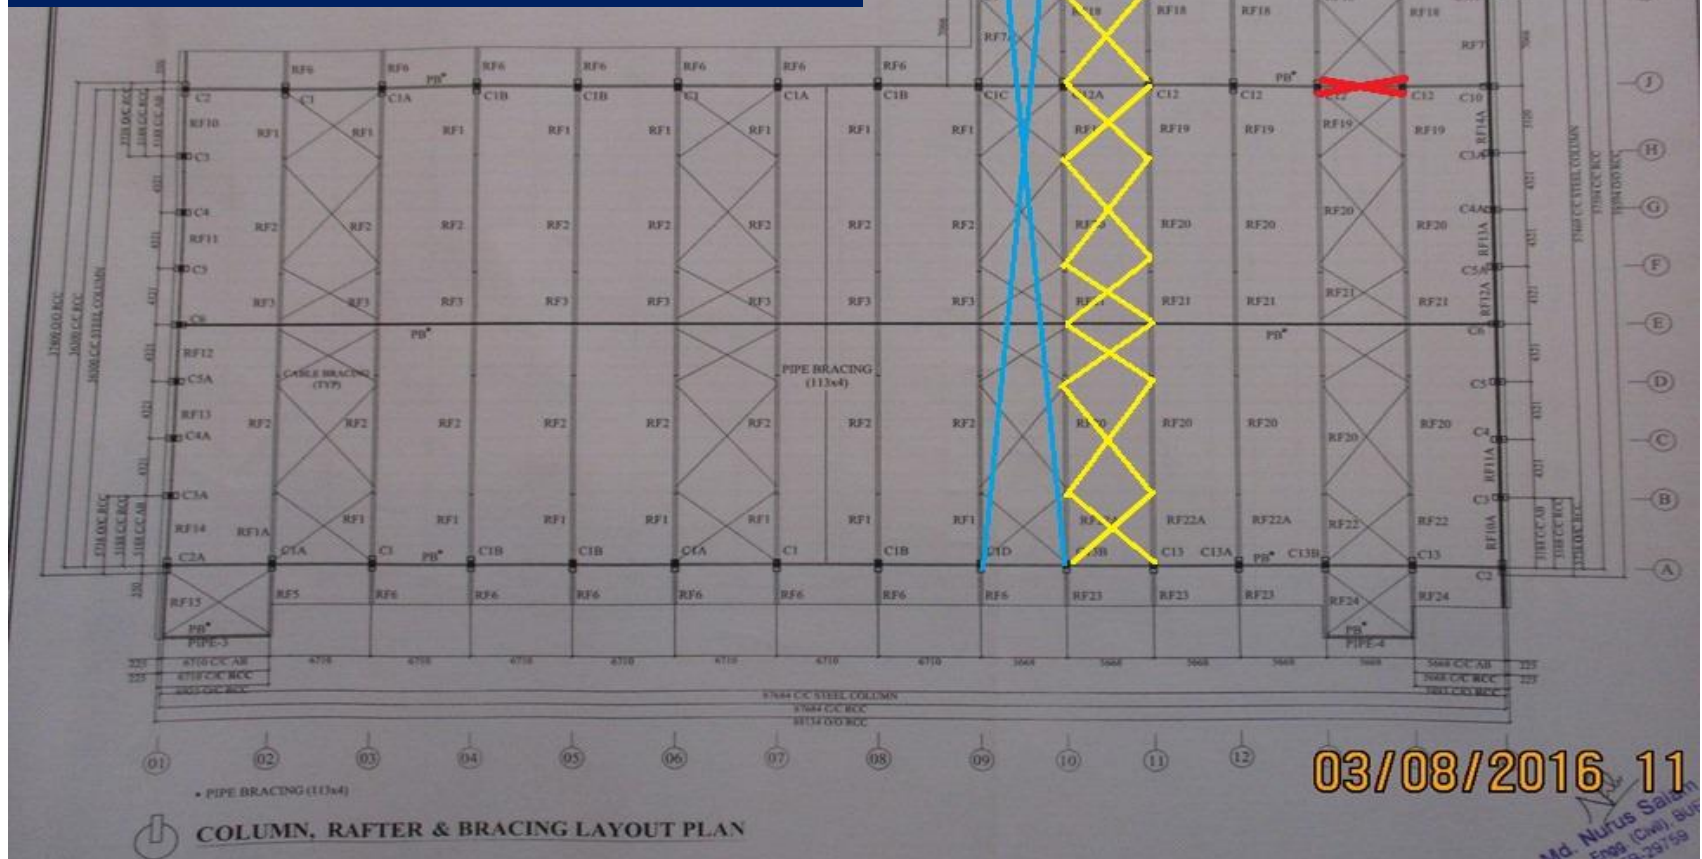
Bracings in between grid 9-10 are not installed according to drawing. Practically that bracing were found in between grid 10-11. One vertical bracing missing shown in red at drawing.

| Item No | Observation | Recommended action plan | Recommended timeline |
|---|---|---|---|
| 9 | <b>Discrepancies between Structural drawings and site observations</b> | Engage an Engineer to produce an “as constructed” drawings which reflect the actual site dimensions with complete structural information's. | 6 Weeks |
| 10 | <b>Discrepancies between Structural drawings and site observations</b> | Factory Engineer to review design and columns stresses for as constructed condition. | 6 Month |
| 11 | <b>Discrepancies between Structural drawings and site observations</b> | Remedial works to be carried out. | 6 Month |

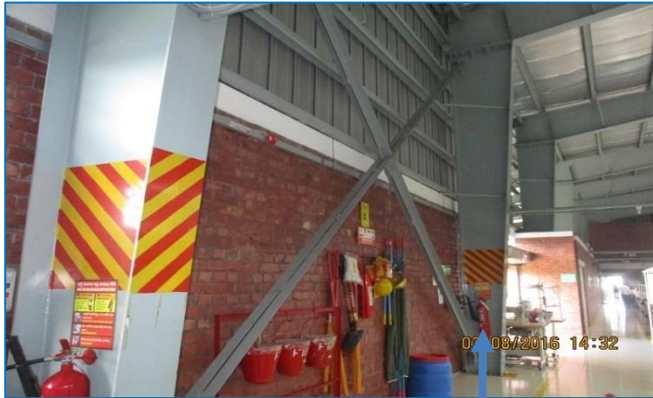
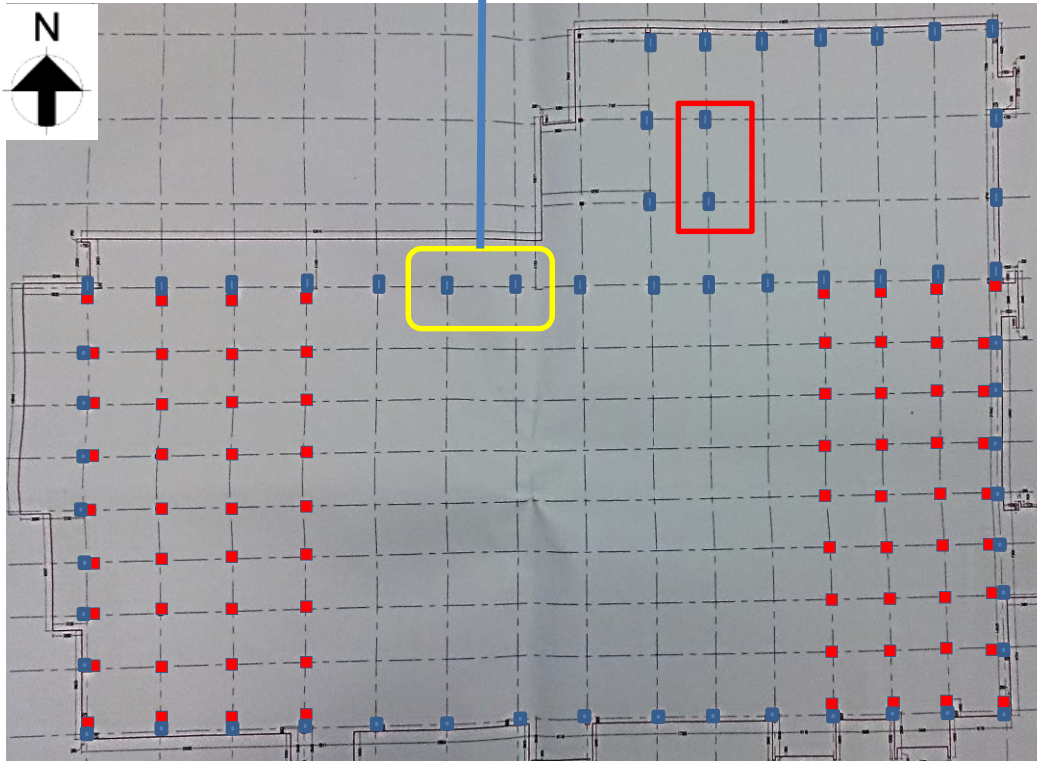
Column schedule for mezzanine floor didn't matched fully. C2, C3 & C4 columns are not exist upper Ground floor. Indicated columns in red box are not shown in column layout or foundation layout.

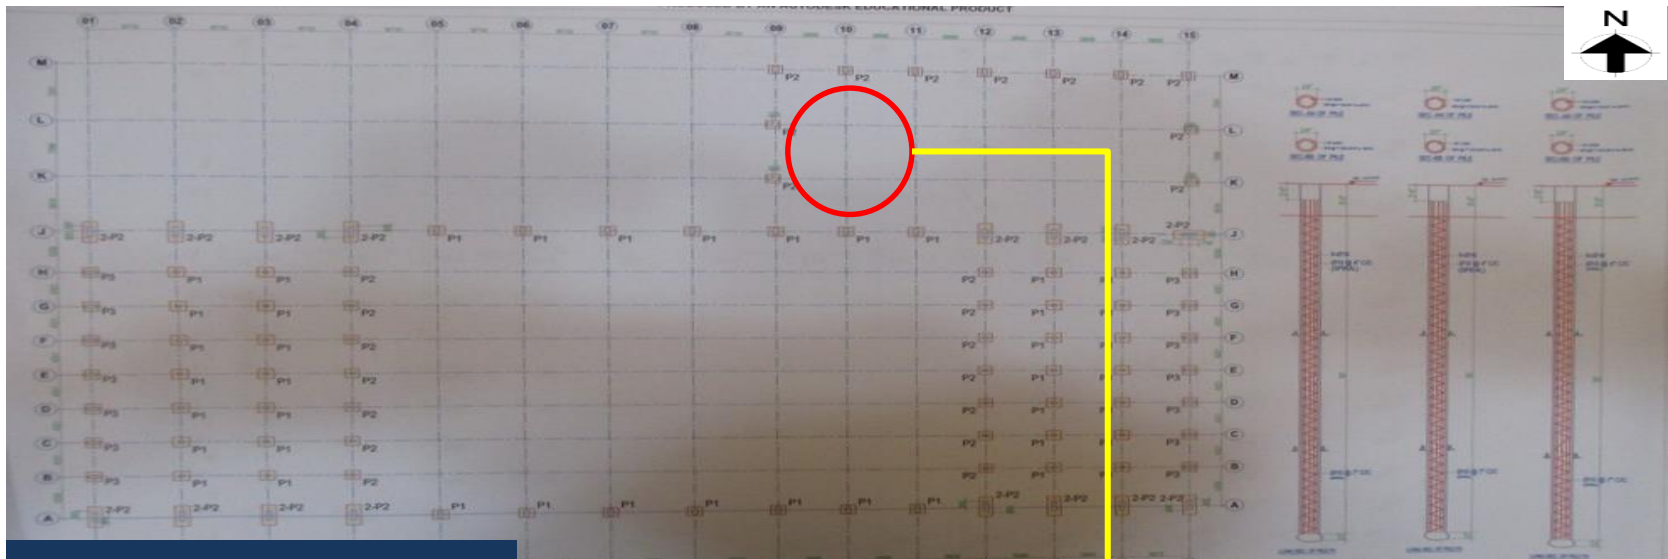
Foundation Layout plan

No foundation or support system is defined or mentioned for the extra columns which found in indicated portion.

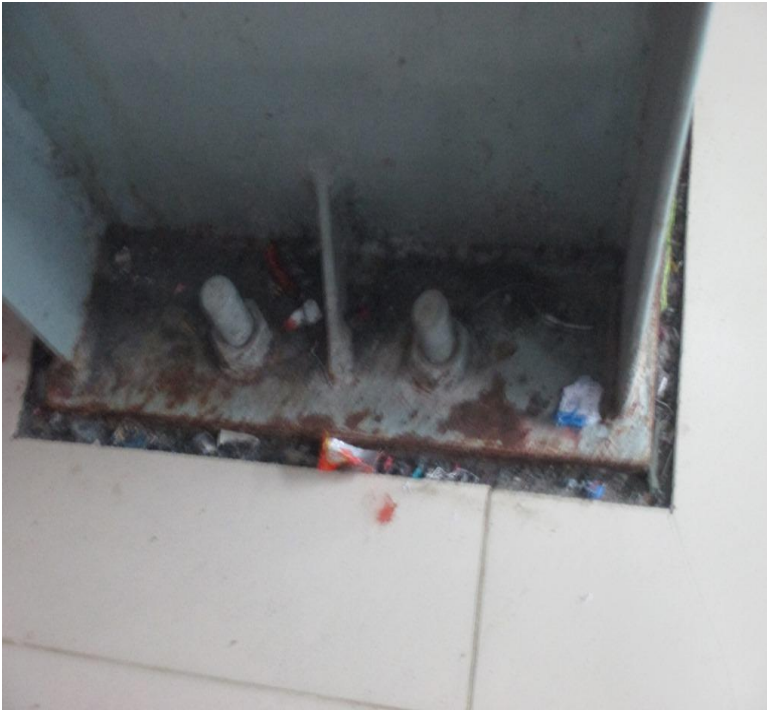
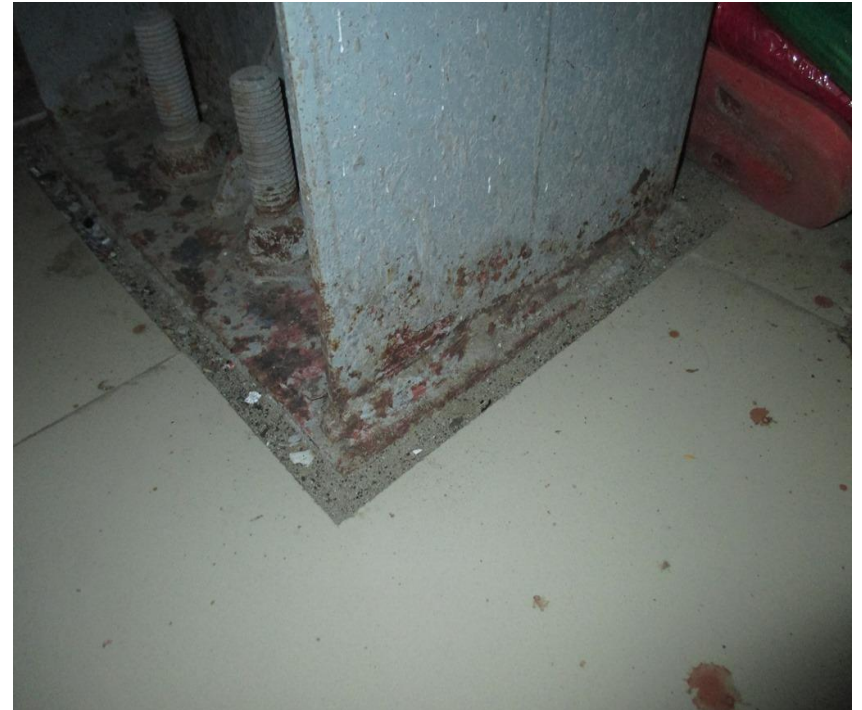
Corrosion observed on several base plate and column joint in main production shed

| Item No | Observation | Recommended action plan | Recommended timeline |
|---|---|---|---|
| 12 | <b>Corrosion on Steel column base plate.</b> | Building Engineer to identify areas of corrosion on the steel frame & base plate. | 6 Month |
| 13 | <b>Corrosion on Steel column base plate</b> | Building Engineer to issue a schedule of remedial works for corrosion protection. | 6 Weeks |

| Item No | Observation | Recommended action plan | Recommended timeline |
|---|---|---|---|
| 14 | <b>Corrosion on Steel column base plate</b> | Remedial works to be carried out. | 6 Month |

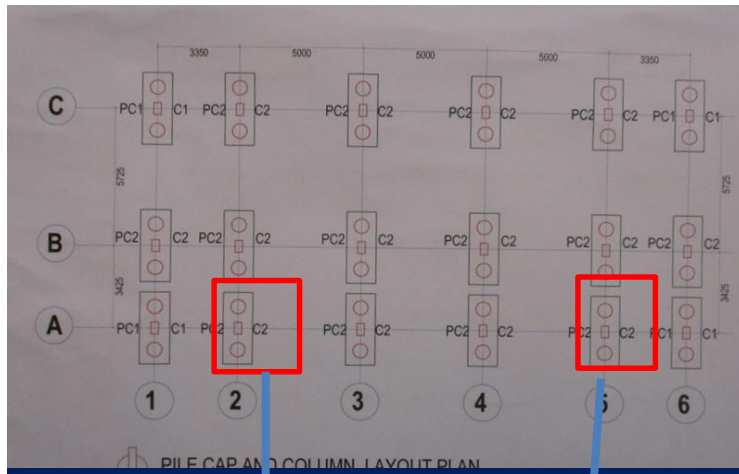
Structural drawing

Column Schedule is missing on structural drawing. Provided column layout & schedule didn't match with as built condition. Column size & number of rebar didn't match.

| Item No | Observation | Recommended action plan | Recommended timeline |
|---|---|---|---|
| 15 | <b>Inadequate information on structural drawing</b> | Building Engineer to survey as constructed building and prepare a set of as-built drawings. | 6 Weeks |

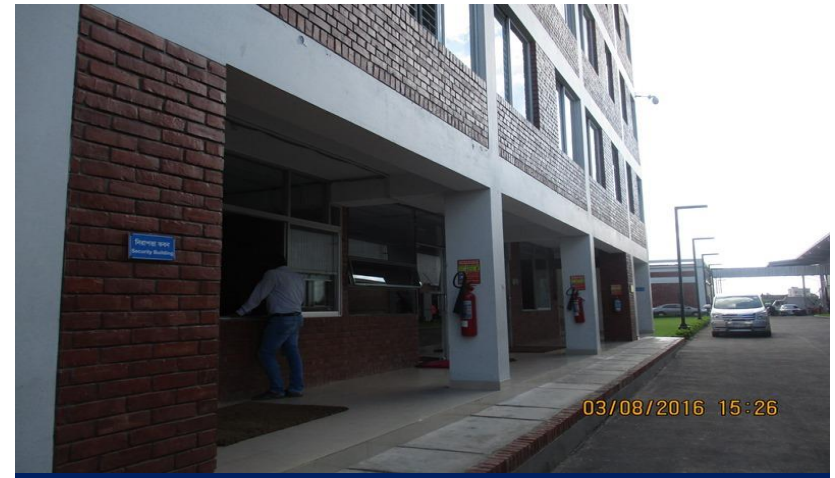
Column size measured 425X300 & 4x3 nos of rebar found

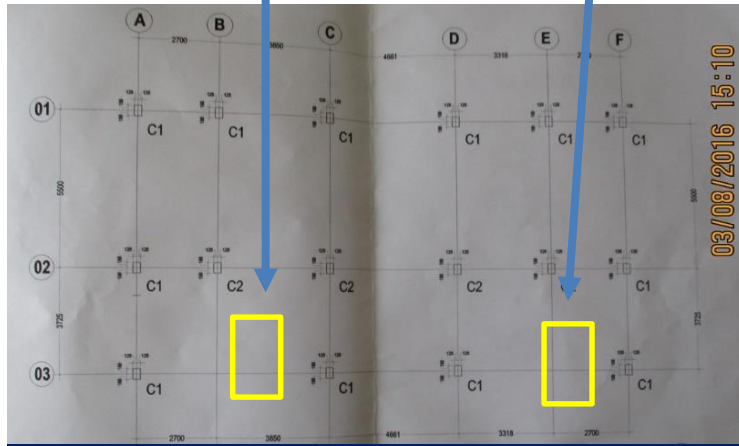
Provided column layout (Two columns are not shown)

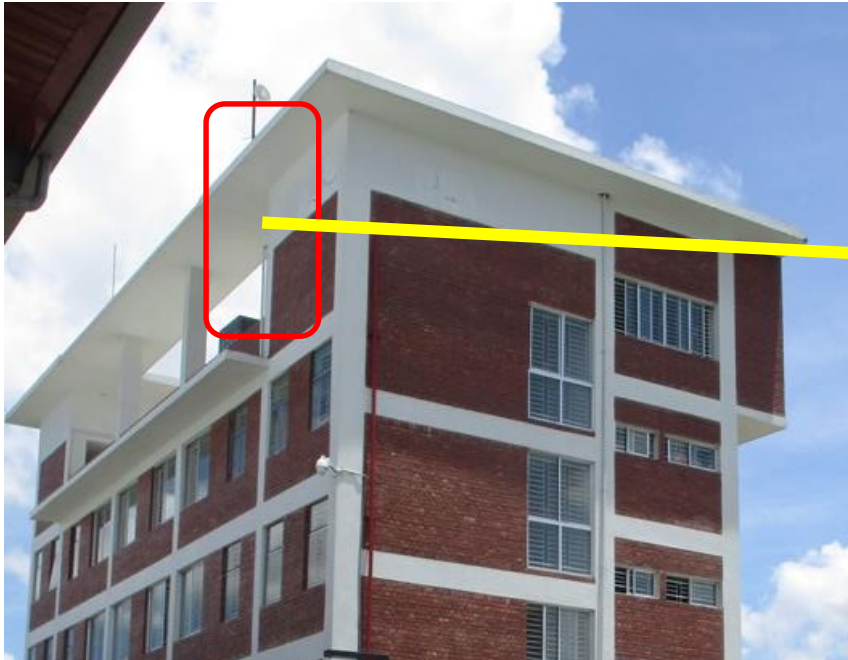
RC slab at roof and an expansion joint found at top of Dining Building. No detail information was found in structural drawing.

RC slab at roof

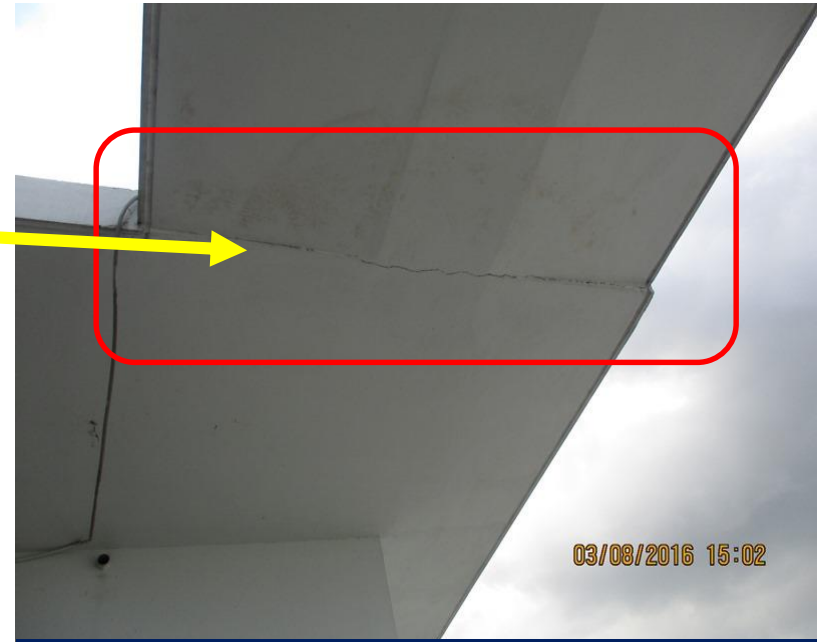
Expansion joint at roof slab

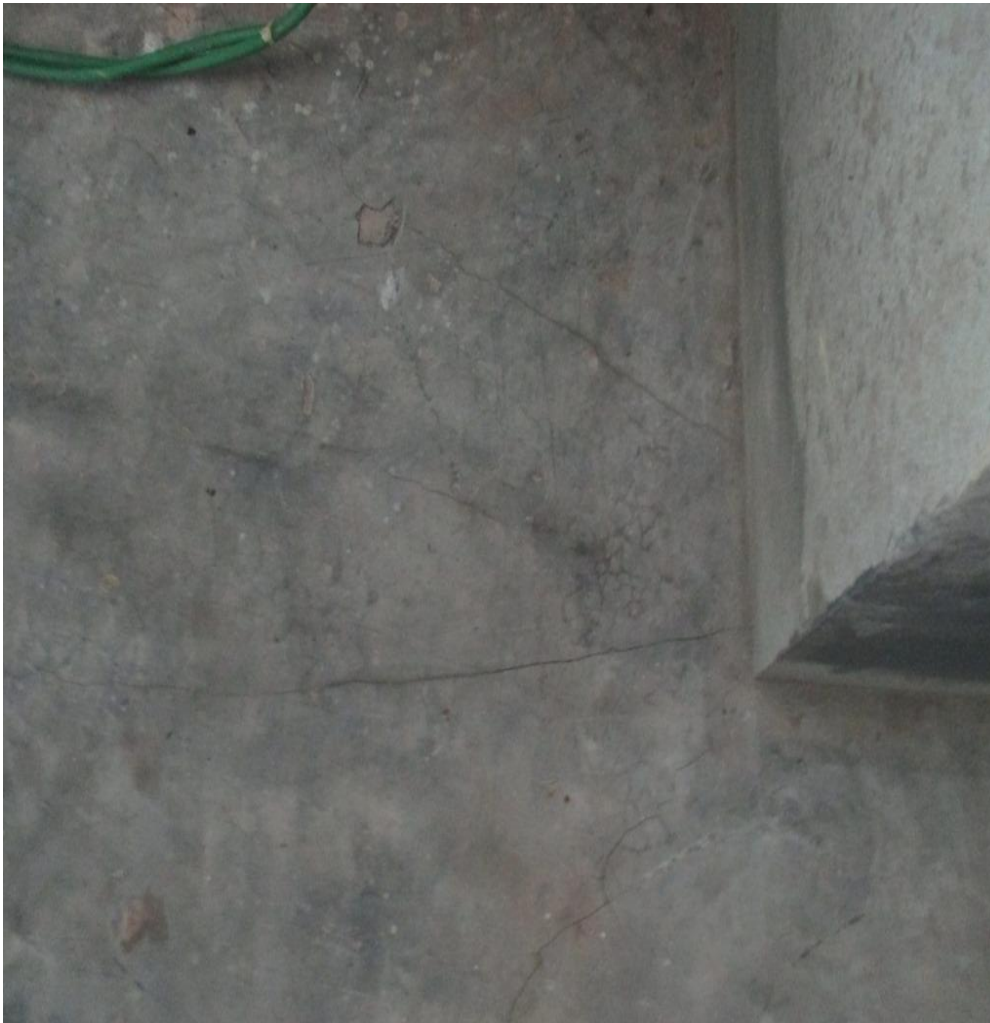
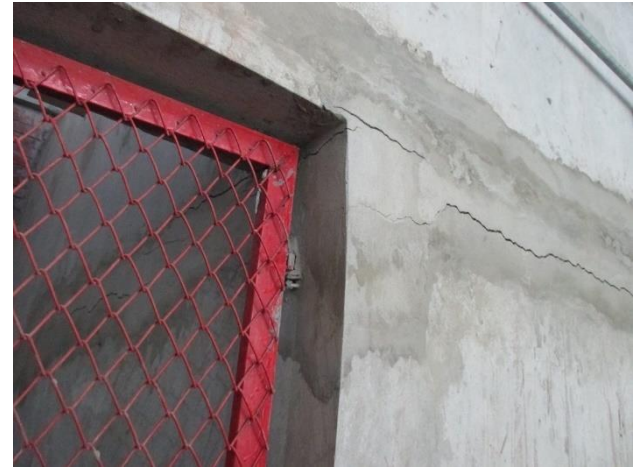
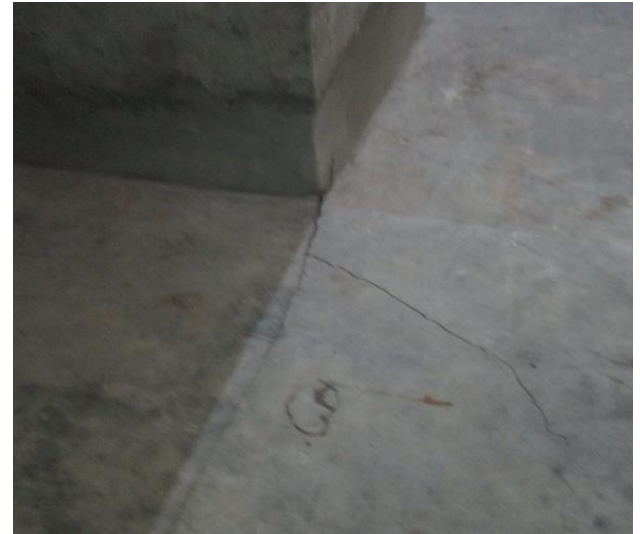
Ground floor has settled down and visible cracks observed on floor and partition wall

| Item No | Observation | Recommended action plan | Recommended timeline |
|---|---|---|---|
| 16 | <b>Cracks on ground floor slab and Brick walls due to soil settlement</b> | The Factory Engineer to check the stability system of the structure for the settlement. | 6 Weeks |
| 18 | <b>Cracks on ground floor slab and Brick walls due to soil settlement</b> | Remedial works to be carried out. | 6 Month |

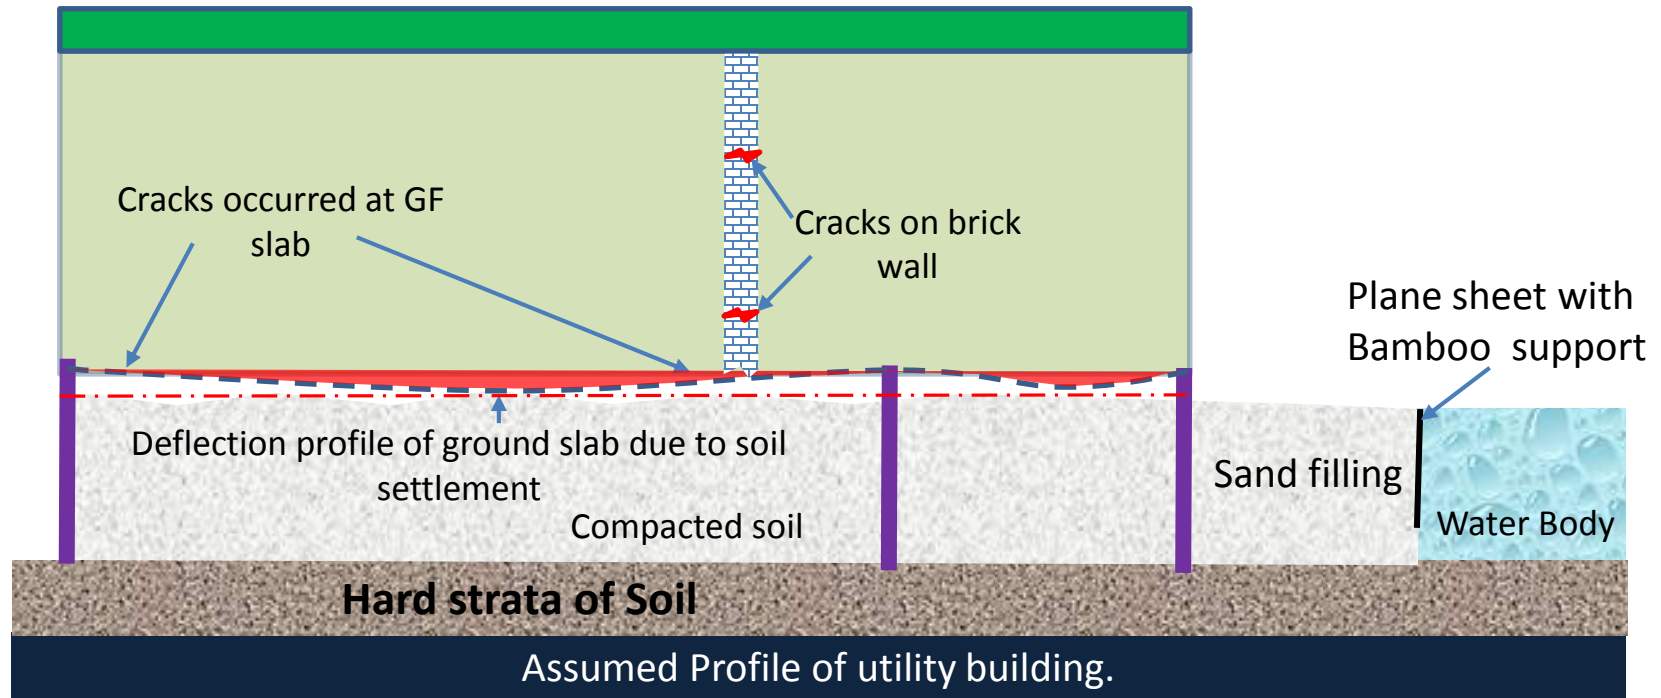
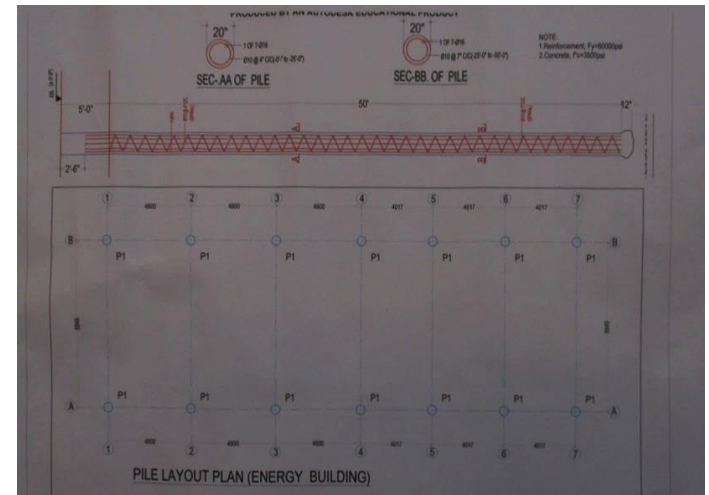
The Utility Building was built with pile foundation. The gap between two piles are almost 9m. There is no clear information about GF slab in structural drawing. GF floor may be made of brick soling. Though the building built in a moorland by sand filling and water body is very close to the building so that soil erosion or water intrusion can easily occur. By this soils are settling down and visible cracks on GF floor slab & brick wall were observed.

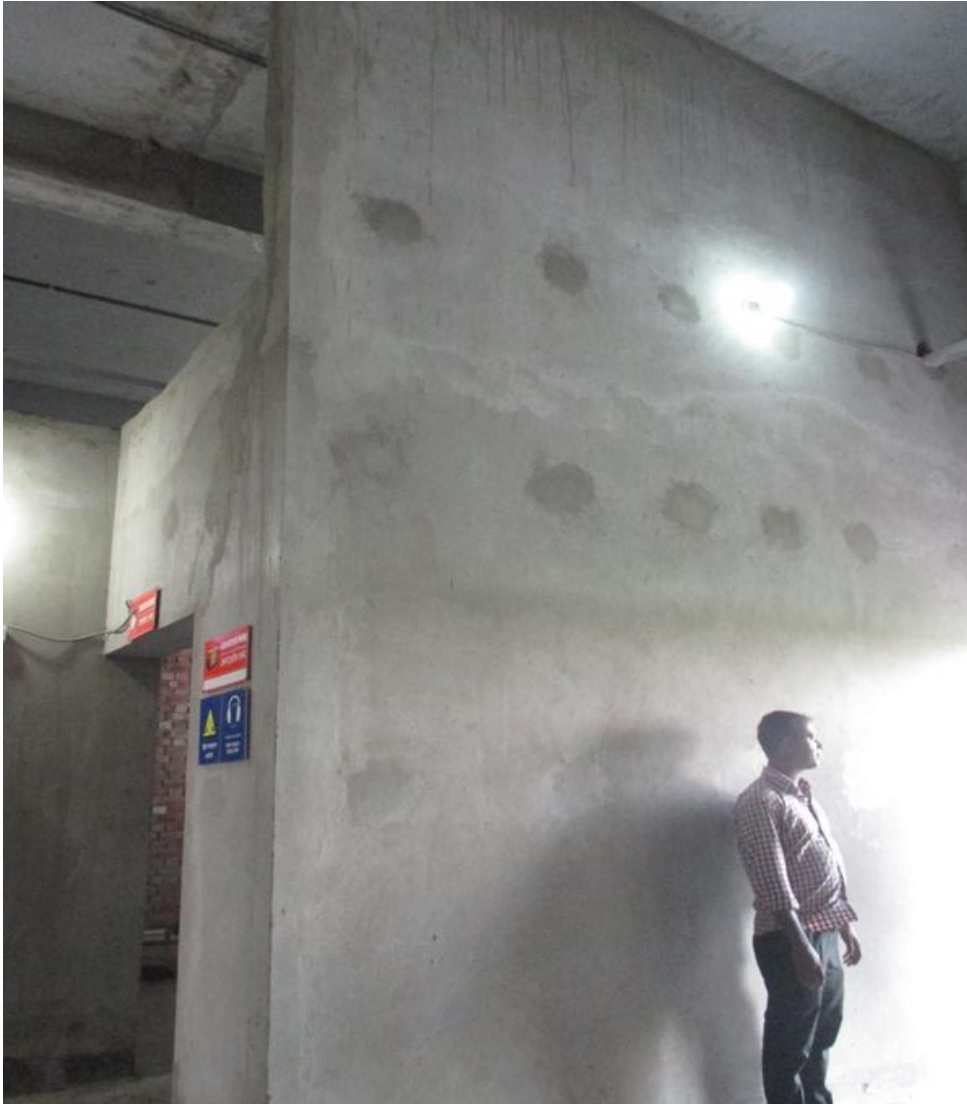
Unsupported 10" Brick wall observed

| Item No | Observation | Recommended action plan | Recommended timeline |
|---|---|---|---|
| 17 | <b>Cracks on ground floor slab and Brick walls due to soil settlement</b> | Check the stability of unsupported wall | 6 Weeks |

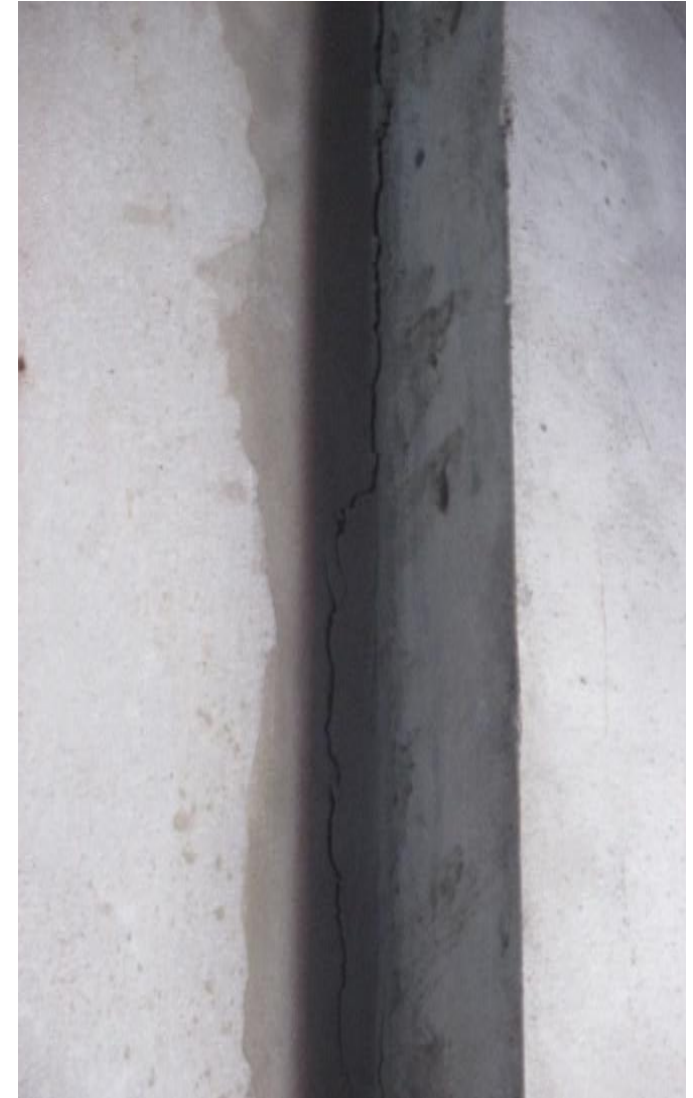
Loose bonding with column

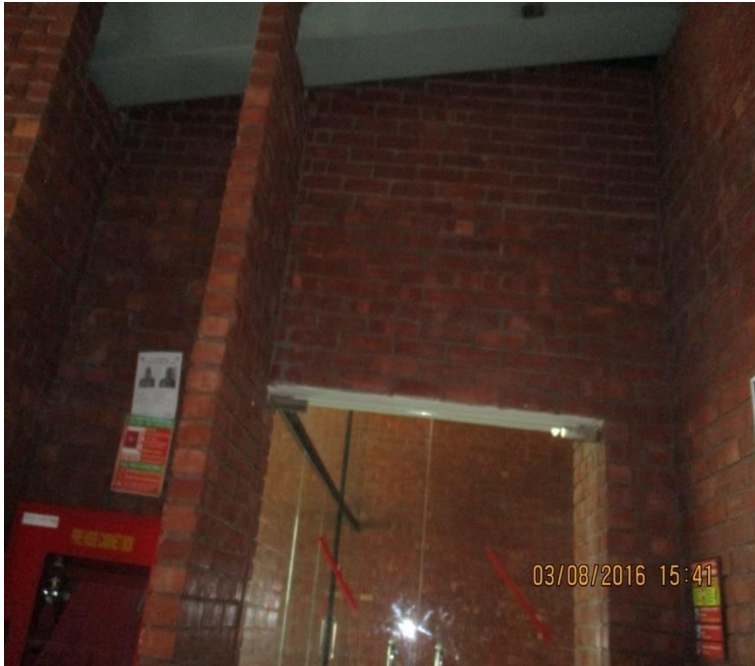
No lintel at the opening of east side mezzanine floor.

| Item No | Observation | Recommended action plan | Recommended timeline |
|---|---|---|---|
| 19 | <b>No lintel found at opening (Main production shed &amp; Utility Building)</b> | Restore lintel beam or any other system that can take the loads from brick wall. | 6 Weeks |
| 20 | <b>No lintel found at opening (Main production shed &amp; Utility Building)</b> | Remedial works to be carried out. | 6 Month |

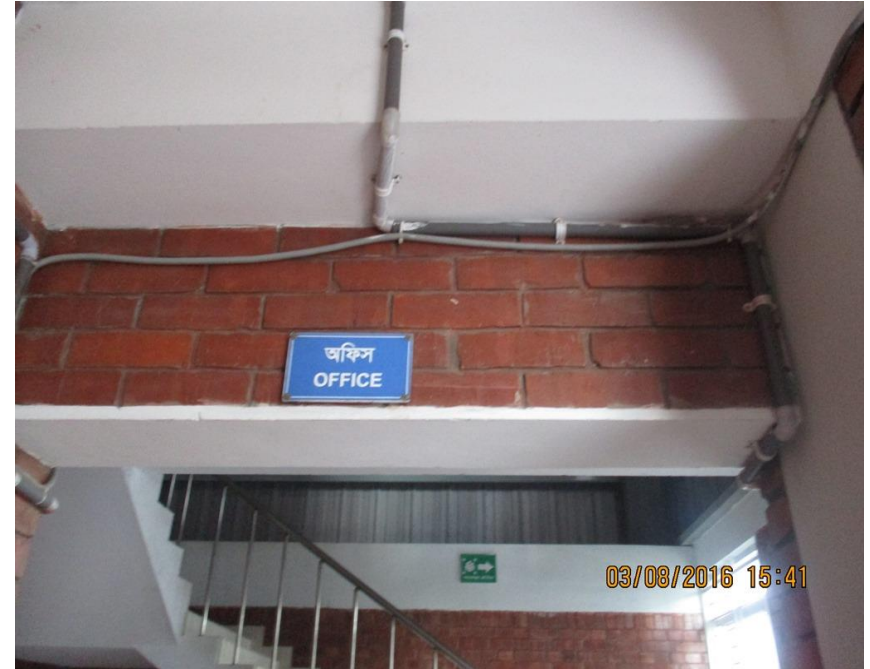
Brick wall found under beam without having lintel at Ground floor exit.
