# KA Design Limited

3<sup>rd</sup> August 2016

## Client Summary report

Observations & Actions

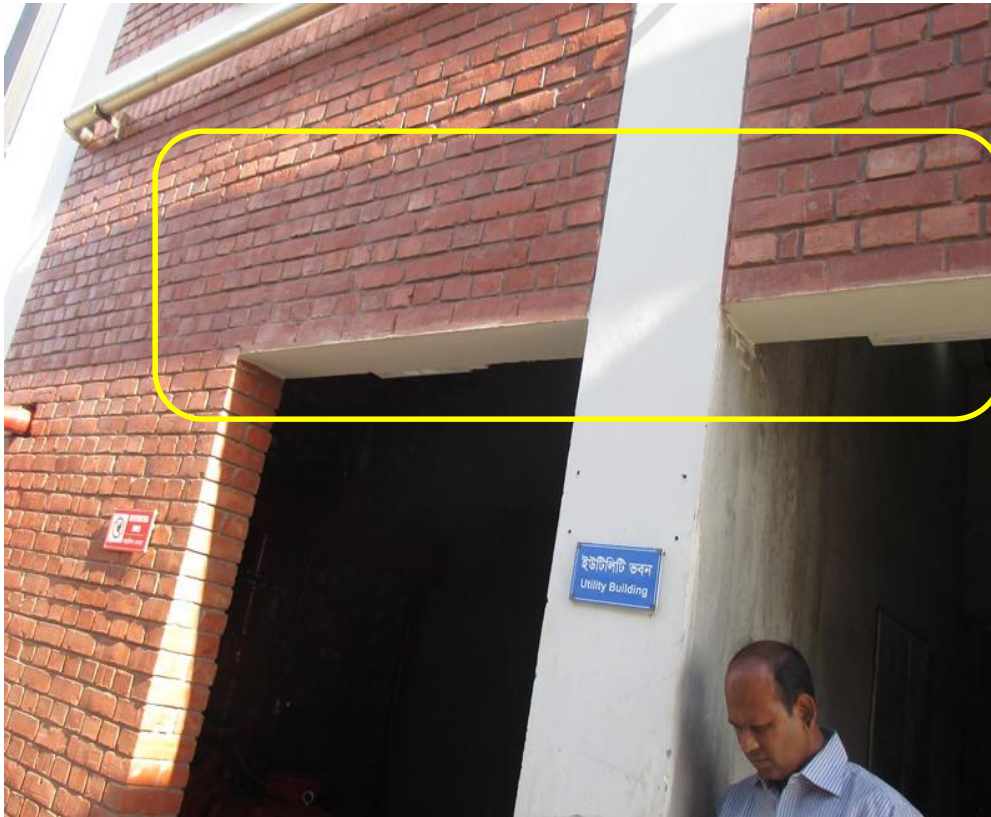
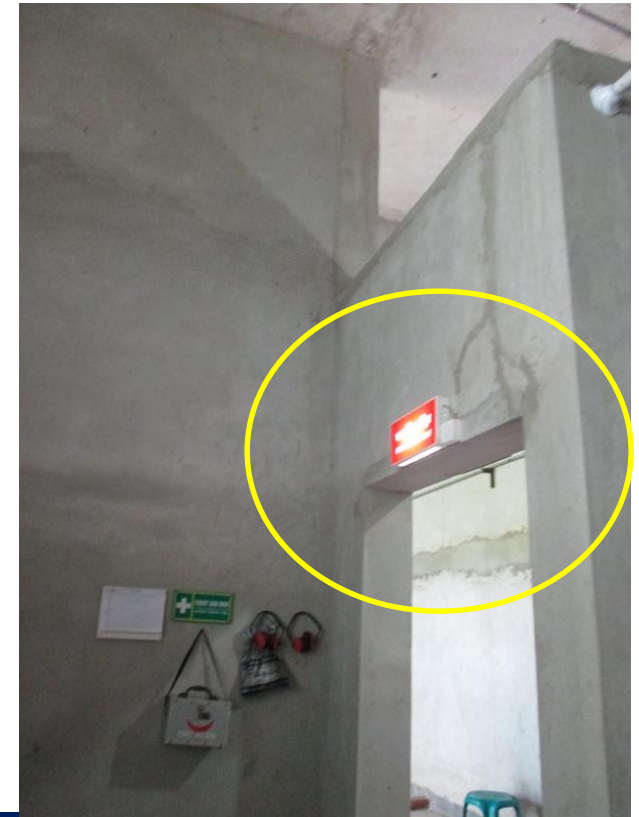
No lintel was found at the exit point and door opening at Utility Building

| Item No | Observation | Recommended action plan | Recommended timeline |
|---|---|---|---|
| 19 | <b>No lintel found at opening (Main production shed &amp; Utility Building)</b> | Restore lintel beam or any other system that can take the loads from brick wall. | 6 Weeks |
| 20 | <b>No lintel found at opening (Main production shed &amp; Utility Building)</b> | Remedial works to be carried out. | 6 Month |
