# Crystal Industrial Bangladesh Private Ltd

Sa plot 2013, Master Para, Kewa, Sreepur, Gazipur, Dhaka  
(24.18587N,90.429583E)  
5th March 2014

# Observations

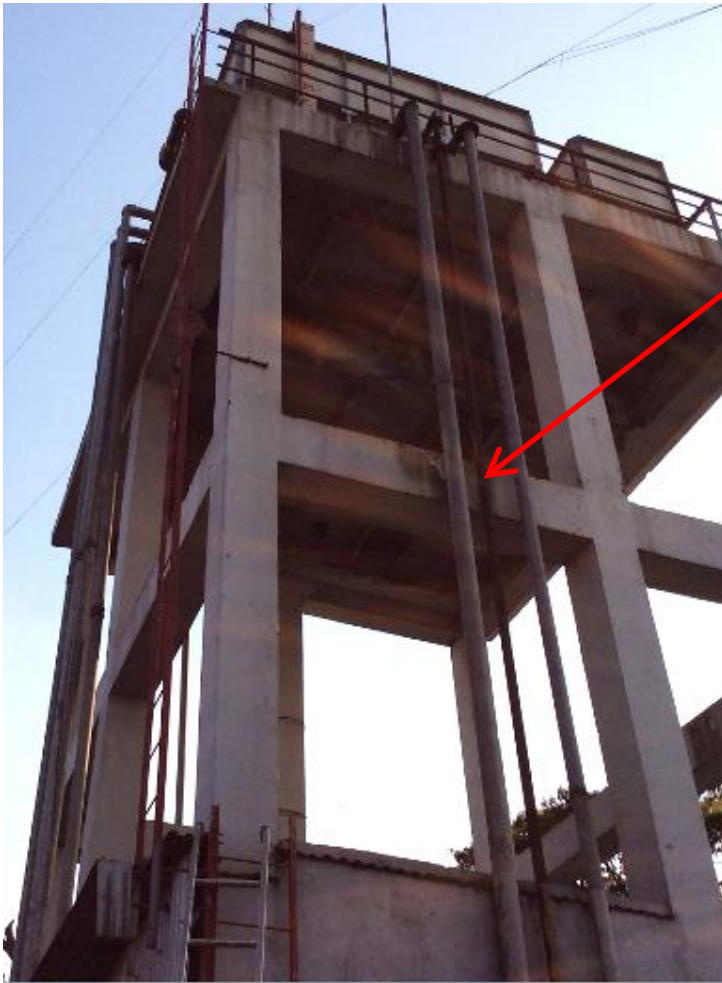
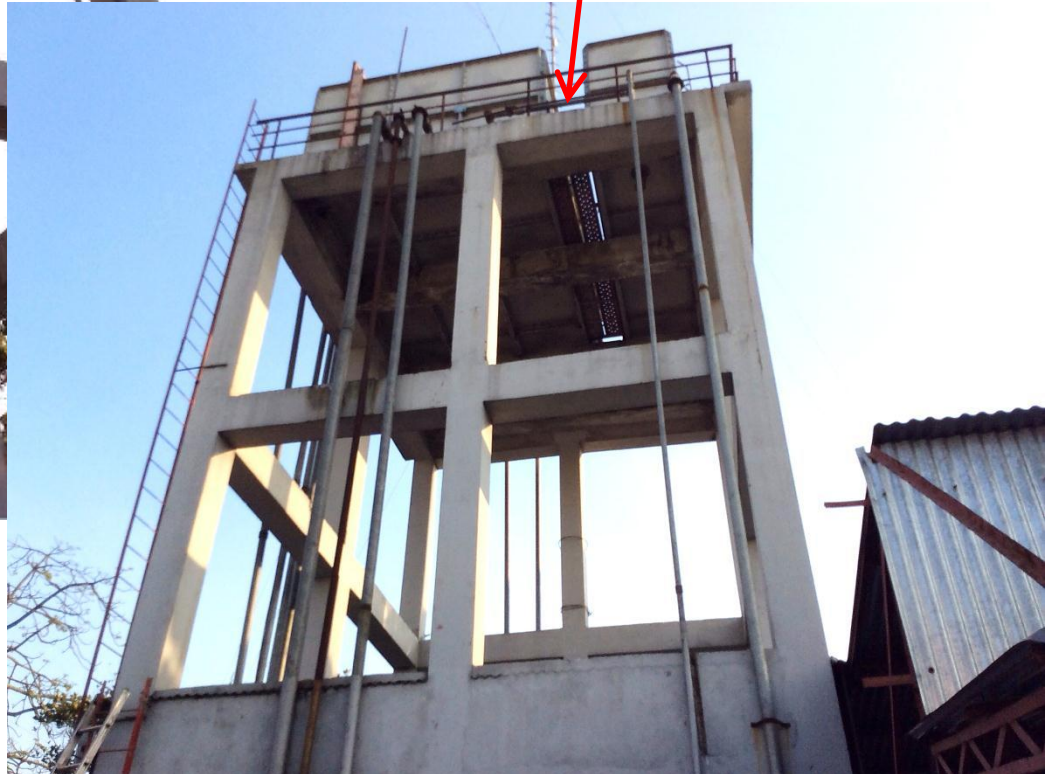
**Water damage**

Water Damage on reinforced concrete structure due to leaking water.

1. Water damage to Concrete Frame supporting Water tank
2. Embankment Stability to East of building

| Item No. | Observation | Recommended Action Plan | Recommended Timeline |
|---|---|---|---|
| 1 | Water damage to concrete supporting water tank | Fix leaks on water tank to prevent further damage to concrete. | 6-months |

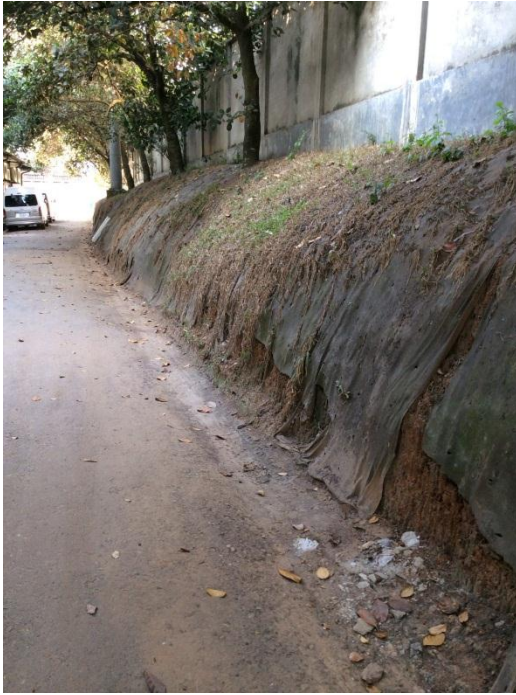
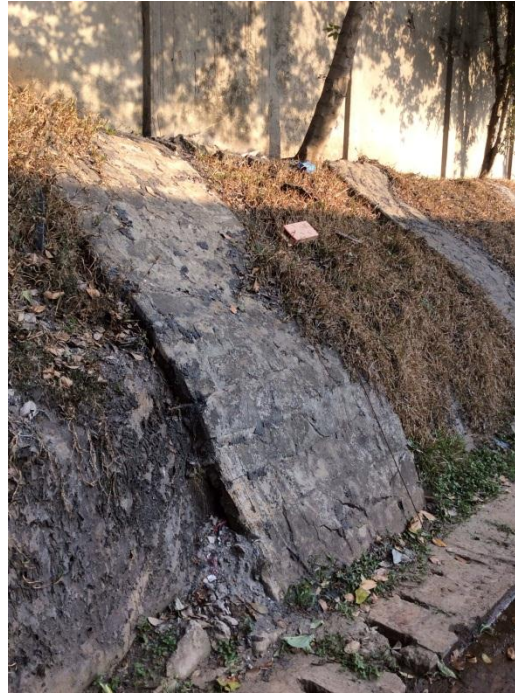
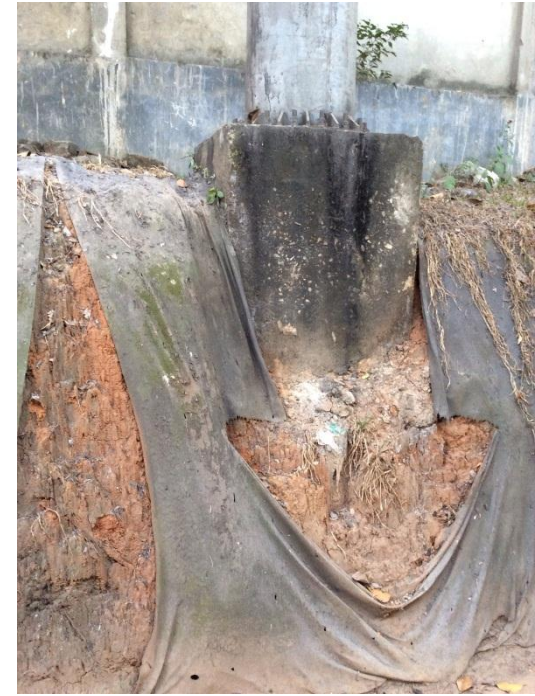
## Embankment

The embankment on the eastern side of the building carries loads of a wall separating the estate. The embankment shows sign of slippage. Slope stability to be assessed.

| Item No. | Observation | Recommended Action Plan | Recommended Timeline |
|---|---|---|---|
| 2 | Slope stability of embankment | Slope stability to be assessed to prevent slippery of embankment. | 6-months |
