# Fame Sweaters Ltd. SS Sweaters Ltd.

Holding-124,Darail, Sataish bazar, Tongi; Gazipur, Dhaka  
(23.91601N, 90.36467E)

05 March 2014

# Observations

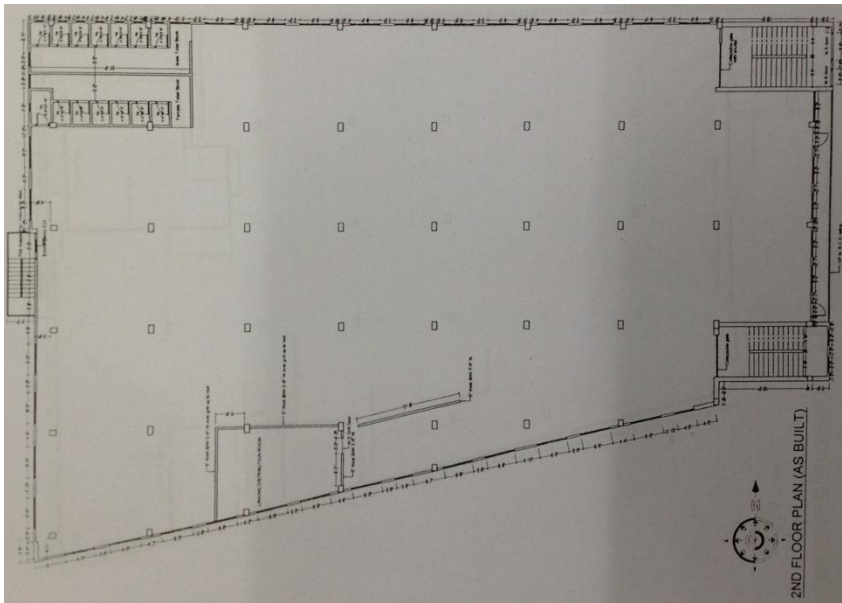
Column layout

**Columns at 2<sup>nd</sup> floor appear to be stressed in excess of normal design limits**

Cursory calculations indicate that columns at 2<sup>nd</sup> floor level are also stressed above normal design levels.

Building Engineer is to perform detailed calculations based on as constructed dimensions and concrete tests to prove column size and (if required) :

- Reduce loads by vacating floors and removing additional structures
- Reinforce columns

| Item No. | Observation | Recommended Action Plan | Recommended Timeline |
|---|---|---|---|
| 6 | Columns at 2nd floor appear to be stressed in excess of normal design limits | Building Engineer to review design, loads and columns stresses in area identified above at 2nd floor level | 6-weeks |
| 7 | Columns at 2nd floor appear to be stressed in excess of normal design limits | Verify insitu concrete strengths (using min. 4 no. 100mm dia. Cores) and existing reinforcement for all columns at 2nd floor level. | 6-weeks |

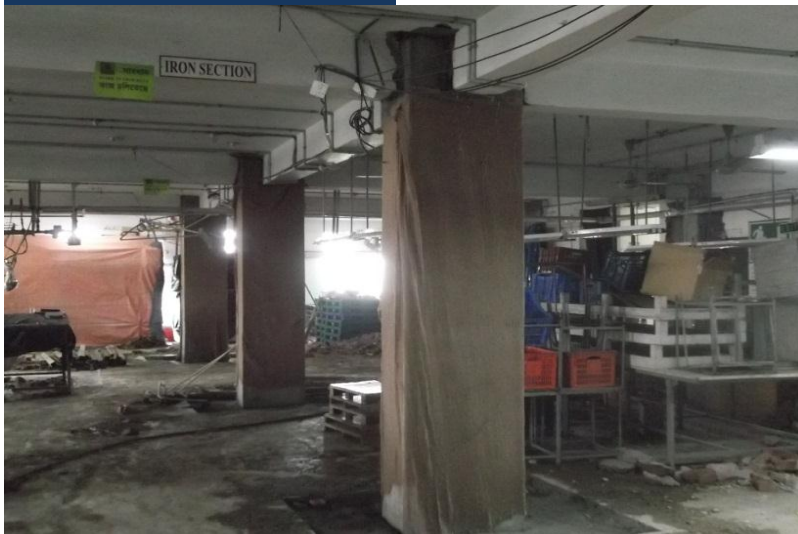
Column strengthening works at Ground Floor

Cursory calculations indicate that the working stress in internal and perimeter columns is at a high level at ground floor level and 1<sup>st</sup> floor. Remedial works, designed by others, are on-going at ground and 1<sup>st</sup> floor level to strengthen columns.

| Item No. | Observation | Recommended Action Plan | Recommended Timeline |
|---|---|---|---|
| 1 | Remedial works to ground and first floor columns | Full details and calculations to be provided by Building Engineer for on-going remedial works. | Immediate - Now |
| 2 | Remedial works to ground and first floor columns | In particular, these calculations need to explain how the column jacketing contributes to the overall capacity. | Immediate - Now |

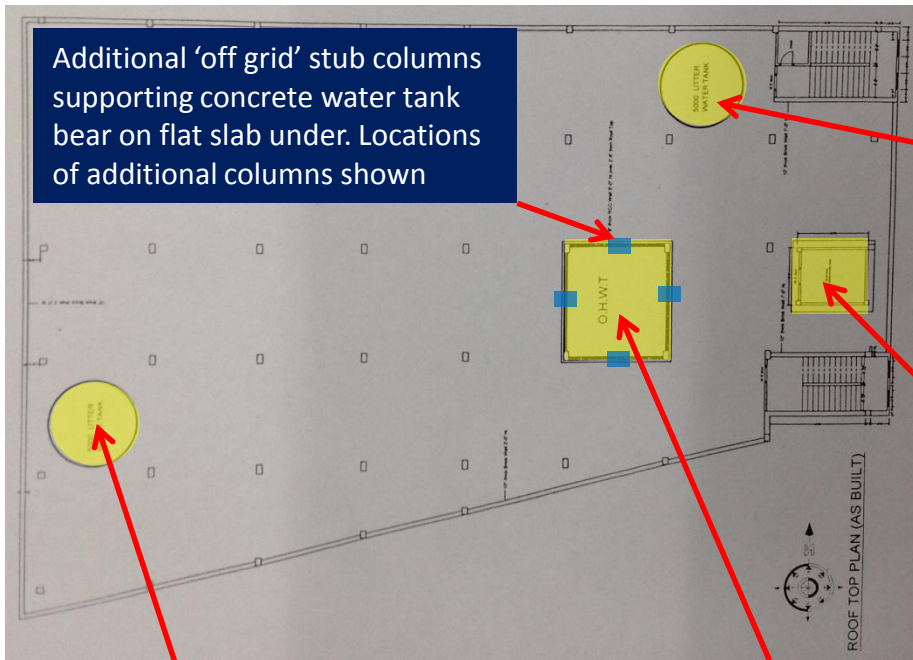
Additional 'off grid' stub columns supporting concrete water tank bear on flat slab under. Locations of additional columns shown

Building Engineer to check that concrete roof slab and columns have been designed to support loads from Antenna house and water tanks.

| Item No. | Observation | Recommended Action Plan | Recommended Timeline |
|---|---|---|---|
| 9 | Structural adequacy of concrete roof slab and columns to support antenna house, plastic water tanks and concrete water tank | Verify that flat slab and support columns have sufficient capacity to support fully filled water tanks and roof antenna house | 6-weeks |

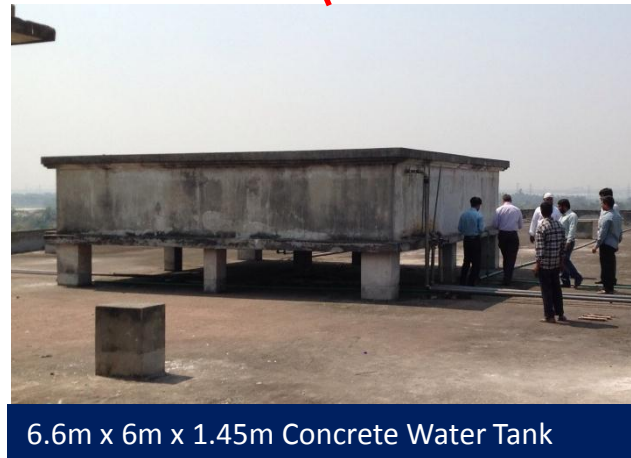
6.6m x 6m x 1.45m Concrete Water Tank

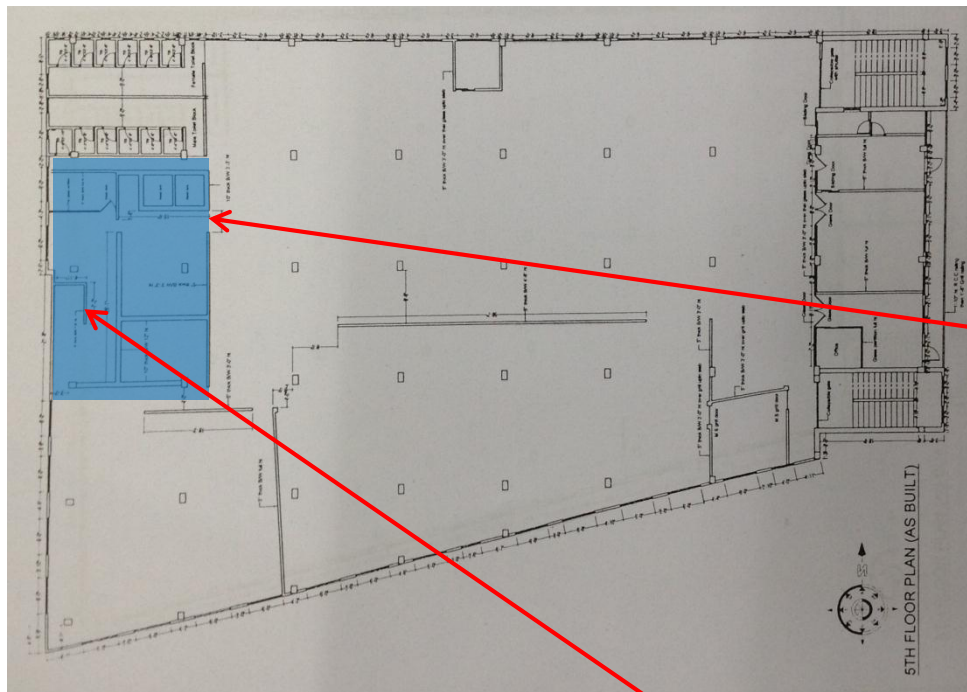
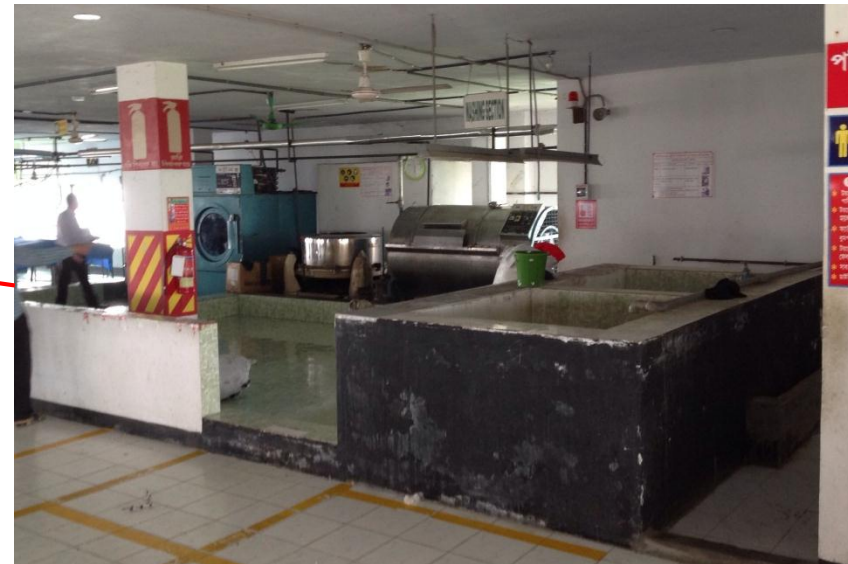
High loading (Concrete water tank and plinth)

High loading due to dryers,  
concrete plinth and concrete  
water tank in area shown

Capacity of concrete beams  
and floor slab to be confirmed  
by Building Engineer

| Item No. | Observation | Recommended Action Plan | Recommended Timeline |
|---|---|---|---|
| 10 | Design check required for dryer equipment loads on 5th floor and Knitting Distribution loads on 2nd and 3rd Floors | Produce and actively manage a loading plan for all floor plates, flat slabs and beam & slab construction, within the factory giving consideration to floor capacity and column capacity. | 6-weeks |

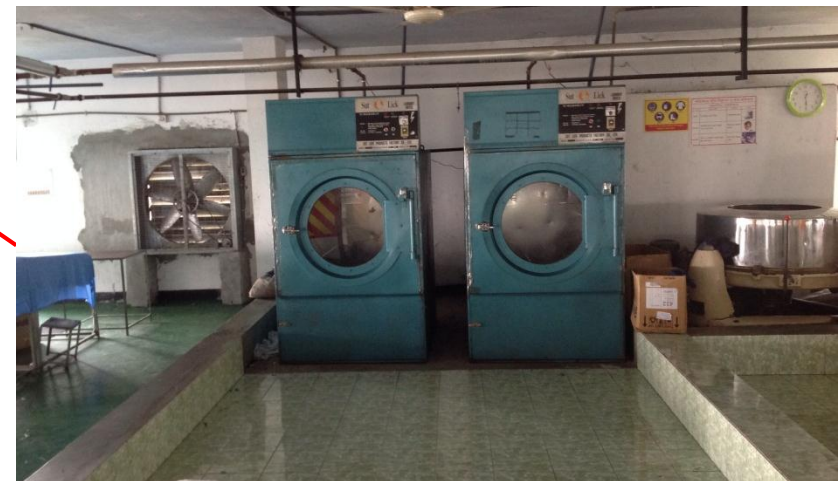
High loading (Dryers and plinth)

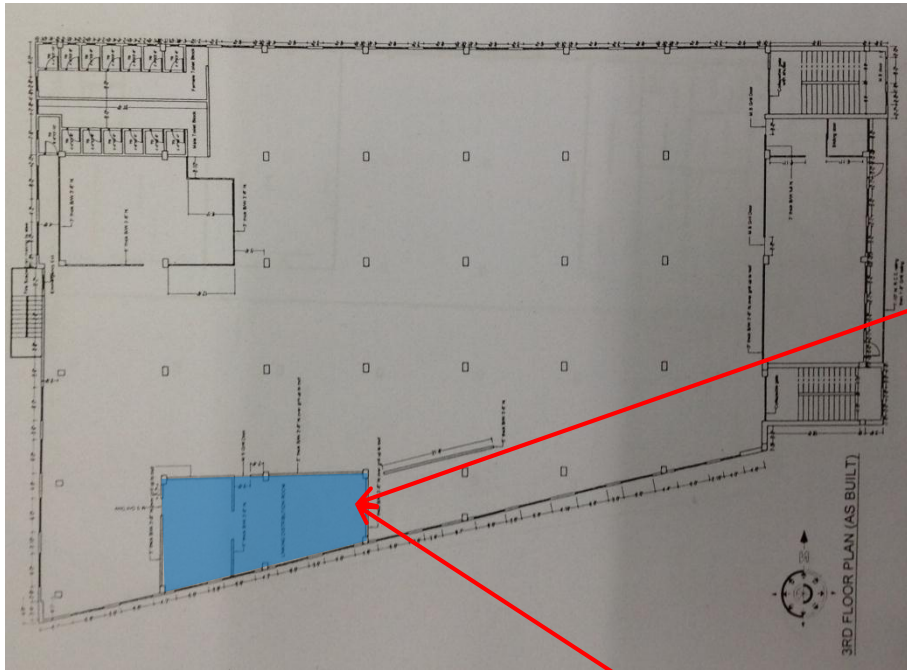
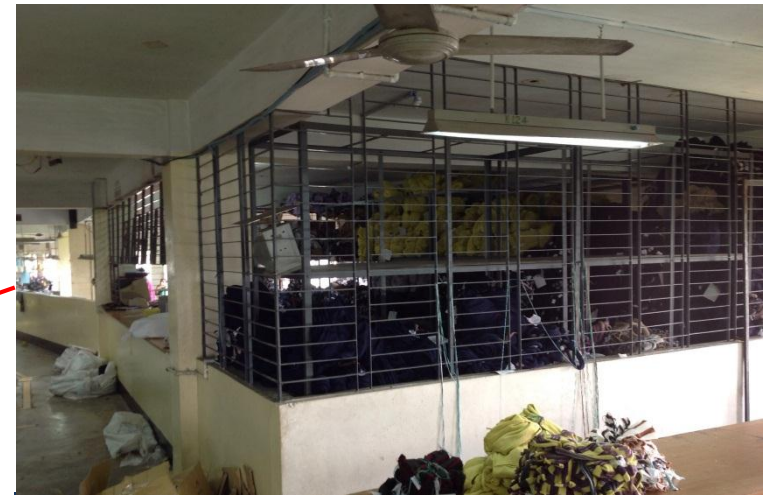
Storage loading (Knitting Distribution Area)

Loading due to storage of garments in the knitting distribution area

Capacity of concrete beams and floor slab to be confirmed by Building Engineer

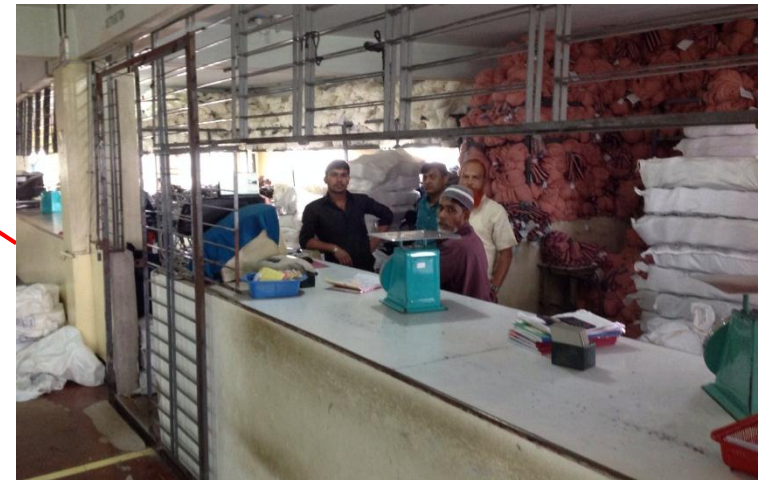
Storage loading (Knitting Distribution Area)

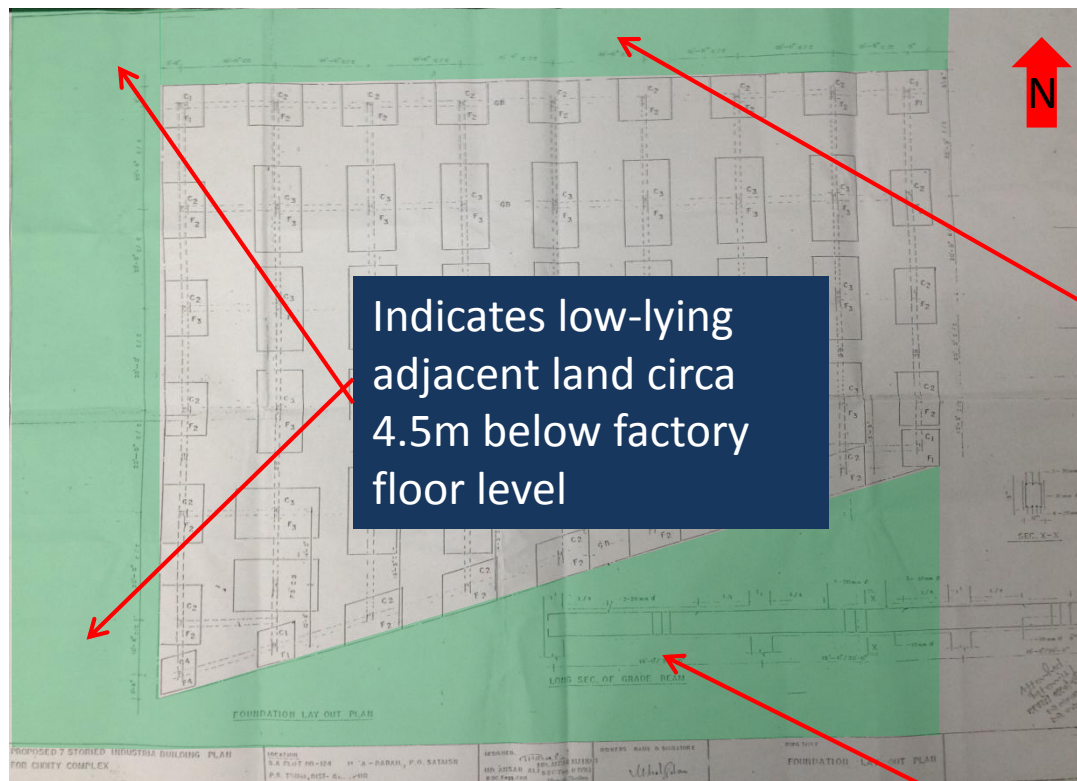
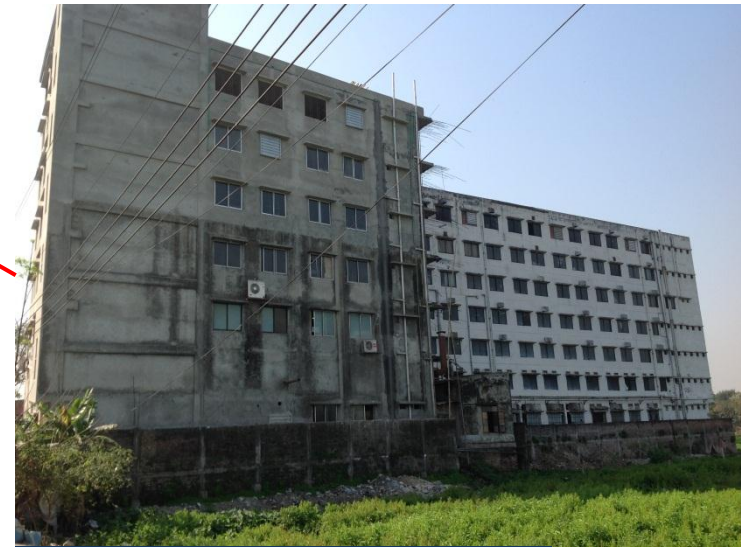
Low-lying adjacent land

Level of perimeter pad foundations to be confirmed by Building Engineer - at sufficient depth below ground level to ensure adequate load distribution due to difference in level between ground floor and adjacent land

| Item No. | Observation | Recommended Action Plan | Recommended Timeline |
|---|---|---|---|
| 12 | Confirmation required that perimeter column foundations are at an appropriate depth to ensure load distribution | Building Engineer to review the Geotechnical (Soils) Report which recommends pad footings to be constructed 13ft below ground level. | 6-weeks |
| 13 | Confirmation required that perimeter column foundations are at an appropriate depth to ensure load distribution | Building Engineer to confirm by physical investigation that foundation position, level, load spread and bearing is adequate with respect to the level difference to the adjacent land. | 6-weeks |

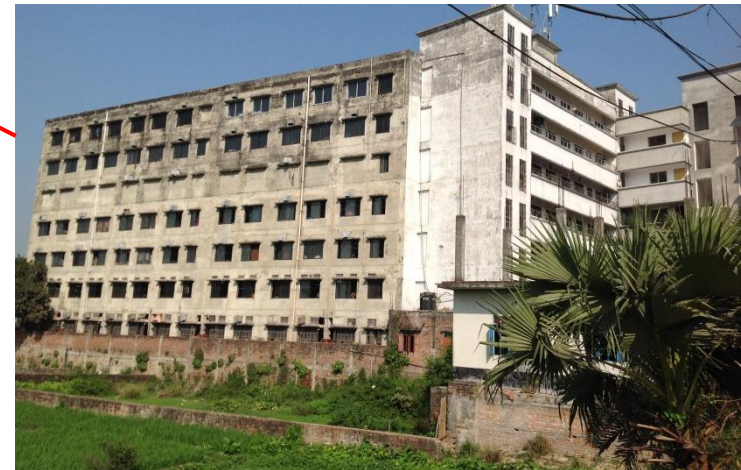
Low-lying adjacent land

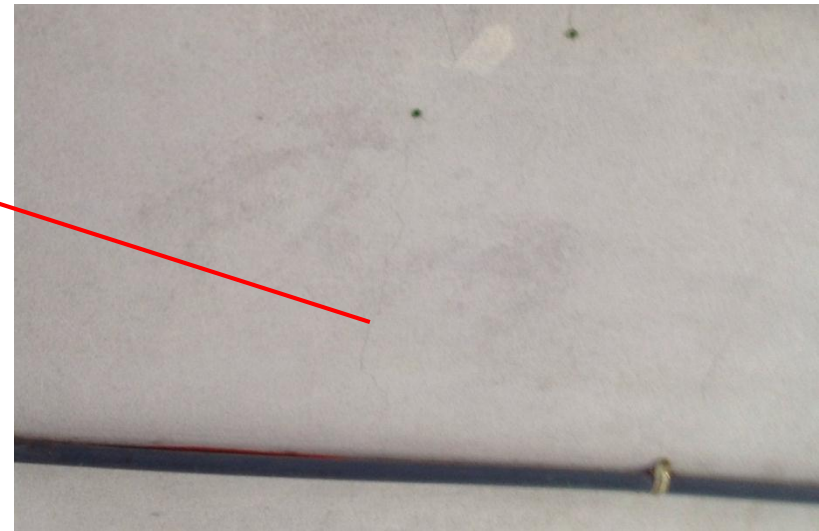
6<sup>th</sup> floor slab soffit-observed cracks

Cracking in soffit of flat slab to be reviewed by removing plaster to confirm that cracks do not extend into structure.

| Item No. | Observation | Recommended Action Plan | Recommended Timeline |
|---|---|---|---|
| 14 | Cracking to underside of 6th floor and roof slabs | Monitor cracks on slab. Conduct regular inspection of cracks. Investigate if cracks are only in the plastering. | 6-months |

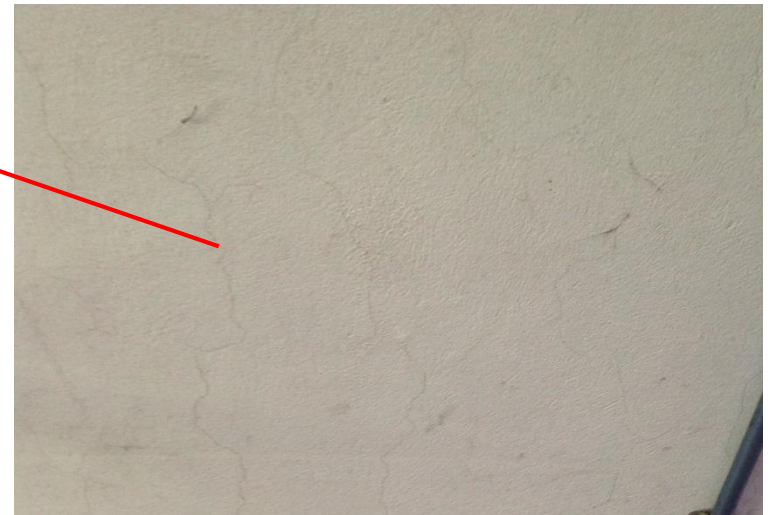
Roof slab soffit-observed cracks

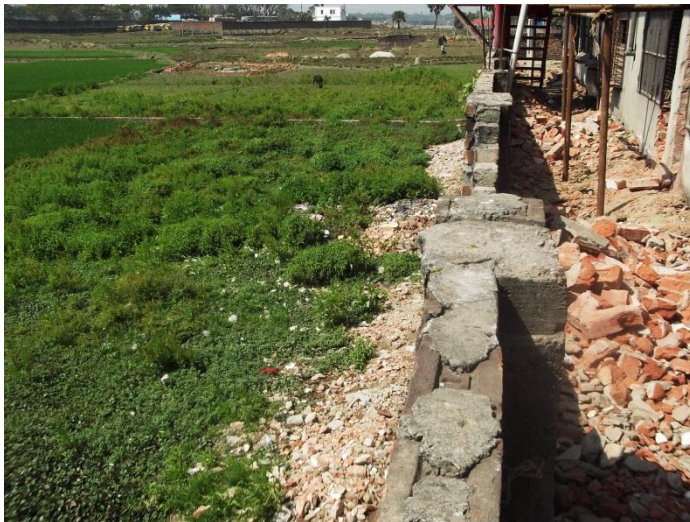
Difference in ground levels – 4.5m

Level of stair foundations to be confirmed to be at sufficient depth below ground level to ensure adequate load distribution due to difference in level between ground floor and adjacent land.

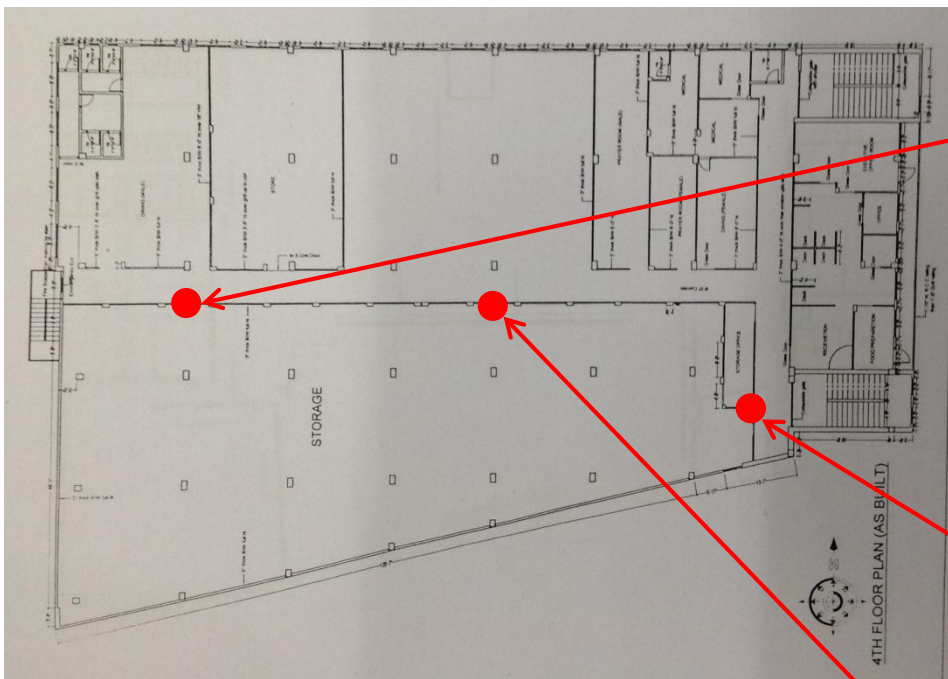
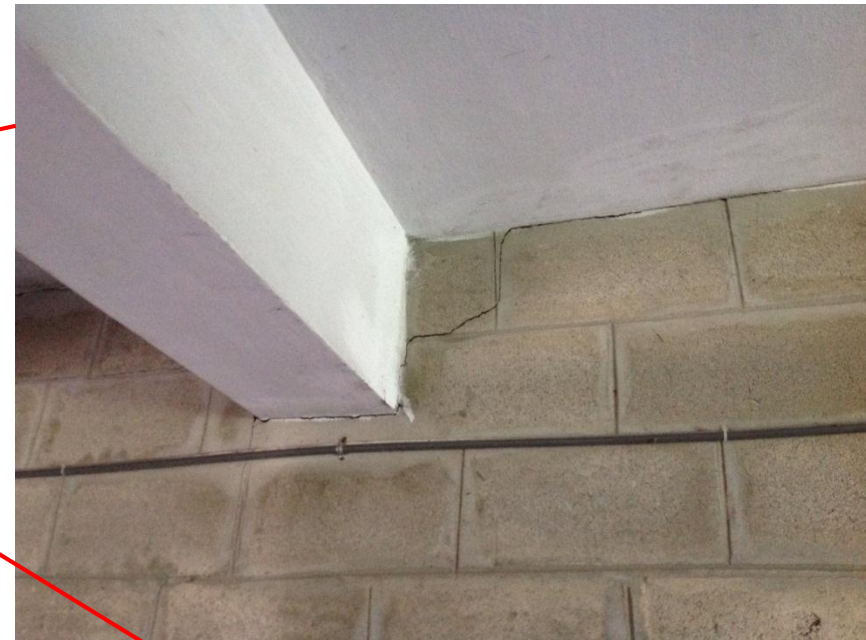
Locations of observed cracks

Evidence of cracking in brickwork partitions on 4<sup>th</sup> floor

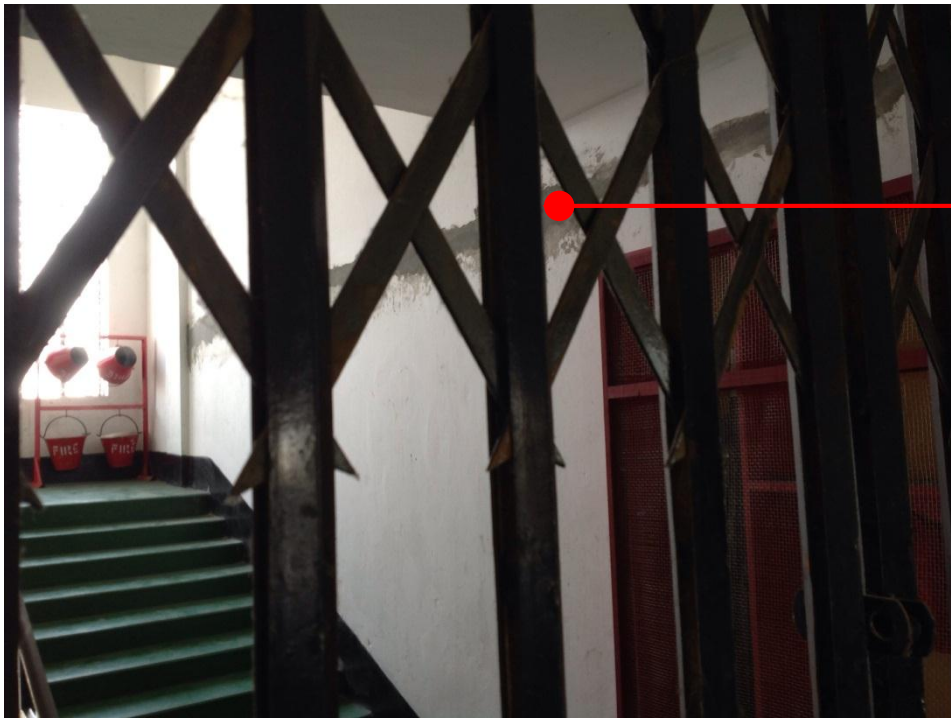
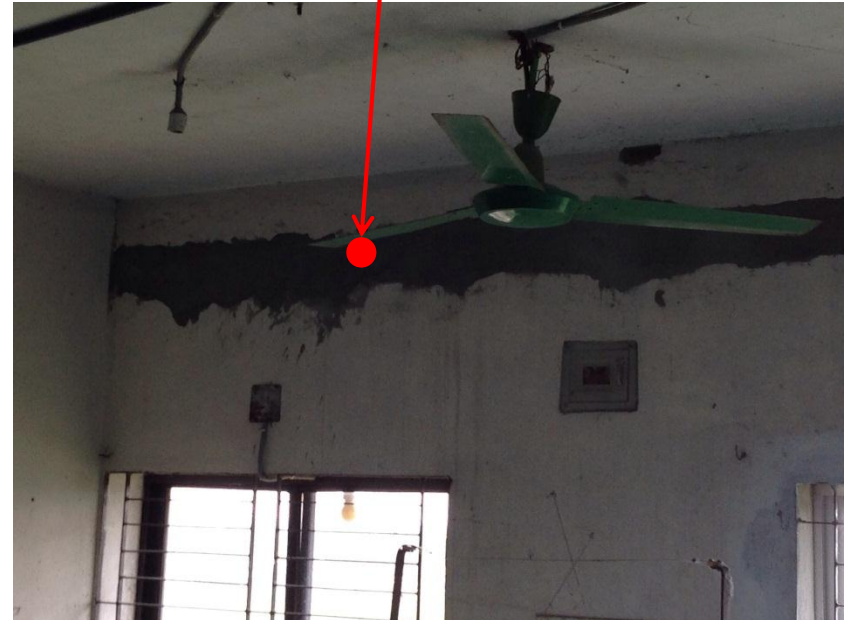
Evidence of repairs to  
cracking in brickwork  
within stairs
