# Mondol Fashion Ltd Shoe Maker Ltd.

Rashid Tower, Tongabari, Asulia, Savar  
(23.90585, 90.32248)

8<sup>th</sup> April 2014

# Observations

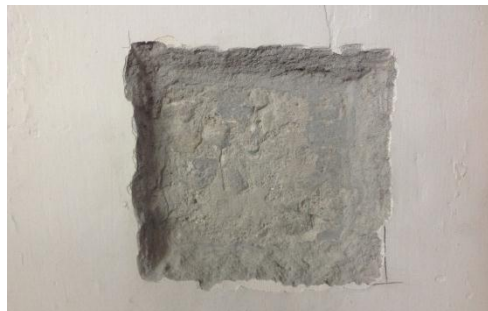
Tested Column C/3 (Stone)

Cursory calculations indicate that the working stress of the columns at Ground Floor and First Floor levels are at a high level. Refer to Action 1.

Construction of the building began in 2006, with construction of Foundations up to 2<sup>nd</sup> Floor level completed in 2007. Levels 3, 4 and 5 were subsequently constructed between 2012 and 2013. Stone aggregate was noted in the Ground Floor (or semi-basement) columns, although brick aggregate was observed at the head of one of the exposed columns at the intersection with the 1<sup>st</sup> Floor Slab. It is understood that the columns up to 2<sup>nd</sup> Floor level have stone aggregate and all other structural concrete members contain brick aggregate. There is a discrepancy between the drawings and the constructed building in relation to the size of the columns at Basement level. The columns were observed to vary in size in a random manner, and are typically smaller than is indicated in the drawings. Steel reinforcement quantities were also observed to be smaller than is indicated in the drawings. Grade 72 High Strength steel, which is called up in the structural drawings, was observed in the columns at Roof level.

| Item No. | Observation | Recommended Action Plan | Recommended Timeline |
|---|---|---|---|
| 1 | Stress levels in Columns | Factory Engineer to investigate aggregate type used in each individual column at Ground and First Floor levels particularly at column top level. | 6-weeks |
| 3 | Stress levels in Columns | Factory Engineer to verify insitu concrete strength by taking 100mm diameter cores from 4 columns . Verify grade of steel reinforcement used | 6-weeks |

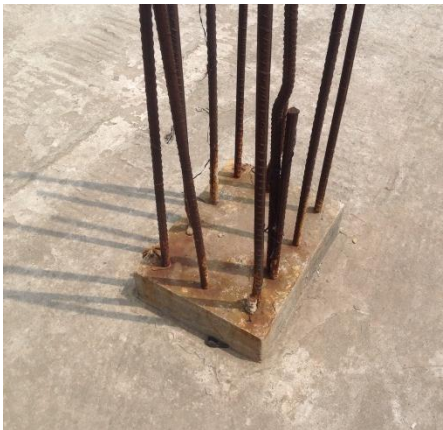
High strength reinforcement steel bars were observed at Roof level. The number of bars observed at Roof level is comparable with observations at basement level using the ferros scanner, but is inconsistent with what is indicated in the Structural Drawings.

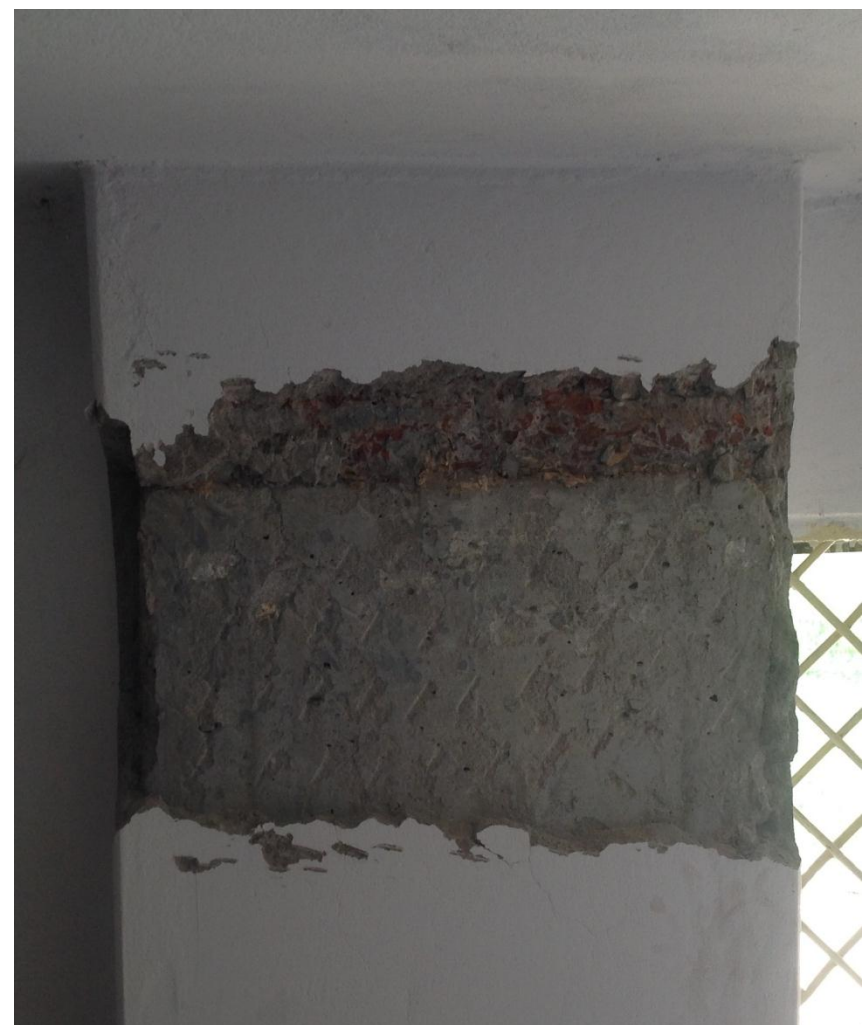
Exposed Column A/2

Hairline cracks were noted to column head. This prompted the removal of plaster, which revealed different aggregate types used in distinct concrete pours for the same column.

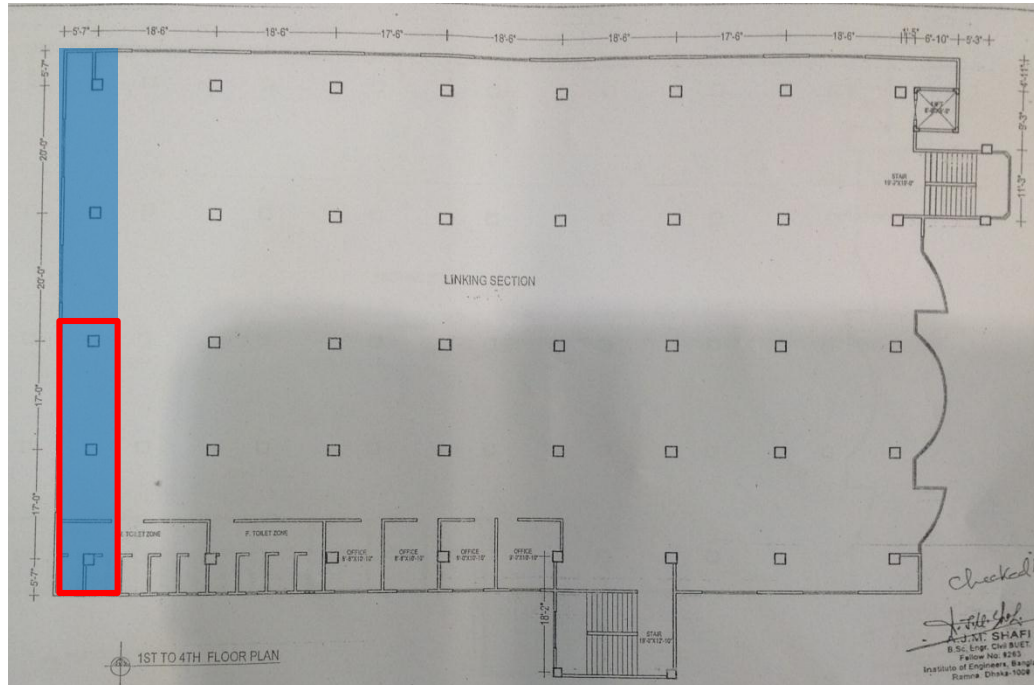
Typical Floor Plan

Areas of high super dead loading were noted in the toilets along the West elevation of the building at the cantilever location, in the form of plinths, suspended slabs and walls. Building Engineer to check that the cantilevers have been adequately designed to accommodate this loading.

Extent of Toilets to 3<sup>rd</sup> and 4th Floors

Extent of Toilets to 1<sup>st</sup>, 2<sup>nd</sup> and 5th Floors

| Item No. | Observation | Recommended Action Plan | Recommended Timeline |
|---|---|---|---|
| 5 | Heavy floor loading in and toilet areas | Engage an Engineer to investigate the floor loading, and advise on any necessary alterations taking account of floor capacity and column capacity | 6-weeks |
| 6 | Heavy floor loading in and toilet areas | Make any structural alterations as advised by Factory Engineer | 6-months |

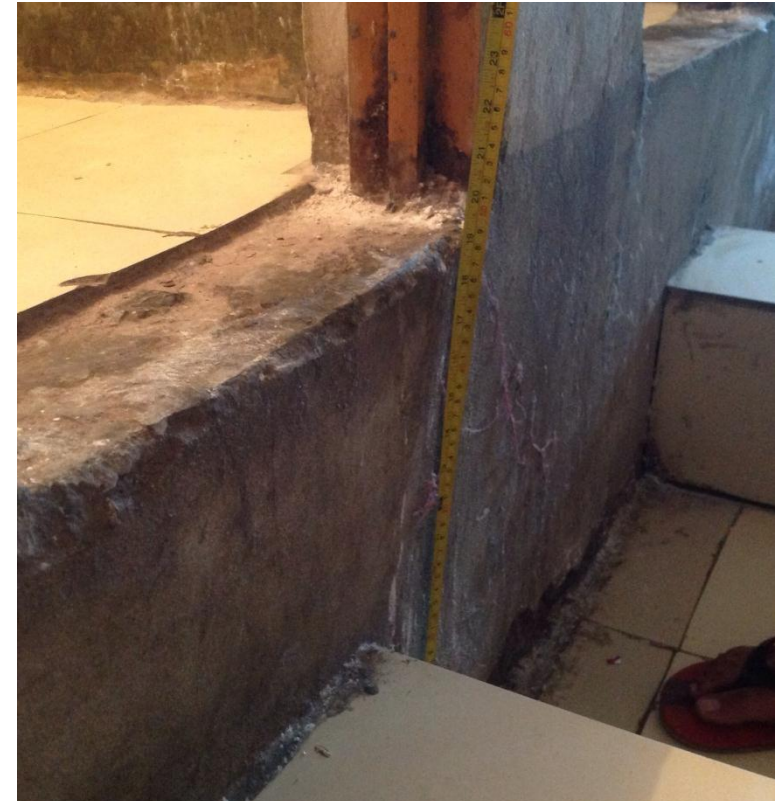
500mm Toilet Plinth to 3<sup>rd</sup> Floor

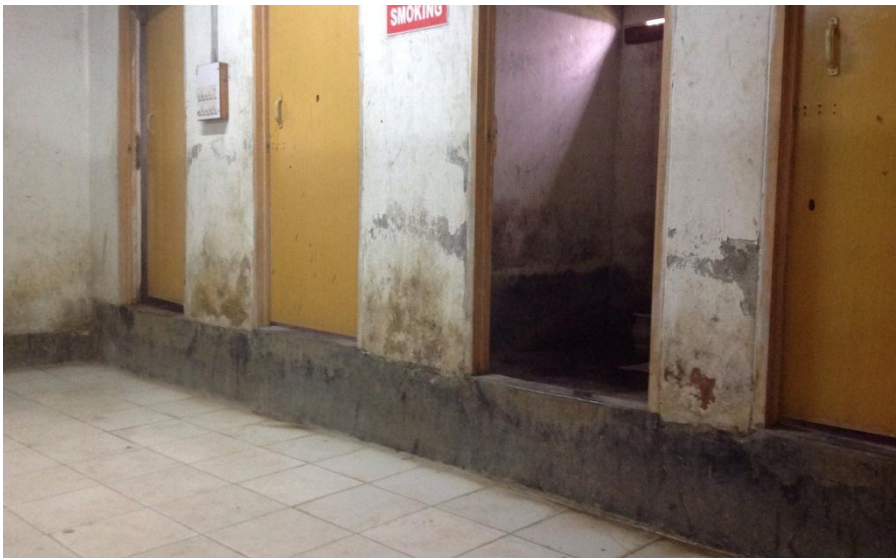
300mm Toilet plinth to 2<sup>nd</sup> Floor

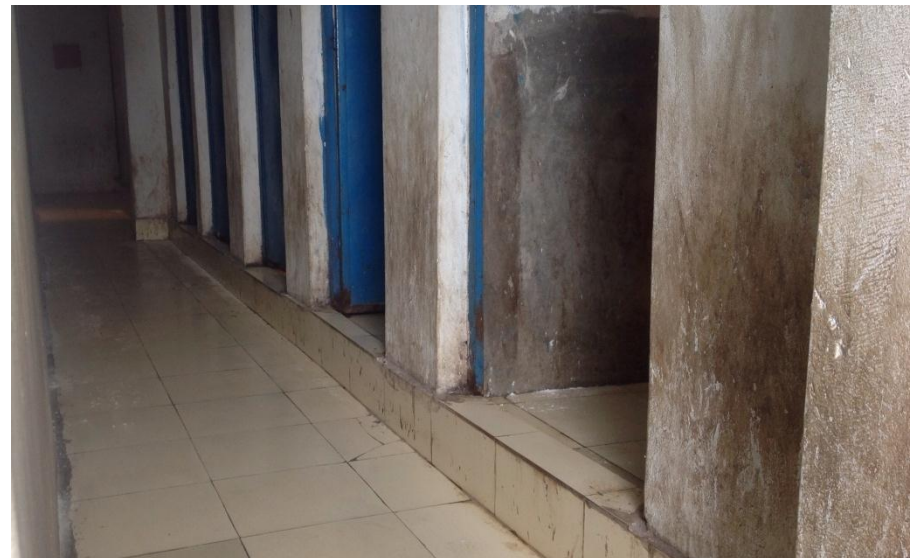
150mm plinths, slabs and walls to 4<sup>th</sup> and 5<sup>th</sup> Floors

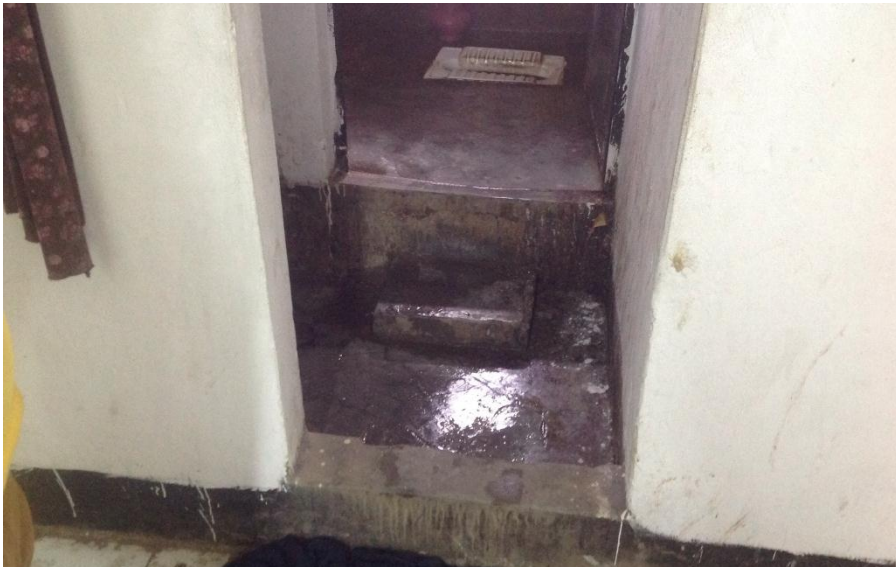
500mm Toilet plinth to 1<sup>st</sup> Floor

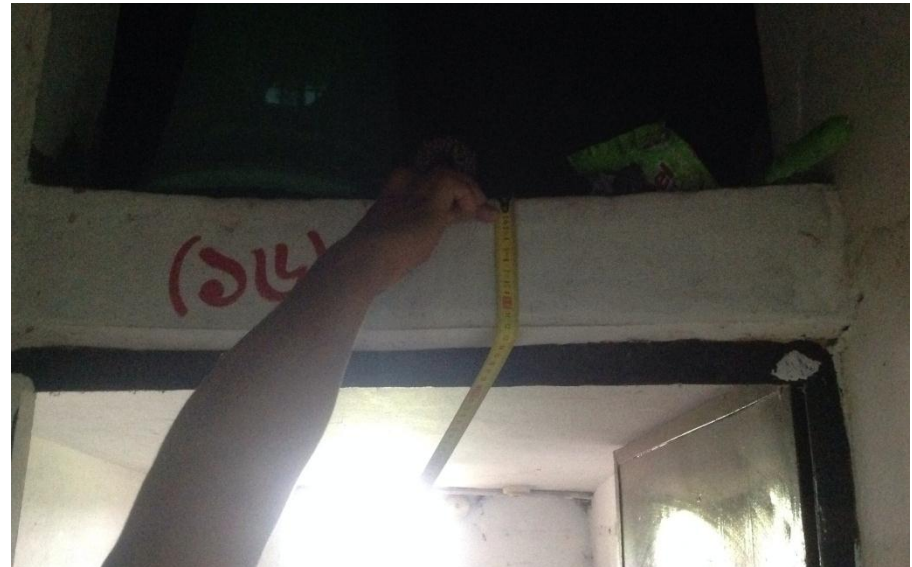
120mm Suspended slab to 1<sup>st</sup> Floor Toilet

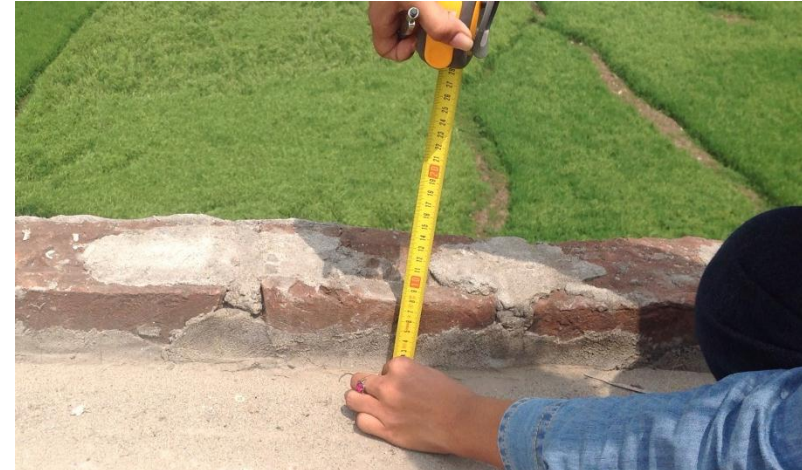
There is no edge protection at Roof level where works are ongoing. Handrails are also missing to stairs. Building Engineer to install adequate fall barrier / guarding with immediately effect.

Height of Parapet to Roof

| Item No. | Observation | Recommended Action Plan | Recommended Timeline |
|---|---|---|---|
| 7 | Lack of any guarding/edge protection at Roof Level and at some stairs levels | Provide adequate edge protection at Roof Level and at stairs | 6-weeks |

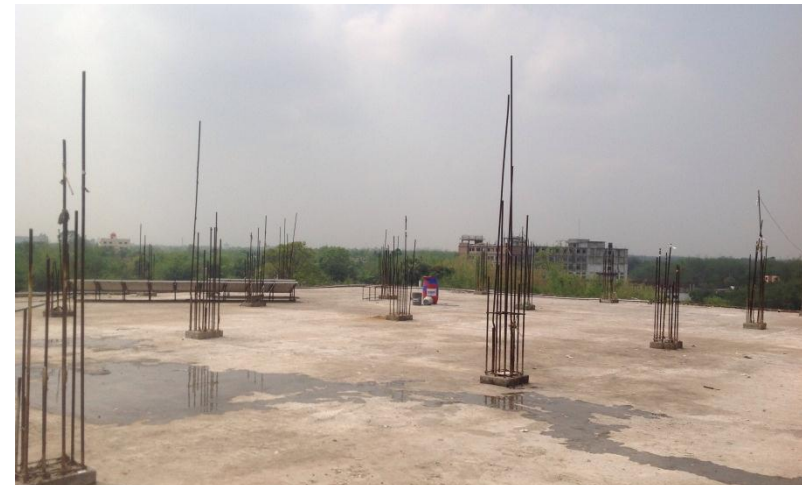
Lack of Fall Barrier to Roof

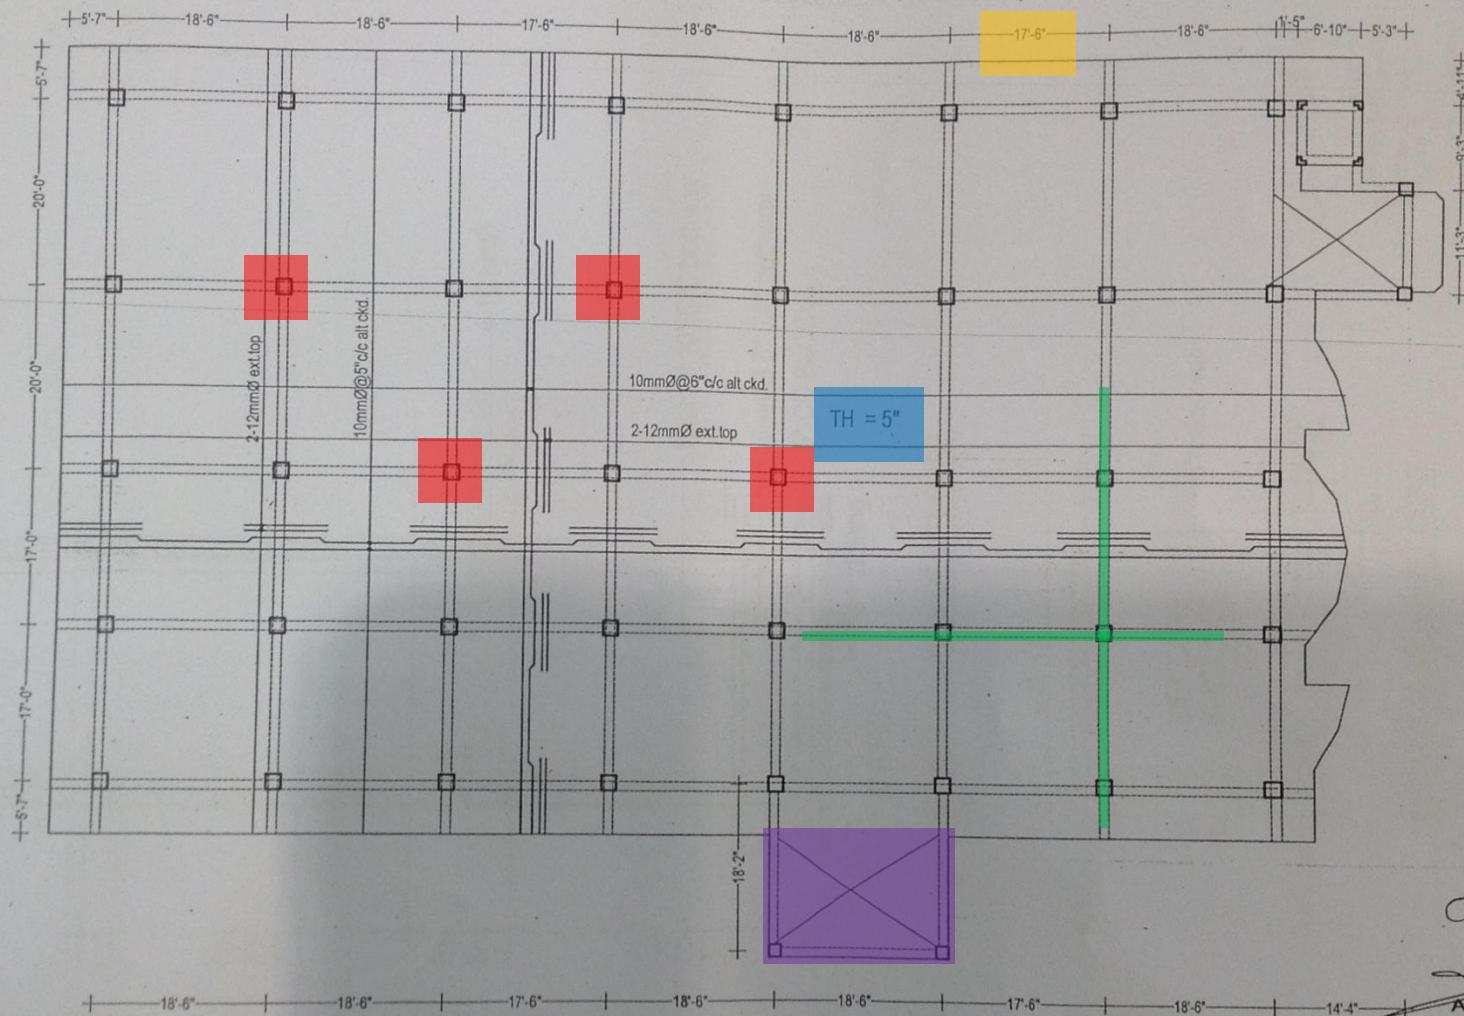
Typical Floor Plan

- Incorrect column sizes, particularly at Ground Floor level where the uniformity in internal column size indicated in the drawings is not apparent;
- Incorrect column reinforcement – the number of bars observed at Roof level, and again at Ground Floor level using the Ferroscanner, was not in accordance with the drawings;

- Inconsistent construction type – the drawings appear to indicate beam and slab construction, whereas flat slab with perimeter beam is observed at 1<sup>st</sup> Floor level, flat slab at 2<sup>nd</sup> and 3<sup>rd</sup> Floor levels, and beam and slab thereafter;

- Inconsistency with aggregate type – stone aggregate is referenced in the drawings, whereas it is understood that brick aggregate has been used in all structural elements other than columns to 2<sup>nd</sup> Floor level.

- Slab thickness is called up as 5” in the drawings, whereas a minimum of 6” is observed;
- The layout of the south facing staircore does not appear to be in the correct location.

Under-sized Columns

Incorrect Staircore position

Incorrect slab thickness

Inconsistent construction type

Incorrect Grid dimension

Building Engineer to review and provide clarification.

| Item No. | Observation | Recommended Action Plan | Recommended Timeline |
|---|---|---|---|
| 8 | Differences between actual construction and information on design drawings | Engage an Engineer to survey the structure and prepare a full set of “as-constructed” drawings | 6-weeks |

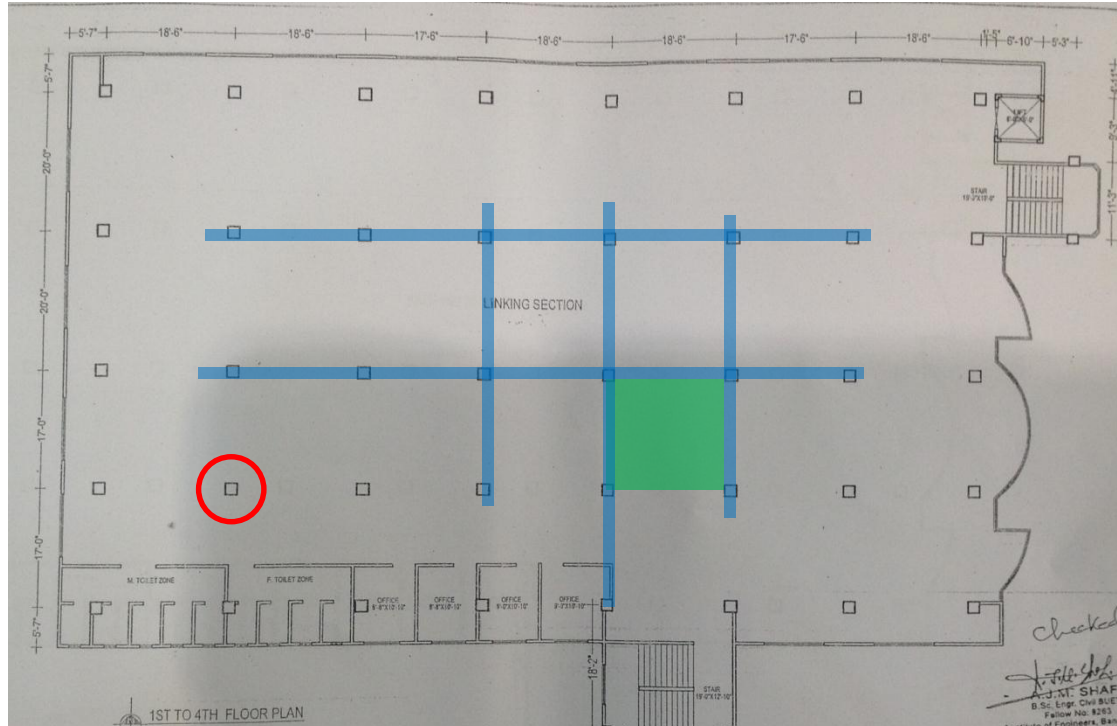
Typical Floor Plan

Hairline cracking was observed to the soffit of a number of beams and slabs at Ground, 2<sup>nd</sup>, 3<sup>rd</sup>, and 4<sup>th</sup> Floor levels. Building Engineer to investigate and carry out remedial works to the structure as required.

Non-exhaustive extent of cracking to beams to 2<sup>nd</sup>, 3<sup>rd</sup> & 4<sup>th</sup> Floors

Cracking to underside of slab adjacent to column X

Location of cracking to 4<sup>th</sup> Floor slab

| Item No. | Observation | Recommended Action Plan | Recommended Timeline |
|---|---|---|---|
| 9 | Hairline cracking in beams and slab soffits | Monitor cracks on beams. Engage an engineer to investigate if cracks are only in the plastering | 6-months |
| 10 | Hairline cracking in beams and slab soffits | Engage an engineer to advise on load reduction and repair and strengthening of the beams if required | 6-months |

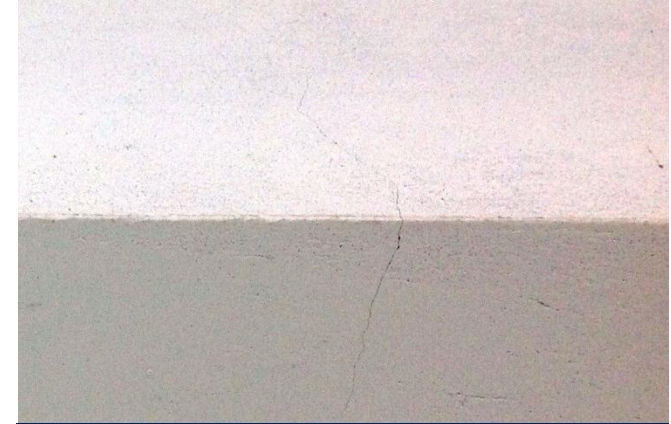
Cracking to underside of beam

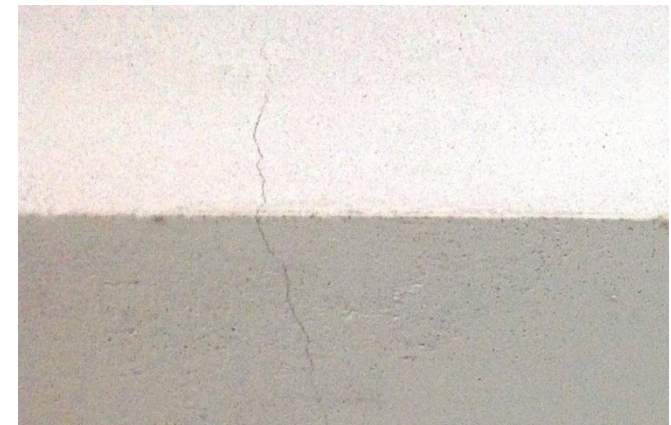
Cracking to underside of beam

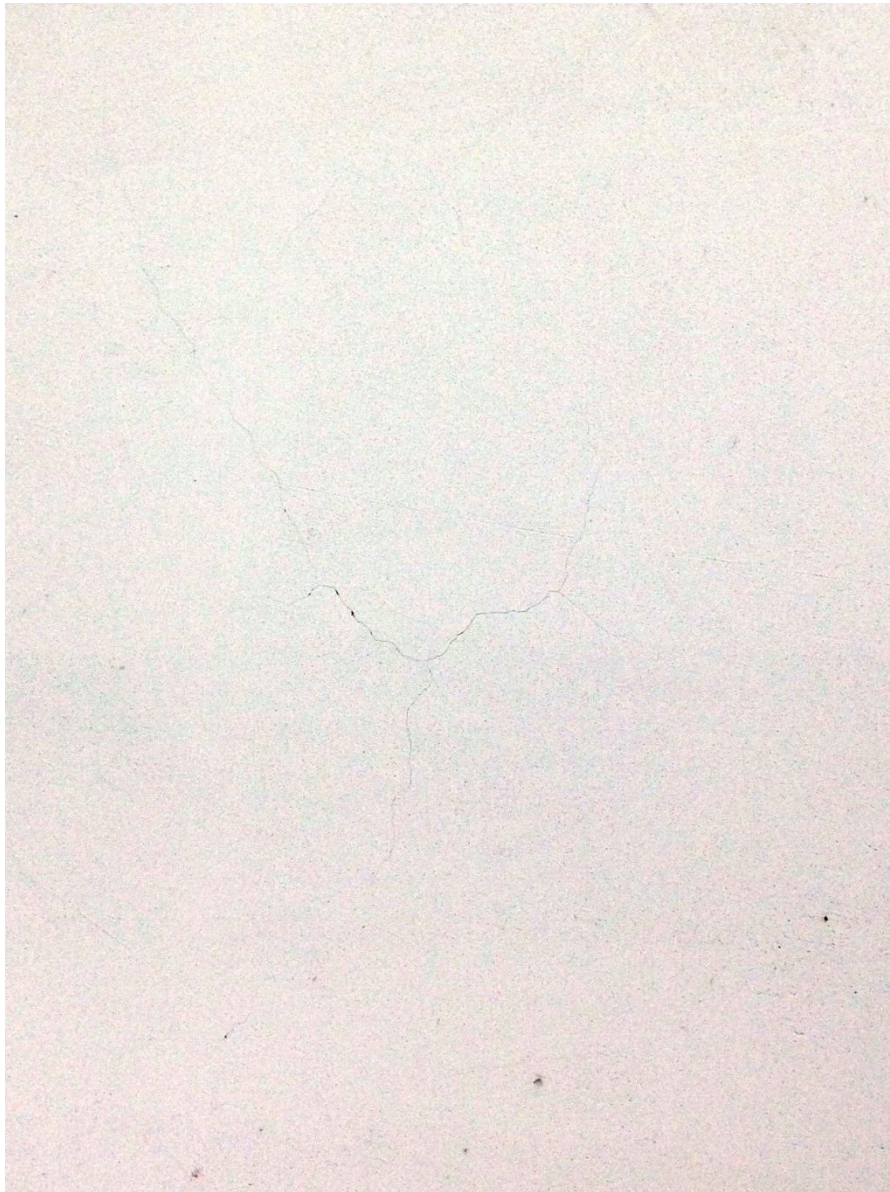
Cracking to underside of two-way spanning slab

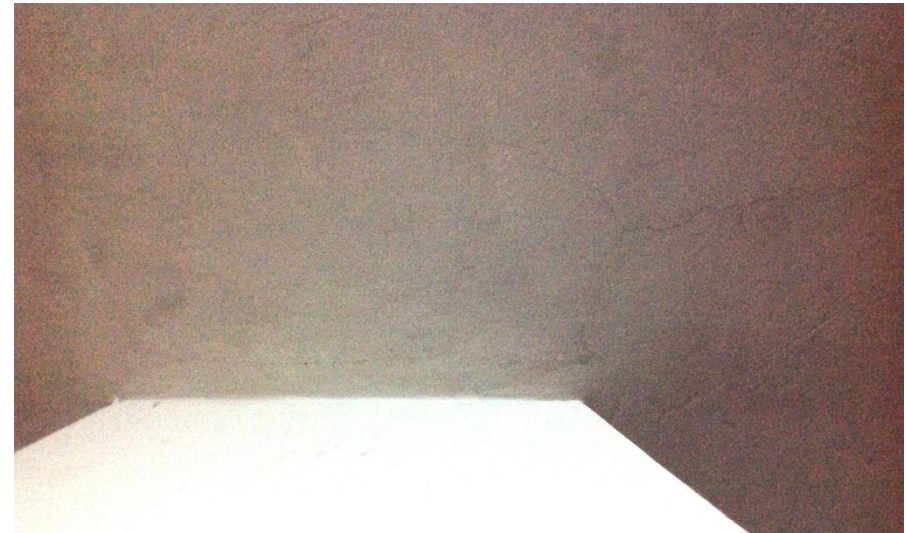
Cracking to underside of flat slab adjacent to column

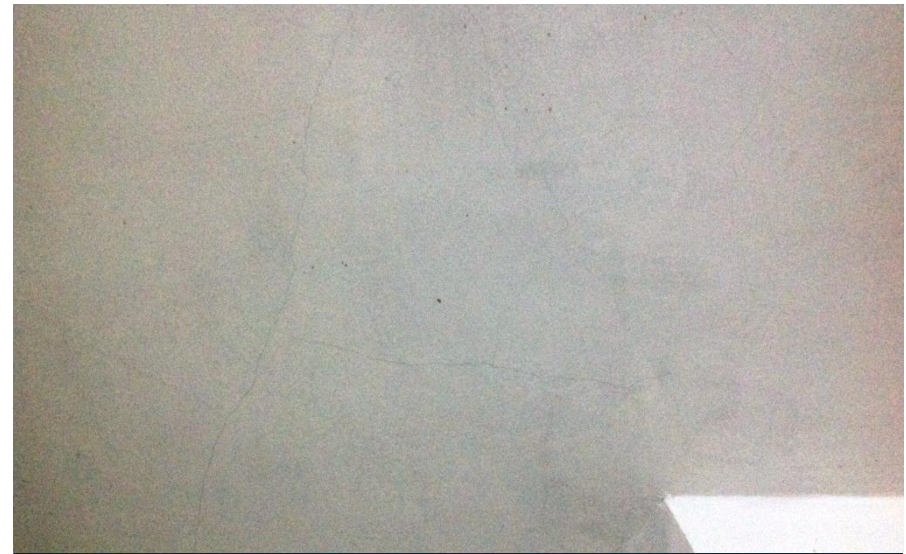
Cracking to underside of flat slab adjacent to column

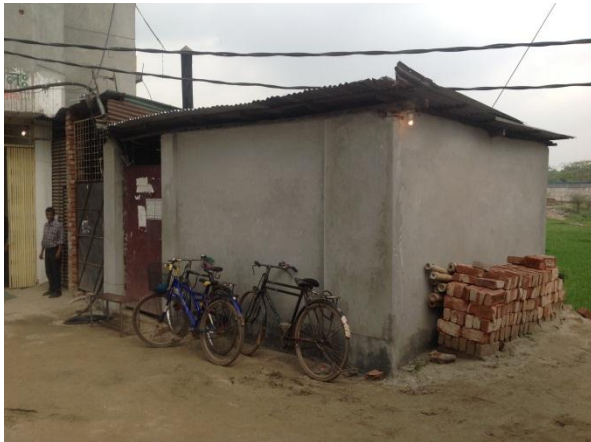
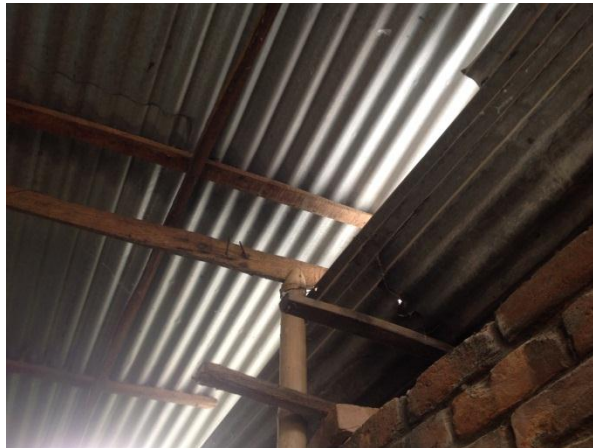
Building Engineer to review the design of the lightweight roof structure to the Ground Floor Generator Room to the East of the building. Metal steel sheeting was also observed at Roof level adjacent to the south-facing staircore, which did not appear to be adequately held in place. Building Engineer to implement any upgrade works to the Generator Room structure, as deemed necessary following the above review, and to remove / secure the loose metal sheeting, as required.

Lightweight Steel Roof to Ground Floor Generator Room

| Item No. | Observation | Recommended Action Plan | Recommended Timeline |
|---|---|---|---|
| 11 | Apparently non engineered roof structure to Generator Room | Building Engineer to check the capacity of the lightweight roof and make any necessary alterations | 6-months |

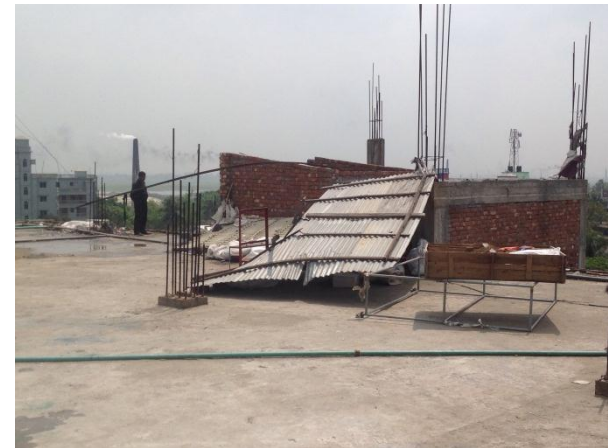
Apparently loose metal sheeting at Roof level
