# Agami Fashion Ltd.

No. H79/1, Chandra, Gazipur-1751, Bangladesh  
(24.037616N, 90.254016E)  
27<sup>th</sup> July 2016

# **Incomplete Structural drawing of Main factory building & Raw Materials Building**

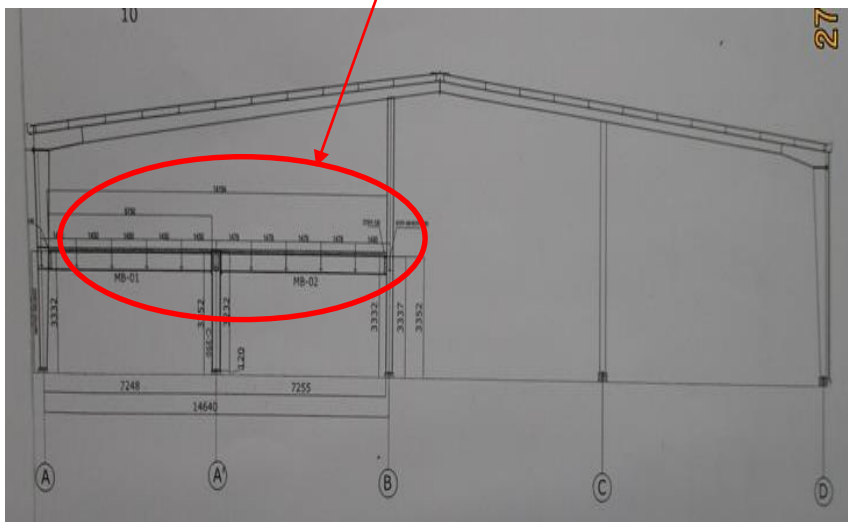
Different heightened mezzanine floor

No proper structural drawing was found for different heightened mezzanine floor

| Item No. | Observation | Recommended Action Plan | Recommended Timeline |
|---|---|---|---|
| 1 | Incomplete Structural drawing of Main factory building & Raw Materials Building | Engage an Engineer to update the drawings to “as constructed” status to reflect the actual site dimensions and provide complete structural information including Load Plan Drawings. | 6-weeks |

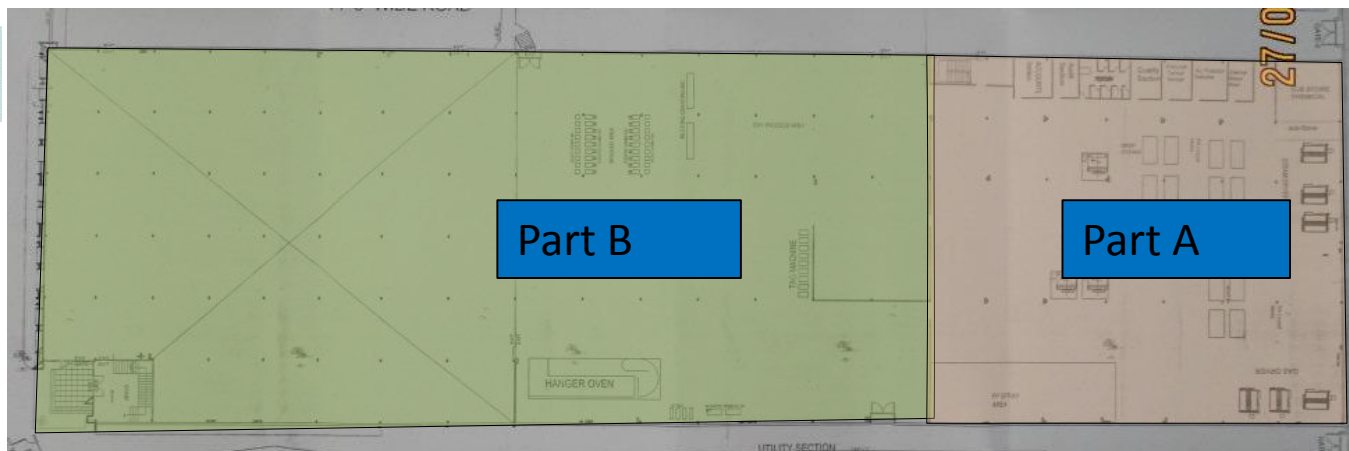
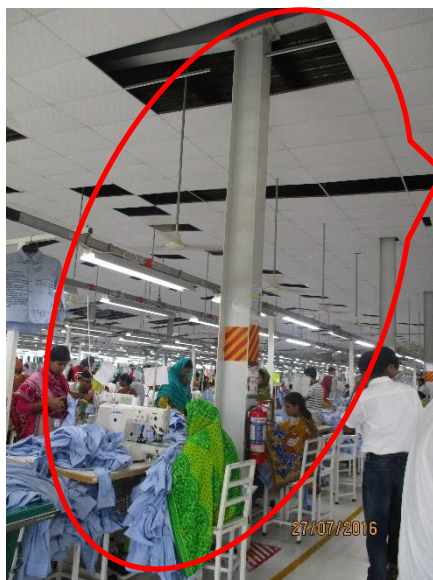
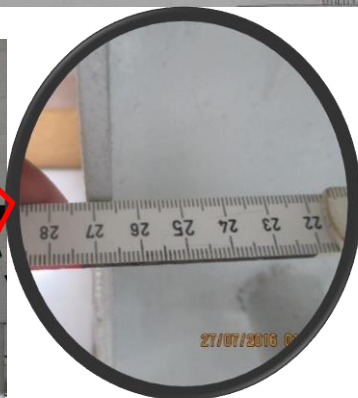
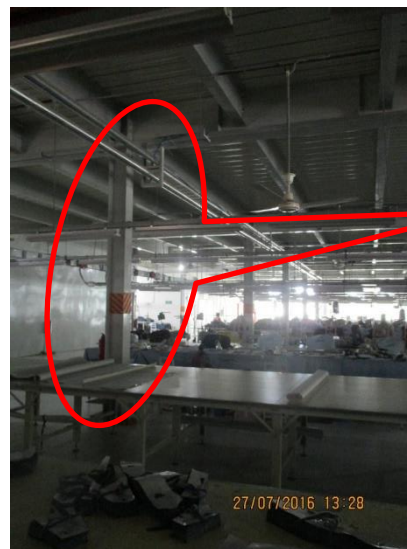
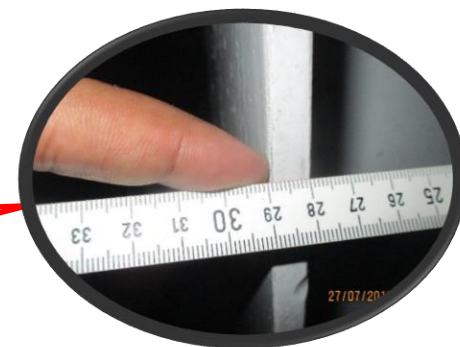
For the part A, no complete drawing was found. In addition with that, different dimension column steel member found on Part A portion.

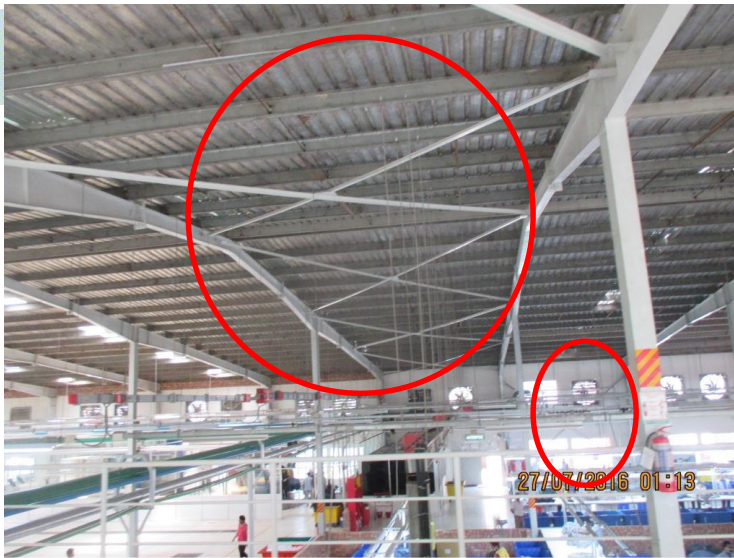
**Vertical and horizontal bracing is not aligned.**

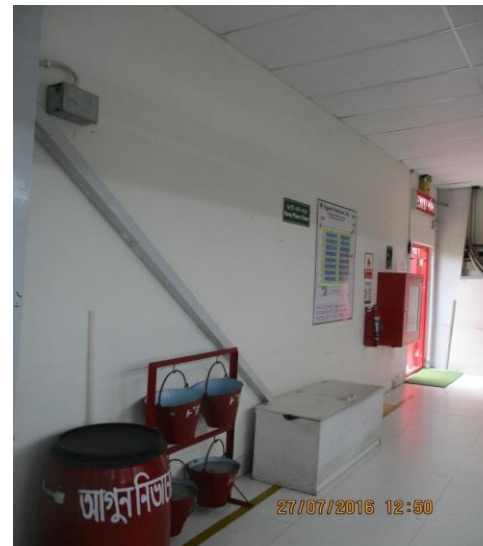
**Observed single bracing instead of cross bracing.**

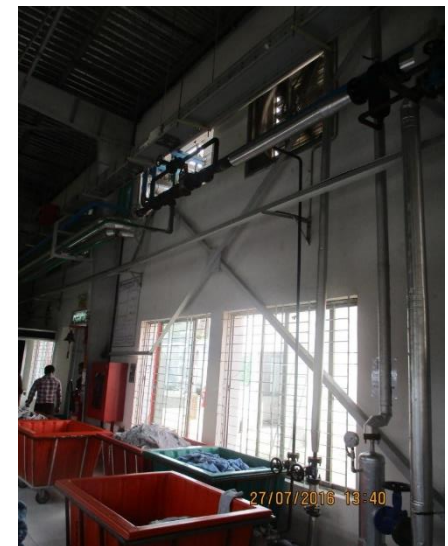
**Observed faulty bracing**

**No proper bracing system was found in structural drawing.**

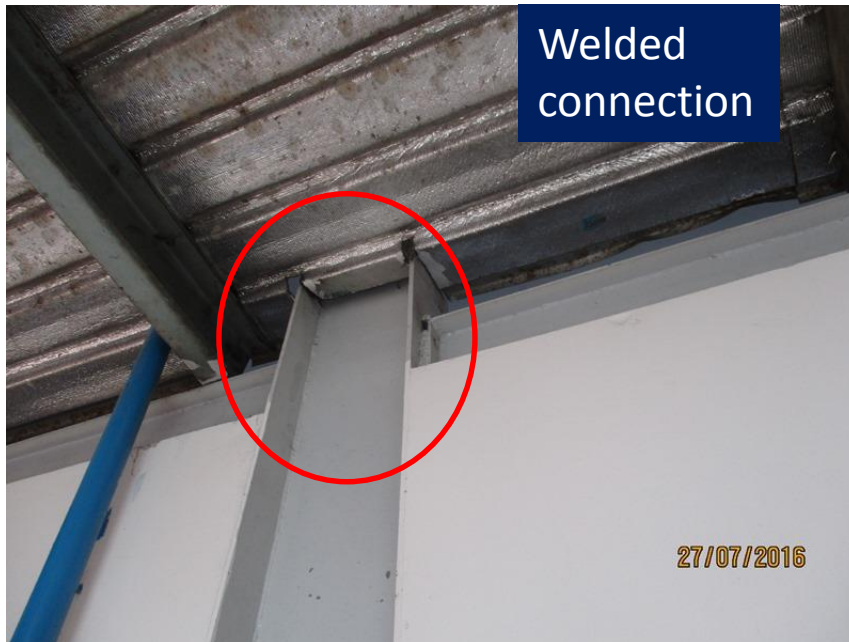
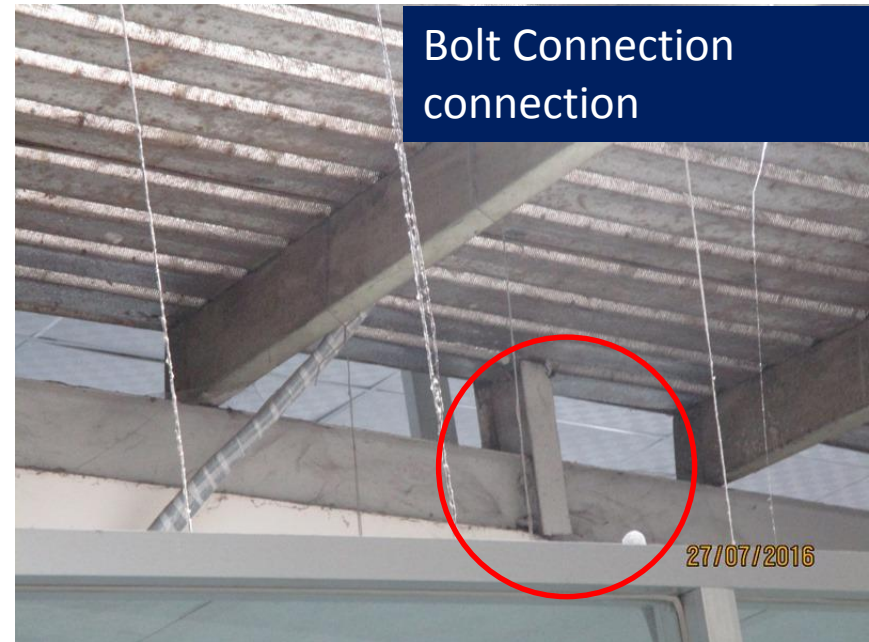
Some connection are Welded and some are Bolt connections

Some Rafters are connected with vertical member by weld and some are connected by bolt in Main Building

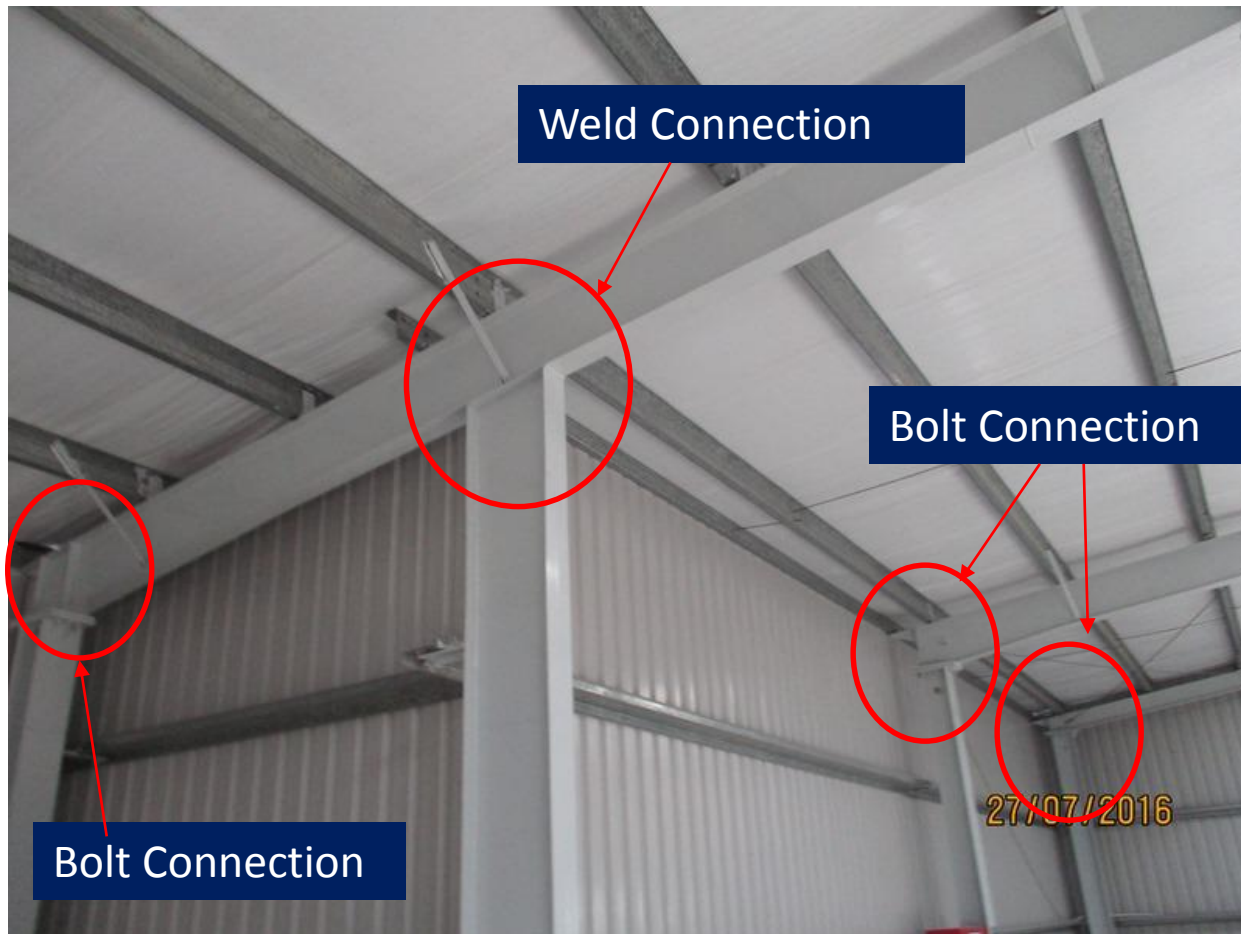
Some connection are Welded and some are Bolt connections

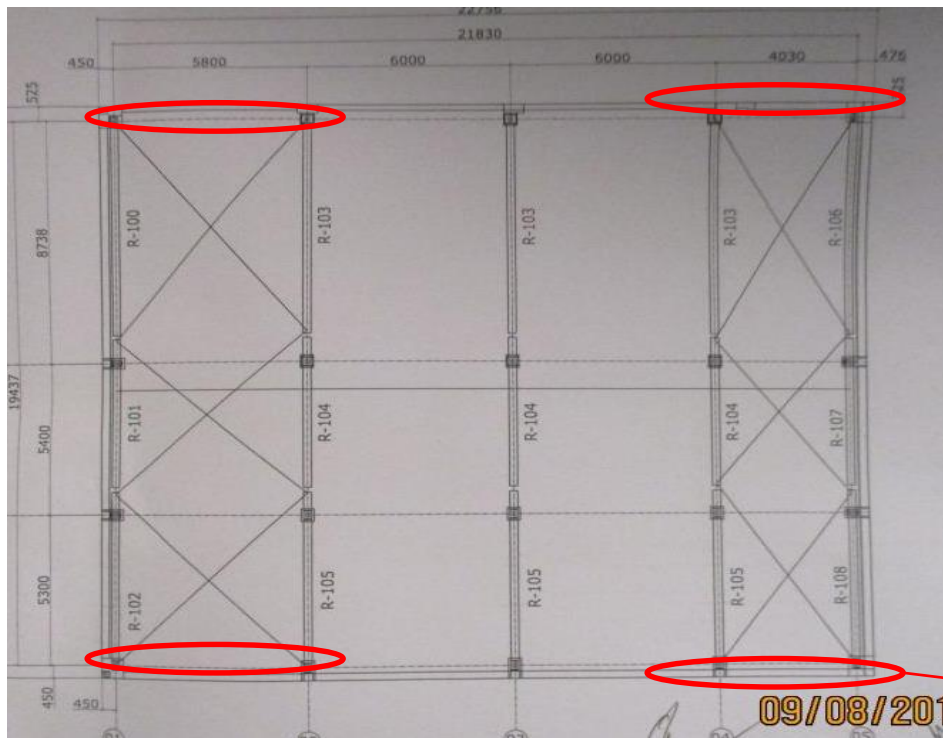
**No vertical bracing system was find in structural drawing.**

| Item No. | Observation | Recommended Action Plan | Recommended Timeline |
|---|---|---|---|
| 2 | Absent vertical Bracing in Structural drawing of Chemical Store & Raw Materials Building | Building engineer to check the capacity of the steel frame to Chemical Store and Raw materials building under horizontal and vertical loading and make any necessary alterations. | 6-weeks |

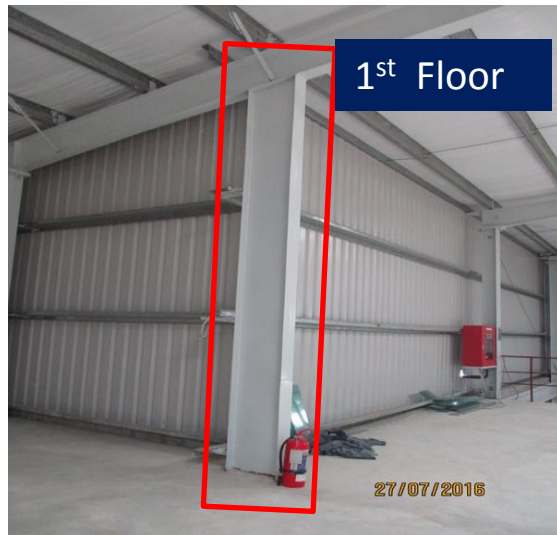
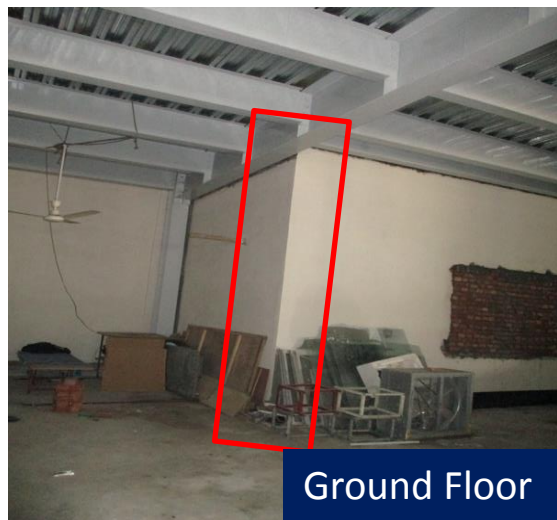
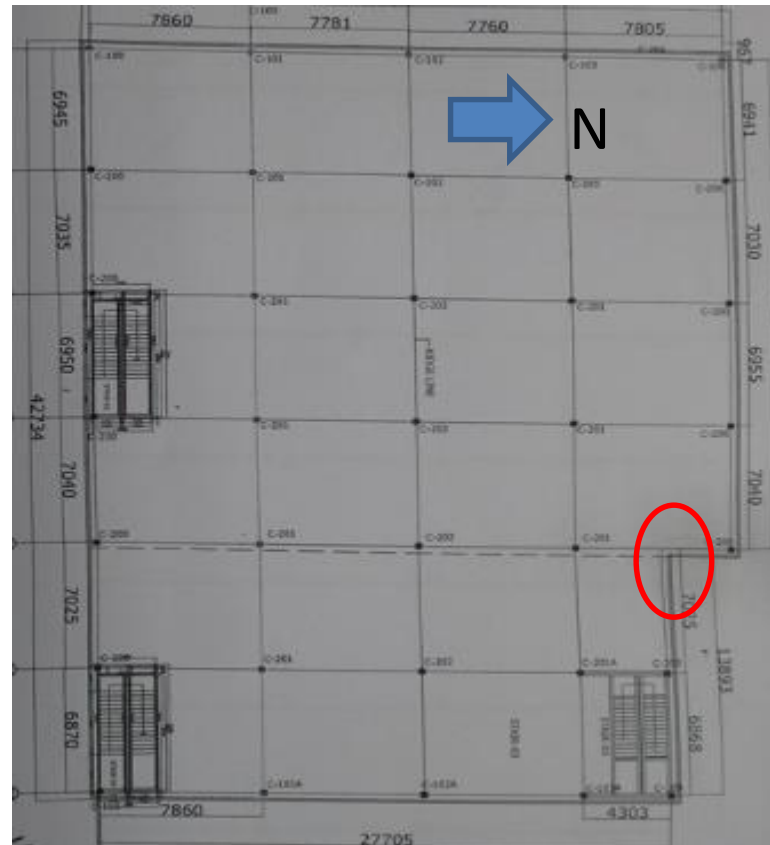
The marked column is not present in drawing. Noted that, the column is observed only on 1<sup>st</sup> floor.

| Item No. | Observation | Recommended Action Plan | Recommended Timeline |
|---|---|---|---|
| 3 | Discrepancy between drawing and as built condition of Raw Materials Building | Factory Engineer to update the drawings to “as-constructed” status as part of the Engineering Assessment. | 6-weeks |

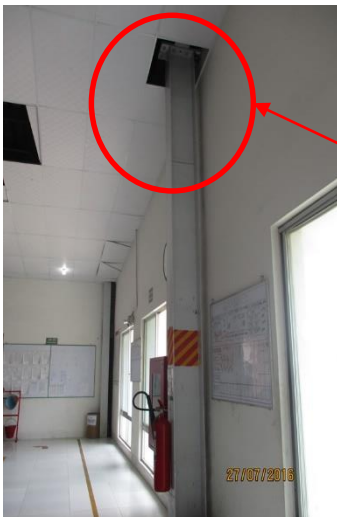
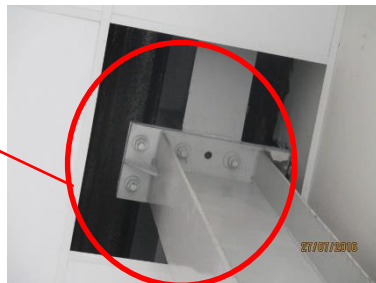
**Main factory building**

**Bolt missing in Beam-Column joint in Main factory Building, Raw materials building & Chemical Store.**

| Item No. | Observation | Recommended Action Plan | Recommended Timeline |
|---|---|---|---|
| 6 | Bolt Missing in Beam column joint at Main factory Building, Raw materials building & Chemical Store | Complete the connections with missing bolts as per advice of factory engineer. | 6-weeks |

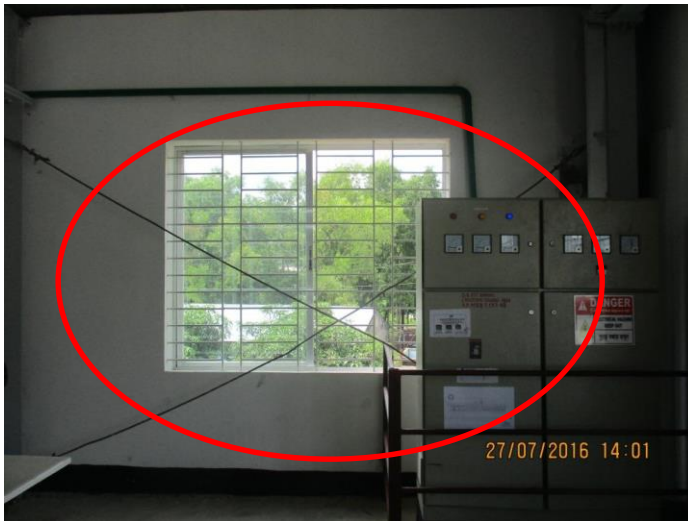
**Chemical Store**

# Loosely tightened cable bracing

| Item No. | Observation | Recommended Action Plan | Recommended Timeline |
|---|---|---|---|
| 7 | Loosely tightened cable bracing | All loosely tightened cable bracing should be tensioned | 6-weeks |

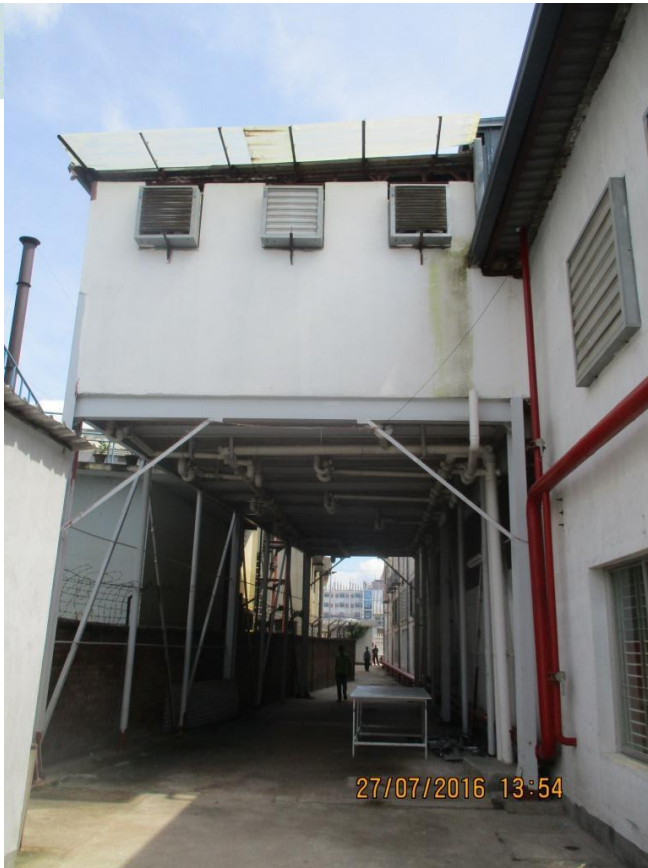
**Toilet building**

# **Lack of structural drawings for Utility Building and Toilet building adjacent with main factory building**

| Item No. | Observation | Recommended Action Plan | Recommended Timeline |
|---|---|---|---|
| 8 | Lack of structural drawings for Utility Building and Toilet building adjacent with main factory building | Building Engineer to produce proper as-built drawings | 6-weeks |
