# NRN Knitting & Garments Ltd.

181, Jamgara, Ashulia, Dhaka.

24<sup>th</sup> August, 2016

# Observations

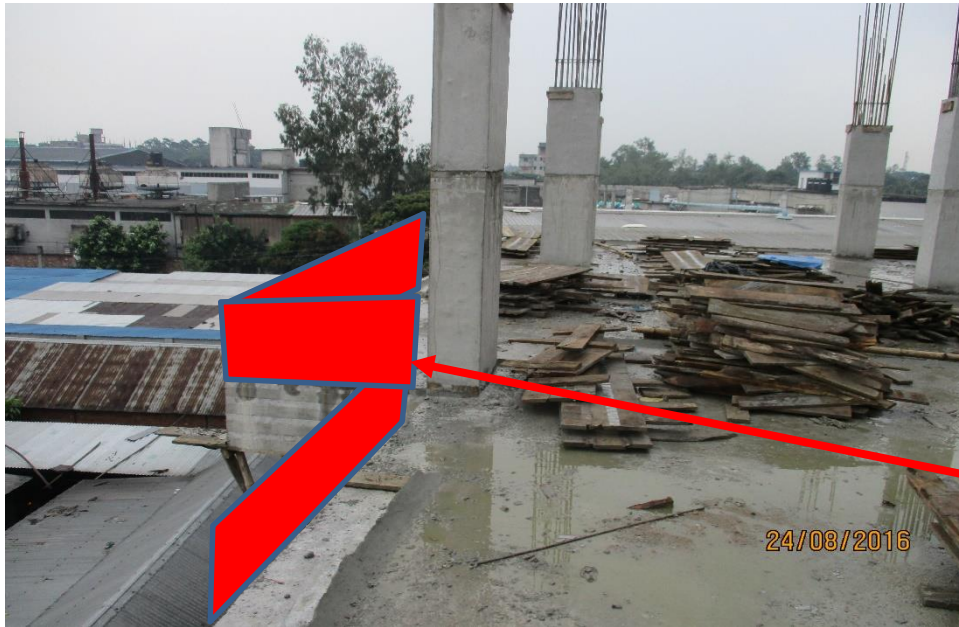
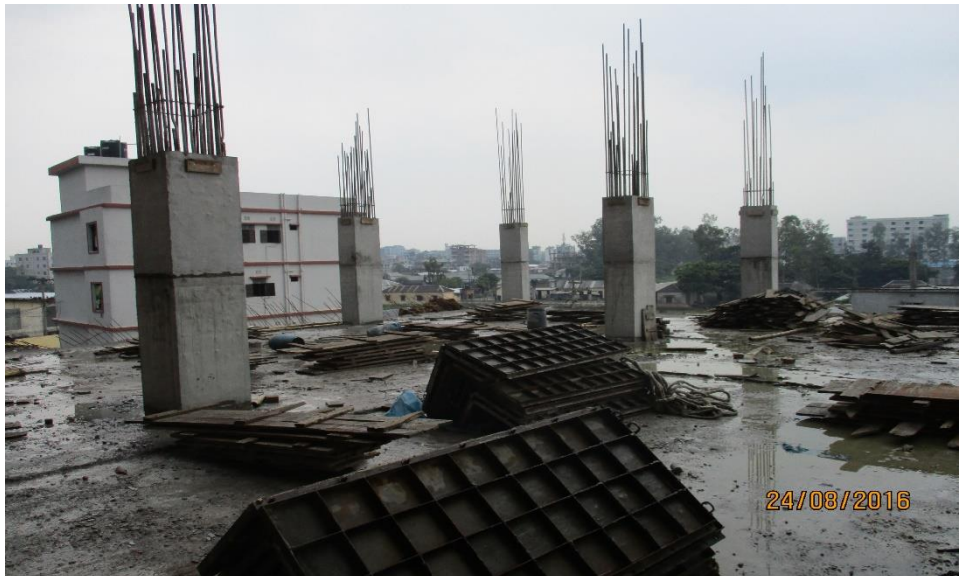
# Worker safety during construction.

Apparently no safety measures were observed to ensure workers safety during construction.

Building's Engineer to ensure this works are carried out in safe manner and keep a safety area on street around the buildings during the works

| Item No. | Observation | Recommended Action Plan | Recommended Timeline |
|---|---|---|---|
| 1 | Worker safety during construction | Carry out construction works in safe manner. | Immediate - Now |
| 2 | Worker safety during construction | Define a safe area on the street during the construction process as per BNBC provision . | Immediate - Now |

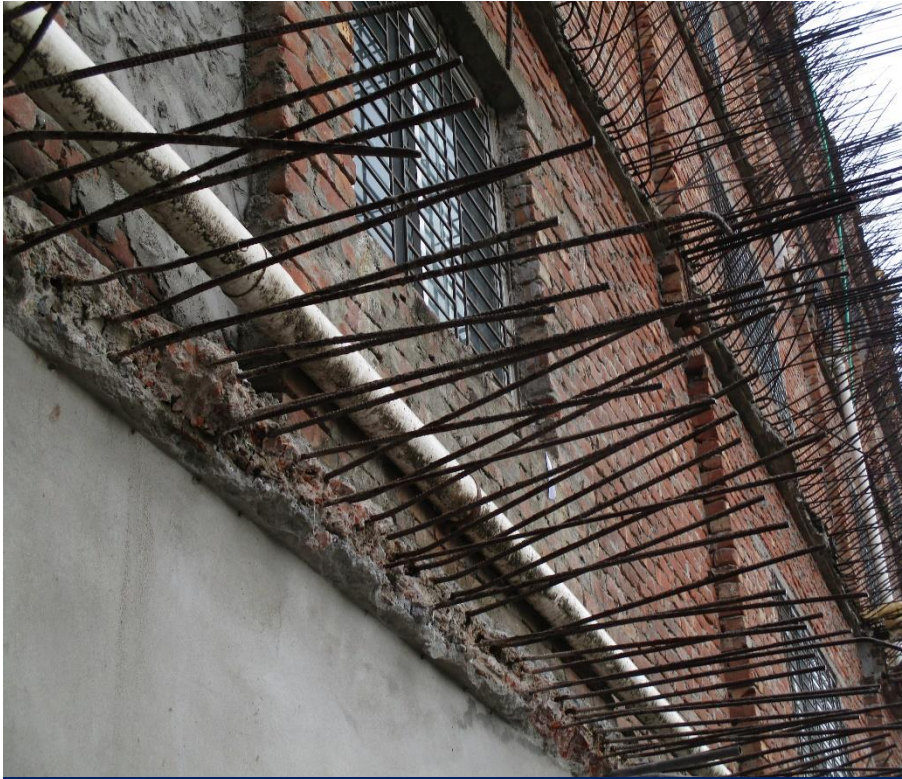
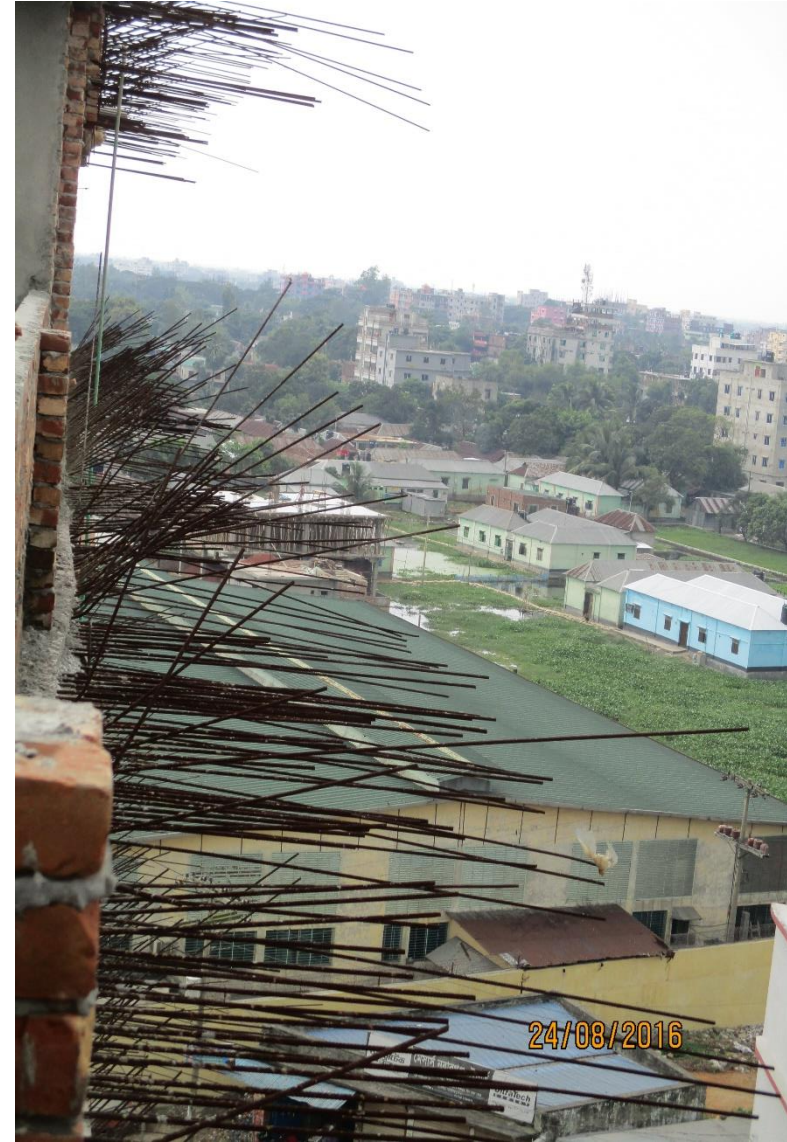
**Exposed rebar at roof and floor levels.**

Part-B of the building will be constructed in future. Rebar kept exposed without any corrosion protection in Part-A.

| Item No. | Observation | Recommended Action Plan | Recommended Timeline |
|---|---|---|---|
| 3 | Exposed rebar at roof and floor levels | For both durability and serviceability, rust proof paint or any appropriate method is recommended. | 6-weeks |

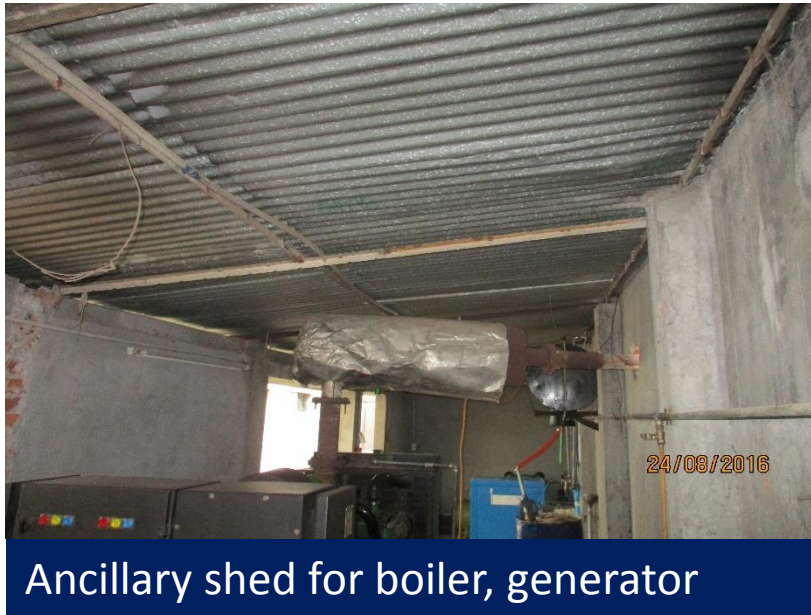
Ancillary shed for boiler, generator

Apparently non  
engineered  
Ancillary steel sheds  
and stair case roof.

| Item No. | Observation | Recommended Action Plan | Recommended Timeline |
|---|---|---|---|
| 4 | Apparently non engineered steel sheds and stair case roof | Carry out Engineering Assessment for the sheds and steel roof to verify that it is stable under lateral loading as per BNBC. | 6-weeks |
| 5 | Apparently non engineered steel sheds and stair case roof | Engage a Building Engineer to survey the structure and prepare a full set of “as-constructed” drawings for Structural and Architectural. | 6-weeks |
| 6 | Apparently non engineered steel sheds and stair case roof | Carry out remedial works arise from Engineering Assessment if any. | 6-months |

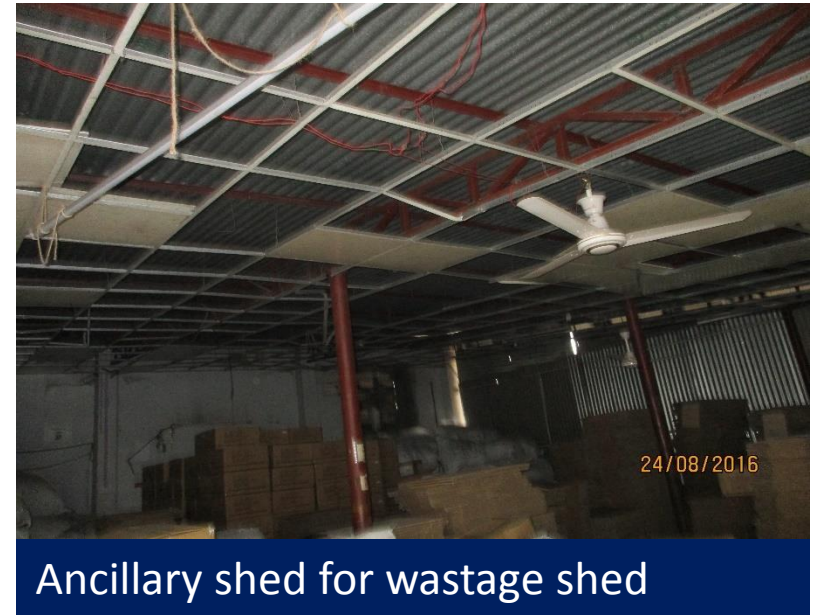
Ancillary shed for waste shed

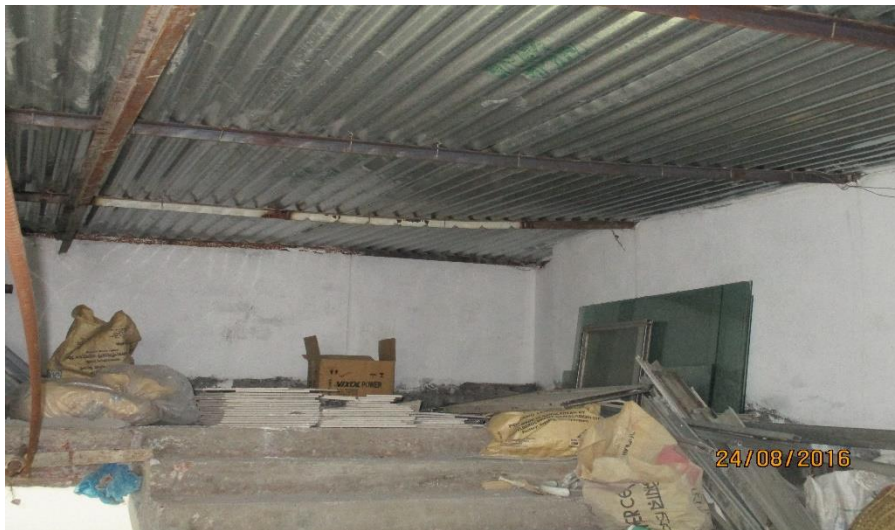
Stair case roof

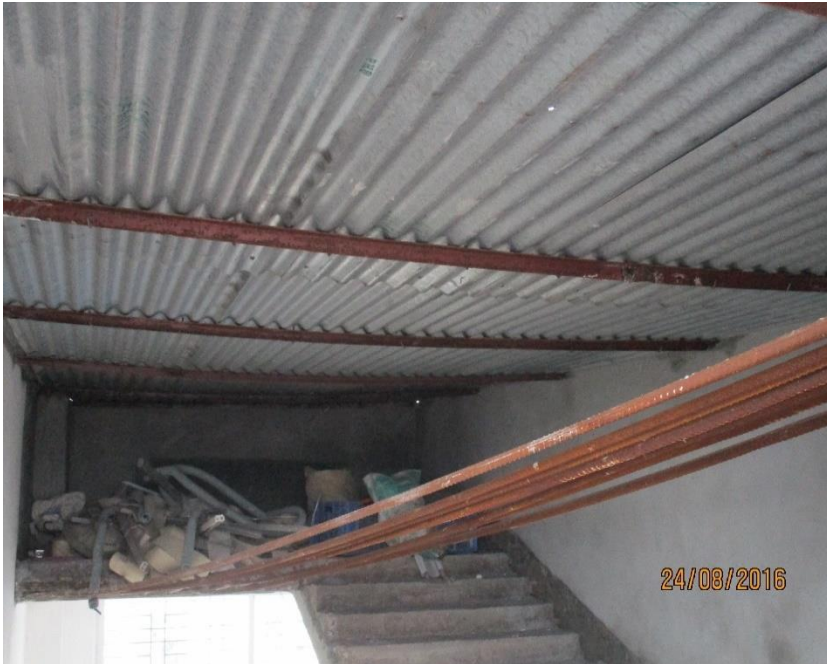
Deflection of steel member in roof of stair case.

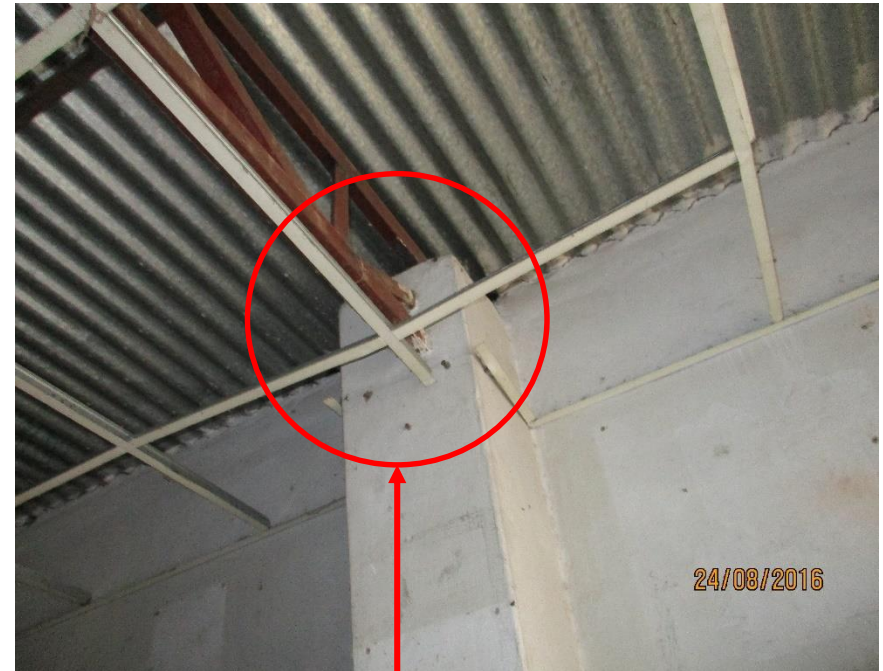
Poor connection between brick wall and steel truss.

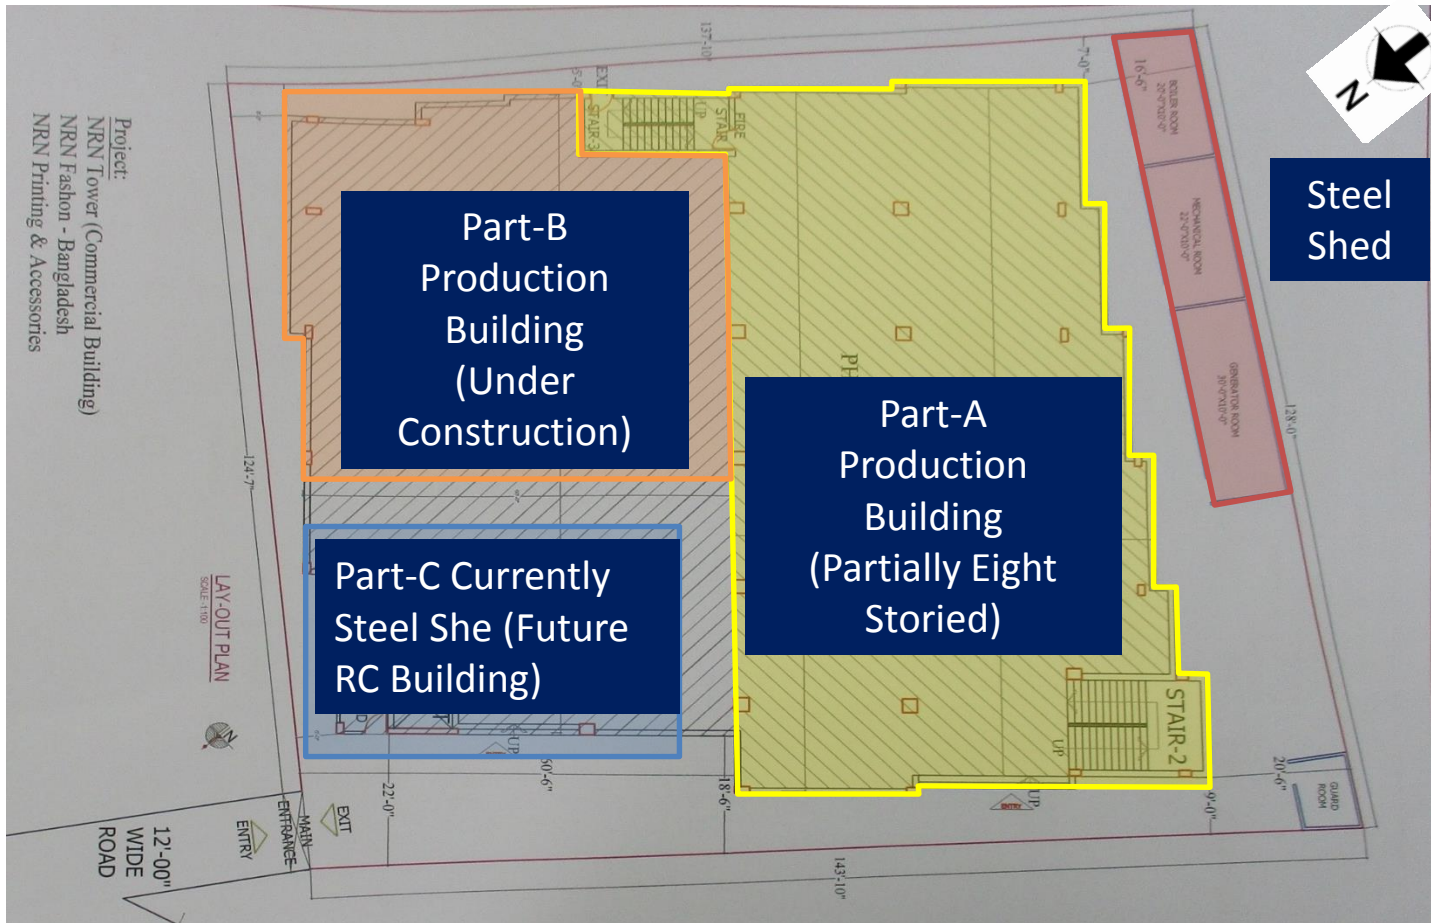
## Extension Cases in future

Factory will be vertically extended in Part-B portion. Horizontal and Vertical Extension will be executed in Part-C portion. All three parts will be act as a single building in future. For that A Detail Engineering Assessment requires to carry out according to BNBC provision.

| Item No. | Observation | Recommended Action Plan | Recommended Timeline |
|---|---|---|---|
| 7 | Extension cases in future | Any extensions or modifications of the existing building needs to be carryout Detail Engineering Assessment by a structural Engineer and in full compliance with the BNBC provision. | 6-months |
| 8 | Extension cases in future | Carry out remedial works from outcome of Detail Engineering Assessment if required. | 6-months |
