# Dekko Designs Ltd. (New Building)

Purba Naroshinapur, Ashulia, Savar, Dhaka  
(23.927480N, 90.304272E)  
25<sup>th</sup> August 2016

# Observations

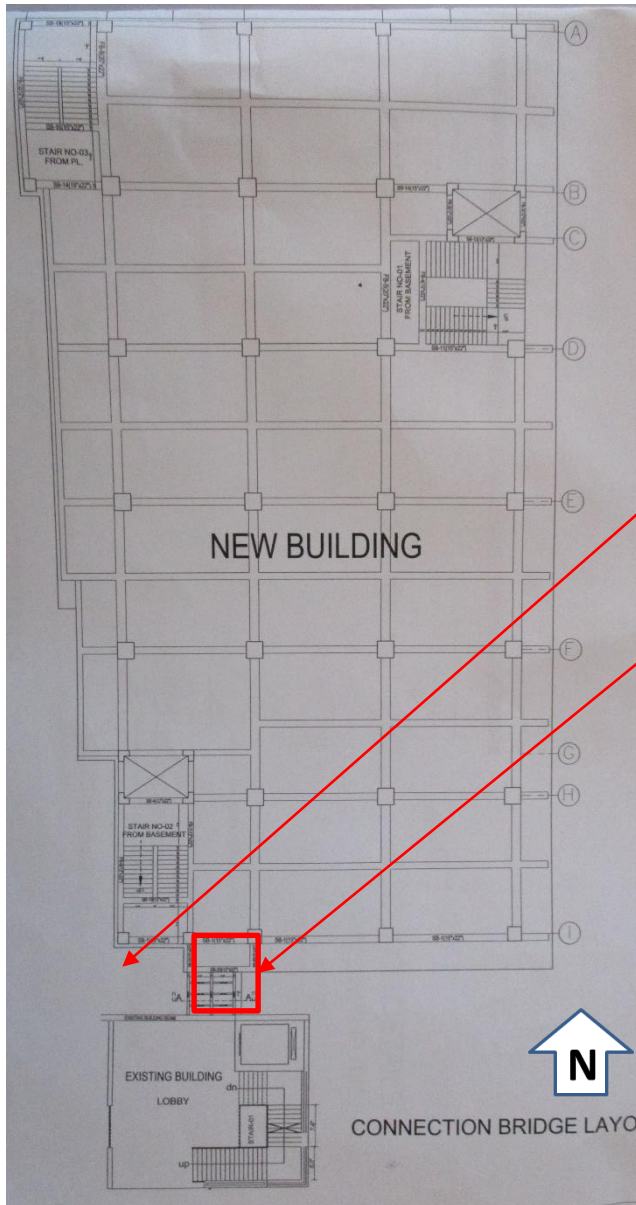
Connecting bridge location having mismatch between drawing and site condition

Actual bridge position

According to drawing bridge position

| Item No. | Observation | Recommended Action Plan | Recommended Timeline |
|---|---|---|---|
| 1 | Discrepancies in Architectural and Structural drawing | Engage a Building Engineer to survey the structure and update a full set of “as-constructed” drawings for Structural and Architectural. | 6-weeks |

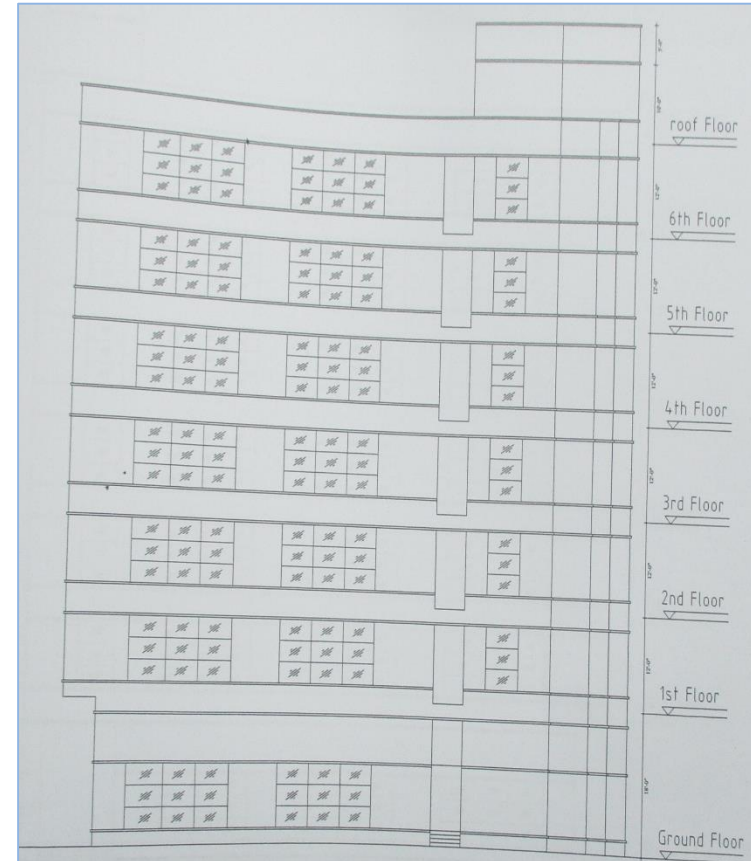
SOUTH SIDE ELEVATION

Roof plan missing and North-South elevation doesn't reflect as built condition.

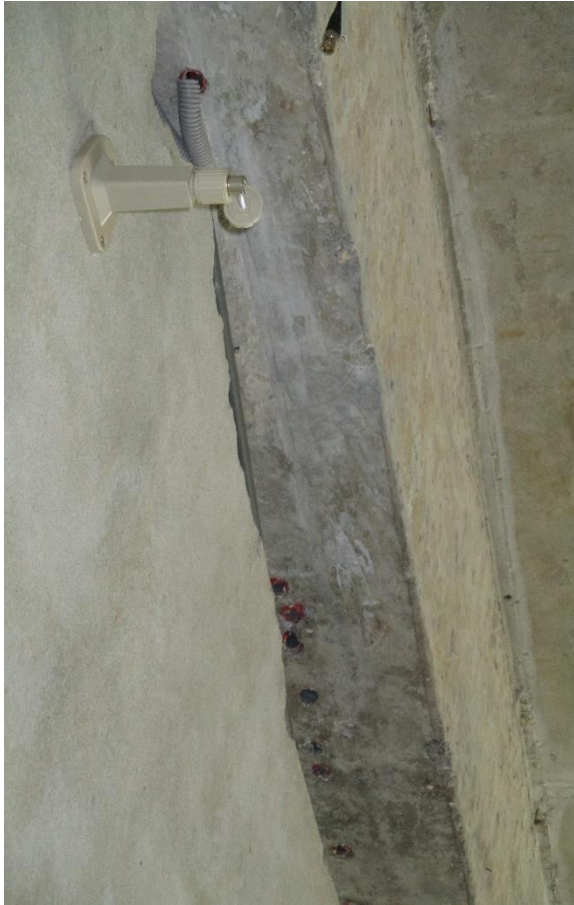
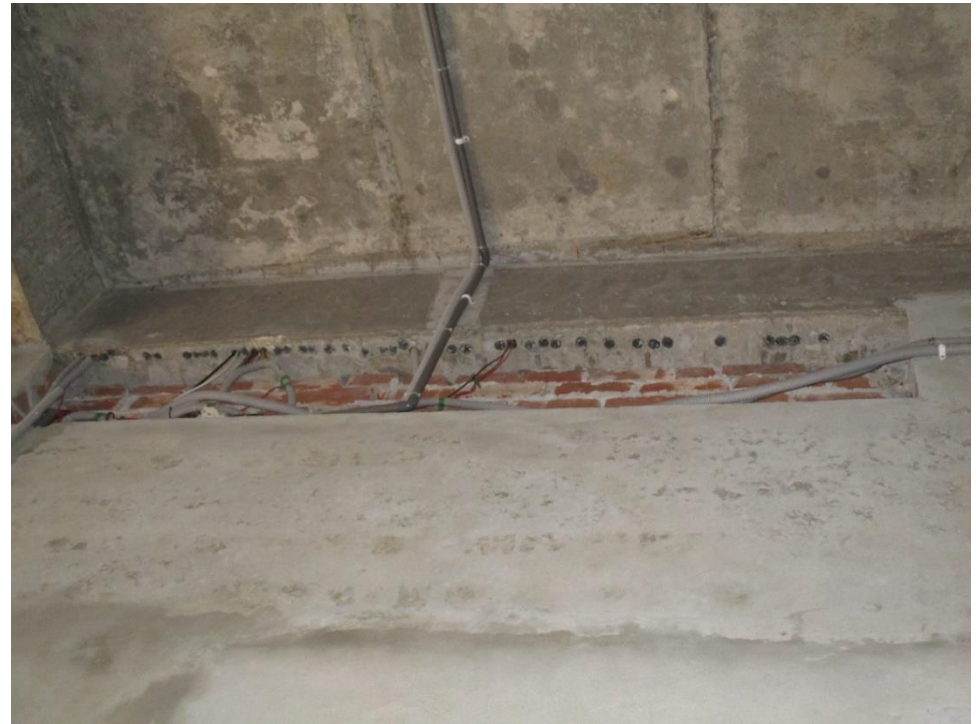
**Damage to underside of beams and visible reinforcement at locations of cast-in electrical conduits**

A number of beams throughout the building have significant penetrations/damage close to the beam-column connection. Apparently this will impact upon the shear and moment capacity of these joints. The Building Engineer requires to review these connections.

| Item No. | Observation | Recommended Action Plan | Recommended Timeline |
|---|---|---|---|
| 2 | Damage to underside of beams and visible reinforcement at locations of cast-in electrical conduits. | Building Engineer to carry out survey to identify locations where structural capacity of reinforced concrete beams has been reduced by penetrations or electrical conduit installation. | 6-weeks |
| 3 | Damage to underside of beams and visible reinforcement at locations of cast-in electrical conduits. | Building Engineer to carry out design calculations to verify the adequacy of the structure and to prepare a schedule of remedial works to reinstate the areas affected by the electrical installation. | 6-months |

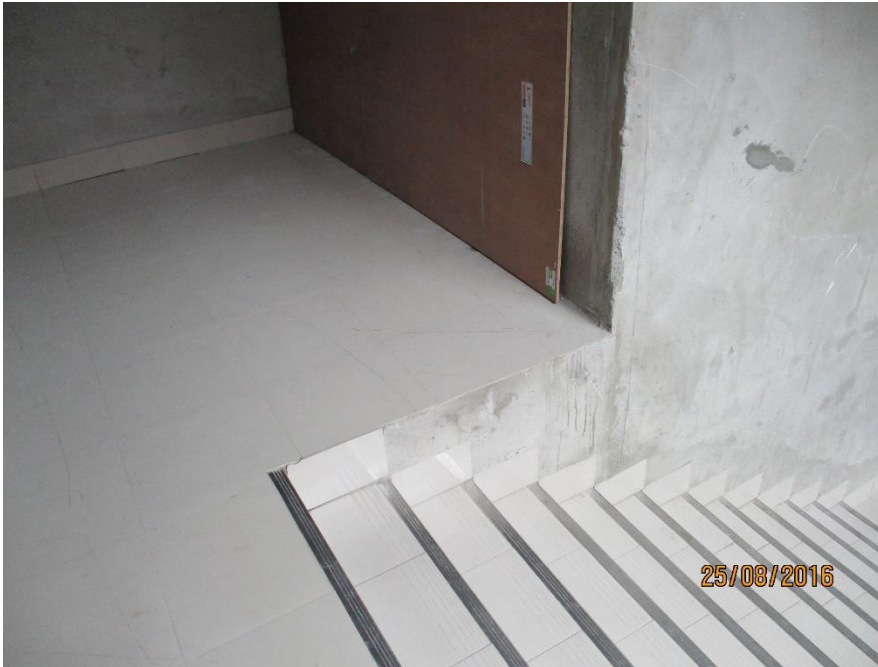
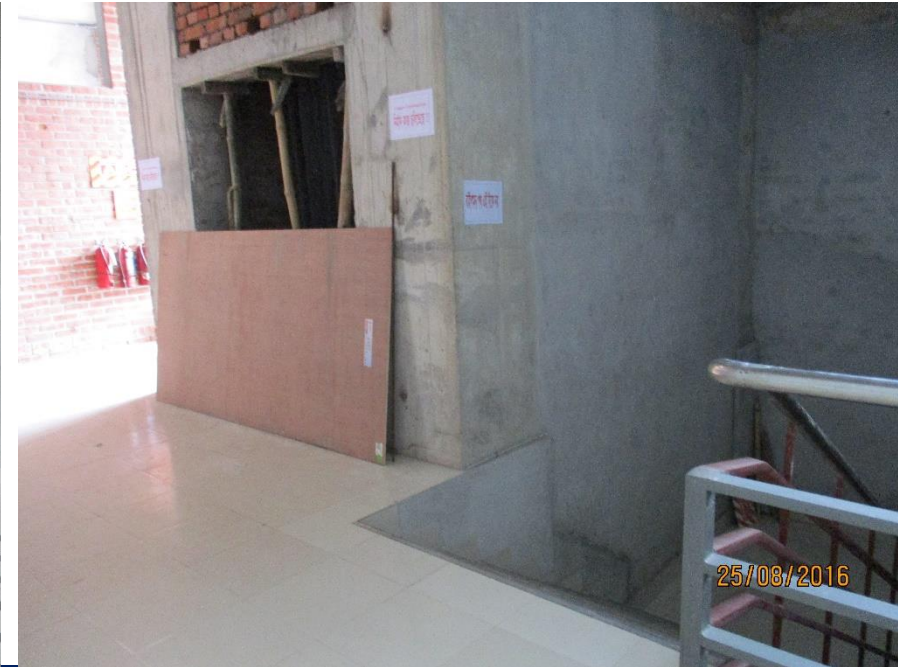
**Lack of protection on around lift core**

Lack of edge protection around the lift core near stair areas to caused falling hazards.

| Item No. | Observation | Recommended Action Plan | Recommended Timeline |
|---|---|---|---|
| 4 | Lack of protection on around lift core. | Provide protection to ensure safe working passage. | Immediate - Now |

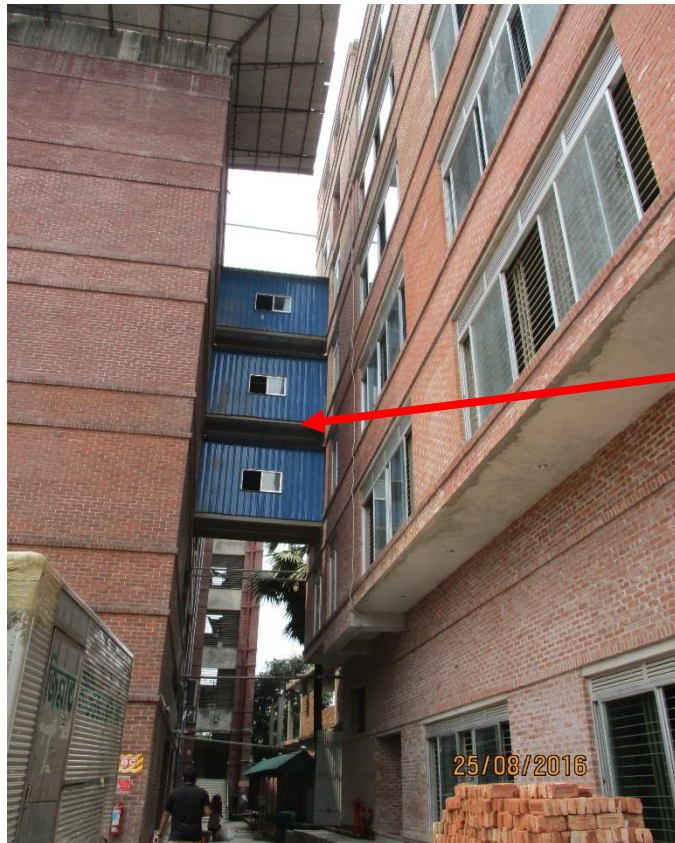
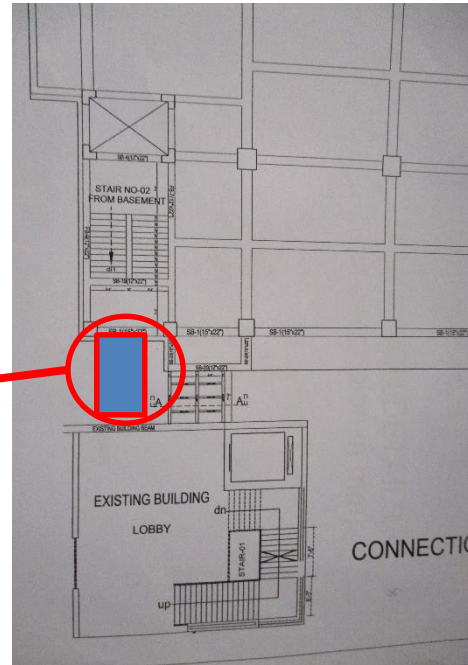
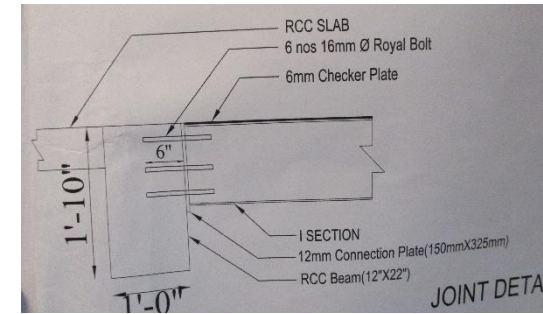
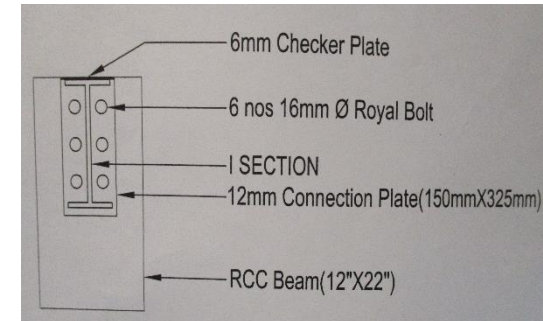
**Connecting bridge joint between two buildings having  
inadequate seismic provision**

According to connection details of connecting bridges between two building have partial moment connection. It may cause lateral loading transformation between two building under Seismic loading.

| Item No. | Observation | Recommended Action Plan | Recommended Timeline |
|---|---|---|---|
| 5 | Connecting bridge joint between two buildings having questionable seismic provision. | Building engineer to verify the joint connections of connecting bridges to comply the seismic provision and update the structural drawings and connection details of connecting bridge. | 6-weeks |
| 6 | Connecting bridge joint between two buildings having questionable seismic provision. | Carry out remedial works arise from assessment if any | 6-months |

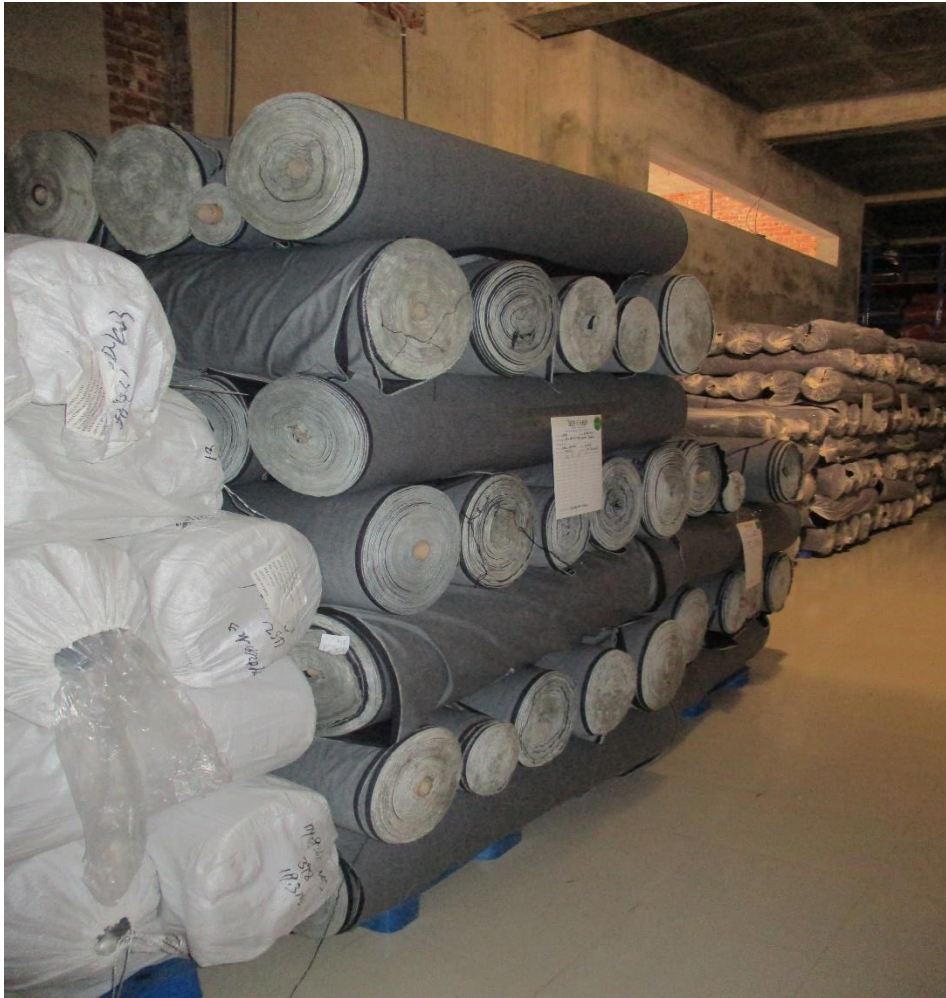
**No loading plan in place**

No loading plan in place on the upper floors to insure full compliance with specified design loads.

| Item No. | Observation | Recommended Action Plan | Recommended Timeline |
|---|---|---|---|
| 7 | No loading plan in place | Produce and actively manage a loading plan for all floor plates within the factory giving consideration to floor capacity and column capacity. | 6-weeks |
| 8 | No loading plan in place | Continue to implement load plan | 6-months |
