# TAMAI KNIT FASHION LTD.

141/A, BSCIC Industrial Area, Fatullah, Narayanganj, Bangladesh  
(23.625863N, 90.479213E)  
01<sup>st</sup> Sep 2016

# Observation

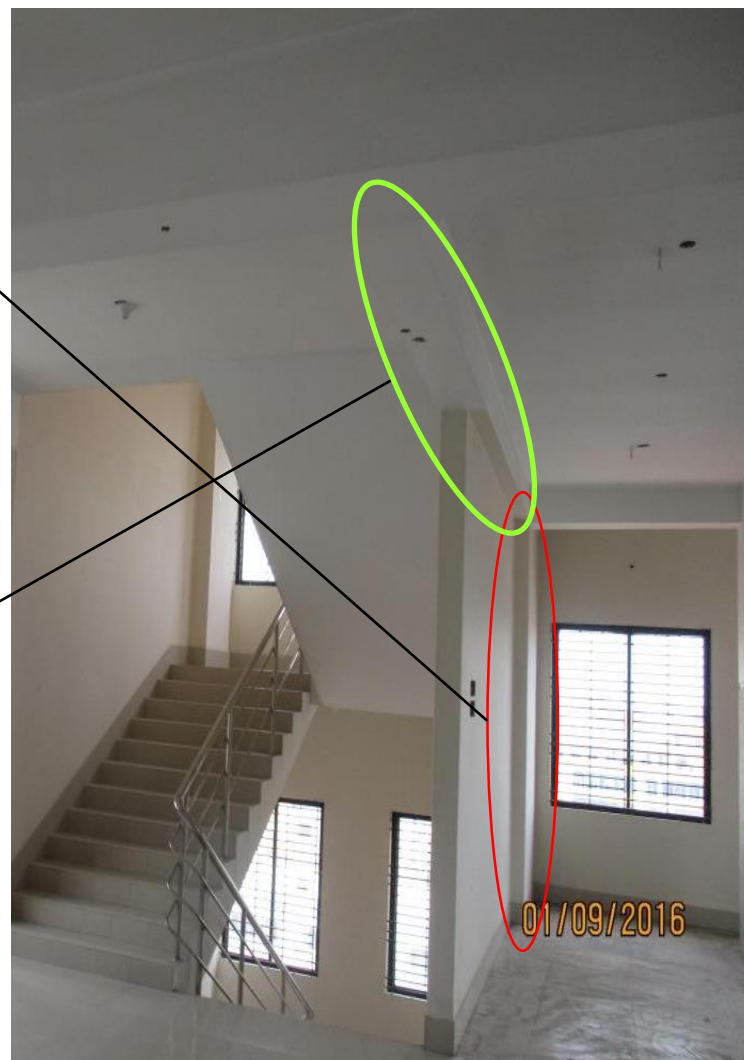
A column with a beam was found adjacent with the stair case which was not shown in provided layout drawing

| Item No. | Observation | Recommended Action Plan | Recommended Timeline |
|---|---|---|---|
| 1 | Discrepancy between provided drawing and site condition | Building engineer to investigate the whole building and produce as-built documentation reflecting the as constructed condition. | 6-weeks |

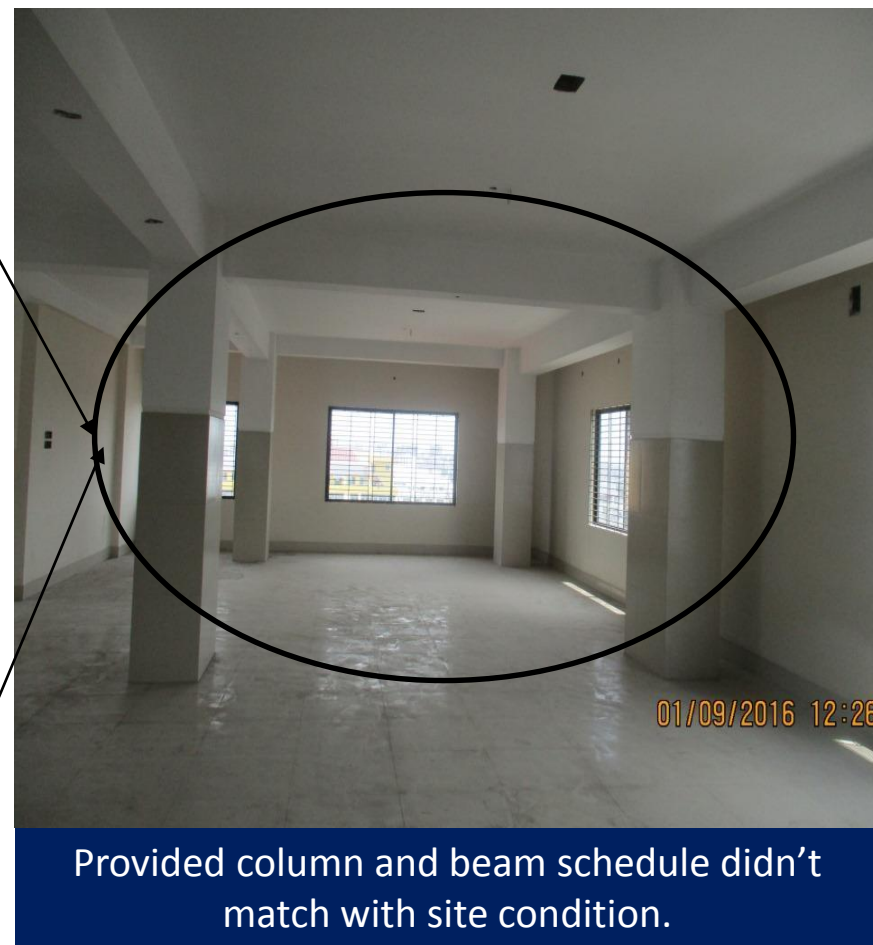
Provided column and beam schedule didn't match with site condition.

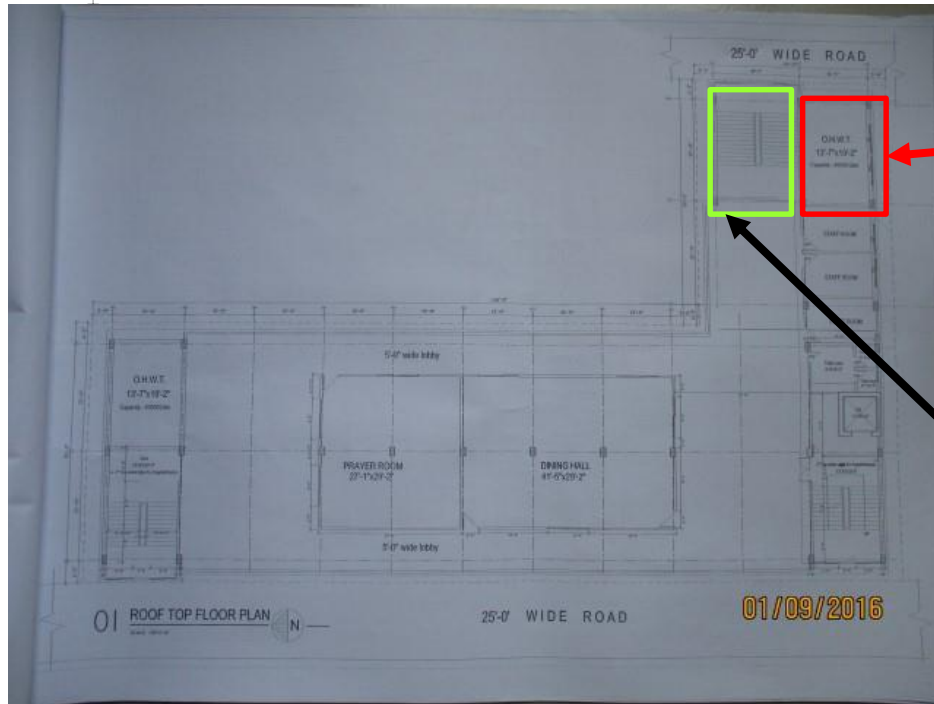
Location of over head water tank on provided architectural drawing.

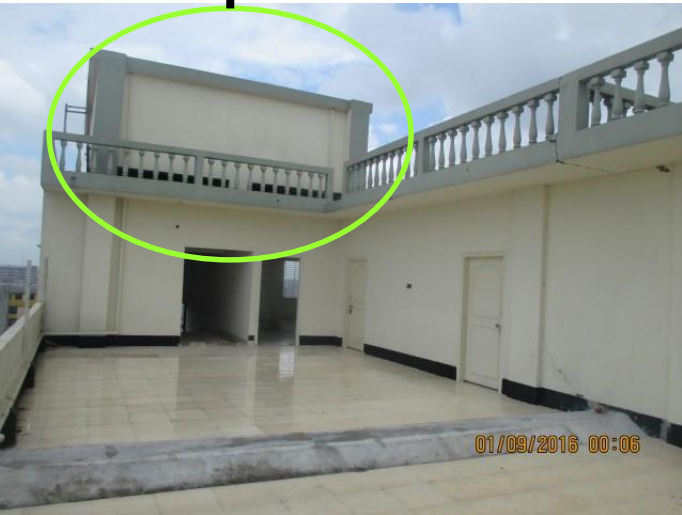
Observed Location of over head water tank

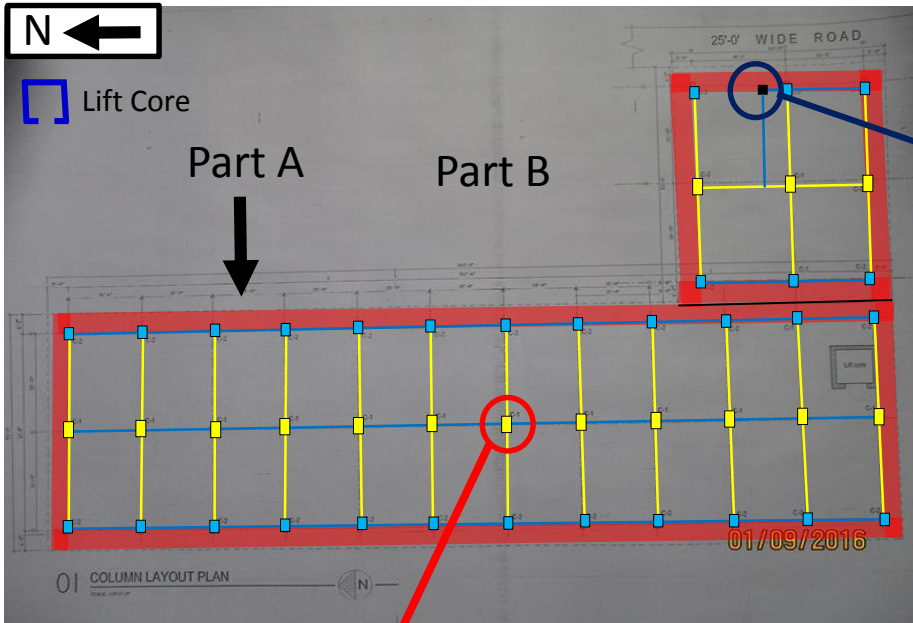
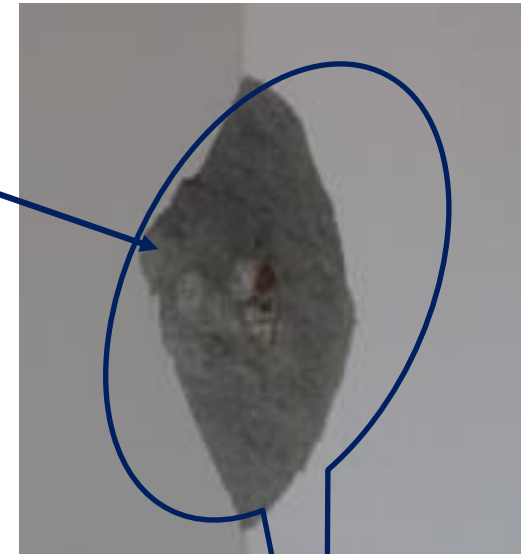
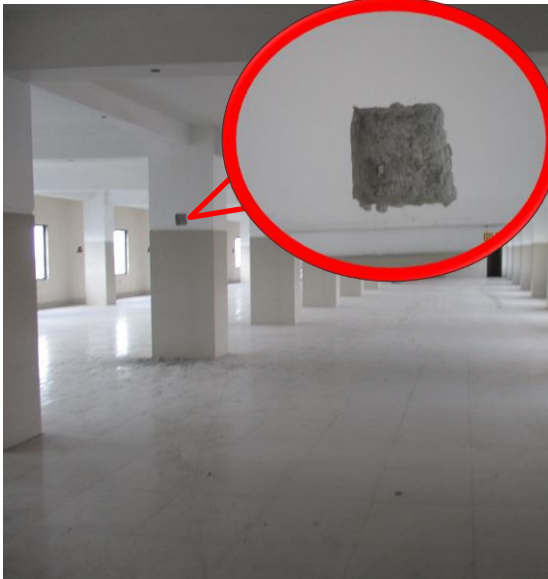
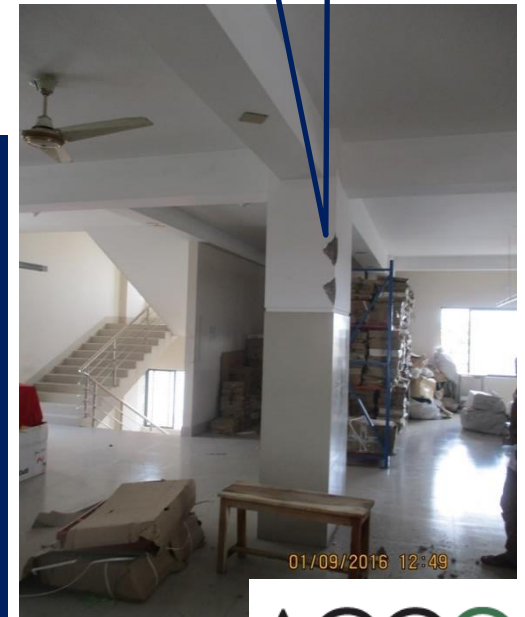
Brick aggregate found in 7<sup>th</sup> floor on part B and stone aggregate found in all other floor on Part A but aggregate type was mentioned as stone chips for both part A&B in working drawing.

| Item No. | Observation | Recommended Action Plan | Recommended Timeline |
|---|---|---|---|
| 2 | Discrepancy between provided drawing and site condition | Building engineer to investigate the material type through whole building both in Part A&B and make sure the correct aggregate type. | 6-weeks |

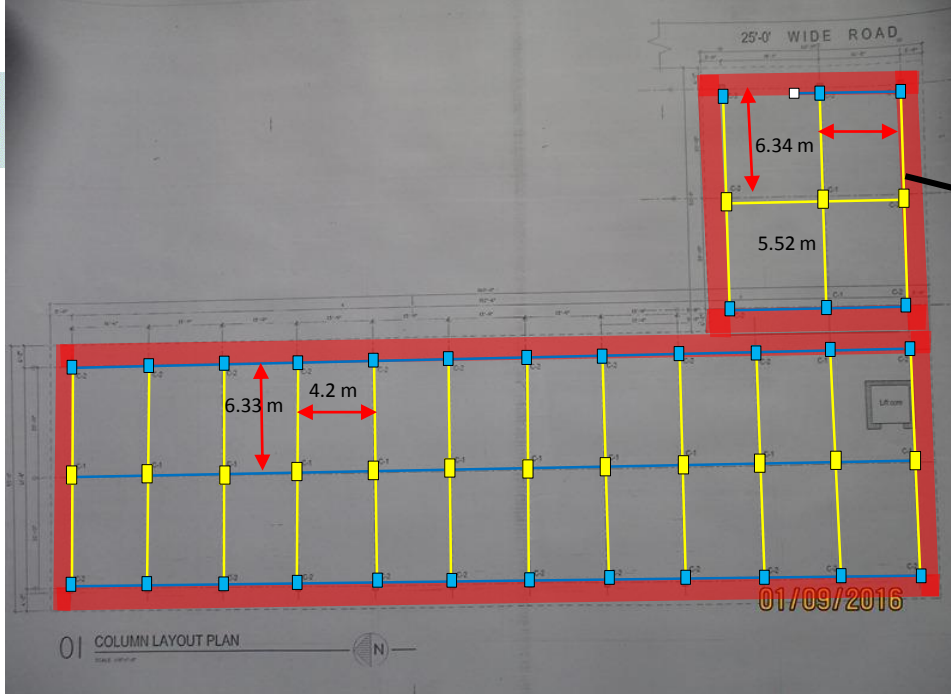
Typical Layout Plan

Building engineer to check lateral stability of the building against lateral load combination for poor aspect ratio . The structural arrangement in tall slender building may result in net tension structural element.

| Item No. | Observation | Recommended Action Plan | Recommended Timeline |
|---|---|---|---|
| 4 | Lack of lateral stability | Building engineer to review stability of the building against the lateral load. | 6-weeks |

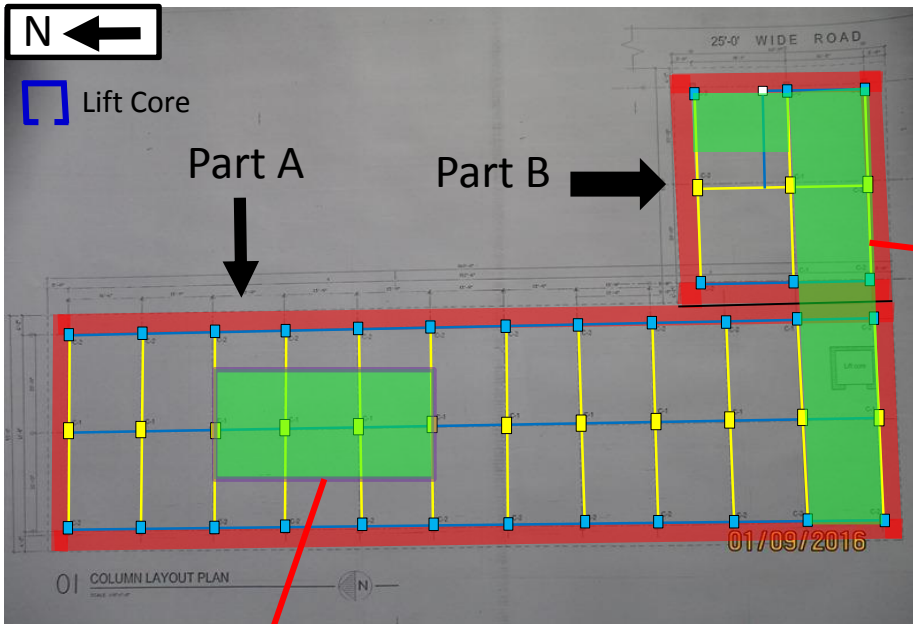
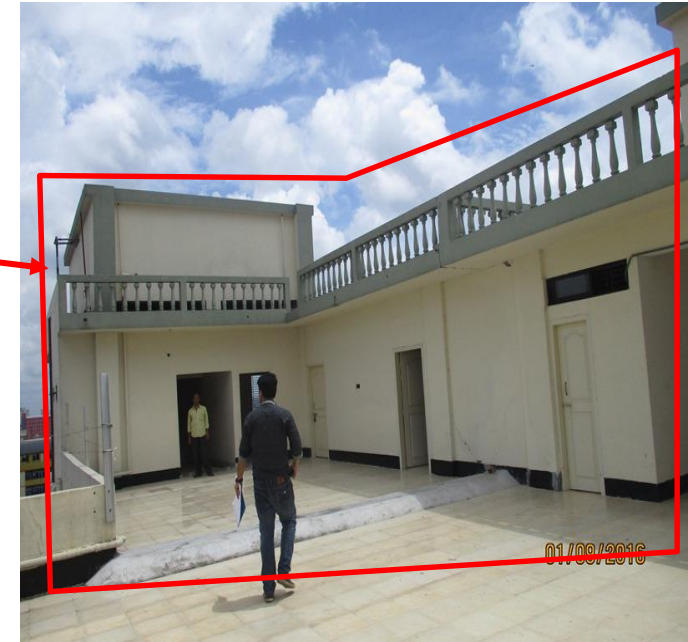
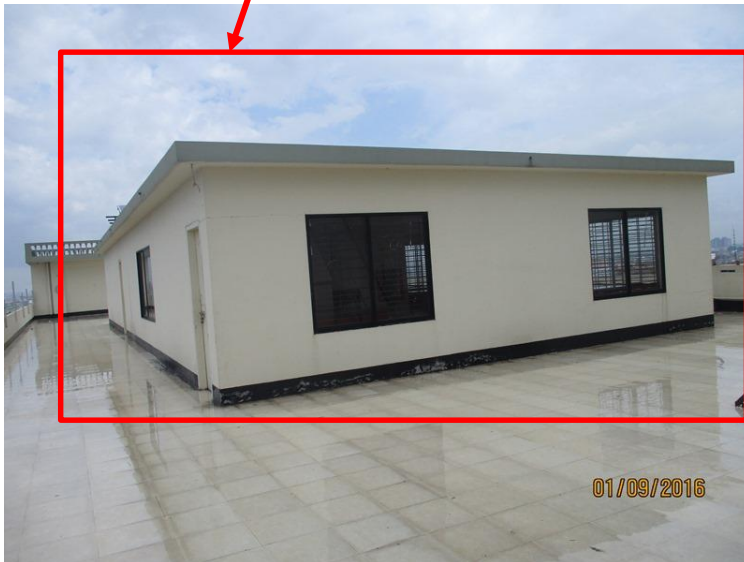
■ Undocumented extensions were found at roof level in both part-A and part-B of the building.

| Item No. | Observation | Recommended Action Plan | Recommended Timeline |
|---|---|---|---|
| 8 | Undocumented extension at roof level | Building engineer to review design and column stress considering the extension at roof level. | 6-weeks |
| 9 | Undocumented extension at roof level | Implement remedial work if required. | 6-months |

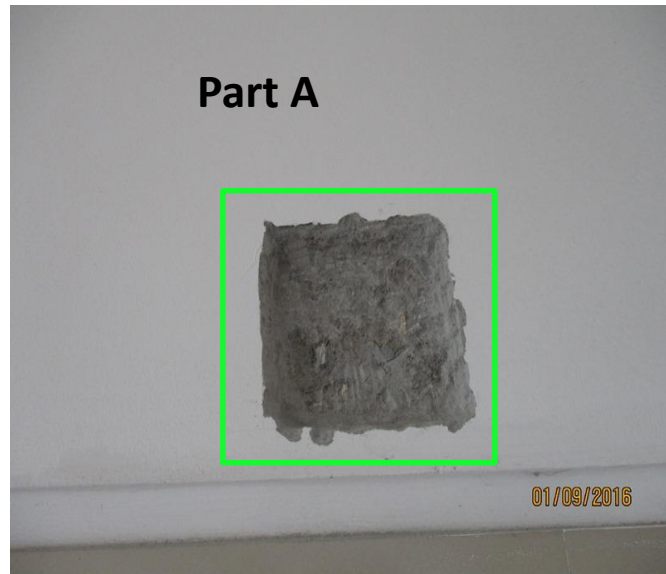
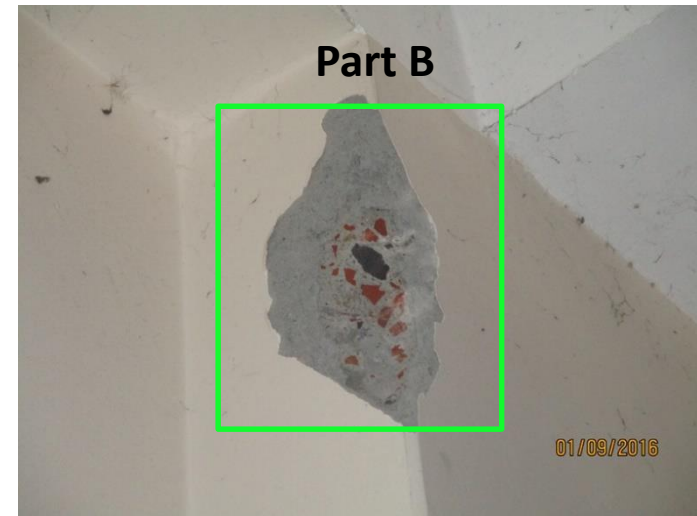
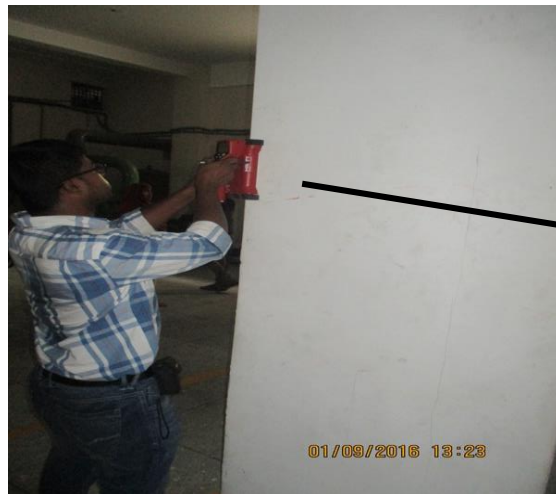
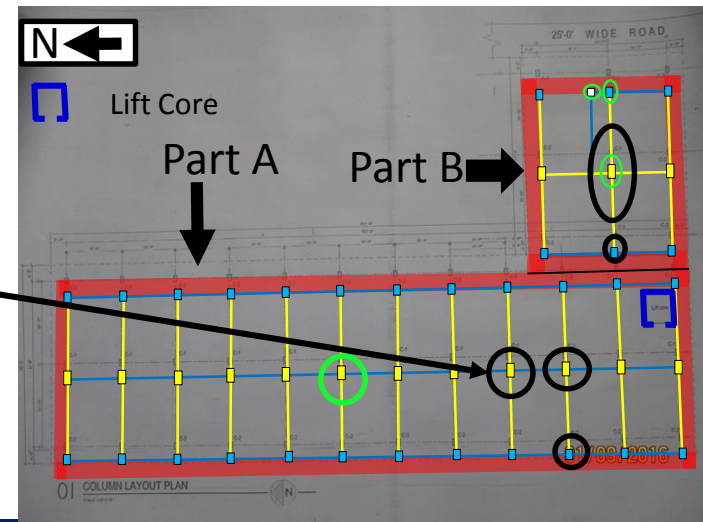
Stone aggregate found in column of Part-A and Brick aggregate found in part-B on 7<sup>th</sup> floor. Ferro scanning also carried out to figure out the no of rebar
